**OCEANA GOLD (NZ) LTD, MACRAES GOLD
PROJECT
TOP TIPPERARY TAILINGS STORAGE FACILITY
TECHNICAL REPORT**

13 April 2011

EXECUTIVE SUMMARY

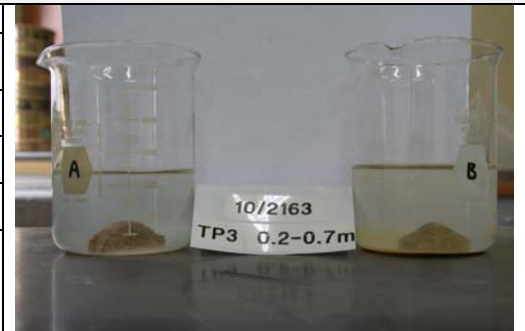
TP#3 - CRUMB TEST: ASTM D6572-06		
Elapsed Time	Estimated Slaking	Observations Recorded
2 min	< 5 %	Very minor colloid cloud
1 hr	100 %	Visible cloud evident
6 hr	100 %	Visible cloud evident
Crumb Test Classification:	Grade 3 (Dispersive)

- Distilled water was used in the pinhole dispersion and crumb test.
- The pinhole dispersion test sample was compacted to a target 95% of NZ standard compaction – see TP:17.
- The crumb test was carried out on a remoulded sample. Photograph at completion of test.
- The sample tested was the fraction passing a 2.00mm test sieve.

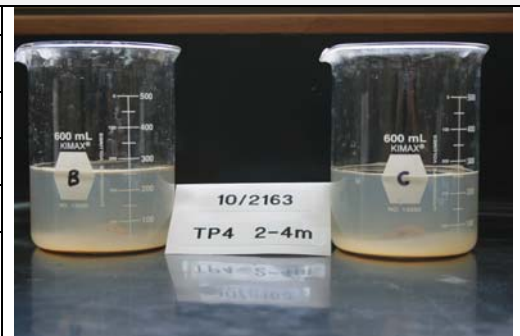
TP#4 - CRUMB TEST: ASTM D6572-06		
Elapsed Time	Estimated Slaking	Observations Recorded
2 min	≈ 5 %	Visible cloud over entire base
1 hr	100 %	Visible cloud ≈ 10mm high over entire base
6 hr	100 %	Visible cloud ≈ 5mm high over entire base
Crumb Test Classification:	Grade 4 (Highly Dispersive)

- Distilled water was used in the pinhole dispersion and crumb test.
- The pinhole dispersion test sample was compacted to a target 95% of NZ standard compaction – see TP:4.
- The crumb test was carried out on a remoulded sample. Photograph at completion of test.
- The sample tested was the fraction passing a 2.00mm test sieve.

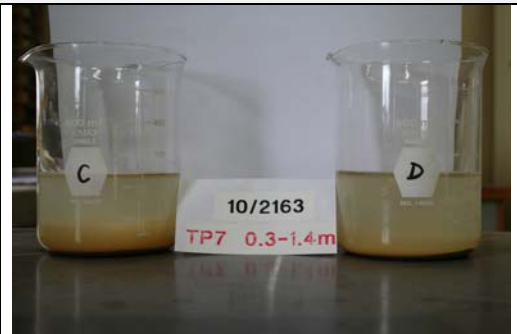
TP#7 - CRUMB TEST: ASTM D6572-06		
Elapsed Time	Estimated Slaking	Observations Recorded
2 min	< 5 %	Visible cloud over entire base
1 hr	≈ 80 %	Visible cloud ≈ 20mm high over entire base
6 hr	100 %	Visible cloud ≈ 20mm high over entire base
Crumb Test Classification:	Grade 4 (Highly Dispersive)

- Distilled water was used in the pinhole dispersion and crumb test.
- The pinhole dispersion test sample was compacted to a target 95% of NZ standard compaction – see TP:17.
- The crumb test was carried out on a remoulded sample. Photograph at completion of test.
- The sample tested was the fraction passing a 2.00mm test sieve.

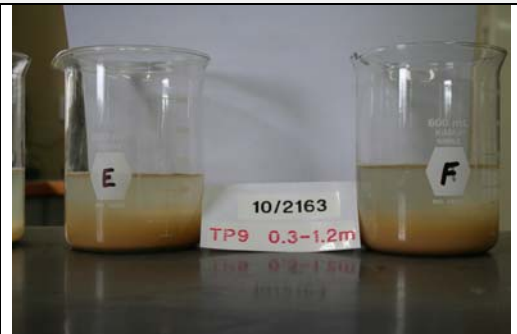
TP#9 - CRUMB TEST: ASTM D6572-06		
Elapsed Time	Estimated Slaking	Observations Recorded
2 min	< 5 %	Visible cloud over entire base
1 hr	≈ 50 %	Visible cloud ≈ 25mm high over entire base
6 hr	100 %	Visible cloud ≈ 25mm high over entire base
Crumb Test Classification:	Grade 4 (Highly Dispersive)

- Distilled water was used in the pinhole dispersion and crumb test.
- The pinhole dispersion test sample was compacted to a target 95% of NZ standard compaction – see TP:11.
- The crumb test was carried out on a remoulded sample. Photograph at completion of test.
- The sample tested was the fraction passing a 2.00mm test sieve.

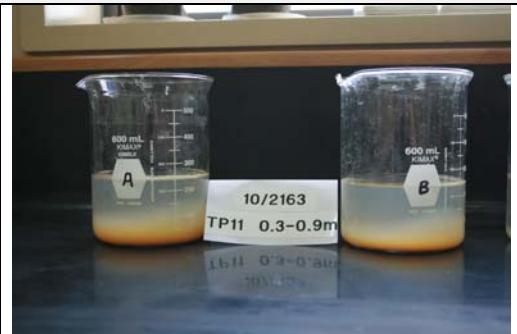
TP#11 - CRUMB TEST: ASTM D6572-06		
Elapsed Time	Estimated Slaking	Observations Recorded
2 min	≈ 2 %	Visible cloud over entire base
1 hr	100 %	Visible cloud ≈ 20mm high over entire base
6 hr	100 %	Visible cloud ≈ 20mm high over entire base
Crumb Test Classification:	Grade 4 (Highly Dispersive)

- Distilled water was used in the pinhole dispersion and crumb test.
- The pinhole dispersion test sample was compacted to a target 95% of NZ standard compaction – see TP:11.
- The crumb test was carried out on a remoulded sample. Photograph at completion of test.
- The sample tested was the fraction passing a 2.00mm test sieve.

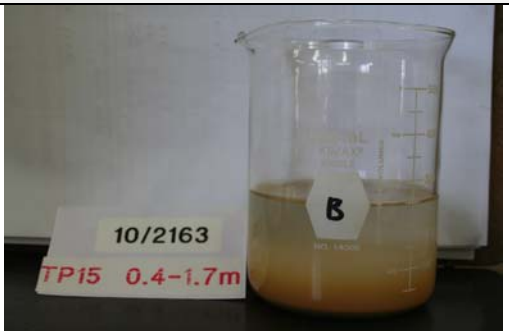
TP#15 - CRUMB TEST: ASTM D6572-06		
Elapsed Time	Estimated Slaking	Observations Recorded
2 min	< 5 %	Cloud surrounding sample
1 hr	≈ 75 %	Visible cloud ≈ 20mm high over entire base
6 hr	100 %	Visible cloud ≈ 20mm high over entire base
Crumb Test Classification:	Grade 4 (Highly Dispersive)

- Distilled water was used in the pinhole dispersion and crumb test.
- The pinhole dispersion test sample was compacted to a target 95% of NZ standard compaction – see TP:11.
- The crumb test was carried out on a remoulded sample. Photograph at completion of test.
- The sample tested was the fraction passing a 2.00mm test sieve.

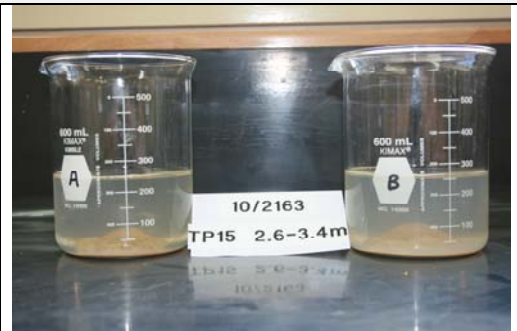
TP#15 - CRUMB TEST: ASTM D6572-06		
Elapsed Time	Estimated Slaking	Observations Recorded
2 min	≈ 5 %	Visible cloud over entire base
1 hr	100 %	Visible cloud ≈ 5mm high over entire base
6 hr	100 %	Slightly visible cloud over entire base
Crumb Test Classification:	Grade 3 (Moderately Dispersive)

- Distilled water was used in the pinhole dispersion and crumb test.
- The pinhole dispersion test sample was compacted to a target 95% of NZ standard compaction – see TP:15.
- The crumb test was carried out on a remoulded sample. Photograph at completion of test.
- The sample tested was the fraction passing a 2.00mm test sieve.

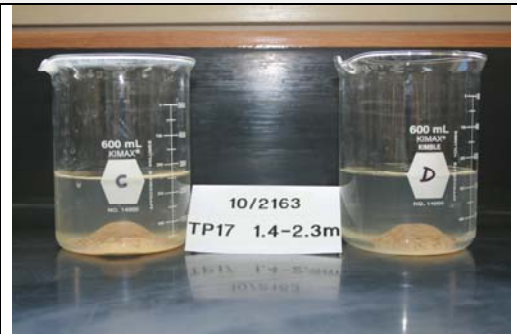
TP#17 - CRUMB TEST: ASTM D6572-06		
Elapsed Time	Estimated Slaking	Observations Recorded
2 min	≈ 10 %	Slight reaction around sample
1 hr	100 %	No colloidal cloud evident
6 hr	100 %	No colloidal cloud evident
Crumb Test Classification:	Grade 1 (Non Dispersive)

- Distilled water was used in the pinhole dispersion and crumb test.
- The pinhole dispersion test sample was compacted to a target 95% of NZ standard compaction – see TP:17.
- The crumb test was carried out on a remoulded sample. Photograph at completion of test.
- The sample tested was the fraction passing a 2.00mm test sieve.

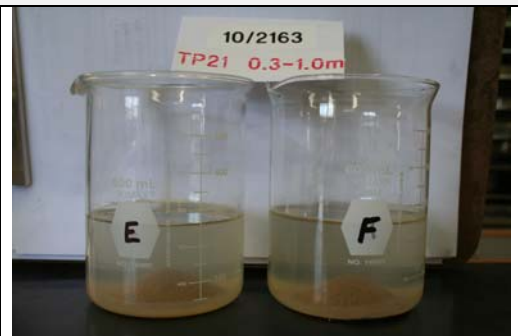
TP#21 - CRUMB TEST: ASTM D6572-06		
Elapsed Time	Estimated Slaking	Observations Recorded
2 min	≈ 20 %	Visible cloud over entire base
1 hr	100 %	Visible cloud ≈ 5mm high over entire base
6 hr	100 %	Visible cloud < 5mm high over entire base
Crumb Test Classification:	Grade 3/4 (Highly Dispersive)

- Distilled water was used in the pinhole dispersion and crumb test.
- The pinhole dispersion test sample was compacted to a target 95% of NZ standard compaction – see TP:11.
- The crumb test was carried out on a remoulded sample. Photograph at completion of test.
- The sample tested was the fraction passing a 2.00mm test sieve.

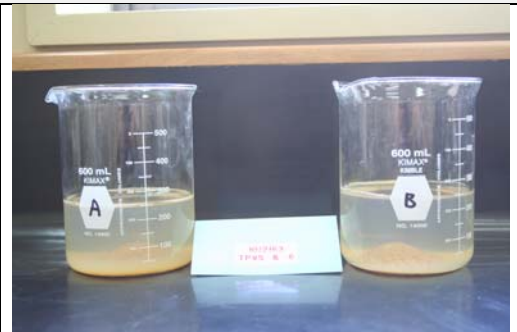
TP#5 & TP#6 - CRUMB TEST: ASTM D6572-06		
Elapsed Time	Estimated Slaking	Observations Recorded
2 min	< 2 %	Visible colloid cloud around sample
1 hr	100 %	Visible cloud evident ≈ 5mm over entire base
6 hr	100 %	Visible cloud evident ≈ 5mm over entire base
Crumb Test Classification:	Grade 3 (Dispersive)

- Distilled water was used in the pinhole dispersion and crumb test.
- The pinhole dispersion test sample was compacted to a target 95% of NZ vibrating hammer compaction (corrected for +2mm fraction).
- The crumb test was carried out on a remoulded sample. Photograph at completion of test.
- The sample tested was the fraction passing a 2.00mm test sieve.

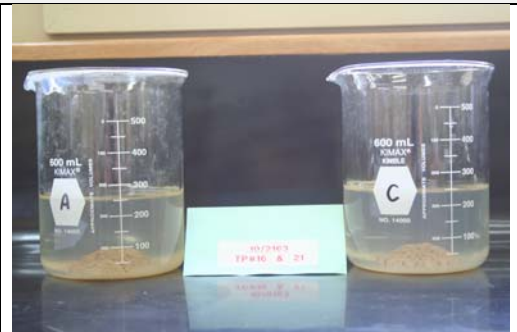
TP#16 & TP#21 - CRUMB TEST: ASTM D6572-06		
Elapsed Time	Estimated Slaking	Observations Recorded
2 min	> 50 %	Visible colloid cloud around sample
1 hr	100 %	Visible cloud evident over entire base
6 hr	100 %	Slightly visible cloud evident
Crumb Test Classification:	Grade 2/3 (Intermediate to Dispersive)

- Distilled water was used in the pinhole dispersion and crumb test.
- The pinhole dispersion test sample was compacted to a target 95% of NZ vibrating hammer compaction (corrected for +2mm fraction).
- The crumb test was carried out on a remoulded sample. Photograph at completion of test.
- The sample tested was the fraction passing a 2.00mm test sieve.

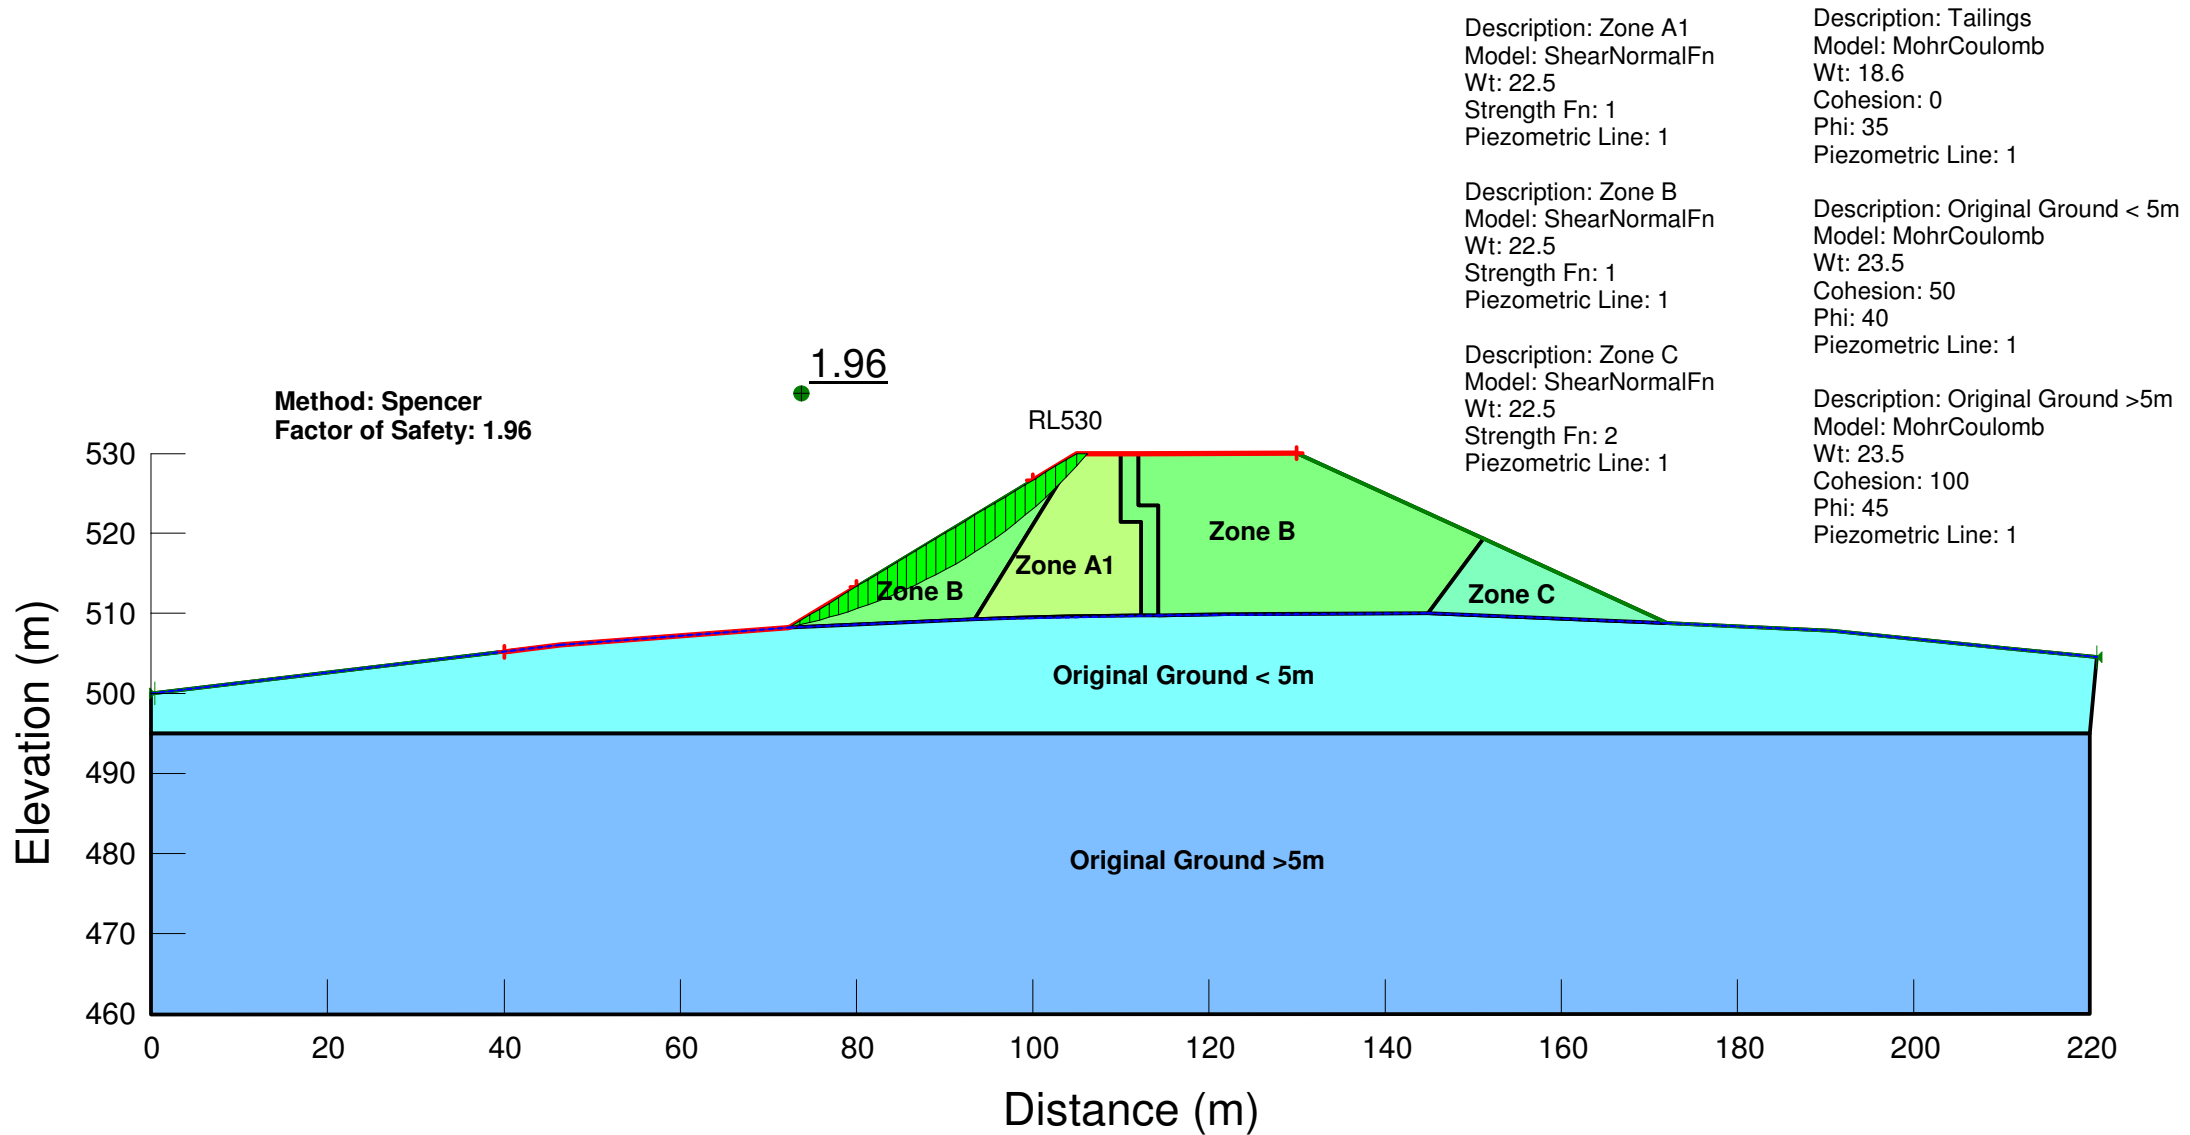
Figure D3

Oceana Gold Mine - Top Tipperary TSF RL530 - Typical Section
Long Term - Static Analysis for Upstream Shoulder

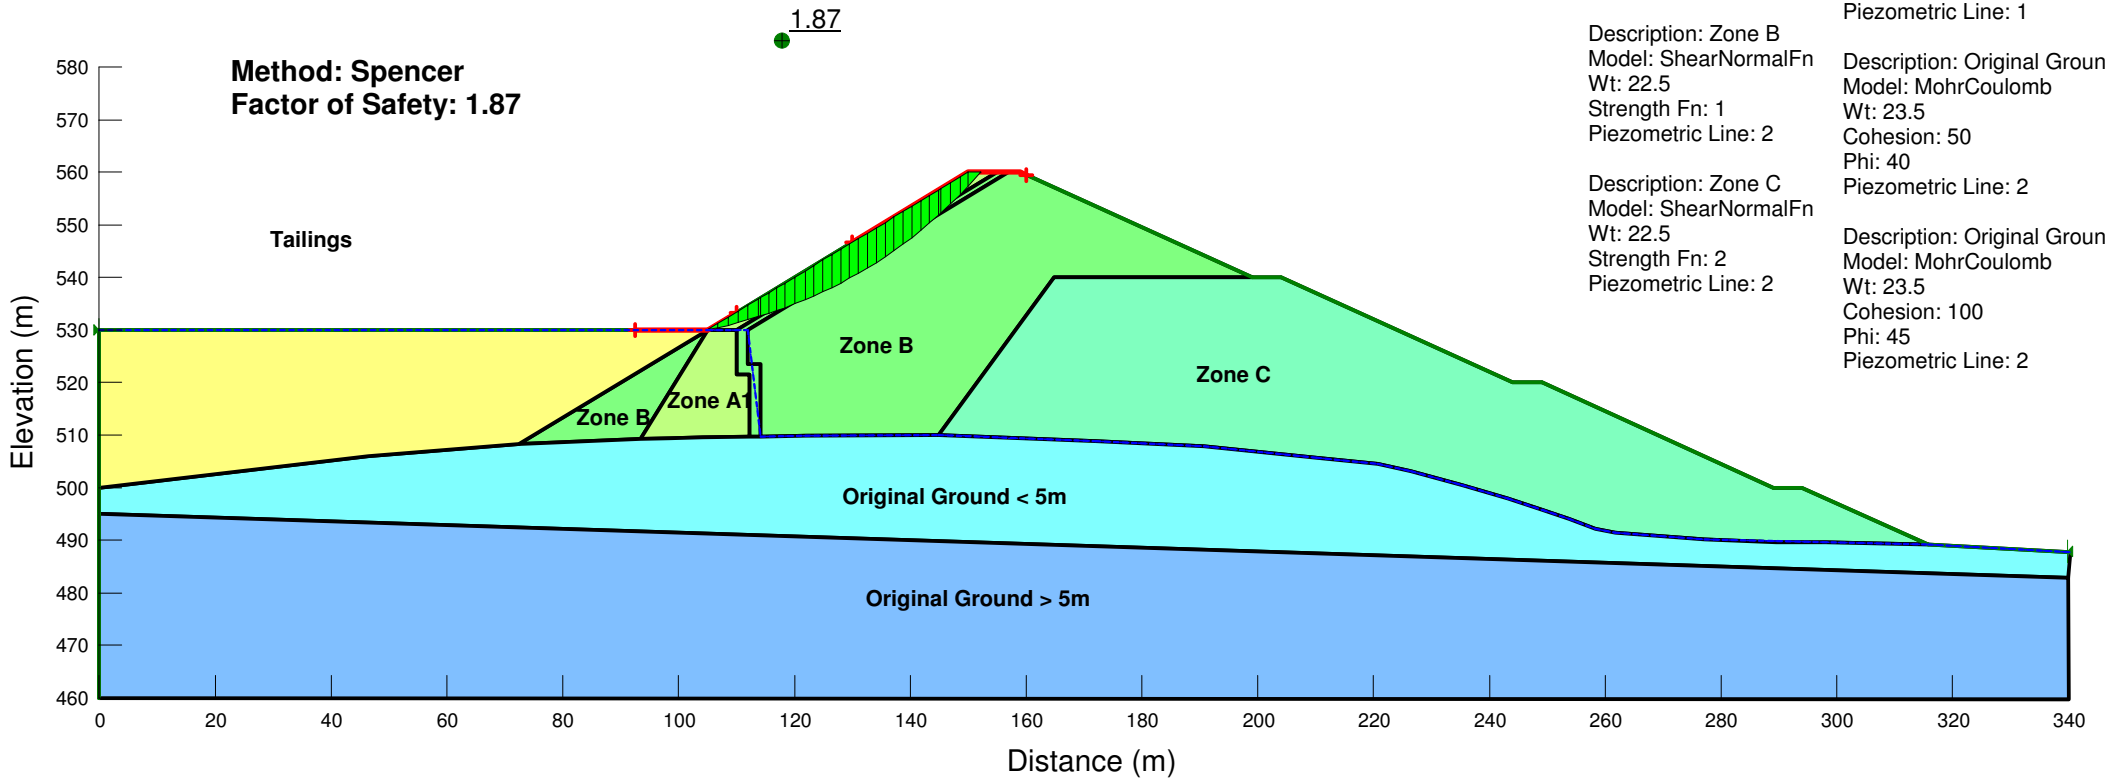
Oceana Gold Mine - Top Tipperary TSF RL560 - Typical Section
Long Term - Static Analysis for Upstream Shoulder

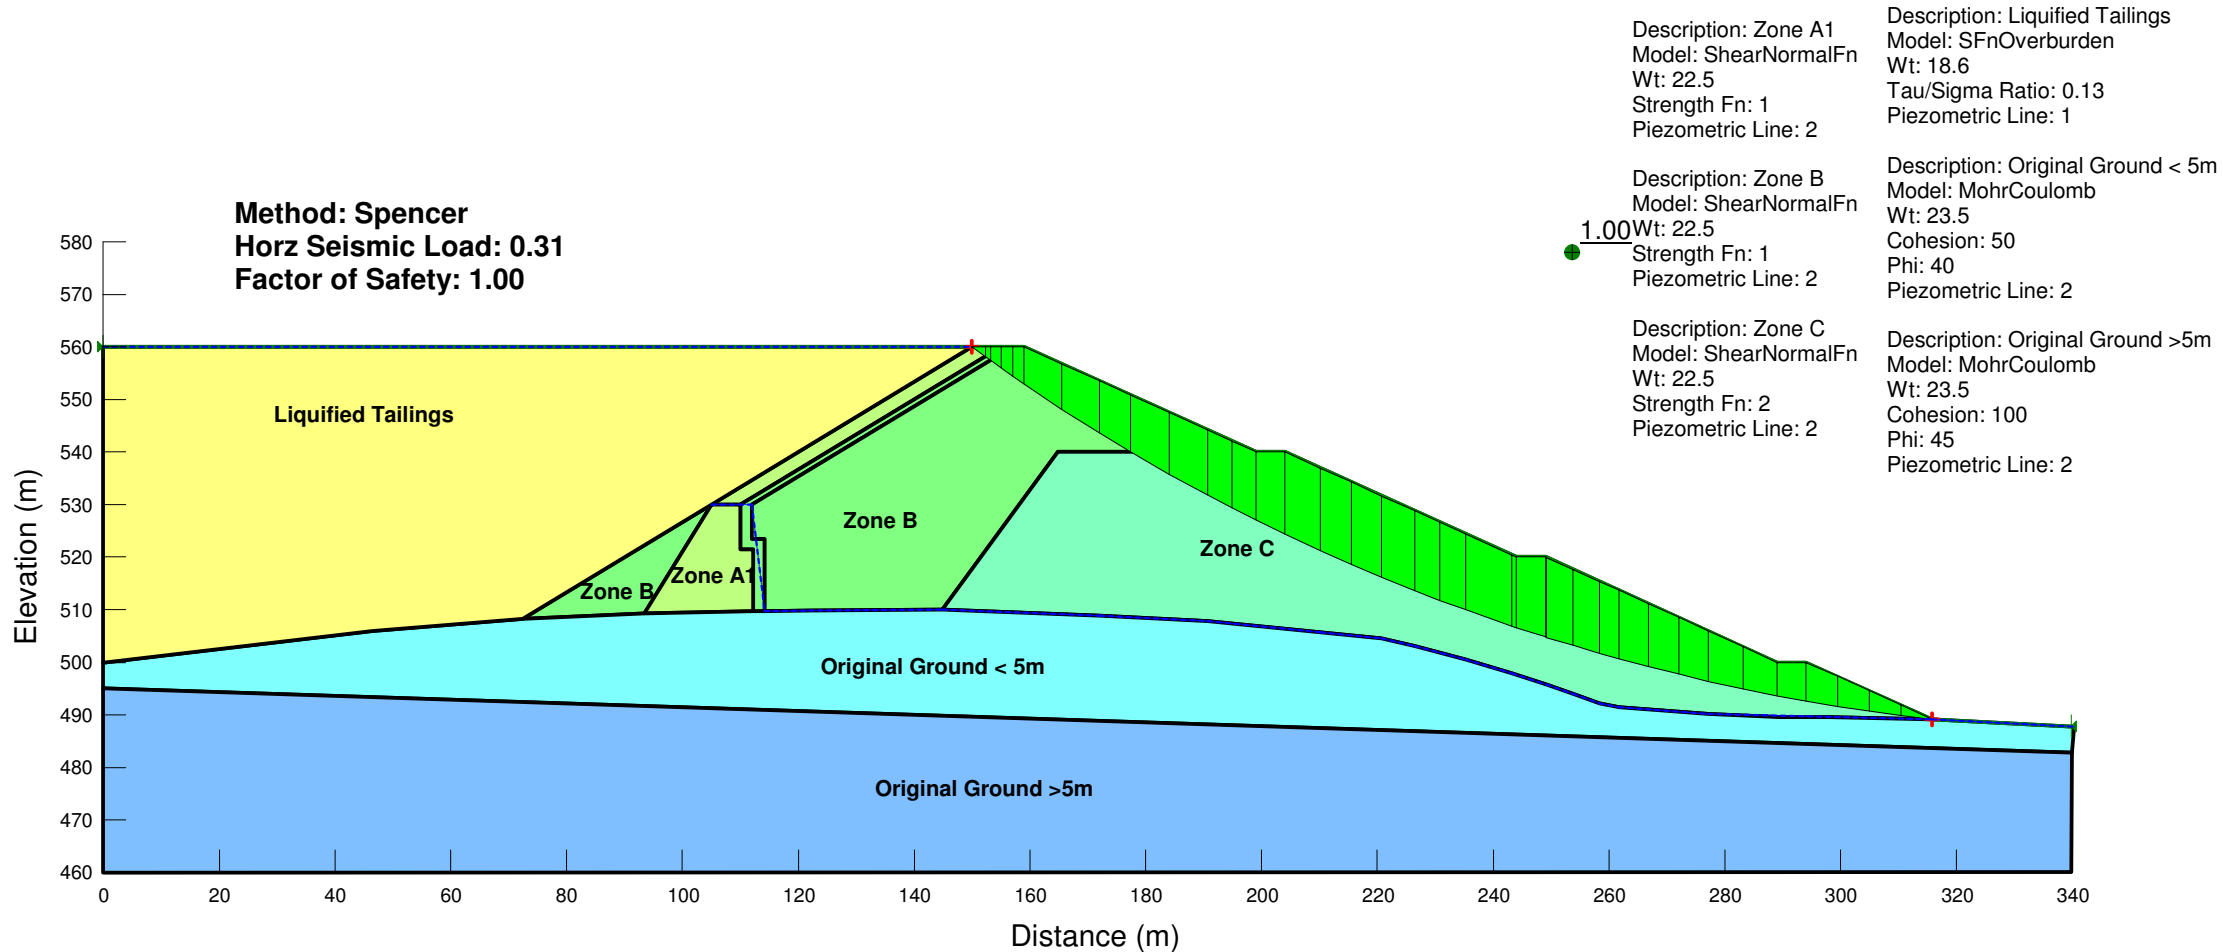
Oceana Gold Mine - Top Tipperary TSF RL560 - Typical Section
Earthquake 2500 Yr Return Period - Full Dam Height (Yield Acceleration)
