DWG REF: FLOOD-5665-3-CAMP

DRAWING TITLE:
**MACRAES
 GOLD
 PROJECT**

CAMP CREEK DAM
 INUNDATION MAP
 FOR BREACH ASSOCIATED
 WITH 1 in 100 AEP FLOOD EVENT

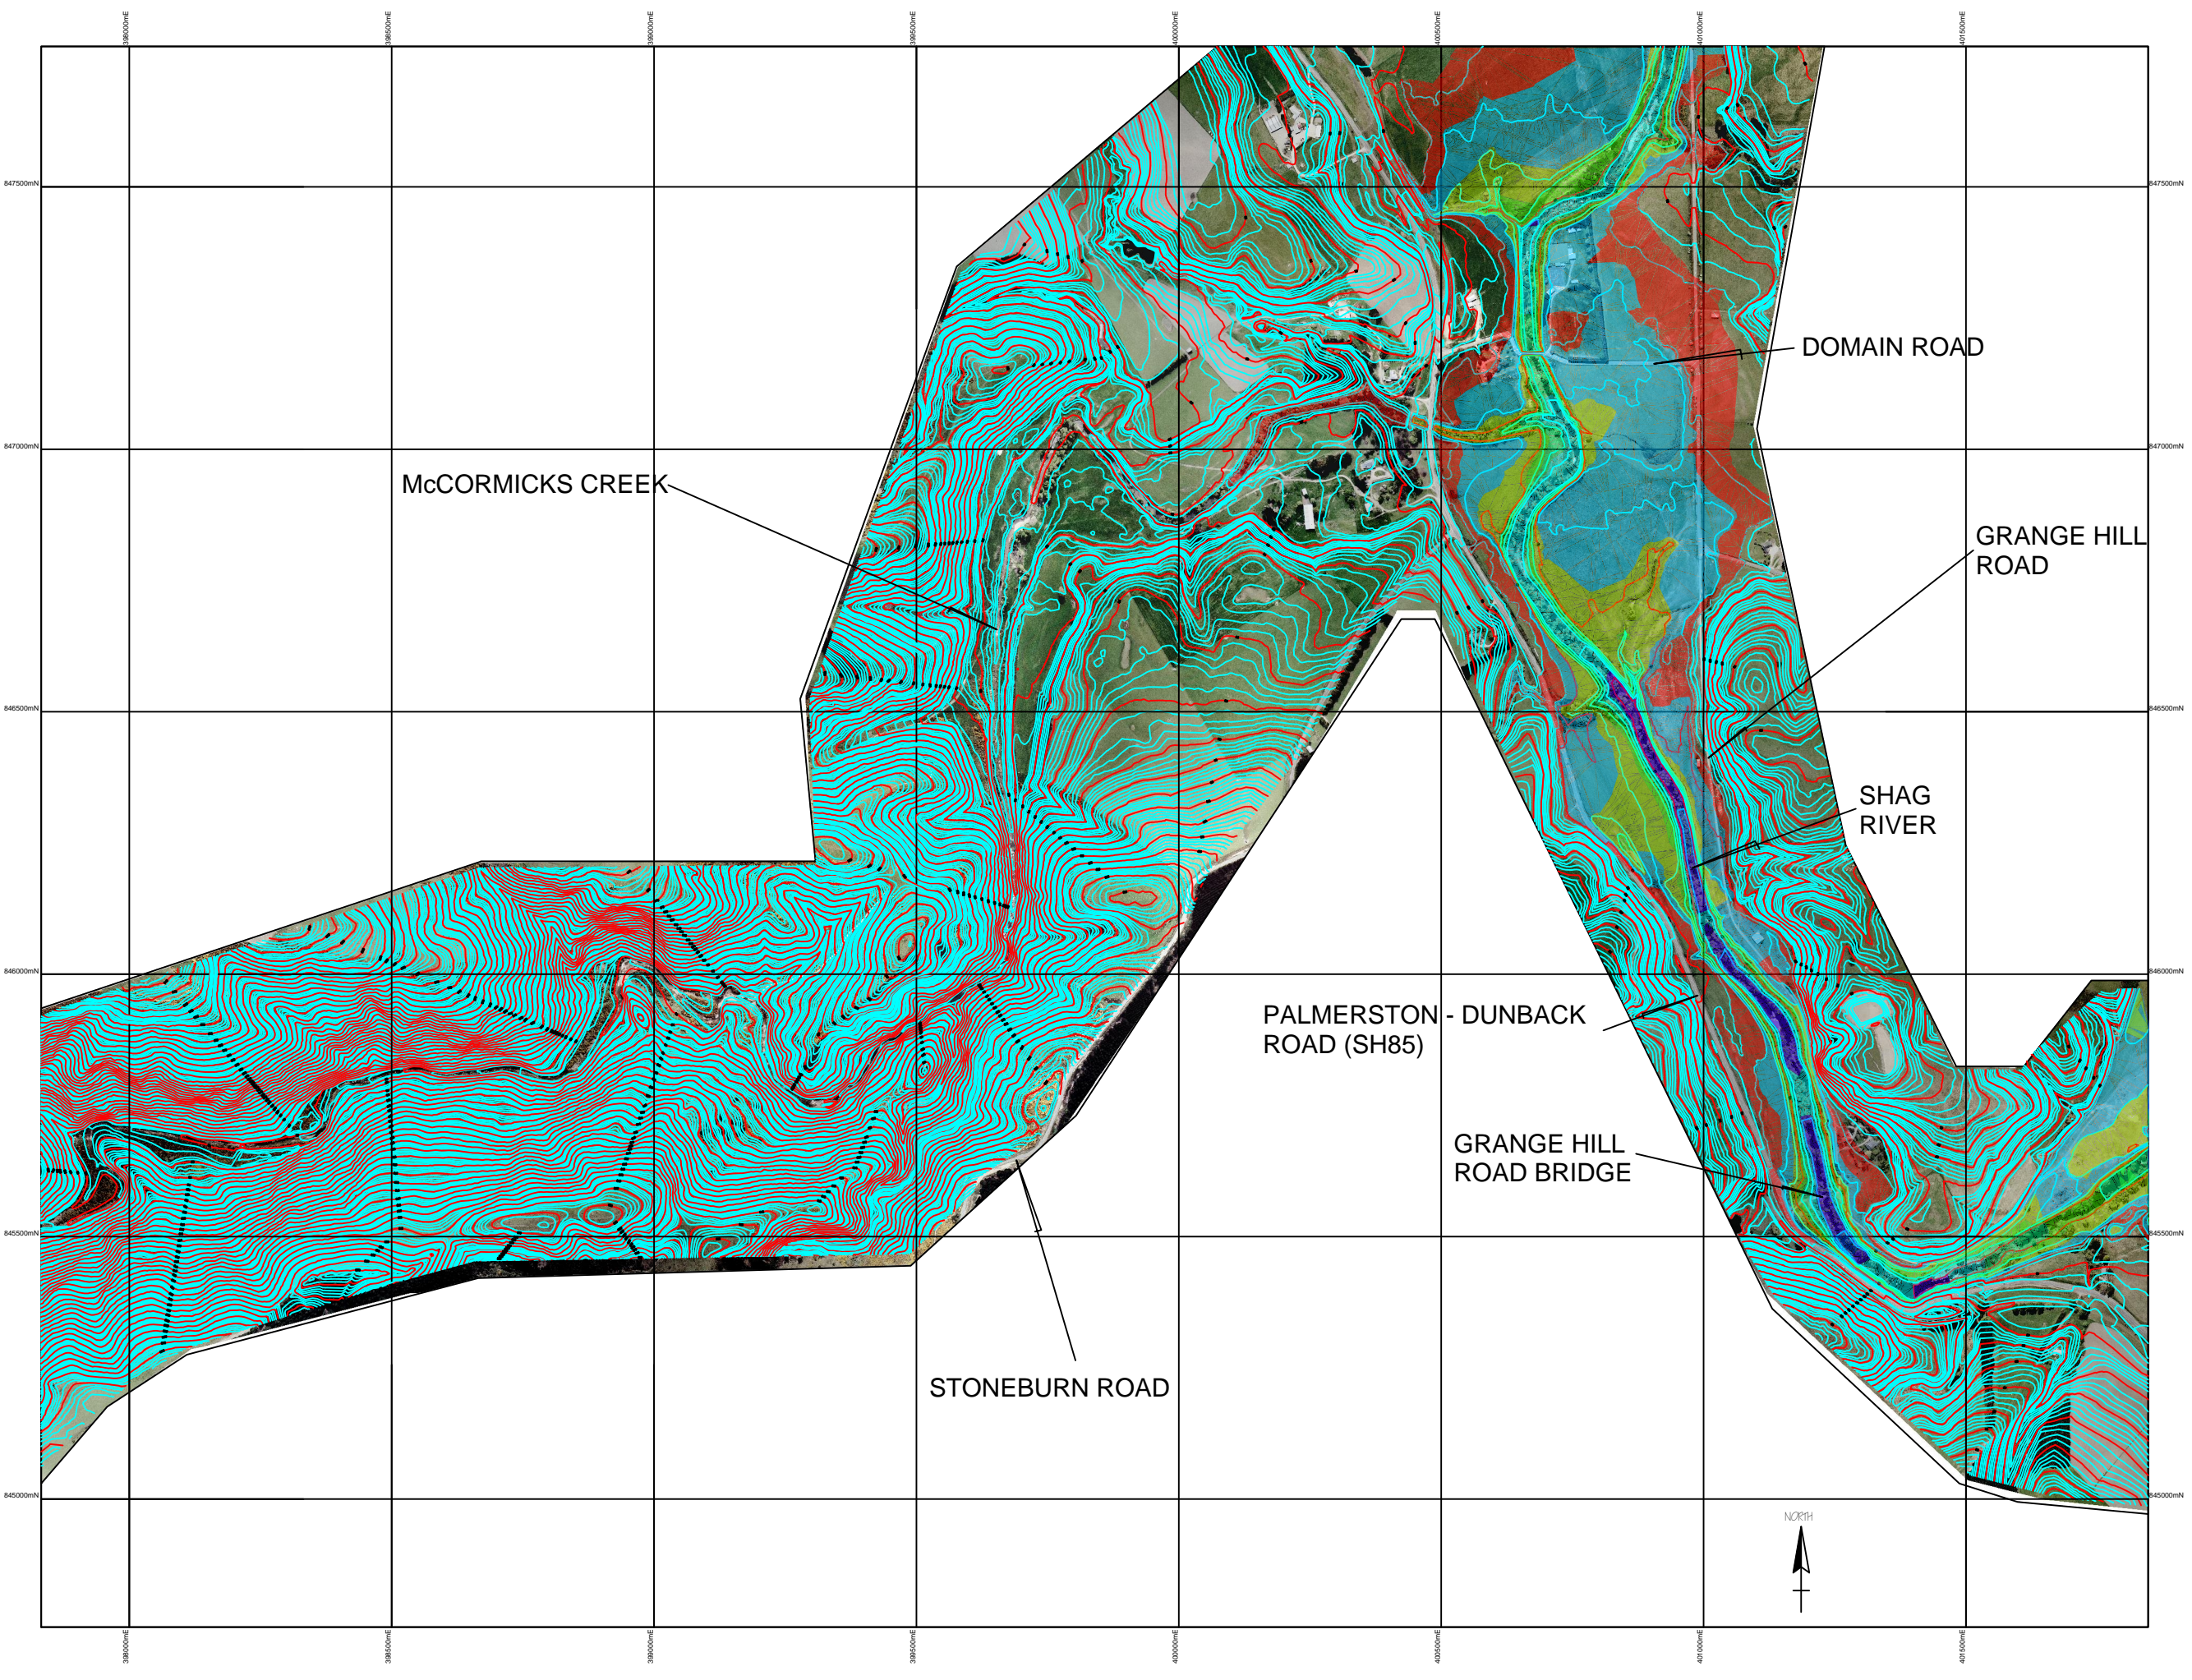
Photogrammetry by: PRECISION AERIAL SURVEYS
 Photography Date: 13th OCTOBER 2010
 Negatives Used: N13102028 - N13102040
 Photo control by: PRECISION AERIAL SURVEYS
 Co-Ordinate Circuit: OBSERVATION POINT 2000
 Datum: MACRAES MINE
 Contour Interval: 1M

DEPTH OF INUNDATION (m)			
Number	Minimum Depth	Maximum Depth	Color
1	0.000	1.00	Red
2	1.00	2.00	Orange
3	2.00	3.00	Yellow
4	3.00	4.00	Light Green
5	4.00	5.00	Green
6	5.00	6.00	Dark Green
7	6.00	7.00	Blue
8	7.00	8.00	Dark Blue
9	8.00	9.00	Very Dark Blue
10	9.00	10.00	Black
11	10.00	11.00	White
