ORIGINAL DATE: DECEMBER 2010
 SCALE @ A1: 1 : 6000
 DWS REF: FLOOD-5665-6-CAMP

DRAWING TITLE
MACRAES GOLD PROJECT

CAMP CREEK DAM
 INUNDATION MAP
 FOR BREACH ASSOCIATED
 WITH 1 in 100 AEP FLOOD EVENT

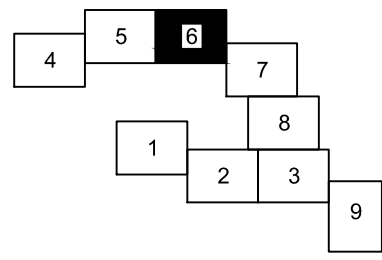
DEPTH OF INUNDATION (m)			
Number	Minimum Depth	Maximum Depth	Color
1	0.00	1.00	Red
2	1.00	2.00	Orange
3	2.00	3.00	Yellow
4	3.00	4.00	Light Green
5	4.00	5.00	Green
6	5.00	6.00	Light Blue
7	6.00	7.00	Blue
8	7.00	8.00	Dark Blue
9	8.00	9.00	Very Dark Blue
10	9.00	10.00	Black
11	10.00	11.00	Black
11	11.00	12.00	Black
