DWG REF
 FLOOD-5665-8-CAMP

DRAWING TITLE
**MACRAES
 GOLD
 PROJECT**

CAMP CREEK DAM
 INUNDATION MAP
 FOR BREACH ASSOCIATED
 WITH 1 in 100 AEP FLOOD EVENT

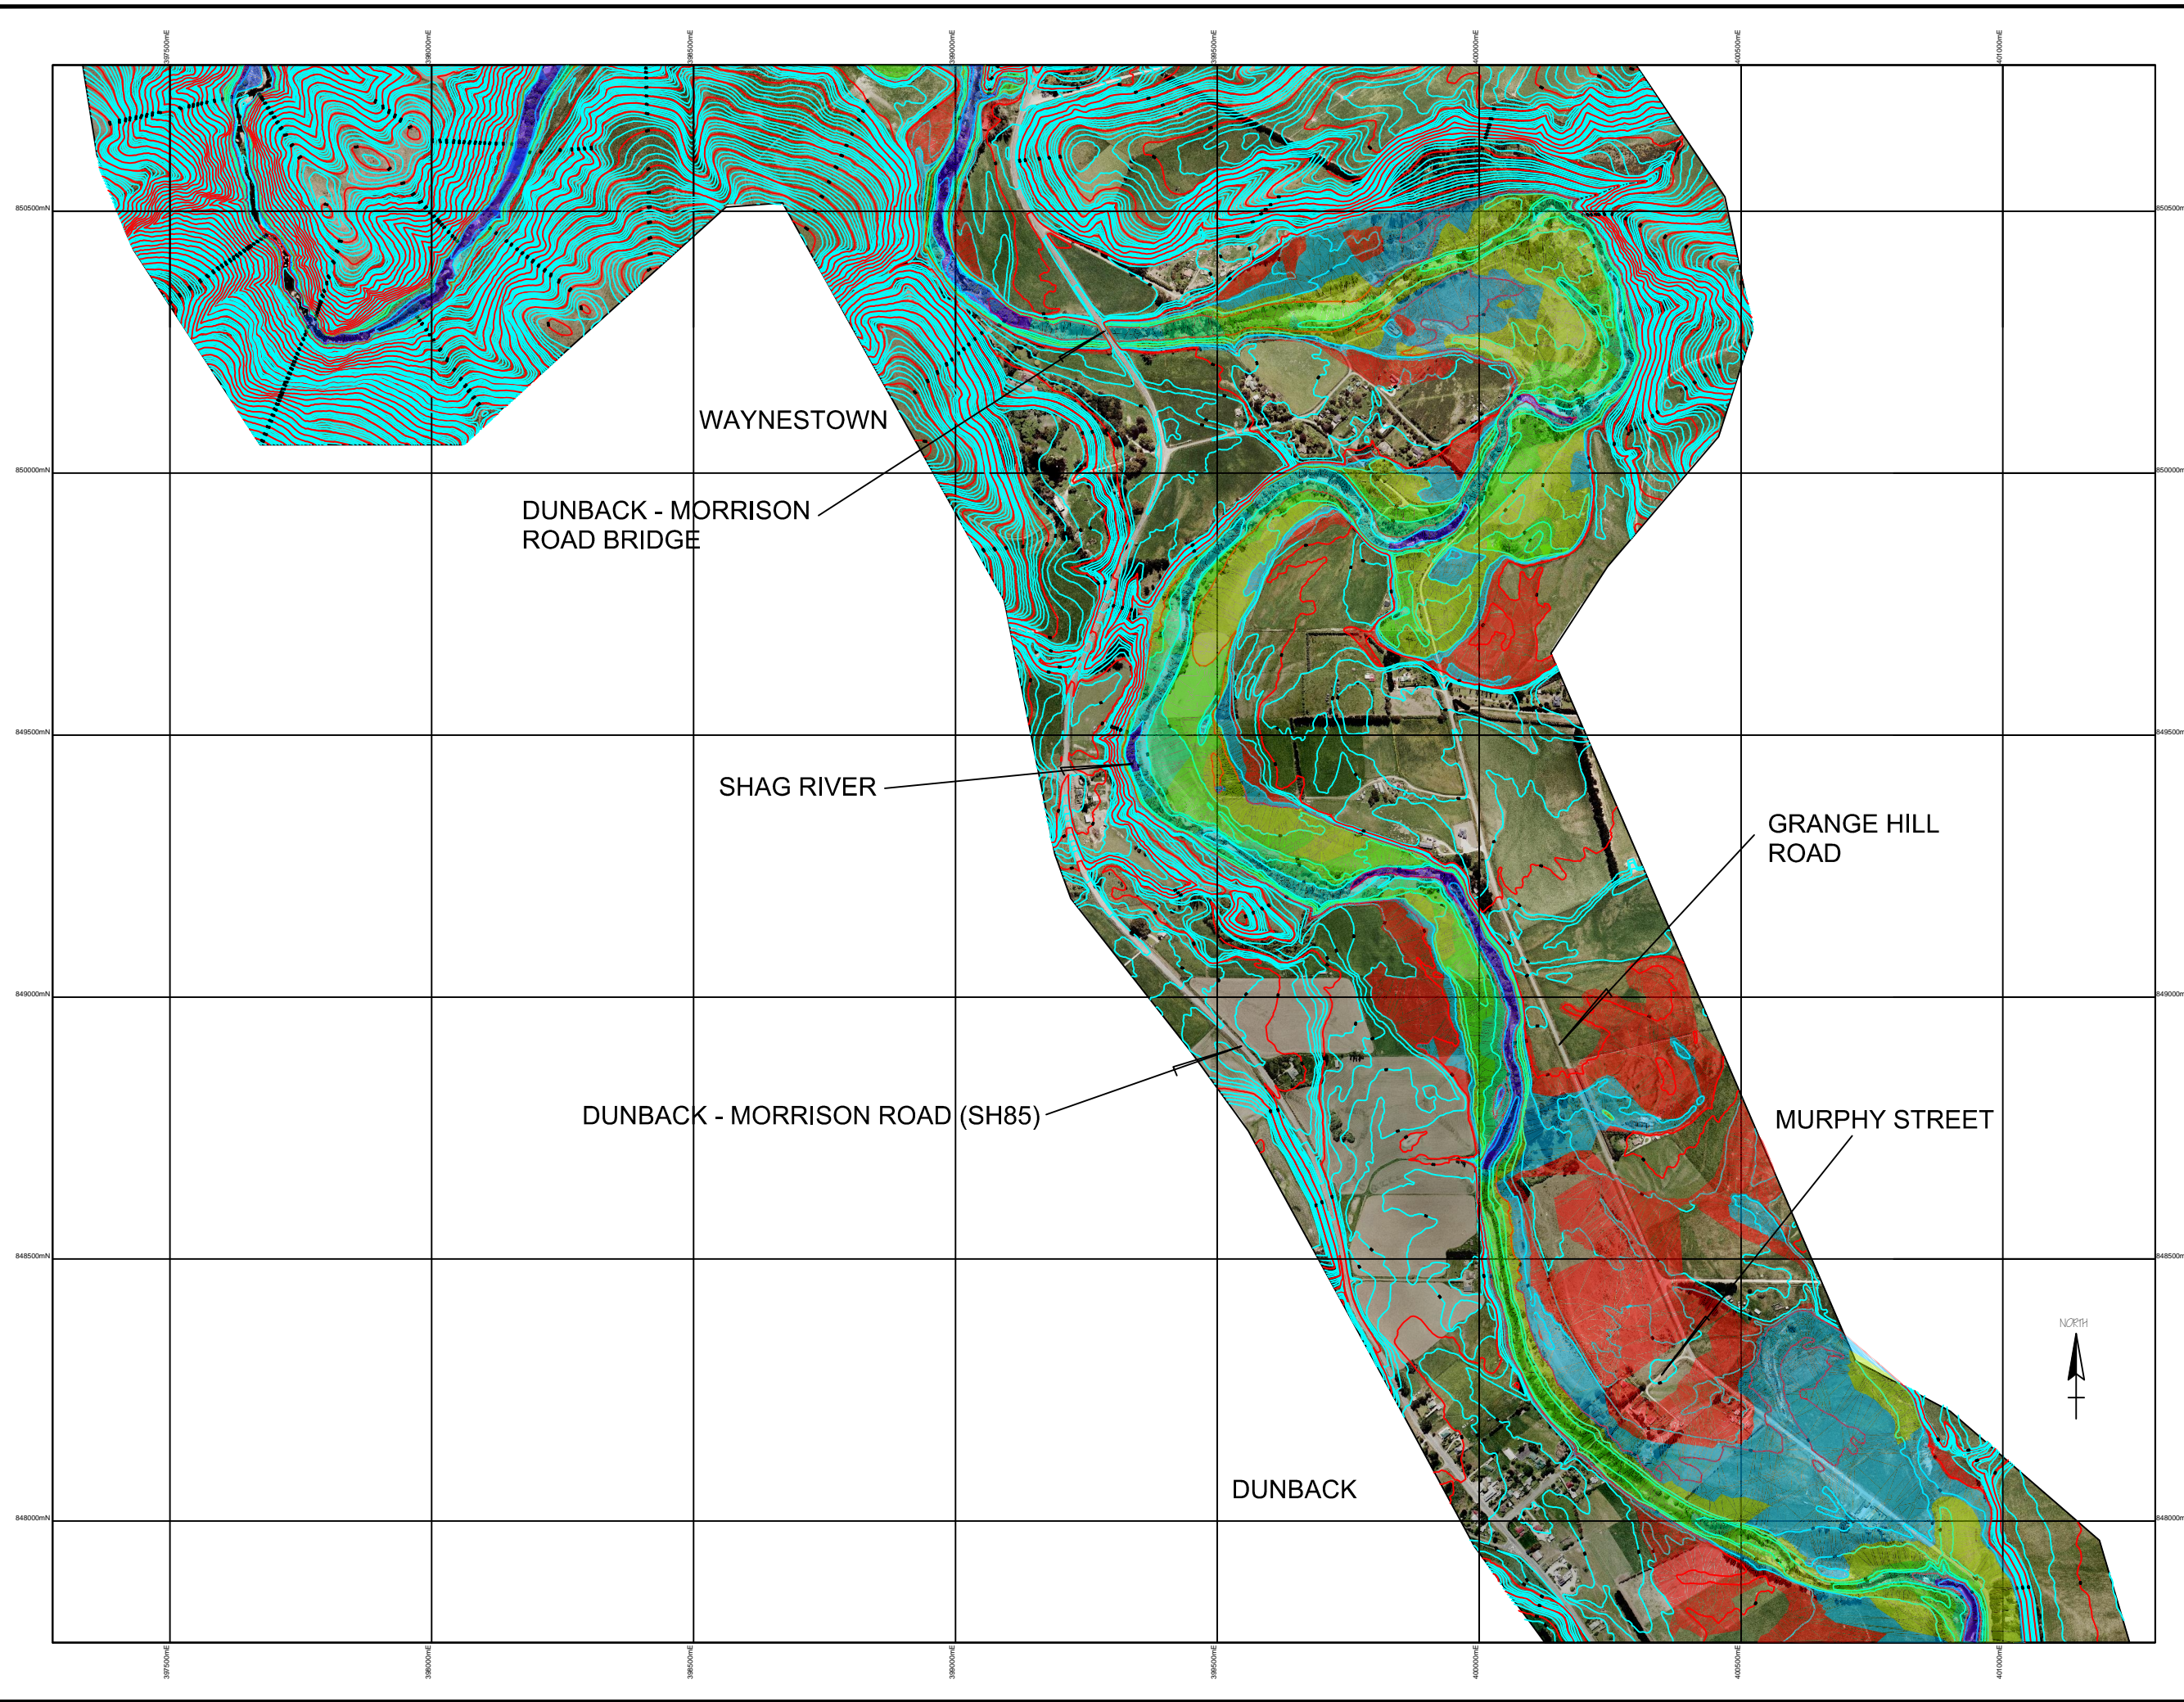
DEPTH OF INUNDATION (m)			
Number	Minimum Depth	Maximum Depth	Color
1	0.00	1.00	Red
2	1.00	2.00	Orange
3	2.00	3.00	Yellow
4	3.00	4.00	Light Green
5	4.00	5.00	Green
6	5.00	6.00	Light Blue
7	6.00	7.00	Blue
8	7.00	8.00	Dark Blue
9	8.00	9.00	Very Dark Blue
10	9.00	10.00	Black
11	10.00	11.00	Dark Purple
