DRAWING TITLE:
**MACRAES
 GOLD
 PROJECT**

CAMP CREEK DAM
 INUNDATION MAP
 FOR BREACH ASSOCIATED
 WITH 1 in 100 AEP FLOOD EVENT

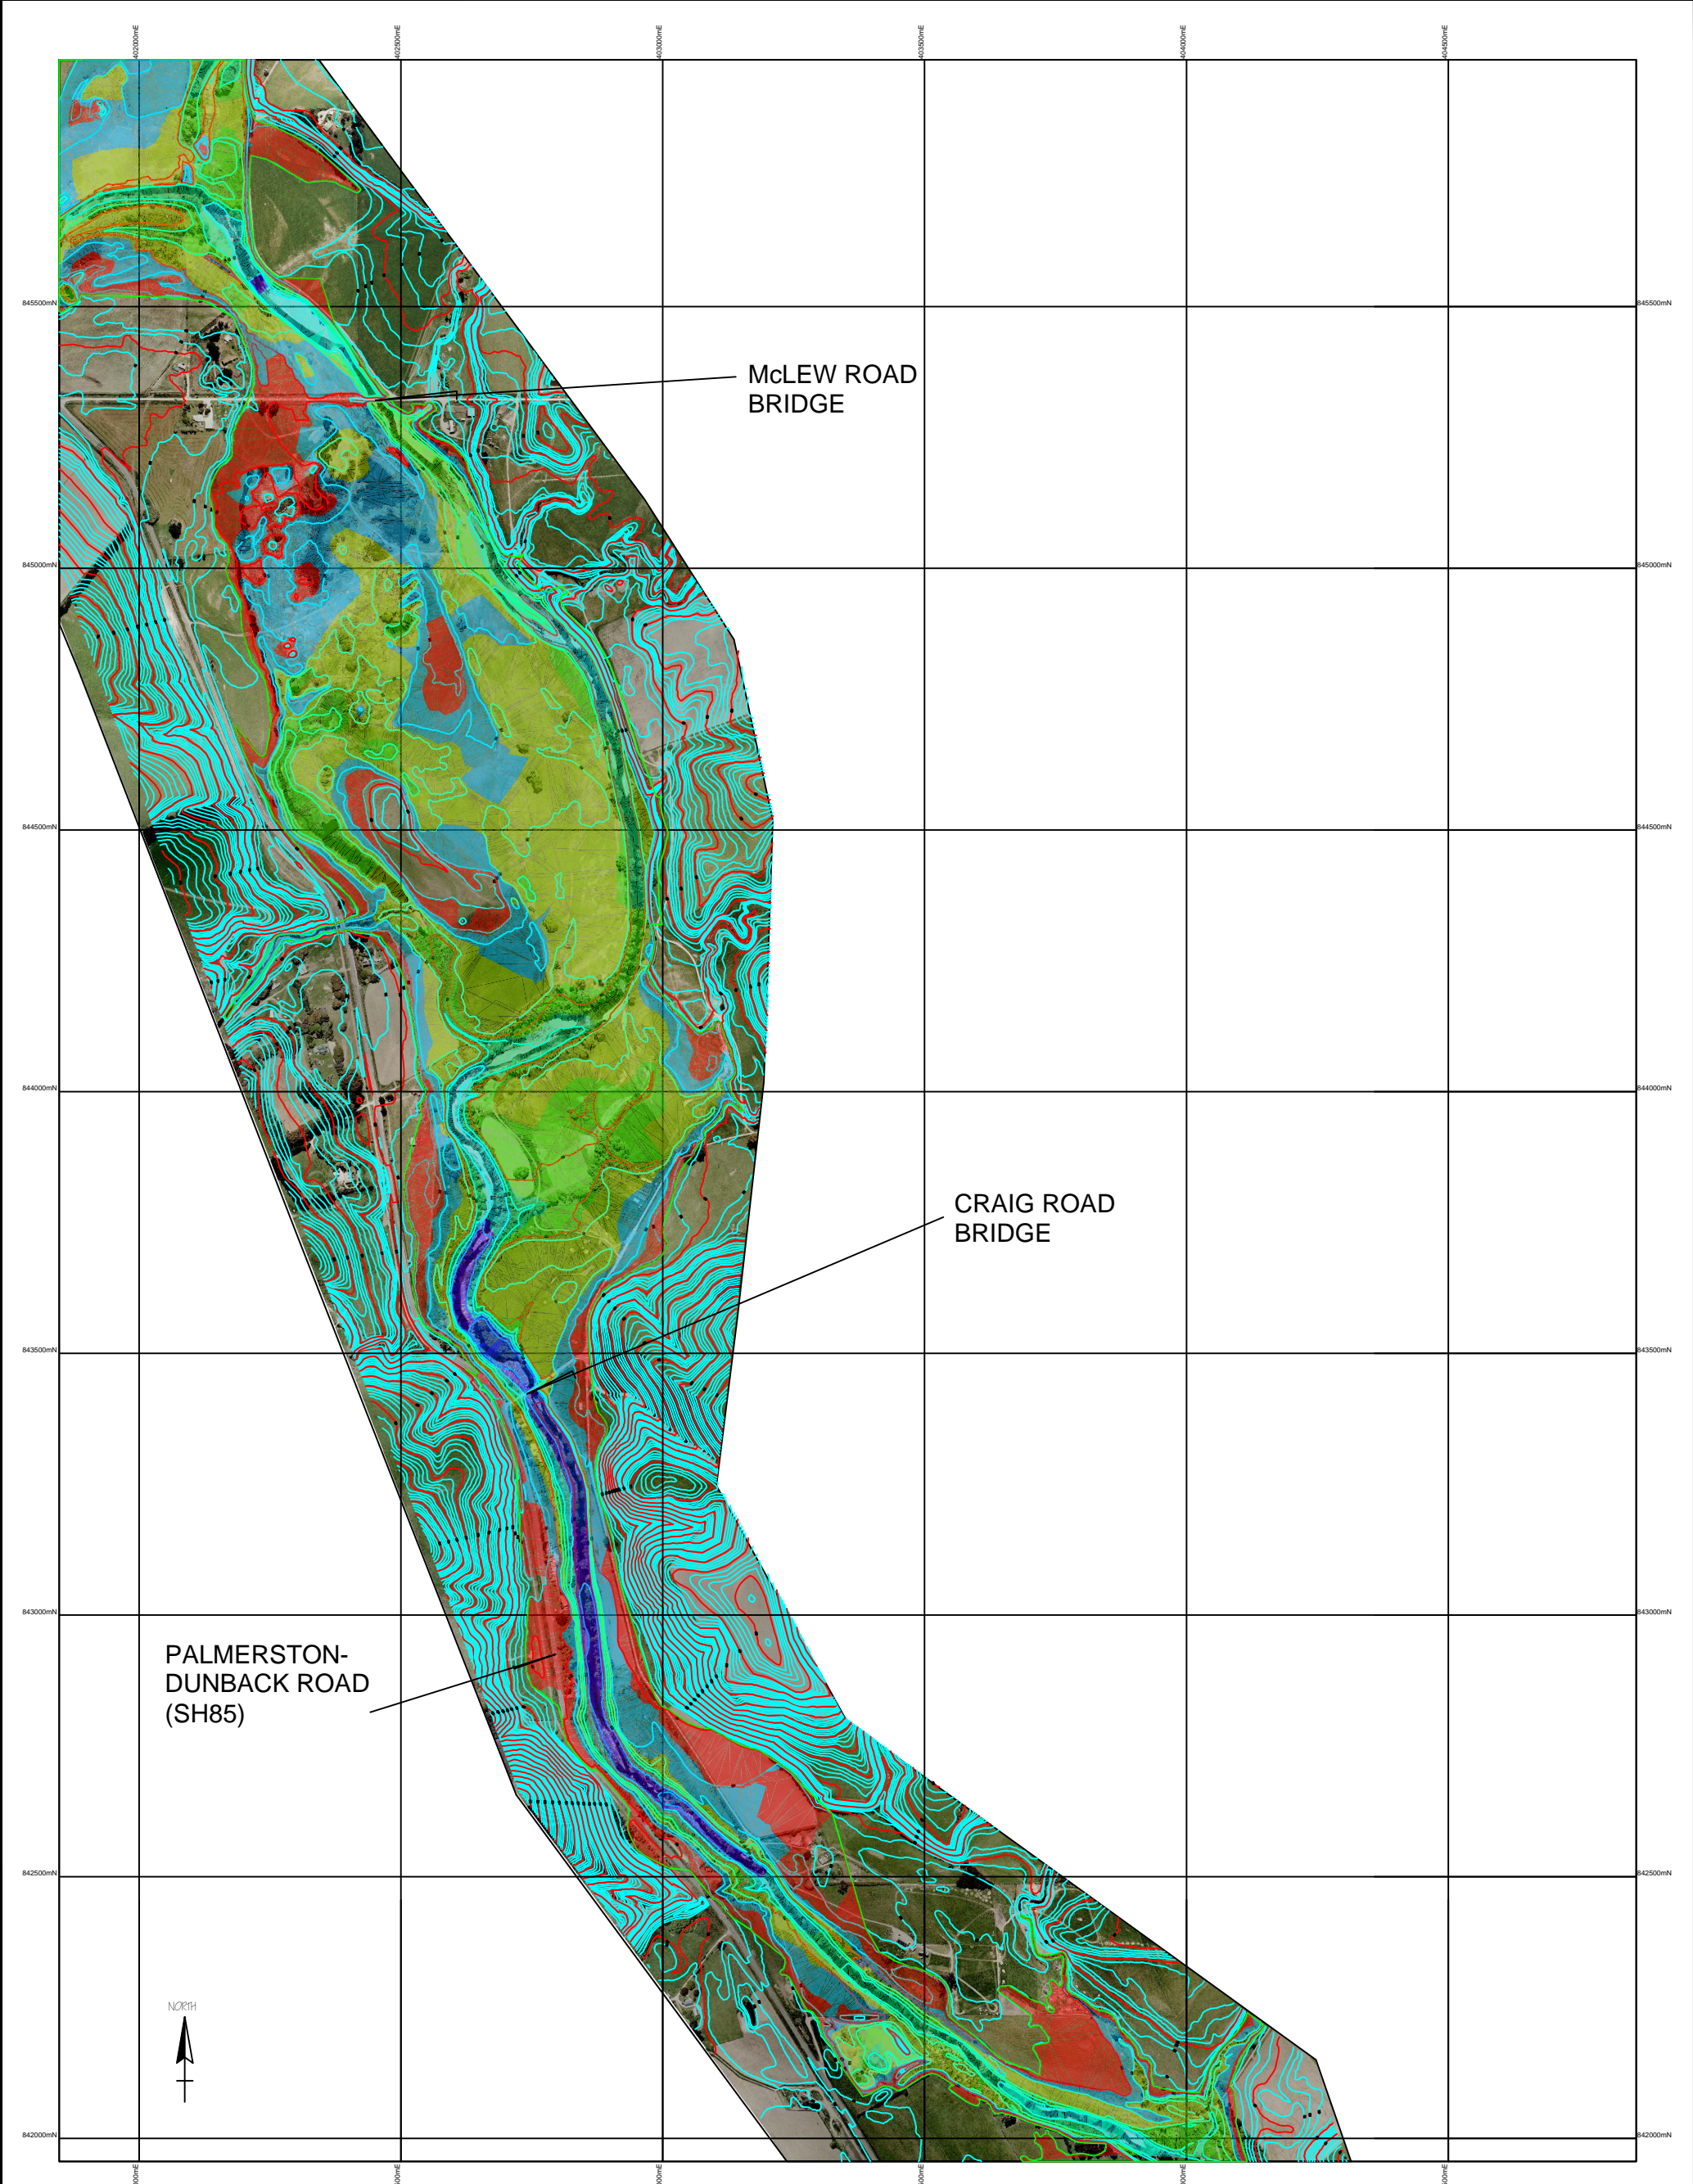
Number	Minimum Depth	Maximum Depth	Color
1	0.000	1.000	Red
2	1.000	2.000	Orange
3	2.000	3.000	Yellow
4	3.000	4.000	Light Green
5	4.000	5.000	Green
6	5.000	6.000	Dark Green
7	6.000	7.000	Blue-Green
8	7.000	8.000	Blue
9	8.000	9.000	Dark Blue
10	9.000	10.000	Very Dark Blue
11	10.000	11.000	Black
