DWG REF
 FLOOD-5665-12-CAMP

DRAWING TITLE
**MACRAES
 GOLD
 PROJECT**

CAMP CREEK DAM
 INUNDATION MAP
 FOR BREACH ASSOCIATED
 WITH 1 in 100 AEP FLOOD EVENT

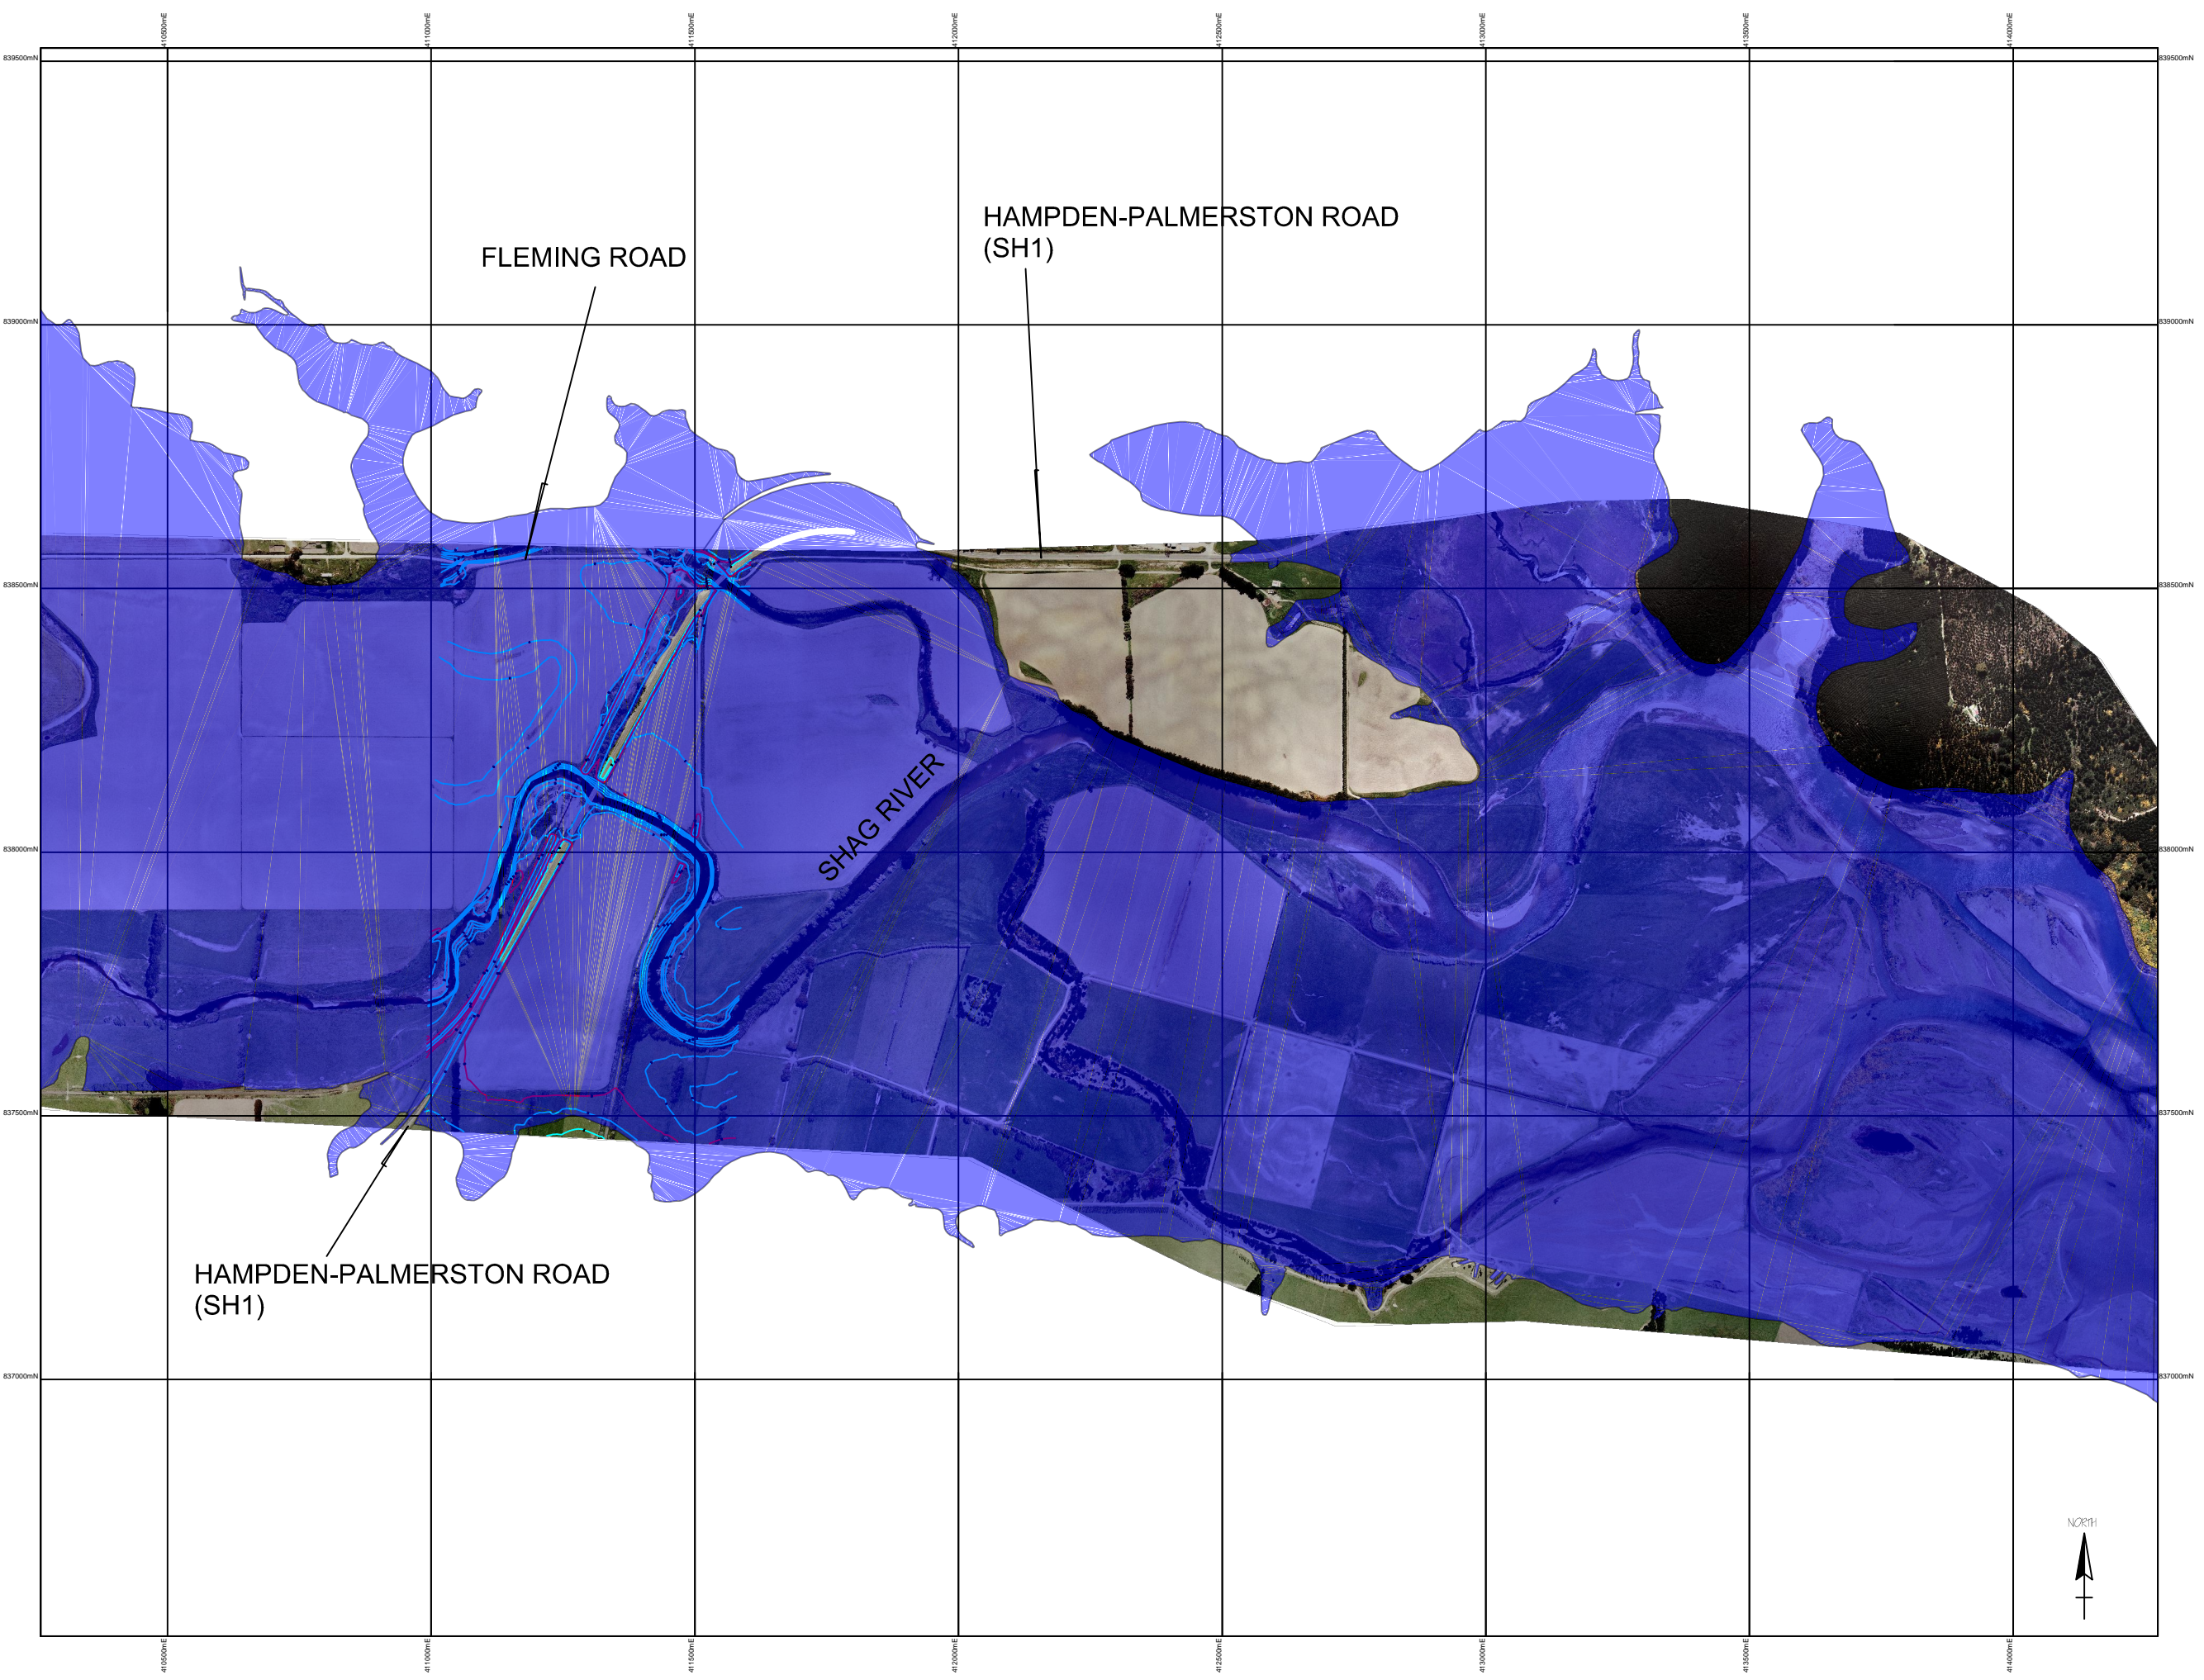
APPROXIMATE EXTENT OF INUNDATION
