IN THE MATTER of an application for resource
consents for Project Next
Generation

BY **PORT OTAGO LIMITED**
Applicant

**SUPPLEMENTARY STATEMENT OF EVIDENCE OF
LINCOLN MURRAY COE
ON BEHALF OF PORT OTAGO LIMITED**

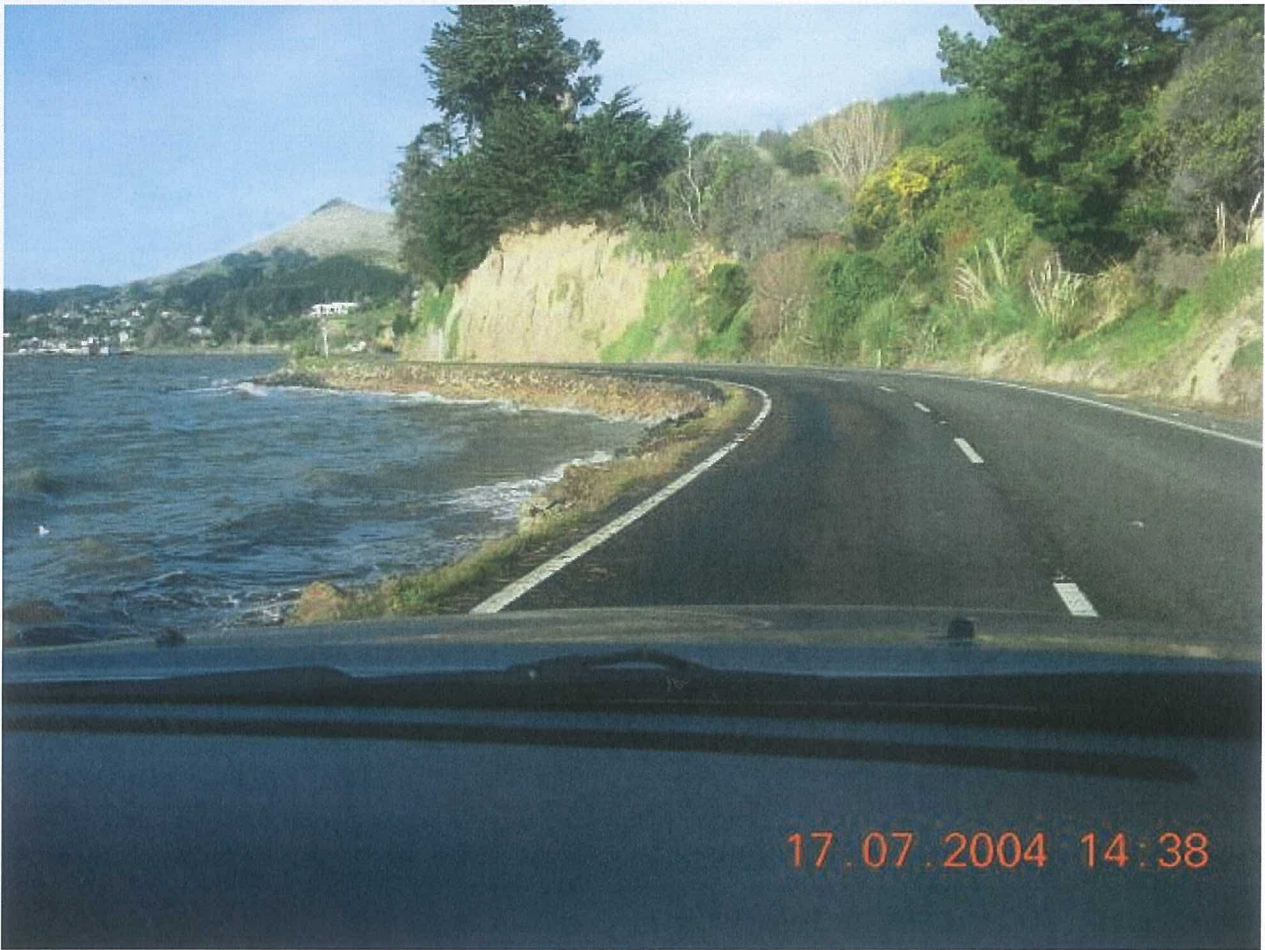
PHOTO 1

South Side Broad Bay – natural conditions strong NE having overtopped the road.

9. The nearshore environment and beach at Te Rauone are both affected by natural environmental conditions that occur from time to time. In particular longer wave NE swells that penetrate the harbour entrance reach the beach and suspend sediment in the shallower nearshore as well as attacking the dune face over the top parts of the tidal cycle. Similarly strong SW or Westerly winds fetching across the harbour cause a short but aggressive wind chop wave that also attack the dune and beach. Once mobilised the beach sands are then available to be transported by any currents flowing along the beach. In that regard, I attach 8 photographs which show 2 separate such events, one a NE event and the other a SW event.

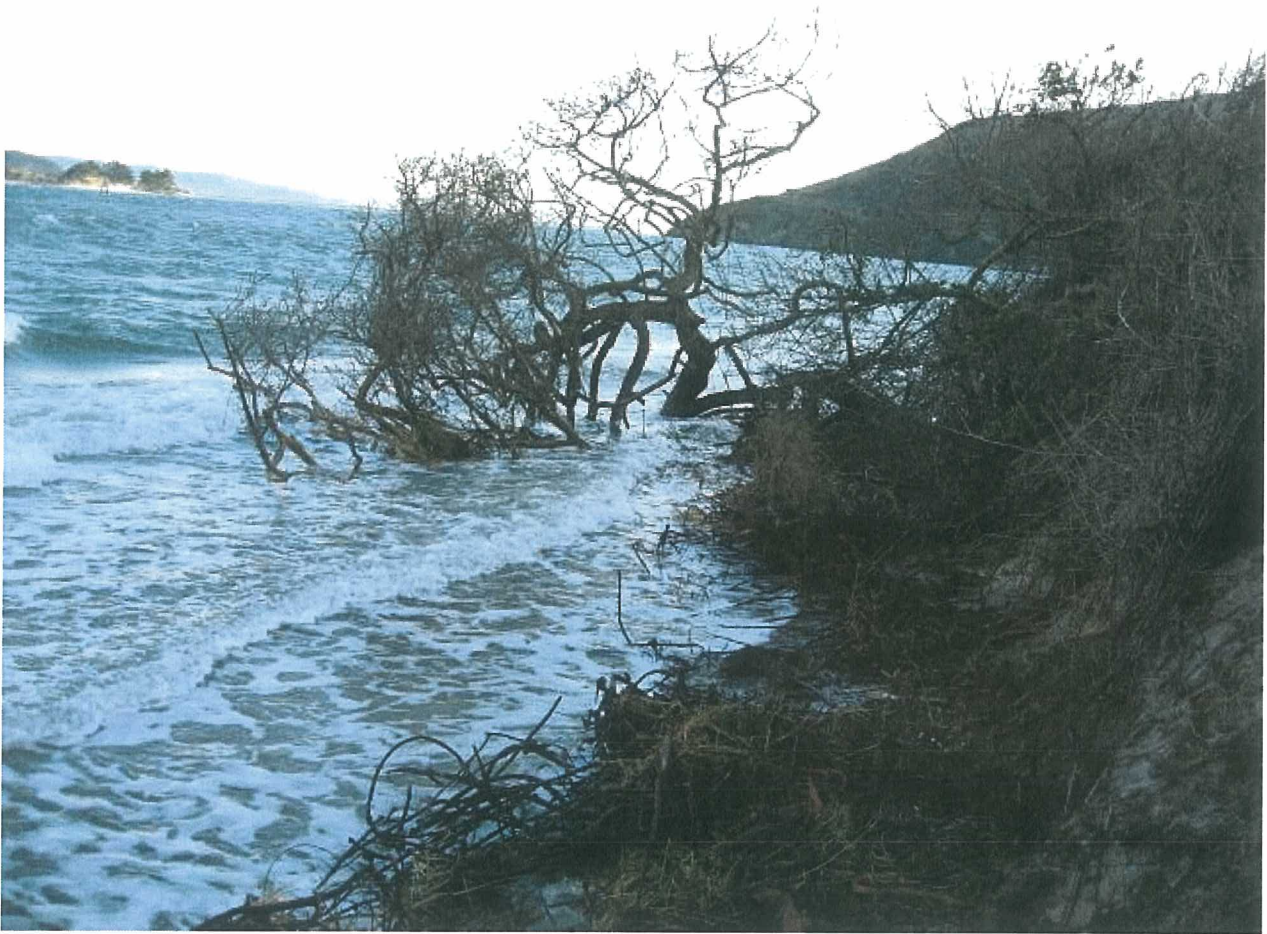
Photo 5 – 8/6/2008

Te Rauone Dune just after high tide. Strong WSW wind blowing across harbour. Looking North towards entrance.

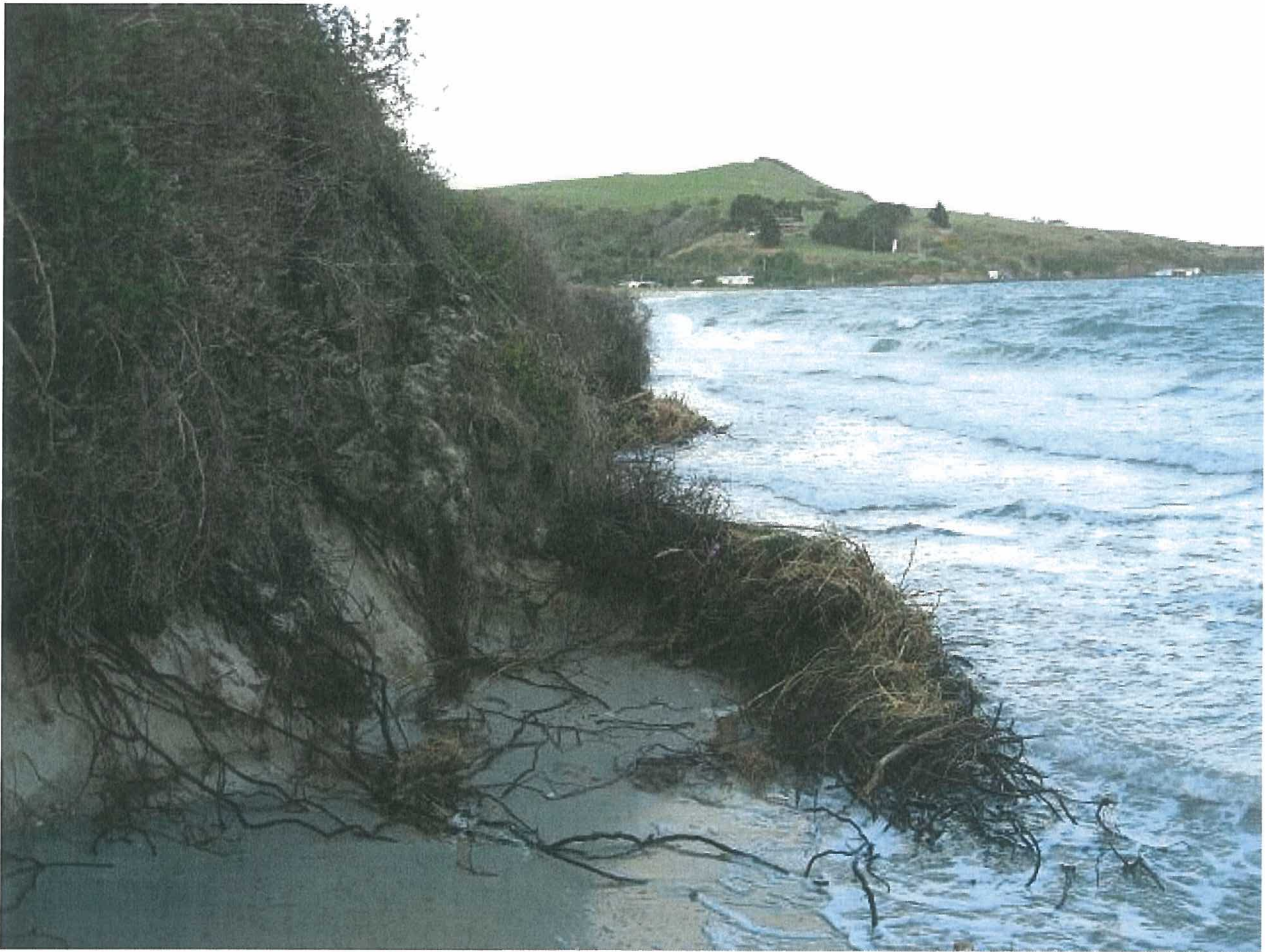
Photo 6 – 8/6/2008

Te Rauone Dune just after high tide. Strong WSW wind blowing across harbour. Looking South along beach. Previous high tide having reached and attacked the base of the dune.

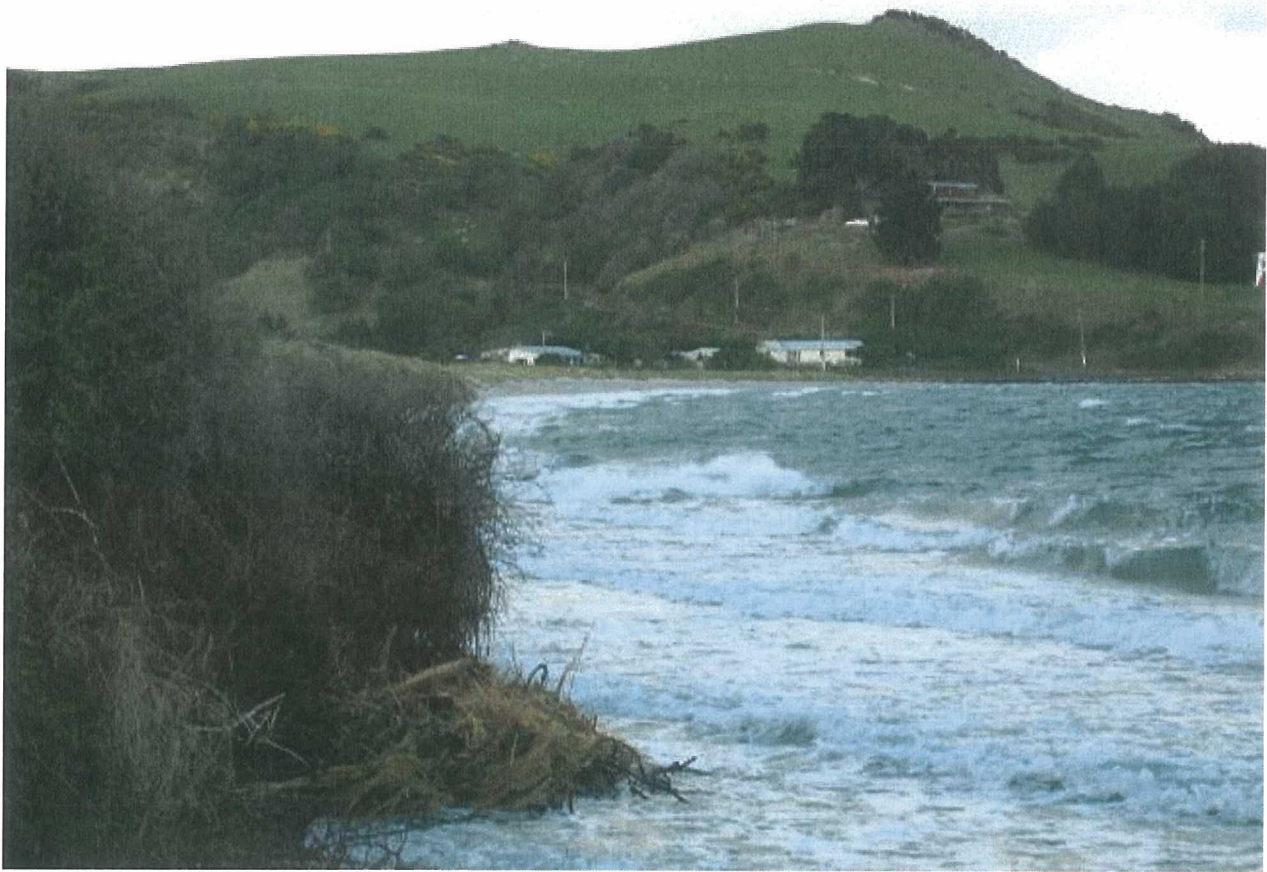
Photo 7 – 8/6/2008

Te Rauone Dune just after high tide. Strong WSW wind blowing across harbour. Looking South along beach. Previous high tide having reached and attacked the base of the dune.

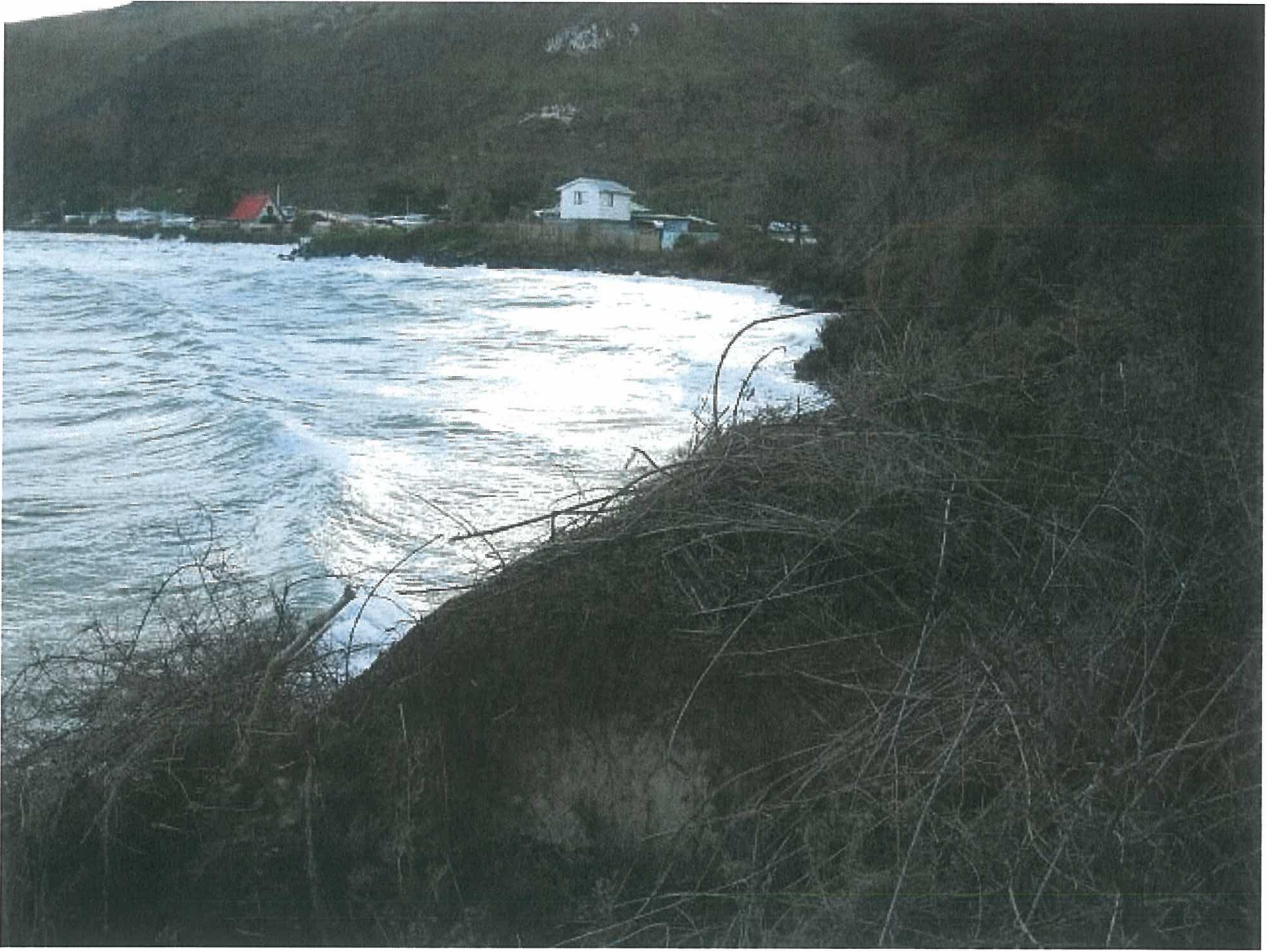
Photo 8 – 8/6/2008

**Te Rauone Dune just after high tide. Strong WSW wind blowing across harbour.
Standing on the Dune looking north towards cribs protected by rockwork.**

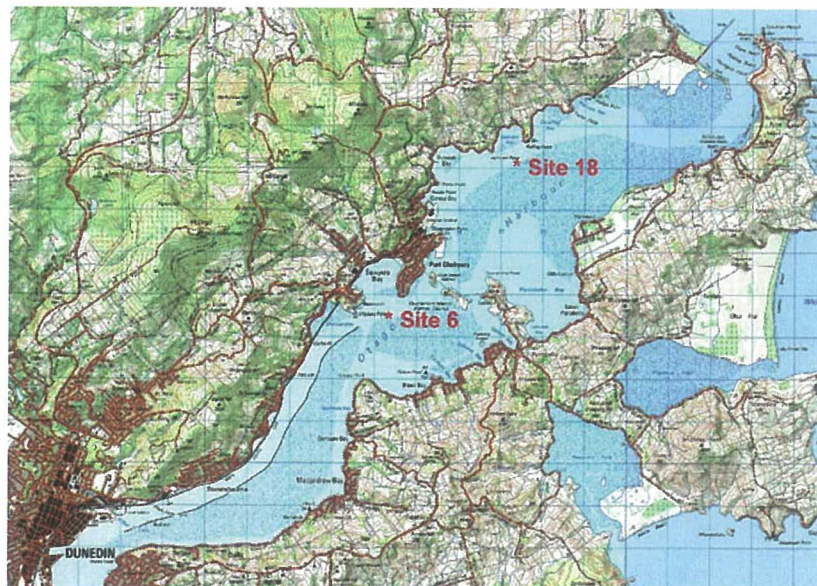
Figure 1: Location map.

NIWA installed two Seapoint Turbidity sensors to monitor in-situ turbidity levels in August 2008. These sensors were mounted on existing channel markers in the vicinity of Blanket Bay (marker 6) and Hamilton Bay (marker 18), (Figure 1).

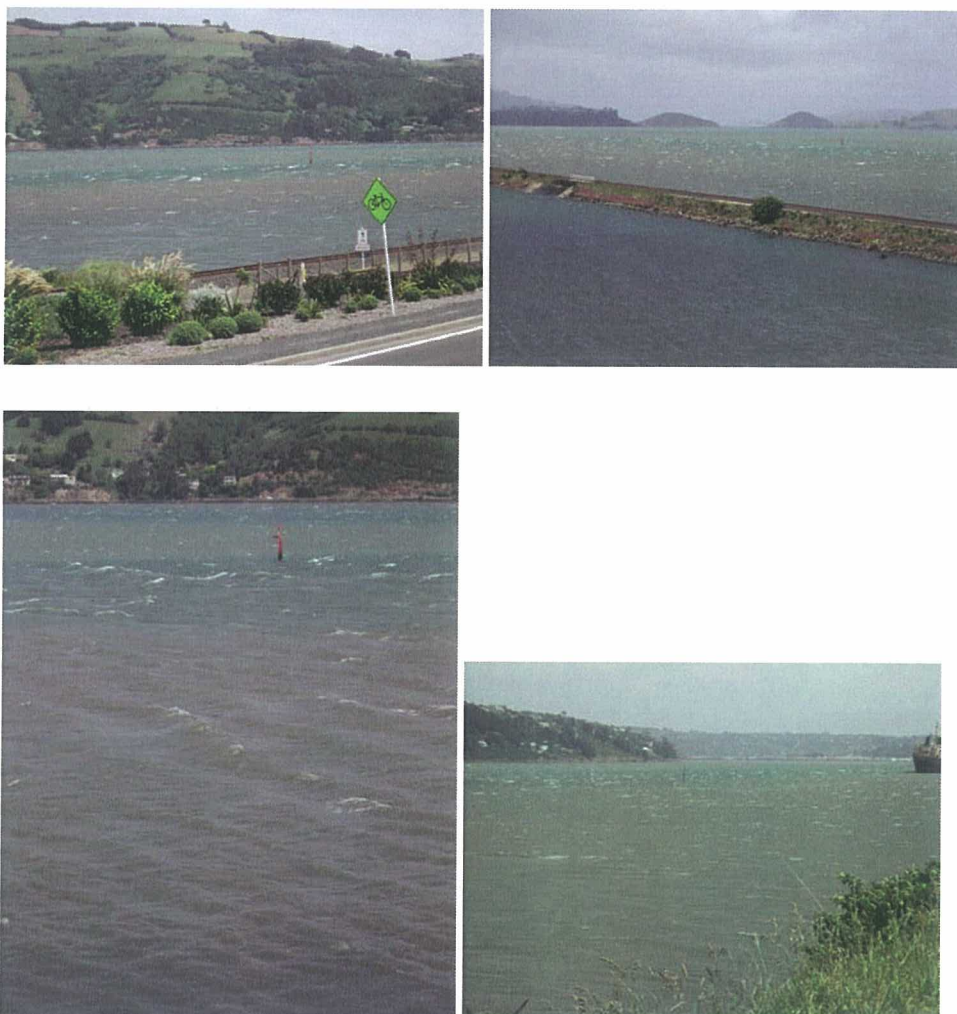
Figure 7: Photographs taken during NE storm on 21 November 2008.

The following photos (Figure 7) were taken during the strong NE storm event on 21 November 2008. The channel is clearly defined with the sand bars either side being stirred up.
