**FACTUAL REPORT OF GEOTECHNICAL  
INVESTIGATIONS**

**Port Otago – Project Next Generation**

Date: August 2008  
Reference: 6-CGP00.01 / 005DD  
Status: Final  
Report #: 1230

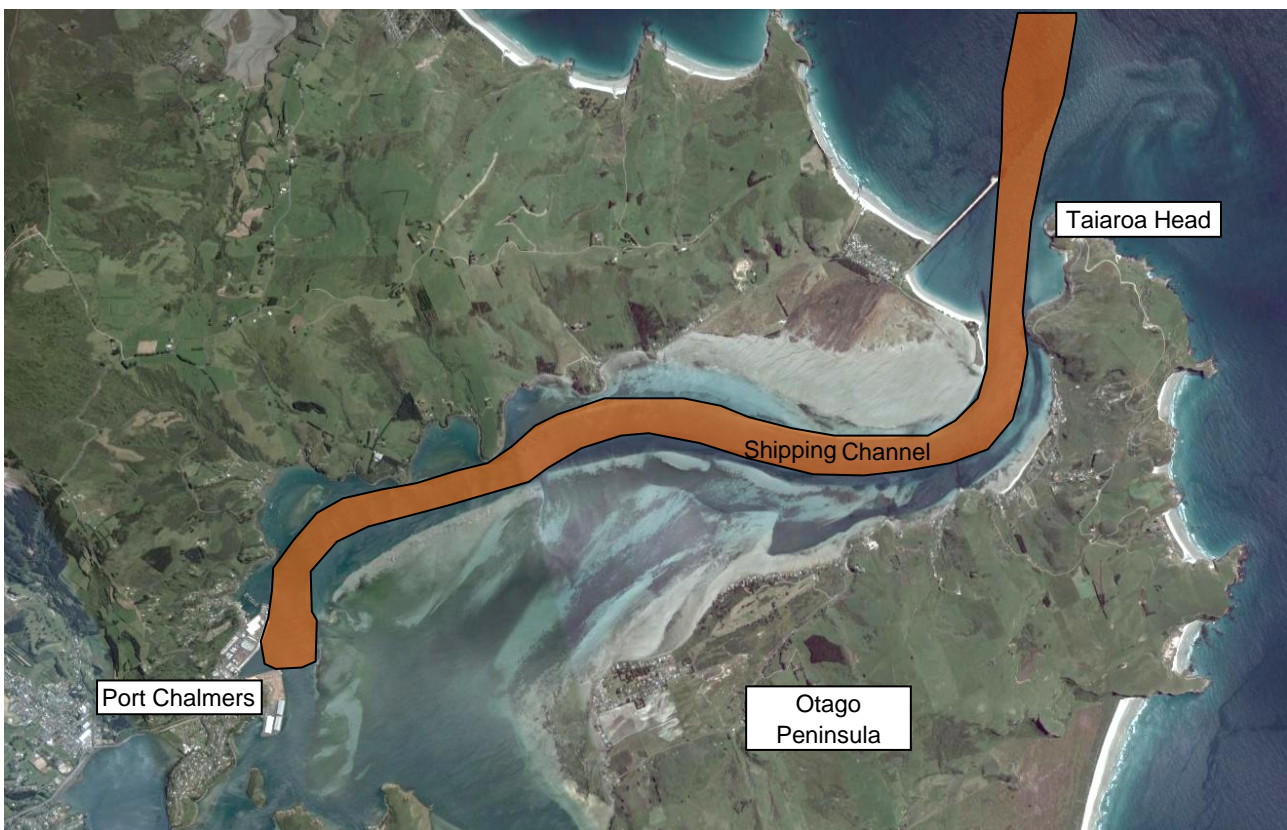
Figure 1 – Aerial photograph of the shipping channel.

The following report outlines the factual data related to the geotechnical investigation completed for the dredging portion of Port Otago Ltd’s “Next Generation” infrastructure development. The purpose of this development is to enable larger container vessels to be serviced at Port Chalmers. The project includes the provision of new plant and container handling equipment as well as the widening and deepening of the shipping channel. The channel is to be deepened along various sections from Port Chalmers past Taiaroa Head as shown in Figure 1 below as well as in Appendix A.

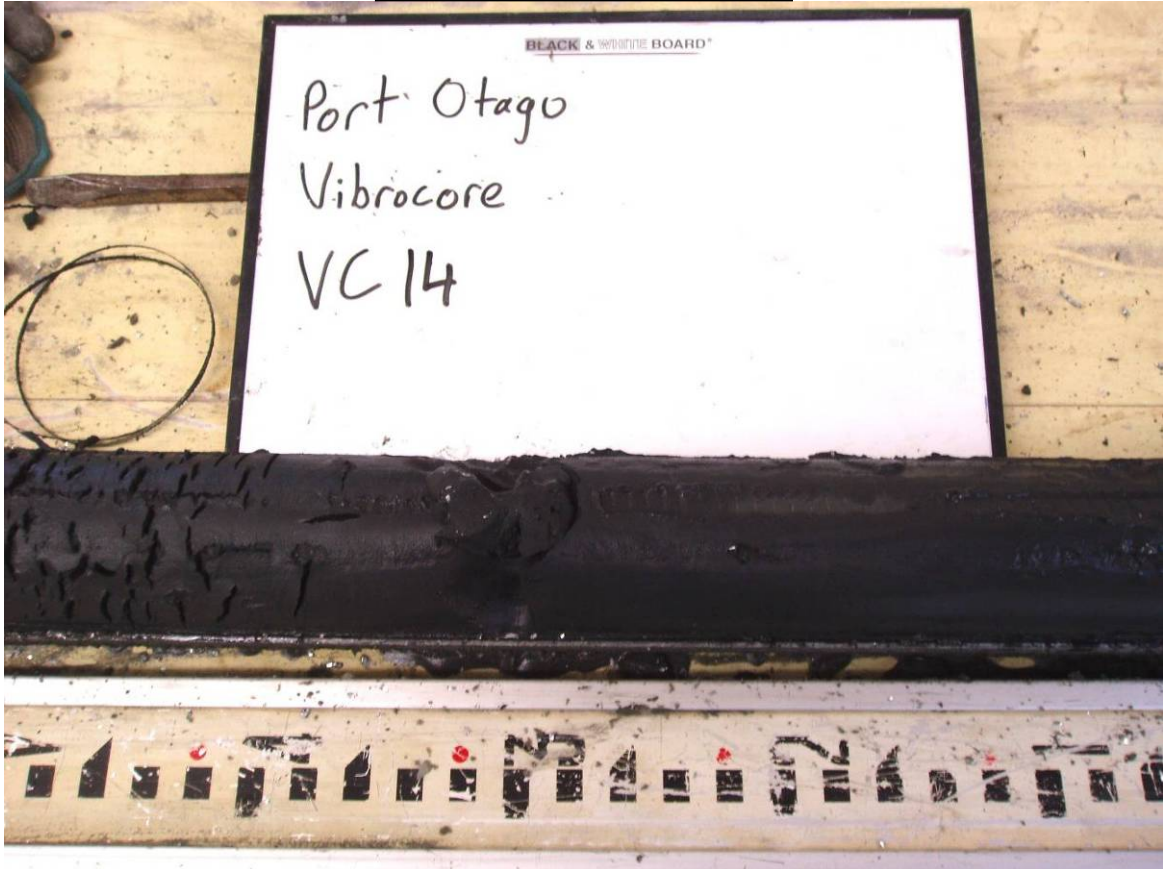
**VC14 – Silty CLAY**

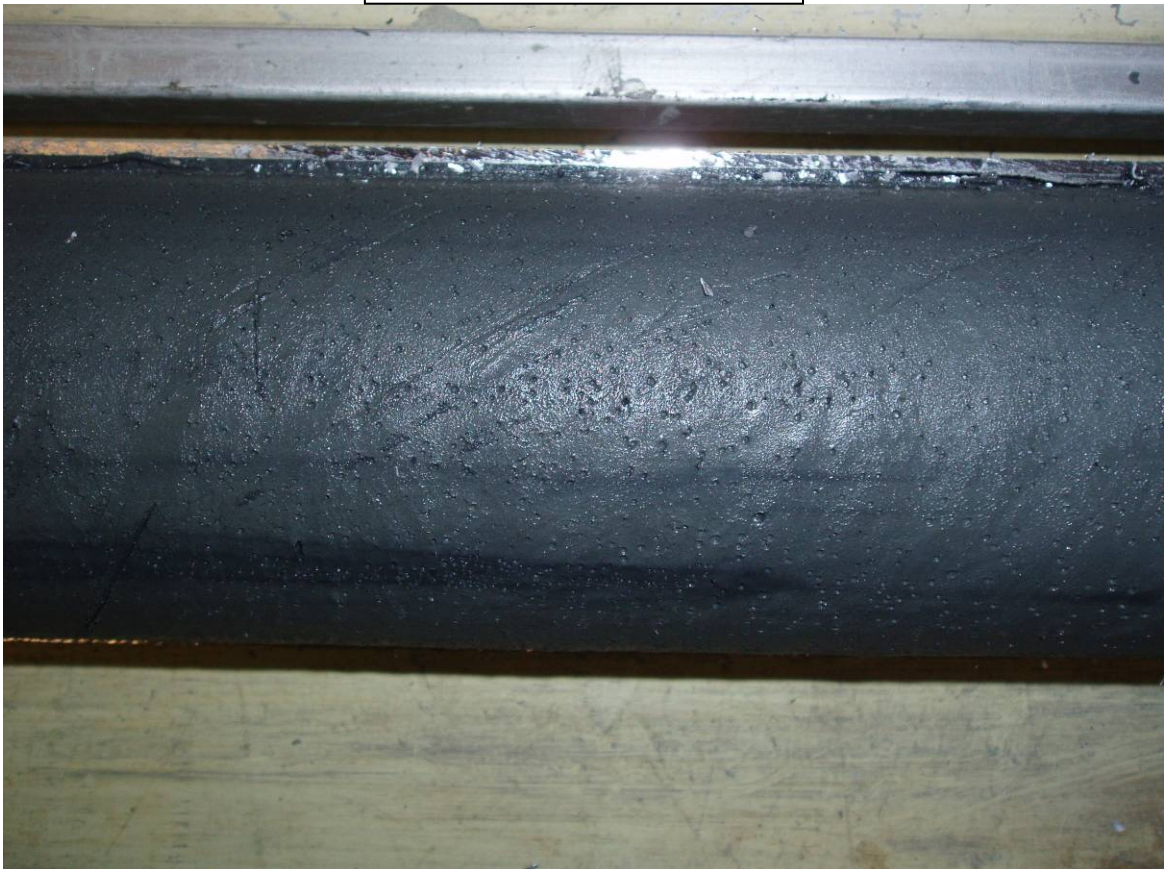
**VC12 – clayey SILT**

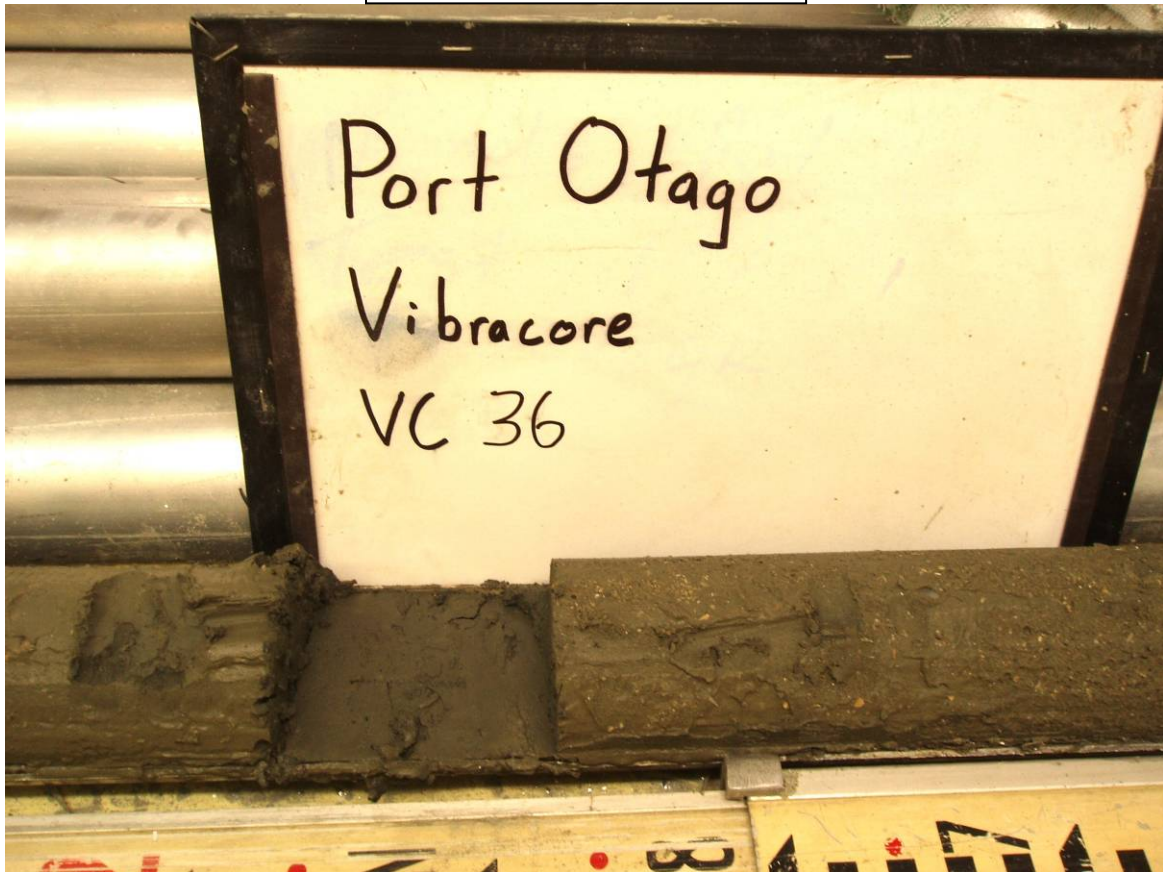
VC36 – Clayey SILT

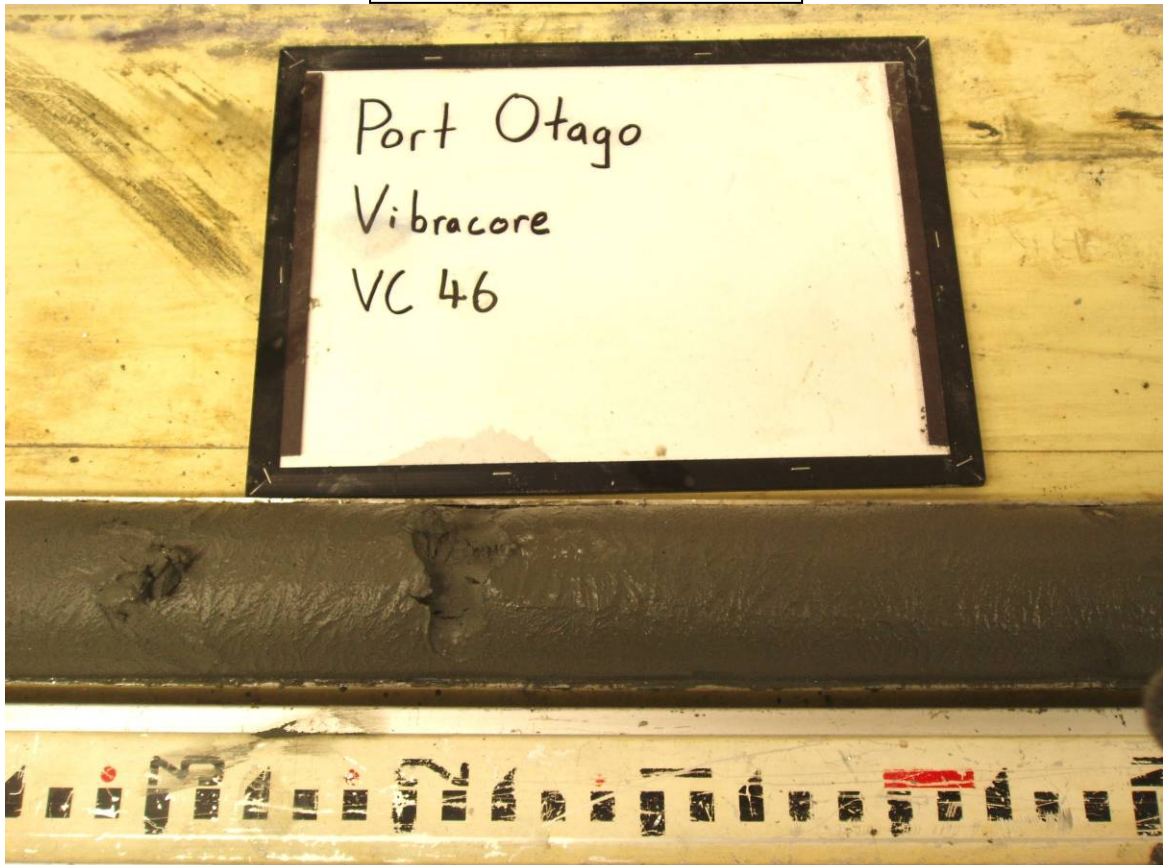
VC46 – clayey SILT

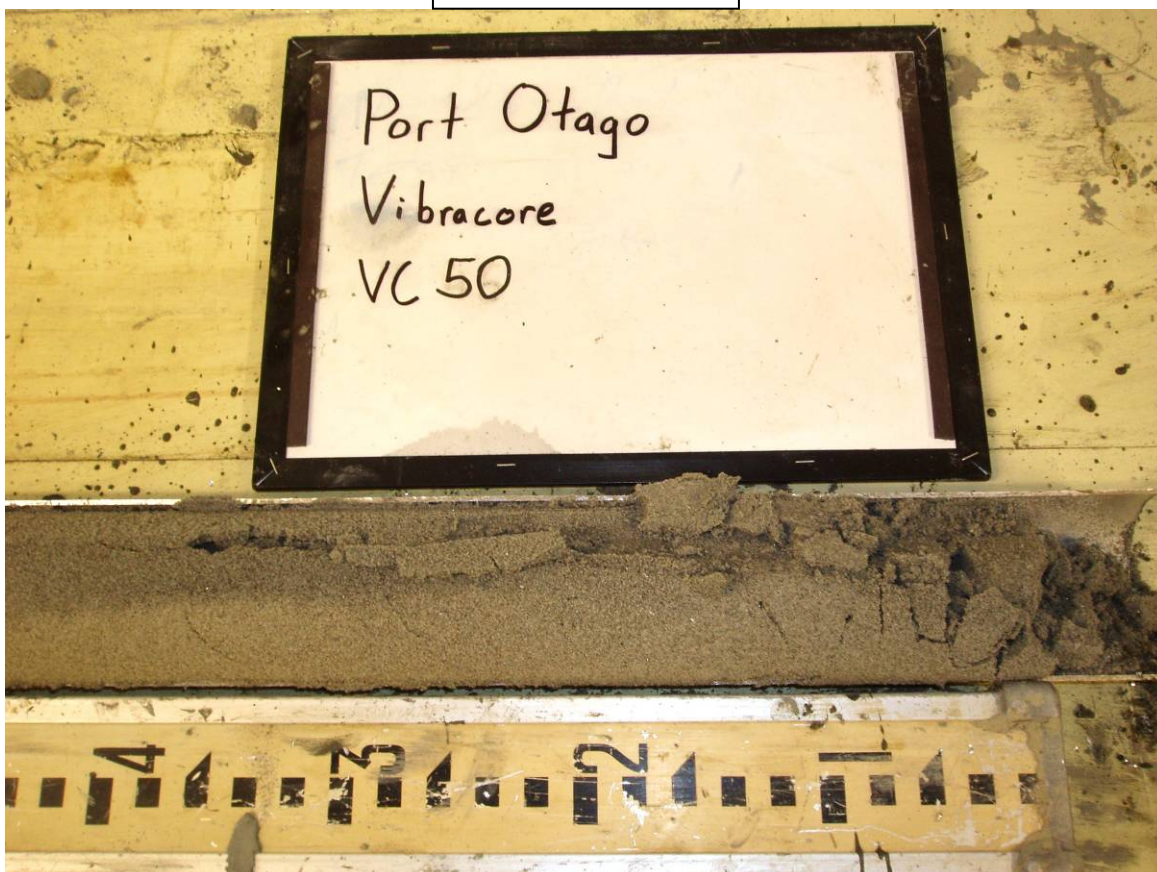
VC50 - SAND

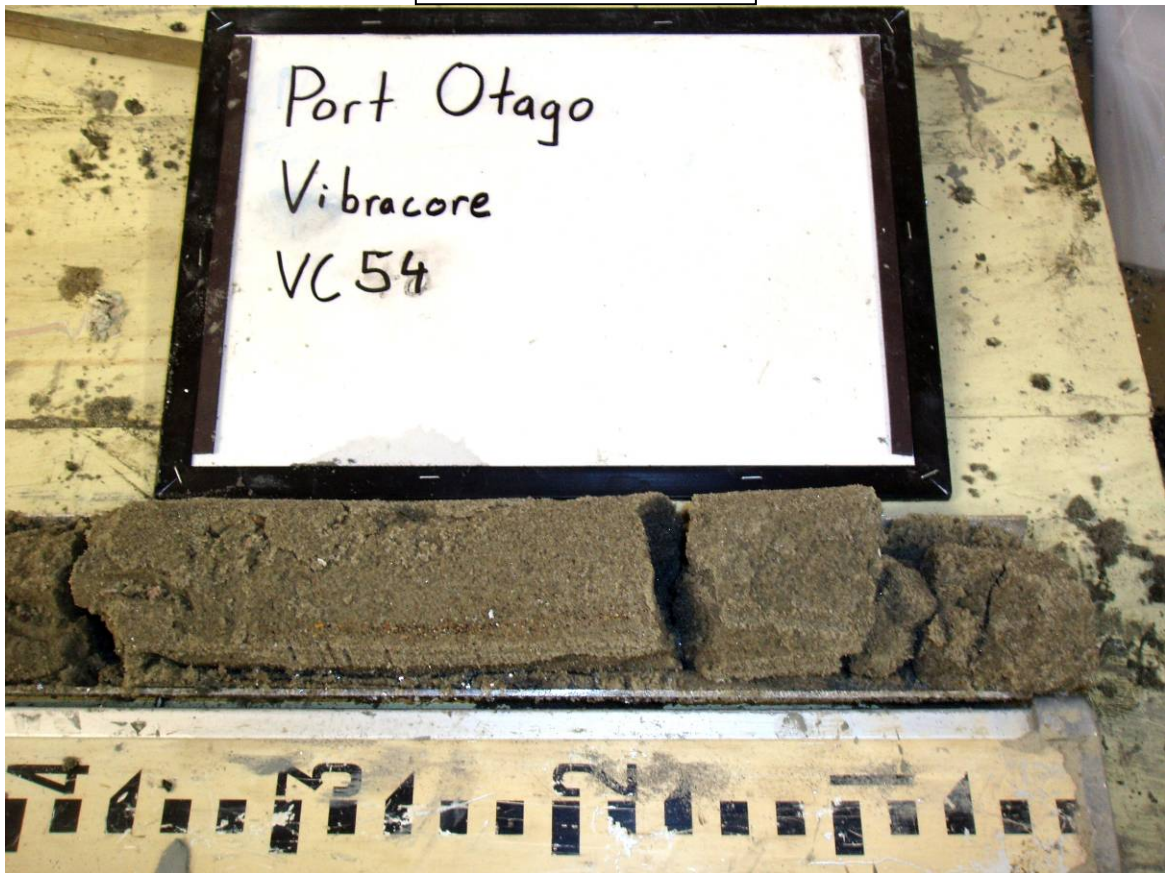
VC54 - SAND

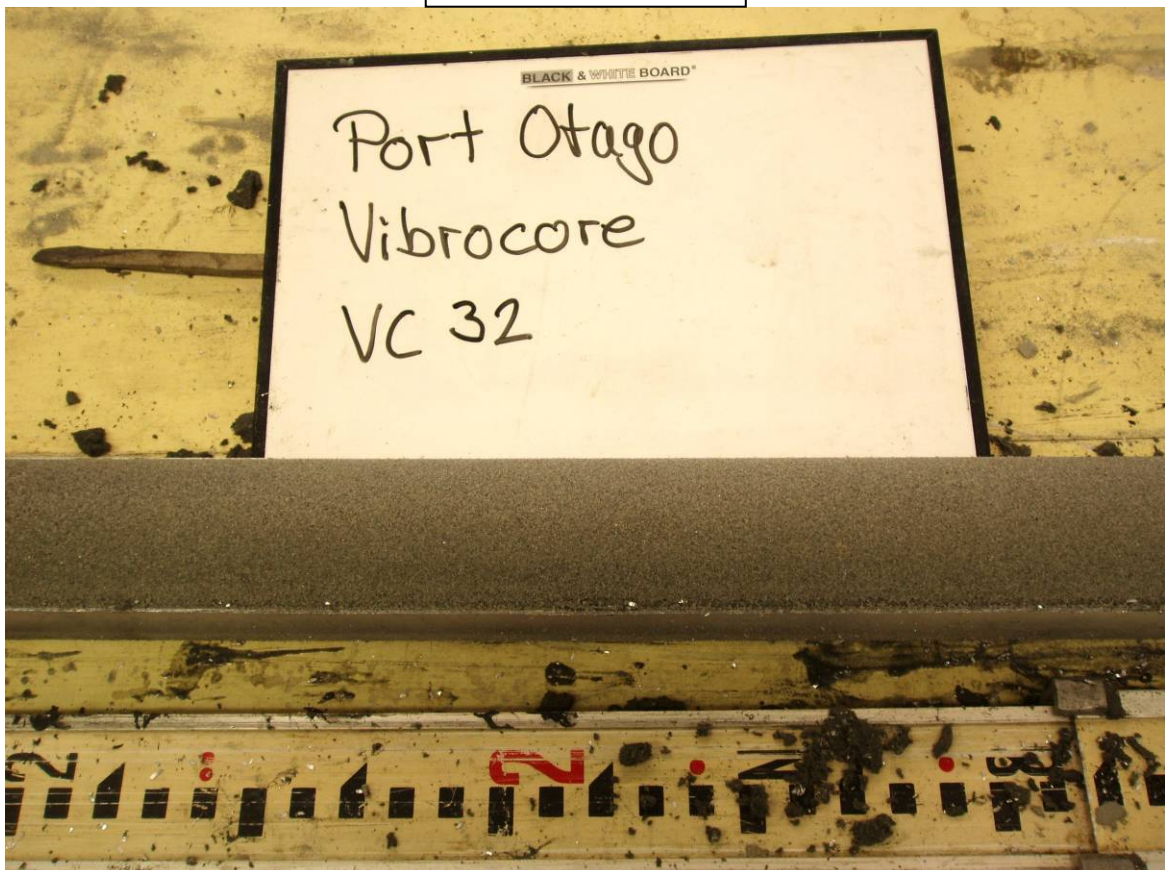
VC32 - SAND

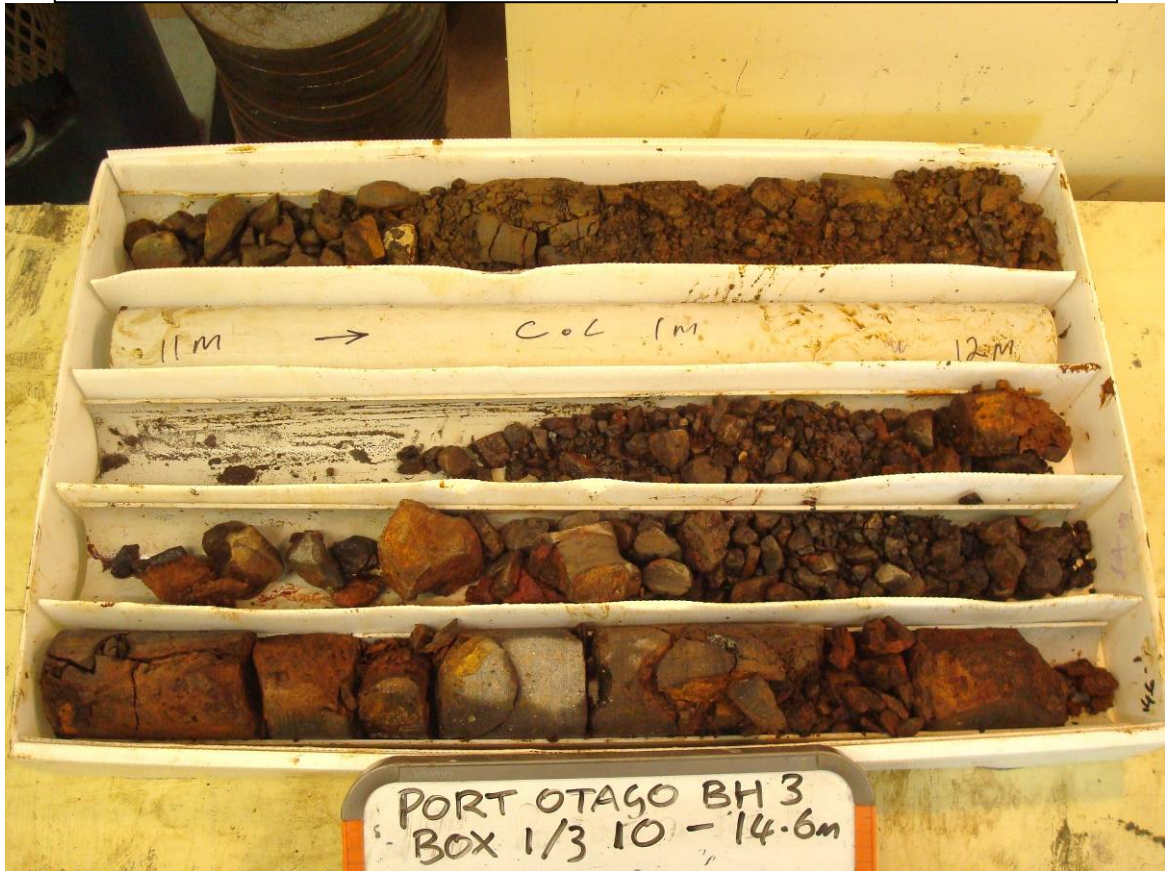
**B3 – Basalt Cobbles and Highly Weathered Basalt**

This was the least common unit and was only encountered at Rocky Point and Acheron Head. This unit consisted of completely weathered basalt near surface and moderately weathered basalt at depth. Borehole B5 encountered basalt cobbles off Pulling Point but the borehole was terminated due to bad weather. It is likely that this unit is also present at Pulling Point. Rock strength ranged from extremely weak to weak within the upper 2 to 4m and became moderately strong to very strong below this. The spacing of defect or discontinuities ranged from closely spaced to very closely spaced. Laboratory testing returned uniaxial rock strength values of 101 MPa and 62 MPa for B3 and B4, respectively.

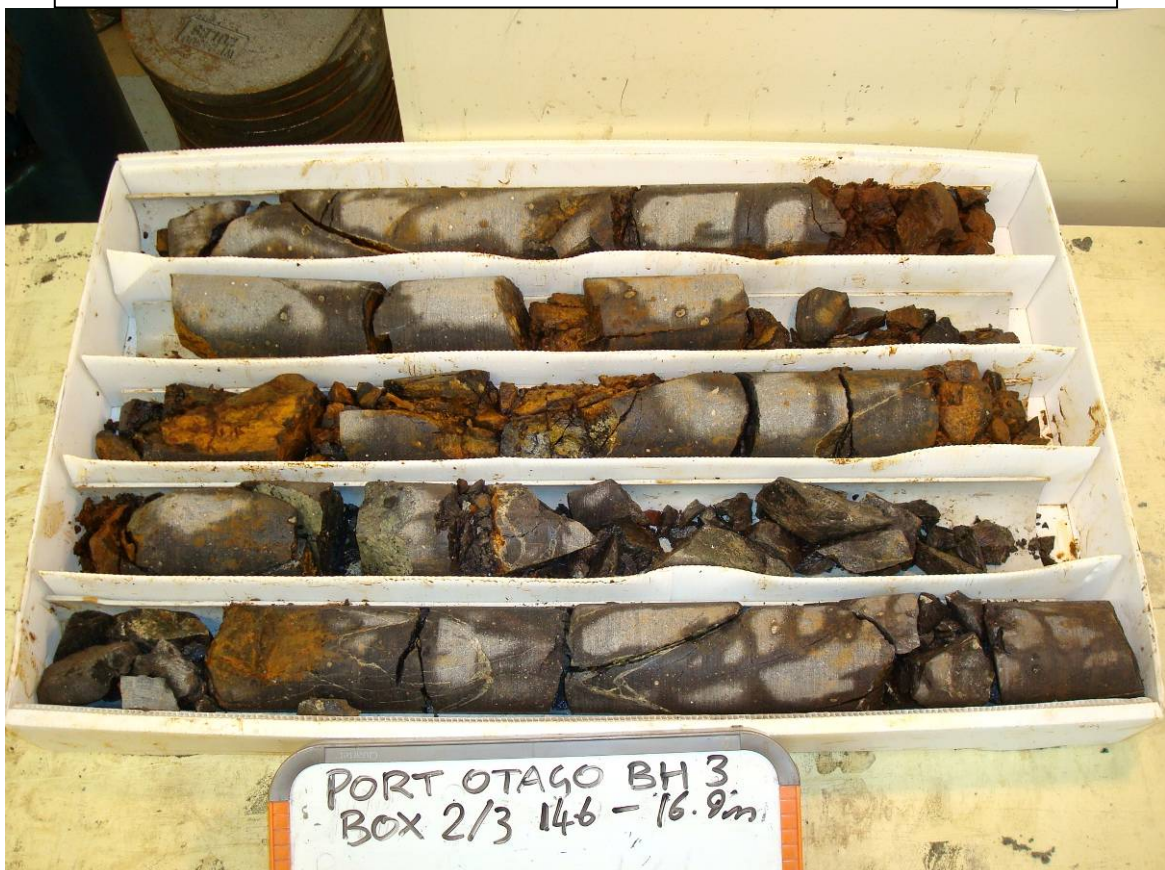
**B3 – Moderately Weathered Basalt**

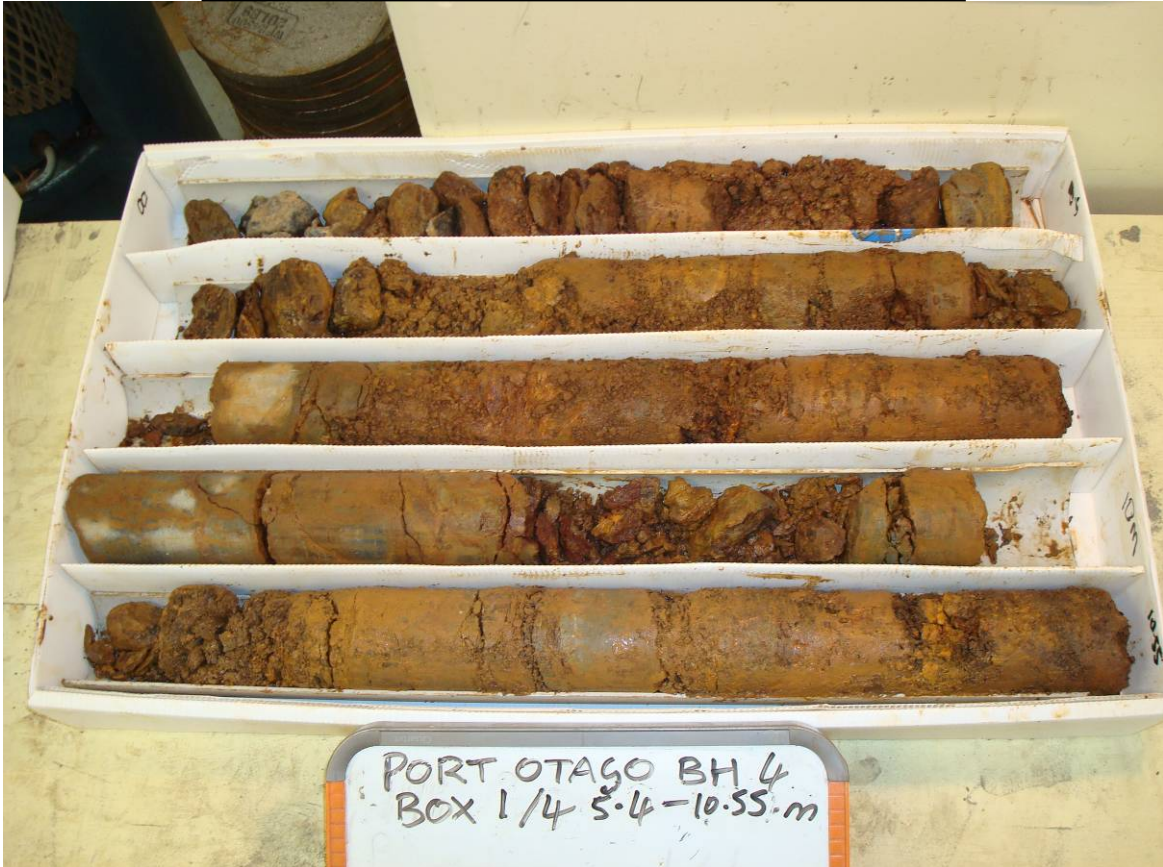
**B4 – Completely Weathered Basalt**

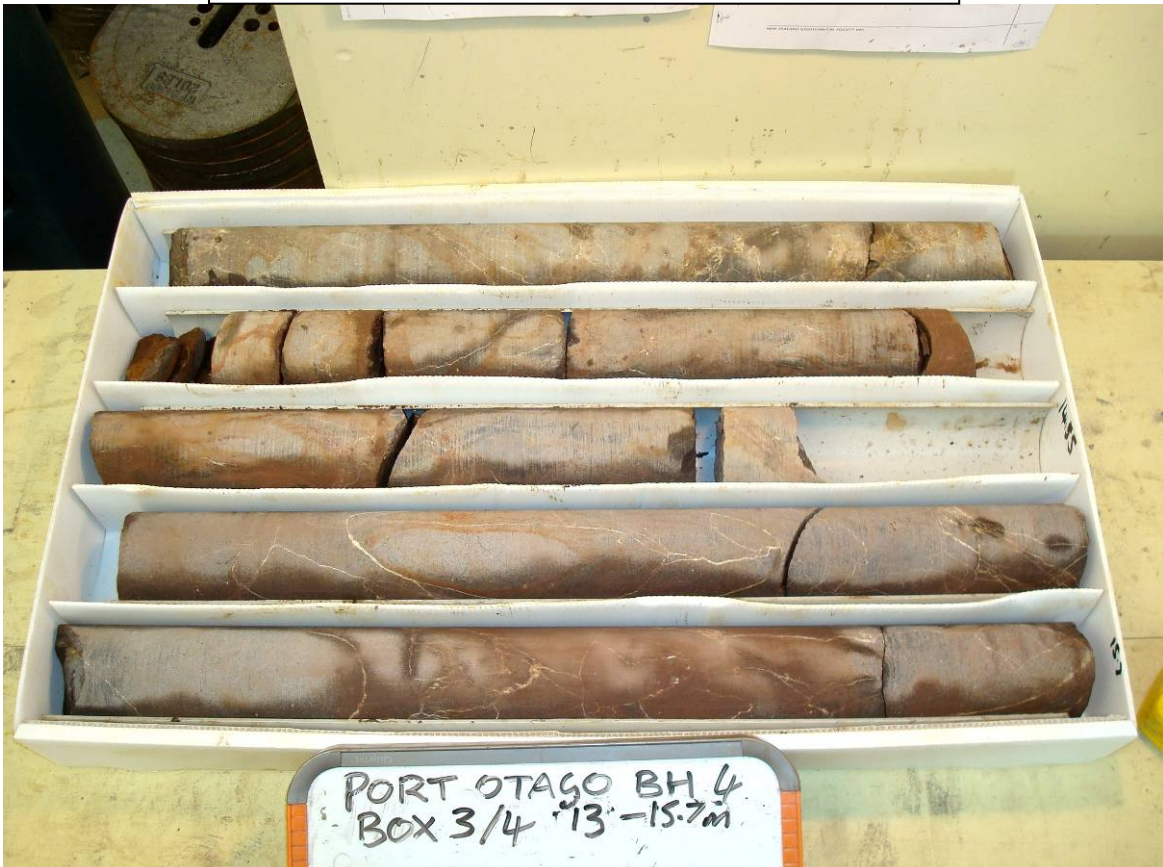
**B4 – Moderately Weathered Basalt**

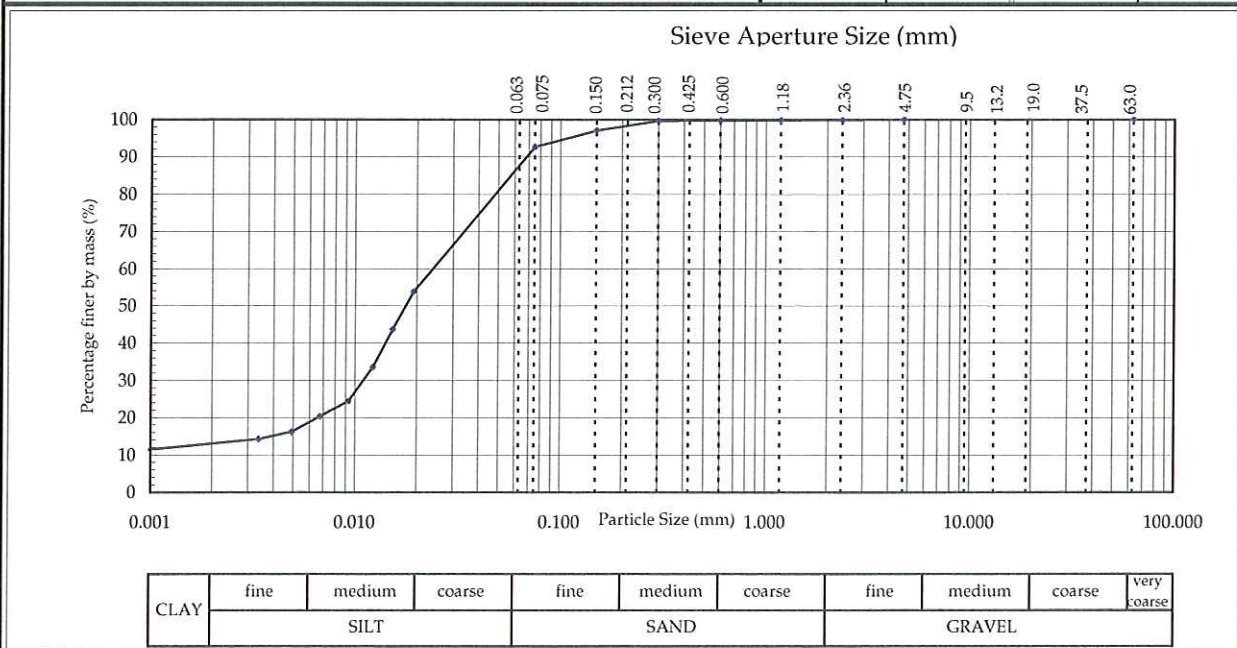
Sieve Analysis						Hydrometer Analysis			
Sieve Size (mm)	Passing (%)	Sieve Size (mm)	Passing (%)	Sieve Size (mm)	Passing (%)	Particle Size (mm)	Passing (%)	Particle Size (mm)	Passing (%)
63.0	--	4.75	100	0.300	100	0.0193	54	0.0034	14
37.5	--	2.36	100	0.212	--	0.0153	44	0.0009	11
19.0	--	1.18	100	0.150	97	0.0122	34	--	--
13.2	--	0.600	100	0.075	93	0.0093	24	--	--
9.5	--	0.425	--	0.063	--	0.0067	20	--	--
<b>Note:</b> "--" denotes sieve not used and/or hydrometer analysis not tested						0.0049	16

Test Methods	Notes
Particle Size Analysis: NZS 4402 1986 Test 2.8.1 (Wet Sieve)	Fraction Tested: Whole soil
Particle Size Analysis: NZS 4402 1986 Test 2.8.4 (Hydrometer)	pH of suspension : 9.0

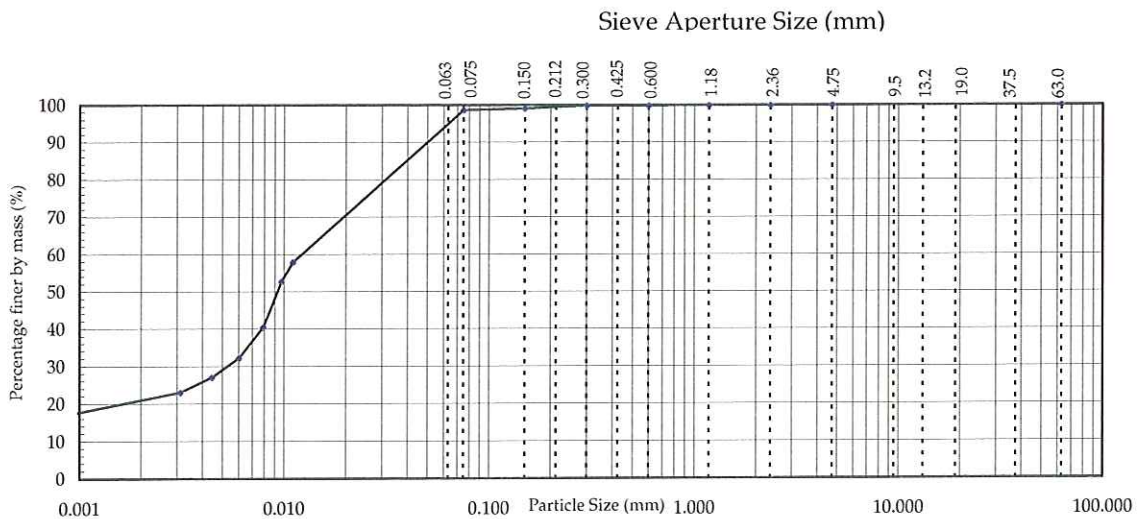
Sieve Analysis						Hydrometer Analysis			
Sieve Size (mm)	Passing (%)	Sieve Size (mm)	Passing (%)	Sieve Size (mm)	Passing (%)	Particle Size (mm)	Passing (%)	Particle Size (mm)	Passing (%)
63.0	--	4.75	100	0.300	100	0.0110	58	0.0008	17
37.5	--	2.36	100	0.212	--	0.0097	53	--	--
19.0	--	1.18	100	0.150	99	0.0079	40	--	--
13.2	--	0.600	100	0.075	99	0.0060	32	--	--
9.5	--	0.425	--	0.063	--	0.0045	27	--	--
<b>Note:</b> "--" denotes sieve not used and/or hydrometer analysis not tested						0.0031	23

<b>Test Methods</b>	<b>Notes</b>
Particle Size Analysis: NZS 4402 1986 Test 2.8.1 (Wet Sieve)	Fraction Tested: Whole soil
Particle Size Analysis: NZS 4402 1986 Test 2.8.4 (Hydrometer)	pH of suspension : 9.0

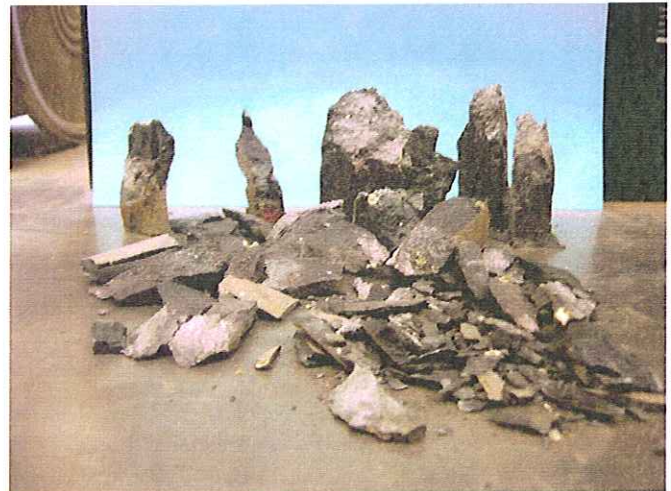
Mode of Failure Brittle/explosive

Test Method: NZS 4402: 1986 Test 6.3.1
