## Technical Committee - 29 November 2017 Attachments

## Summary of recommendations

<b>1. Background and introduction</b>	<b>11</b>
1.1 The Rangitāiki River and its people	12
1.2 The Rangitāiki River Flood Scheme	14
1.3 The review process and the key questions	18
<b>2. The storm (ex-Cyclone Debbie)</b>	<b>21</b>
<b>3. The legal and planning framework for flood hazard management</b>	<b>22</b>

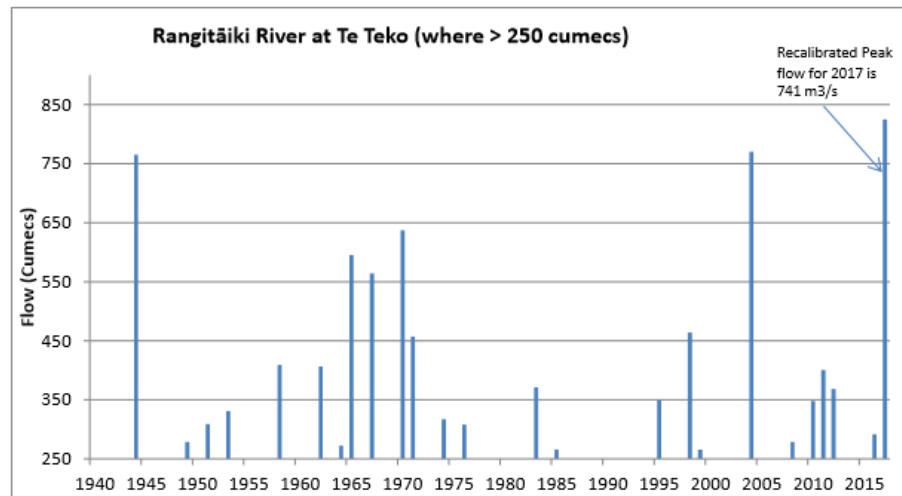
Figure 5 Flood peak history of the Rangitāiki River at Te Teko from 1944 to 2017 (from Te Teko gauging station, plotted by Fransen 2017). 2017 Peak flow has been recalibrated to 741m<sup>3</sup>/s (Ellery, 2017)

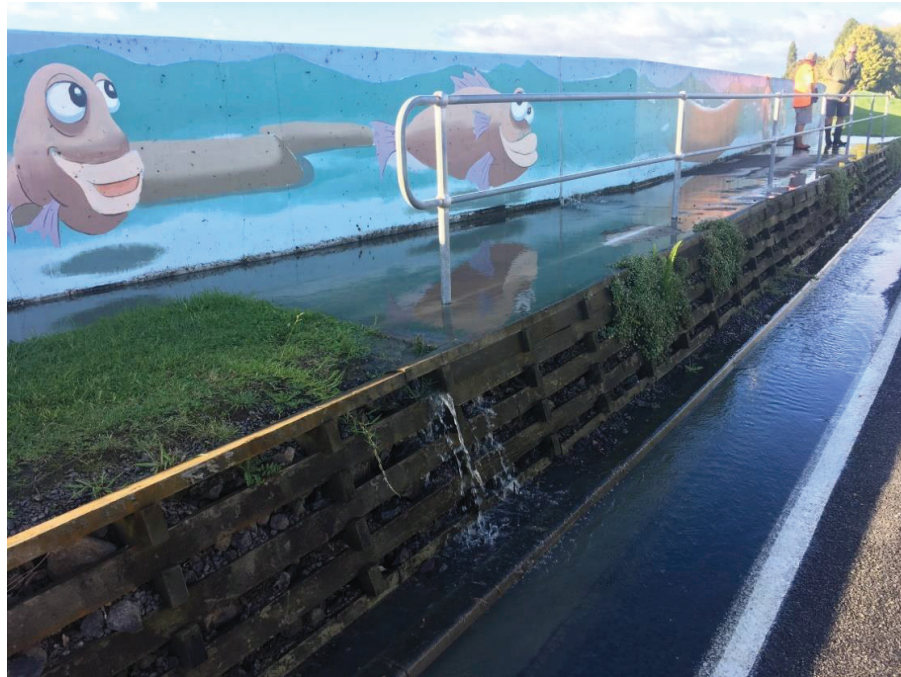
**Figure 18: The Edgcumbe Floodwall, known locally as 'The Painted Wall', at 08.14 on 6 April, 15-20minutes before the breach (Source: Bay of Plenty Regional Council, 2017)**

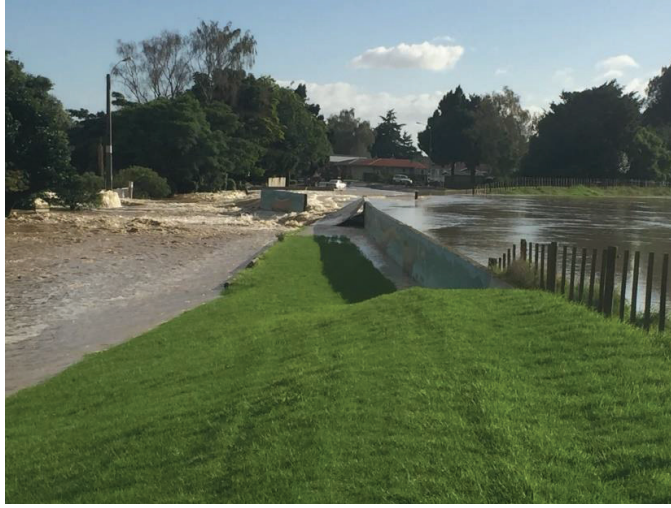
**Figure 20: The breached Floodwall at Edgumbe, looking downstream; image file date-stamped 08:35 6 April, some 5 minutes after the breach (Source: Bay of Plenty Regional Council Contractor, 2017)**

- k. The College Road floodwall should not be replaced with another wall, but ways sought to enable a stopbank to be constructed in its place (noting that the properties closest to the breached wall have been acquired by the Regional Council).

- m. The existing fill at the College Road floodwall and the remnants of the floodwall itself should be removed or thoroughly investigated before construction of a new flood defence structure/stopbank. Investigation and inspection of the fill carried out at that time should be used to provide further insight into its condition and significance to the failure.

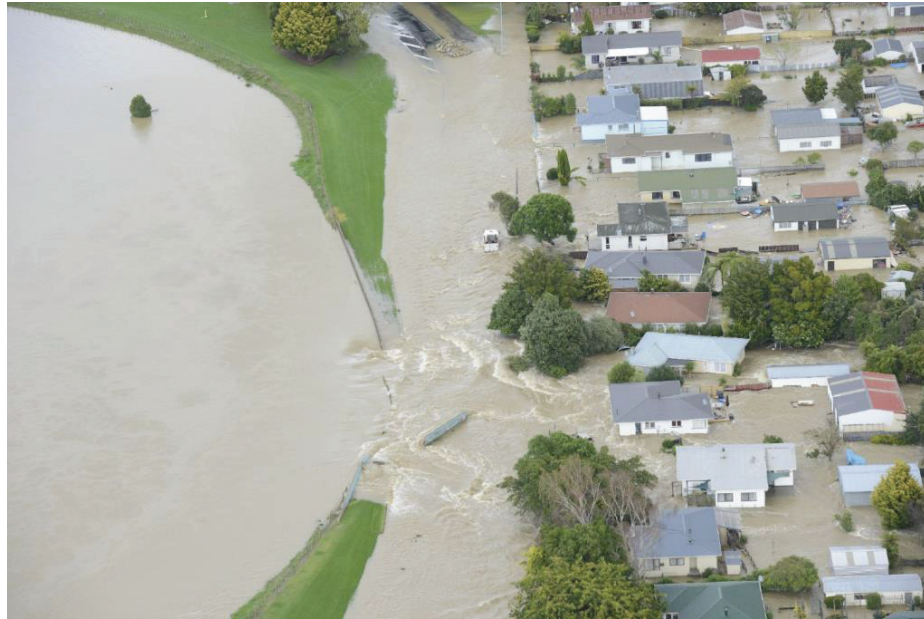
**Figure 21: The breached Floodwall at Edgumbe, at 11:00 6 April. Some of the wall sections can be seen still standing upright in the floodwaters some 2.5 hours after the initial breach (Source: Bay of Plenty Regional Council, 2017)**

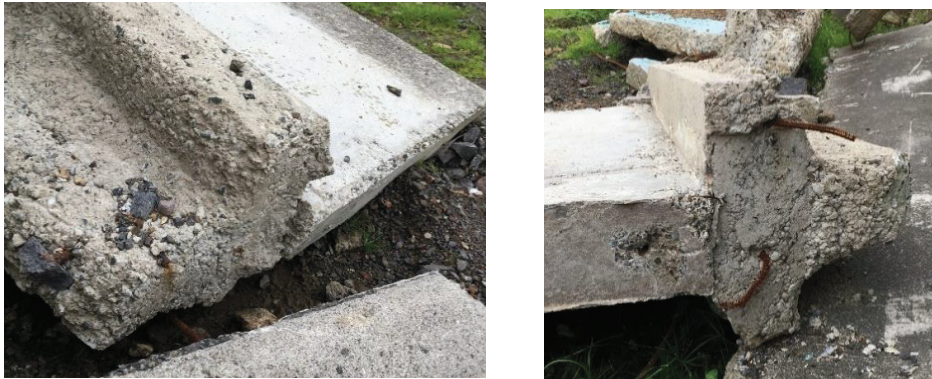
**Figure 23: College Road floodwall - Views of the ends of two of the wall sections, showing the subsurface keys (Source: Bay of Plenty Regional Council, 2017)**

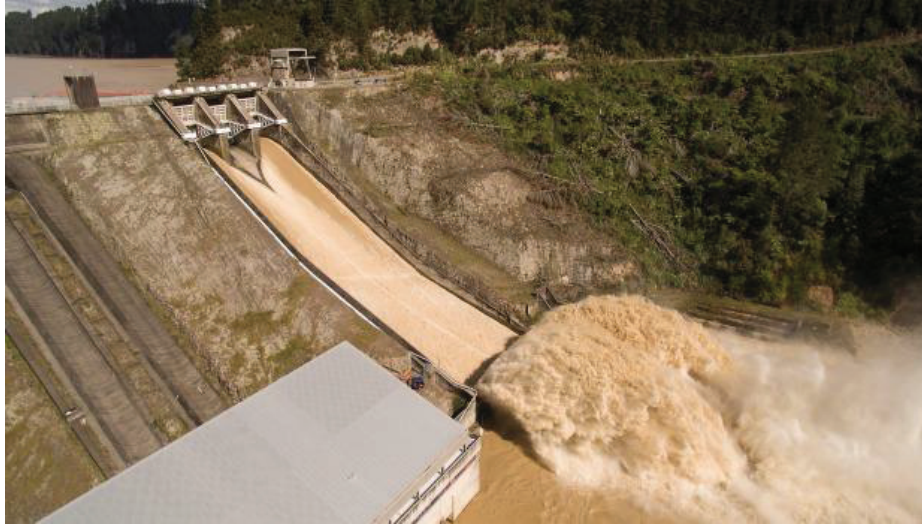
**Figure 25: Matahina Dam spillway operating during April 2017 flood (Source: Chris McKeen/Fairfax NZ)**

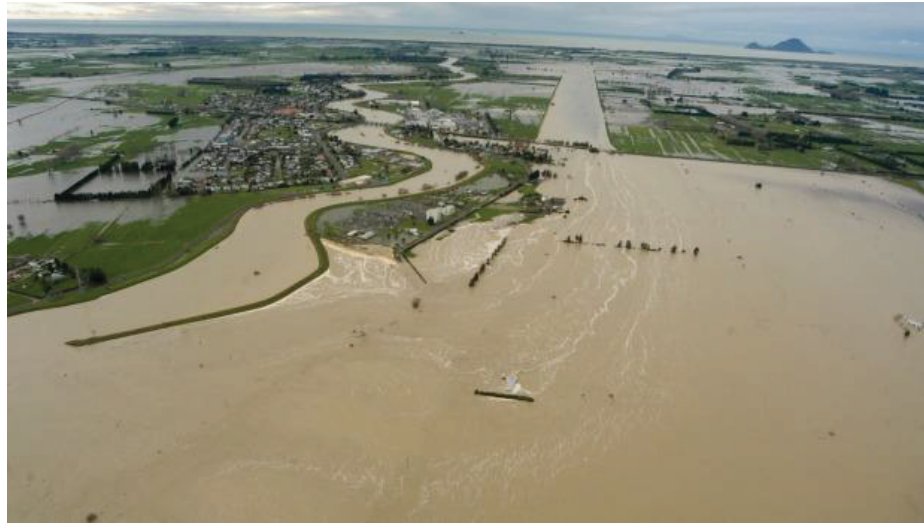
The most significant flood event in recent years, until this year, occurred in 2004 when a major breach of the Rangitāiki River stopbank occurred at Sullivan's bend upstream of Edgecumbe (see Figure 27). The breach occurred at a flow of  $690\text{m}^3/\text{s}$  (approximately a 60-year flood event) when the floodway had only just started to operate for the first time since its construction in the 1970's. The stopbank breach resulted in approximately  $250\text{m}^3/\text{s}$  of flood water spilling into the floodway, exceeding its capacity of  $85 \text{m}^3/\text{s}$  and causing widespread inundation of predominantly rural land to the east of the Rangitāiki River (Opus International Consultants, 2007). This highlighted the limited utility of the floodway. It had never had any floodwater flowing down it since its construction 30 years earlier

**Figure 27: 2004 Flood showing effects of breach and overflows into Reid's Floodway (Source: Whakatāne Beacon)**

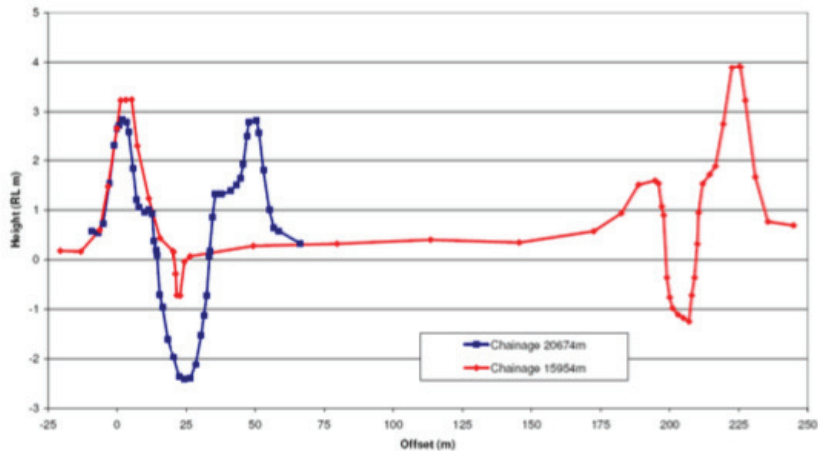
**Figure 28: Existing (pre-2010) typical cross sections of Reid's Floodway (Source: Opus, 2007)**

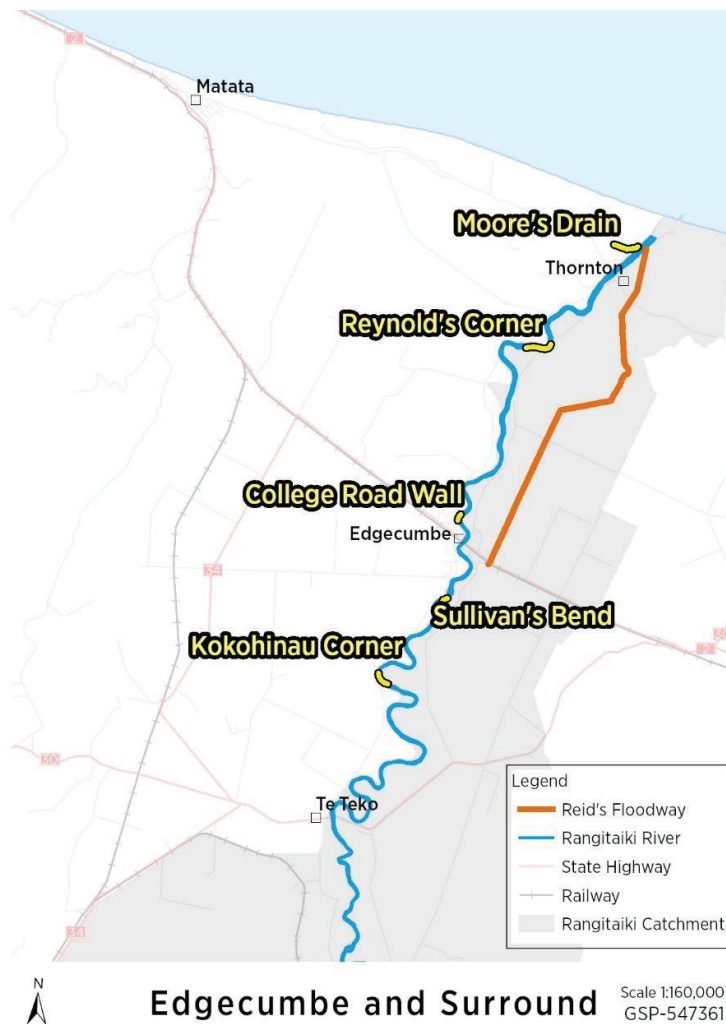
**Figure 33: Edgcumbe area and critical structures related to the 2017 flood event (Source: Bay of Plenty Regional Council 2017)**

The 2011 modelling did consider three breach locations on the Rangitāiki River; Moores Road and Reynold's Bend both downstream of Edgcumbe, as well as at Kokohinau upstream of Edgcumbe (see Figure 33). It is understood that the breach locations were identified based on past areas where there had been

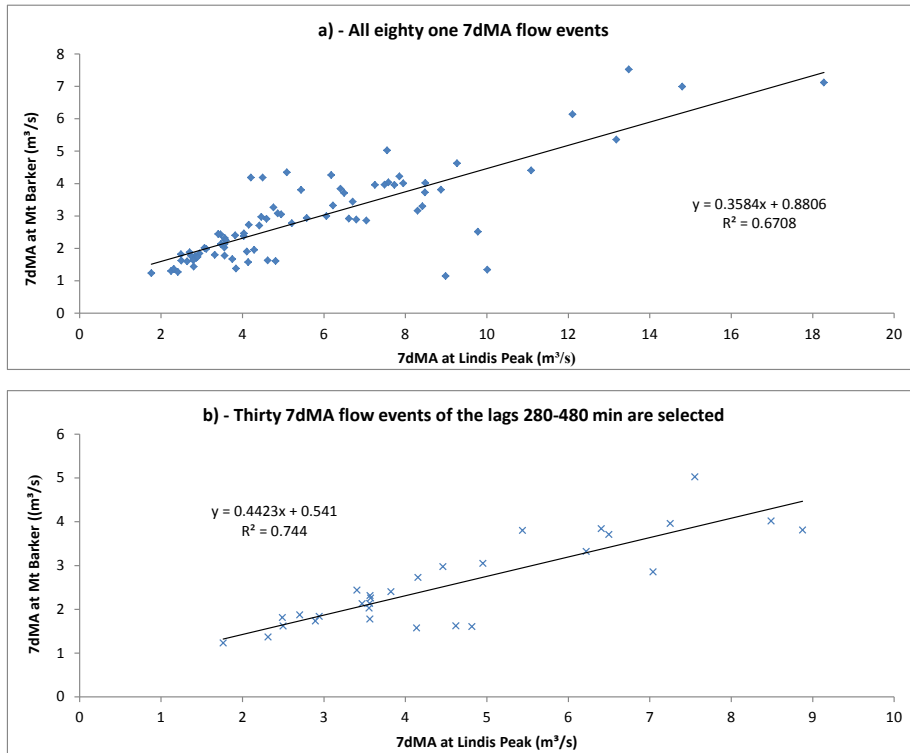
**Figure 3-2** The relationships from (a) all eighty-one minimum 7dMAs and (b) selected thirty minimum 7dMAs with lag time of 280-480 minutes

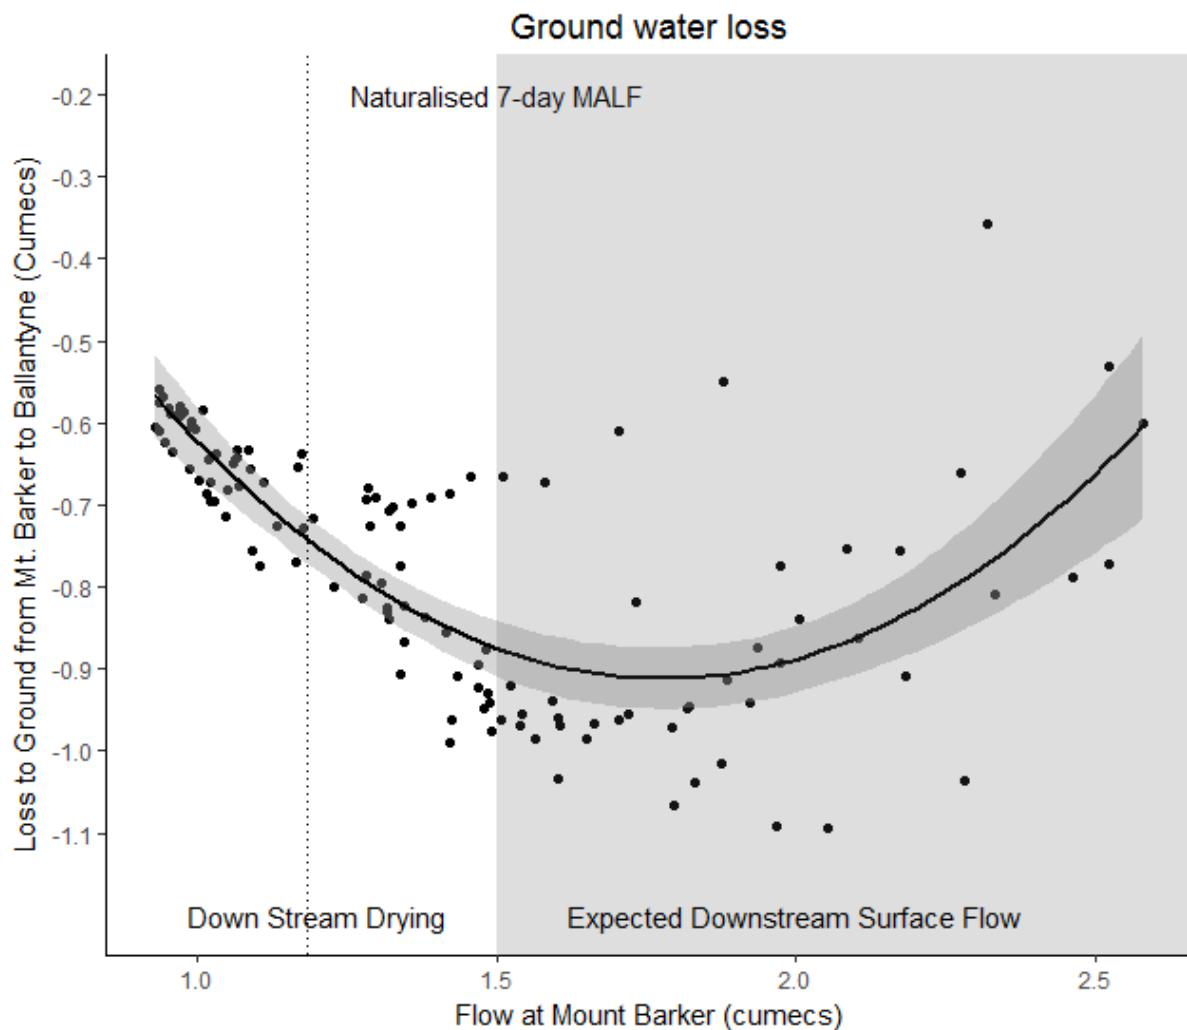
**Figure 3-8** Quadratic model fit of the relationship between flow at Mt. Barker and groundwater loss from Mt. Barker to Ballantyne Road with a shaded (grey) 99% confidence interval and naturalised minimum flow. Shaded expected downstream flow regions are based upon the inflection point of groundwater loss. When flow values exceed this point (1.5 cumeecs), downstream surface connectivity is more likely to be maintained.
