# River and stream health

Clutha River Annual Monitoring Summary

2005-2006

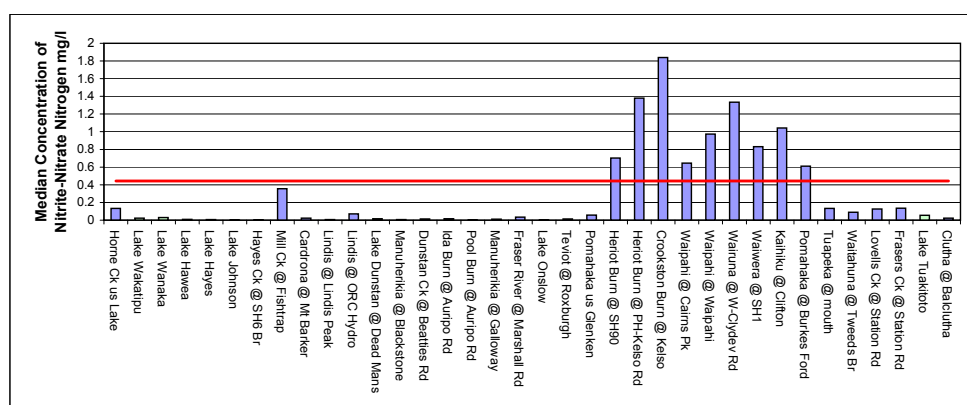
Nitrite-nitrate nitrogen (NNN) is a form of nitrogen primarily derived from land drainage. It is an important nutrient for algae and other plant growth, but can be harmful in higher concentrations. The median concentration of NNN was above the ANZECC trigger value for nine sites, all of which are in the Pomahaka River catchment.

Median dissolved reactive phosphorus (DRP) concentrations were above the ANZECC trigger value for more than half of all sites analysed. These high DRP sites were localised in four areas: small lakes of the Wakatipu basin, the lower Manuherikia River and tributaries, the Pomahaka River and tributaries, and tributaries of the Clutha River.

Note: The red lines on these graphs indicate the ANZECC trigger value or the DoH guideline level. The graphs represent both lakes and rivers/streams, which are colour coded green and blue respectively.

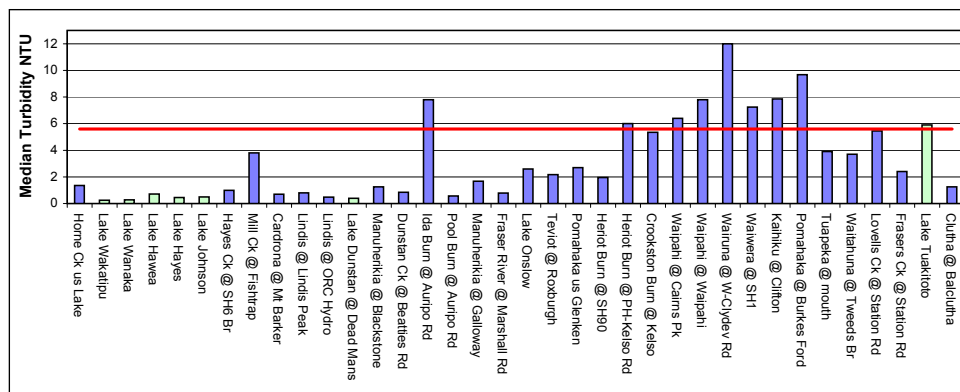
Turbidity was elevated above the ANZECC trigger value in the Pomahaka catchment, Lake Tuakitoto and the Ida Burn (this result is primarily due to irrigation run-off). This graph also shows a general trend for turbidity increasing with distance downstream.

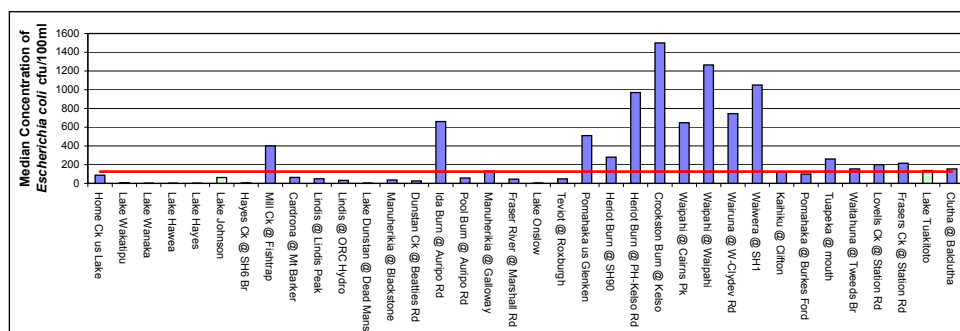
Median levels of *Escherichia coli* were generally above the DoH guideline (126 cfu/100ml) in the Pomahaka catchment, and the lower Clutha and tributaries. The Ida Burn and Mill Creek also show isolated occurrences of elevated *E. coli* levels.

All other sites showed levels below the trigger value, indicating minimal overall health risk, although bacteria levels may become raised following rainfall events.

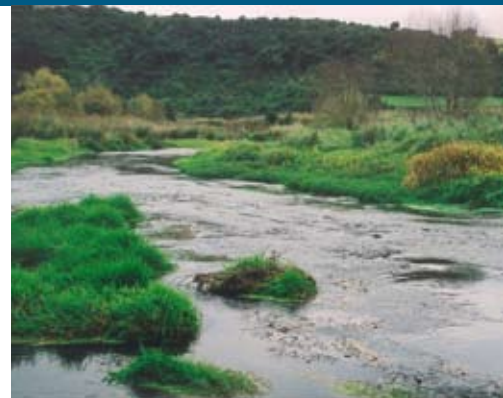
- Total phosphorus was elevated above the ANZECC trigger value in four main areas: Lakes Johnson and Hayes in the Wakatipu basin, the Manuherikia River and its tributaries the Ida Burn and Pool Burn, most sites in the Pomahaka catchment, and in the tributaries of the lower Clutha River.

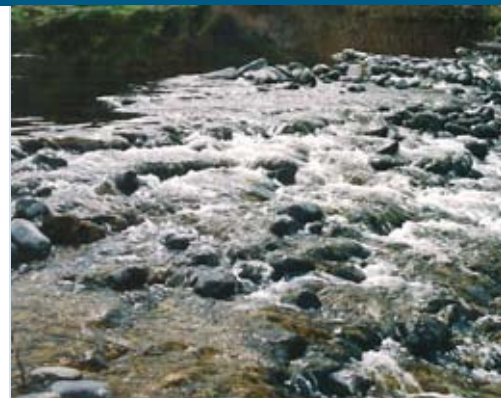
## Clutha River Macroinvertebrate Health 2006

Sample Location	MCI	SQMCI	Total species	Total EPT
Cardrona River @ Larches	100	5.1	14	6
Fraser River @ Marshalls Rd	113	6.2	17	10
Lindis River @ Lindis Peak	110	5.4	20	11
Lindis River @ Ardgour Rd	104	5.6	15	6
Mill Creek @ Fish Trap	91	4.4	15	7
Waipahi River @ Cairns Peak	103	5.3	18	9
Waipahi River @ Waipahi	89	4.4	22	9
Cardrona River @ Larches	100	5.1	14	6
Fraser River @ Marshalls Rd	113	6.2	17	10
