Water Quality of the Lindis and Cardrona rivers

**Water Quality of the
Lindis and Cardrona Rivers**

May 2006

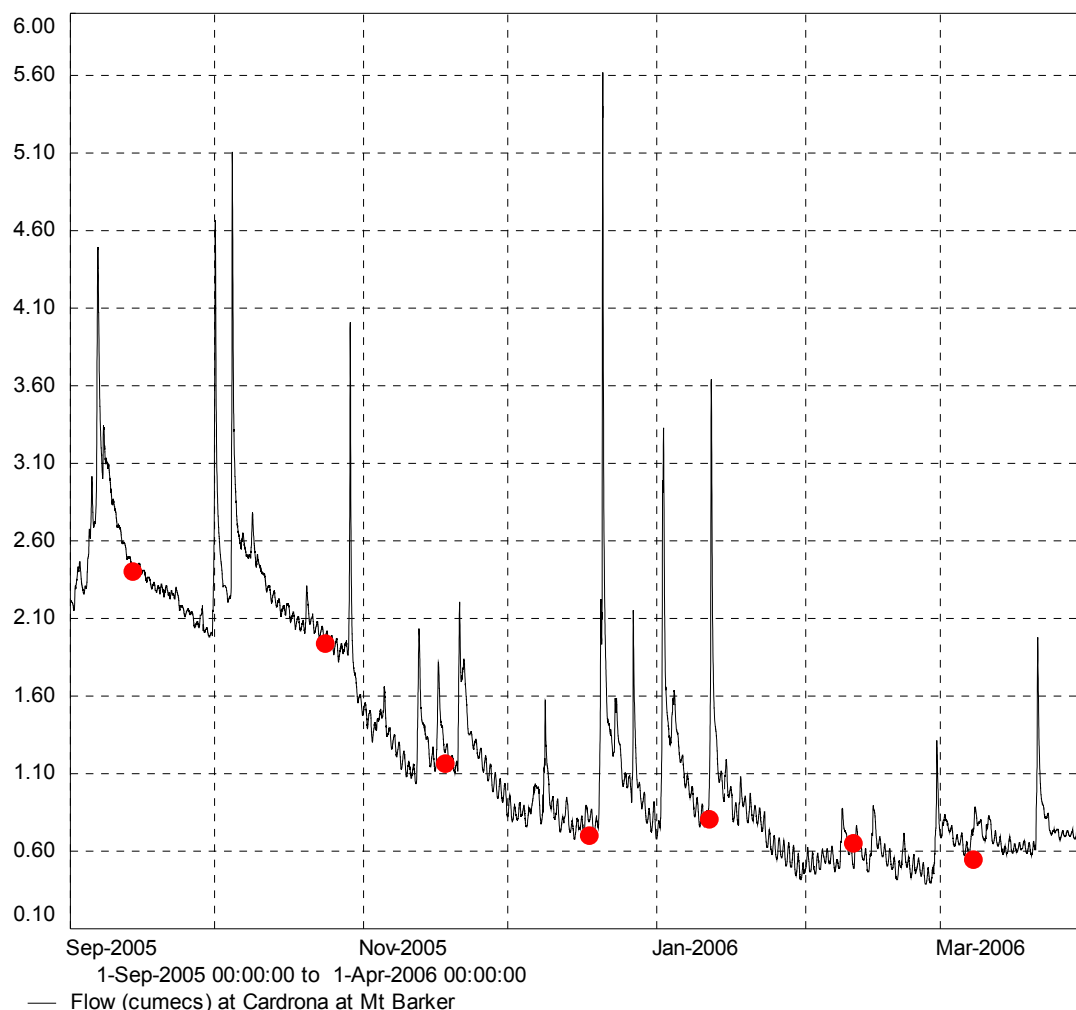
**Figure 2.4** Flow (cumecs) at Mt Barker, Cardrona River. The red spots indicate days when water quality samples were taken

Figure 2.4 and Figure 2.5 graphically depict mean daily flows recorded at Mt Barker (Cardrona River) and Lindis Peak (Lindis River). The red spots indicate days when water quality samples were taken. Figure 2.4 shows that the February sample for the Cardrona River was taken when flows had risen after the 7.7mm rainfall, and Figure 2.5 clearly shows that the December sample was taken when flows were rising after the 15.5mm rainfall recorded in the previous 24 hrs. It is expected that this will have some bearing on water quality results.

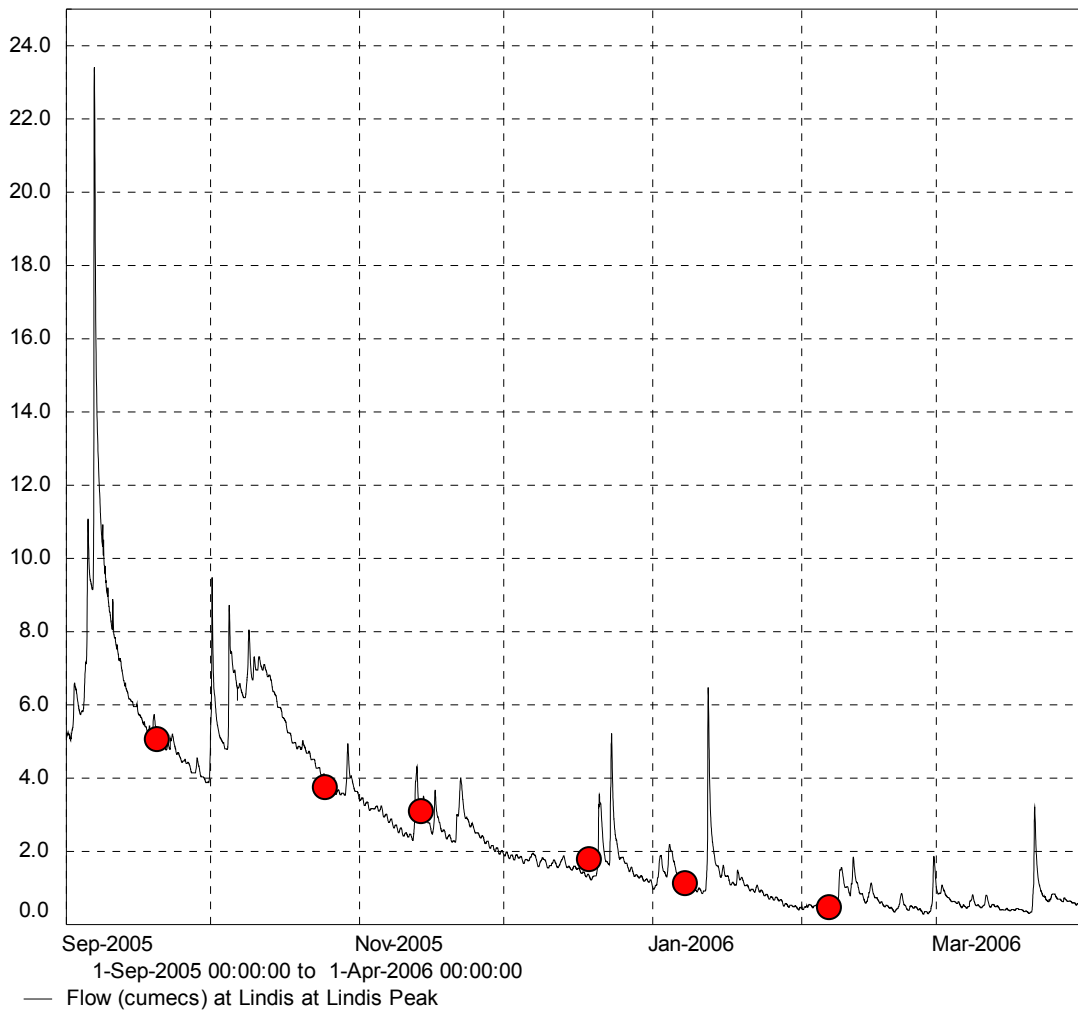
Figure 2.5 Flow (cumecs) at Lindis Peak, Lindis River. The red spots indicate days when water quality samples were taken

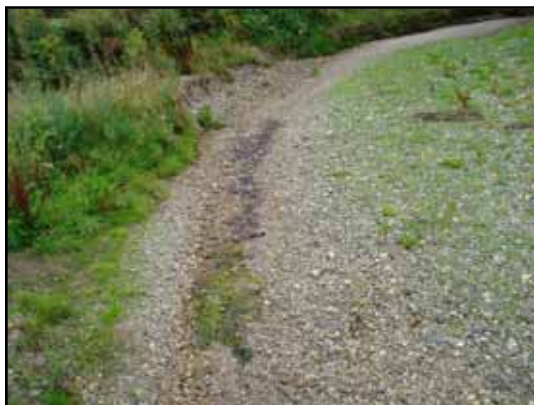
Figure 2.7 Lindis River at SH87, 21 February 2006

Figure 2.6 shows the location of discharges and takes from the Cardrona and Lindis Rivers. Neither river has significant discharges of waste water. However, both rivers have significant takes, particularly in their lower reaches and both rivers dry up in their lower reaches most years. Figure 2.7 shows the Lindis River at SH87.

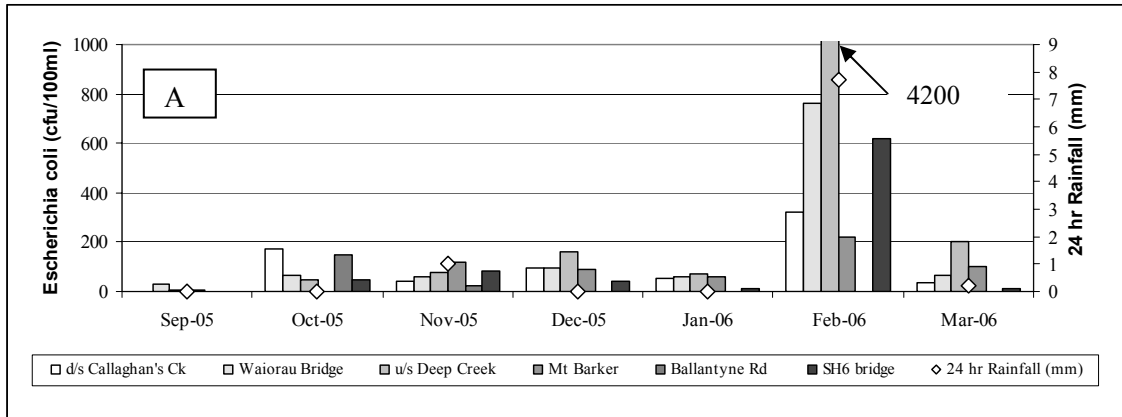
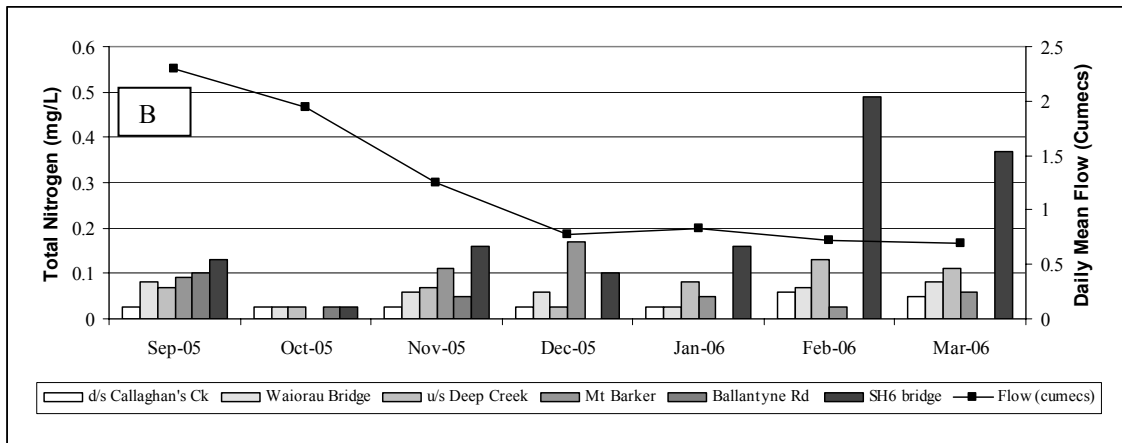
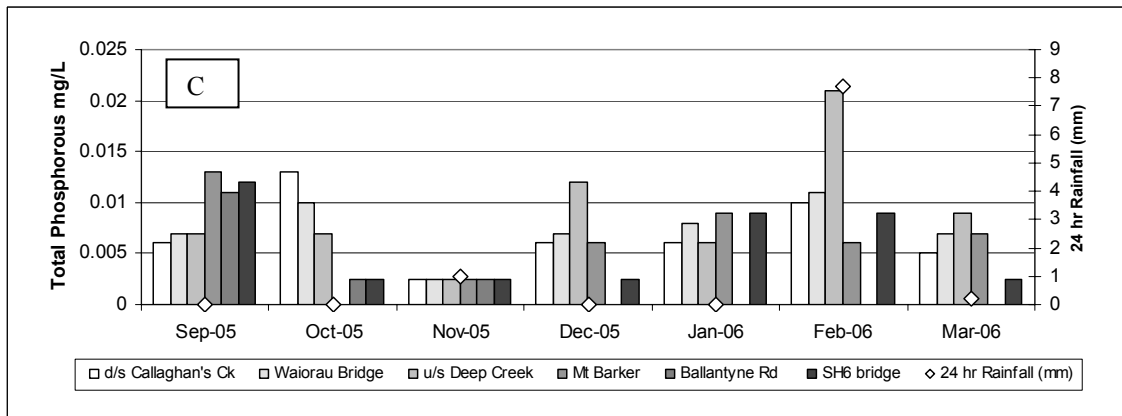
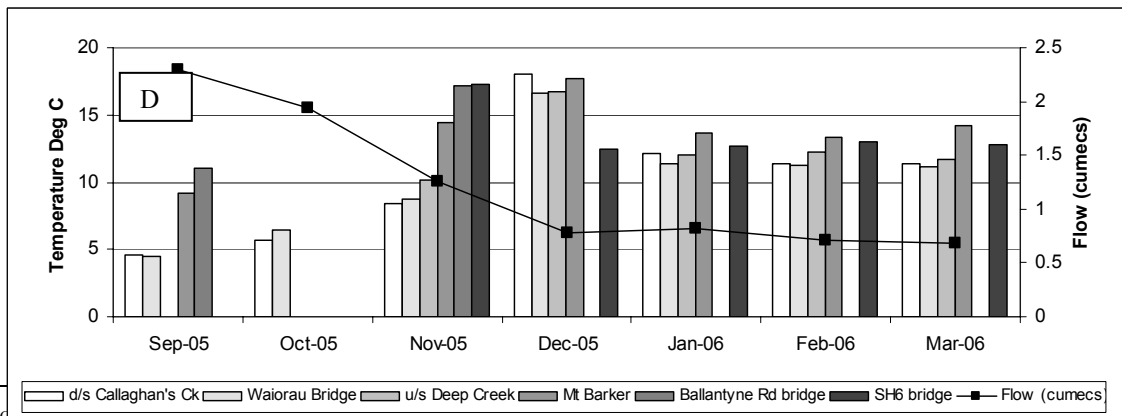
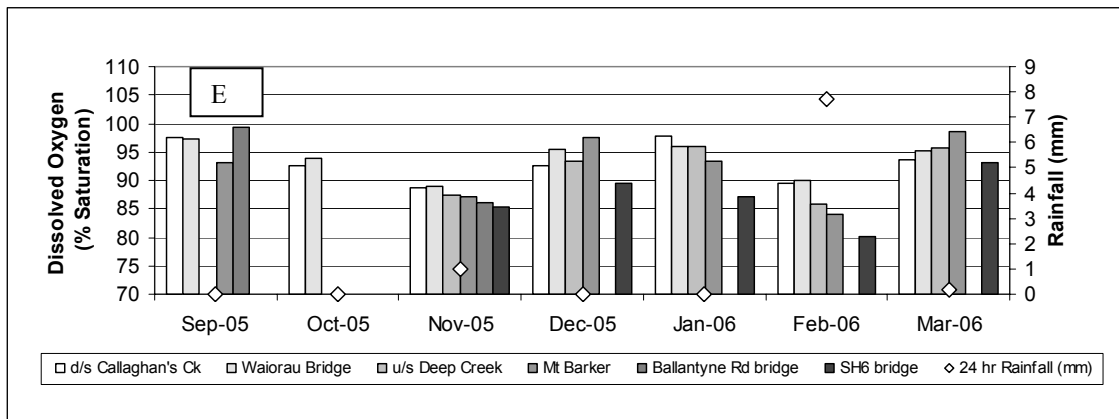
Figure 3.2 Cardrona River water quality. Samples taken at monthly intervals between September 2005 and March 2006. A - *Escherichia coli*; B - Total nitrogen; C - Total phosphorus; D - Temperature; E - Dissolved Oxygen

Table 3.1 shows that median levels for nutrients at all sites in the Cardrona River are below the ANZECC default trigger guidelines for upland rivers. However, Figure 3.2 looks at individual sites and sampling dates and whilst generally the river is of good quality, water quality deteriorates in times of rainfall, as it would in most rivers.

The deterioration due to rainfall is illustrated in Figure 3.2A. This shows that the February sampling run was associated with elevated *E. coli* concentrations which exceeded the surveillance/green mode of the MfE/MoH 2003 Recreational Water Quality Guideline (<260 *E. coli*/100ml). Deep Creek recorded a particularly elevated *E. coli* concentration of 4200 cfu/100ml. In the same sampling run, TN was noticeably elevated at SH6 Bridge and TP exceeded the ANZECC default trigger value for upland rivers at Ballantyne Road.

Figure 3.2 does not show a marked deterioration of water quality over the summer period. However, in some sampling runs a deterioration downstream can be noted, specifically Figure 3.2B and C where the September run shows an increase of TN and TP downstream. Figure 3.2E shows that in January and February DO levels decrease with distance downstream, but are still above the bottom line of 80% saturation (as specified in the Third Schedule of the RMA).

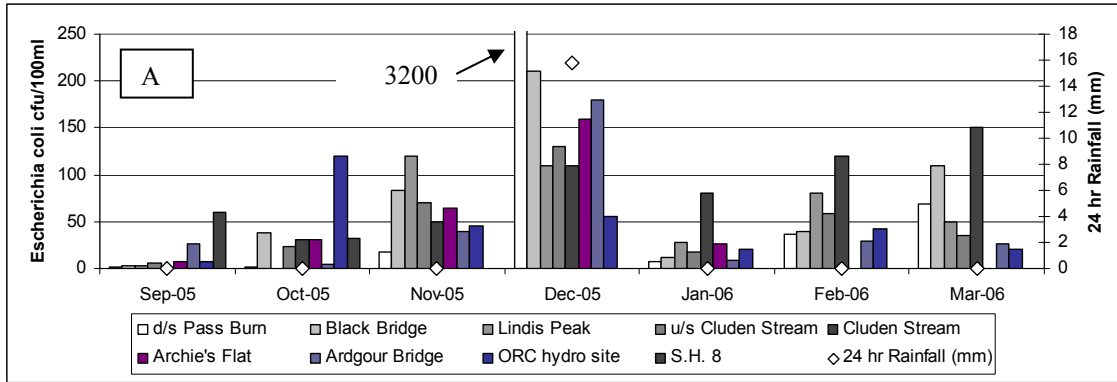
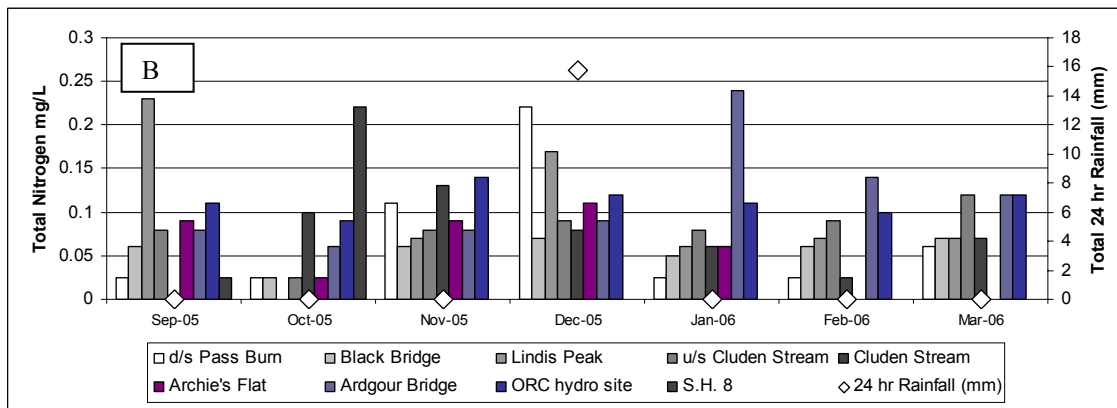
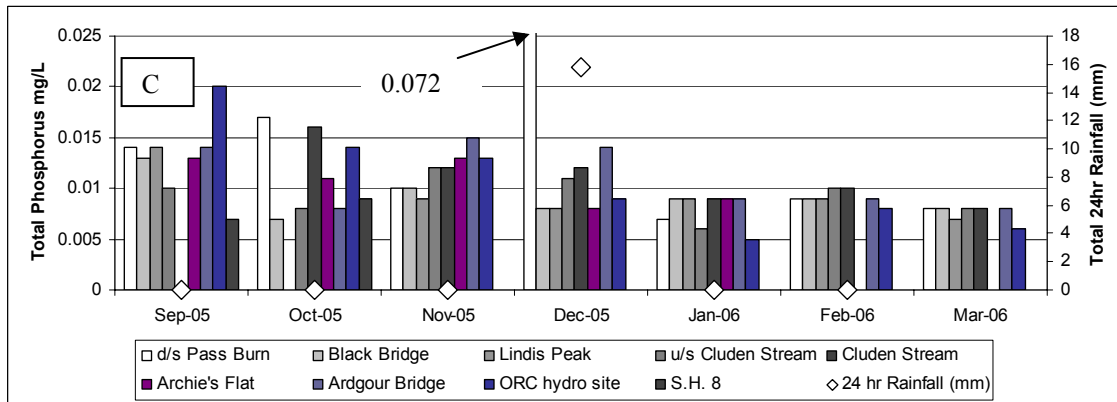
Figure 3.4 Lindis River water quality. Samples taken at monthly intervals between September 2005 and March 2006. A - *Escherichia coli*; B - Total nitrogen; C - Total phosphorus; D - Temperature; E - Dissolved Oxygen

In December 2005, rainfall of 15.5mm fell in the 24 hrs prior to sampling. This resulted in elevated *E. coli* concentrations at all the upstream sites. Figure 3.4A shows that only Passburn exceeded the surveillance/green mode of the MfE/MoH 2003 Recreational Water Quality Guideline (<260 *E.coli*/100ml). Passburn also recorded a particularly high TP result on the same sampling run.

Figure 3.4C shows that TP looks as if it decreases over the summer period, other than the one high reading at Passburn taken just after the rainfall event. It was not expected to find elevated concentrations of phosphorus as the most common cause of elevated phosphorus in watercourses is sediment being washed from paddocks into the stream by heavy rain, and each sampling round was undertaken after periods of dry weather (other than in December). When disregarding the high Passburn result, the P-value of the F-test is less than 0.05, showing a statistically significant difference between the means of the 7 variables at the 95.0% confidence level. This does not occur with TN. In terms of phosphorus, water quality seems to improve over the summer period.

Figure 3.4E shows that DO concentrations remain above 80% at all sites and dates, other than at Ardour Bridge where levels dropped just below this threshold on 7 February.
