Water quality and ecosystem health in Otago

July 2012 to June 2017

Introduction The Otago Regional Council (ORC) is responsible for managing Otago’s surface-water resources and carrying out regular and extensive long-term water-quality monitoring, as part of its State of Environment (SOE) programme. This report card documents the results of water-quality (July 2012 to June 2017), macroinvertebrate, periphyton and fish (2017), monitoring.

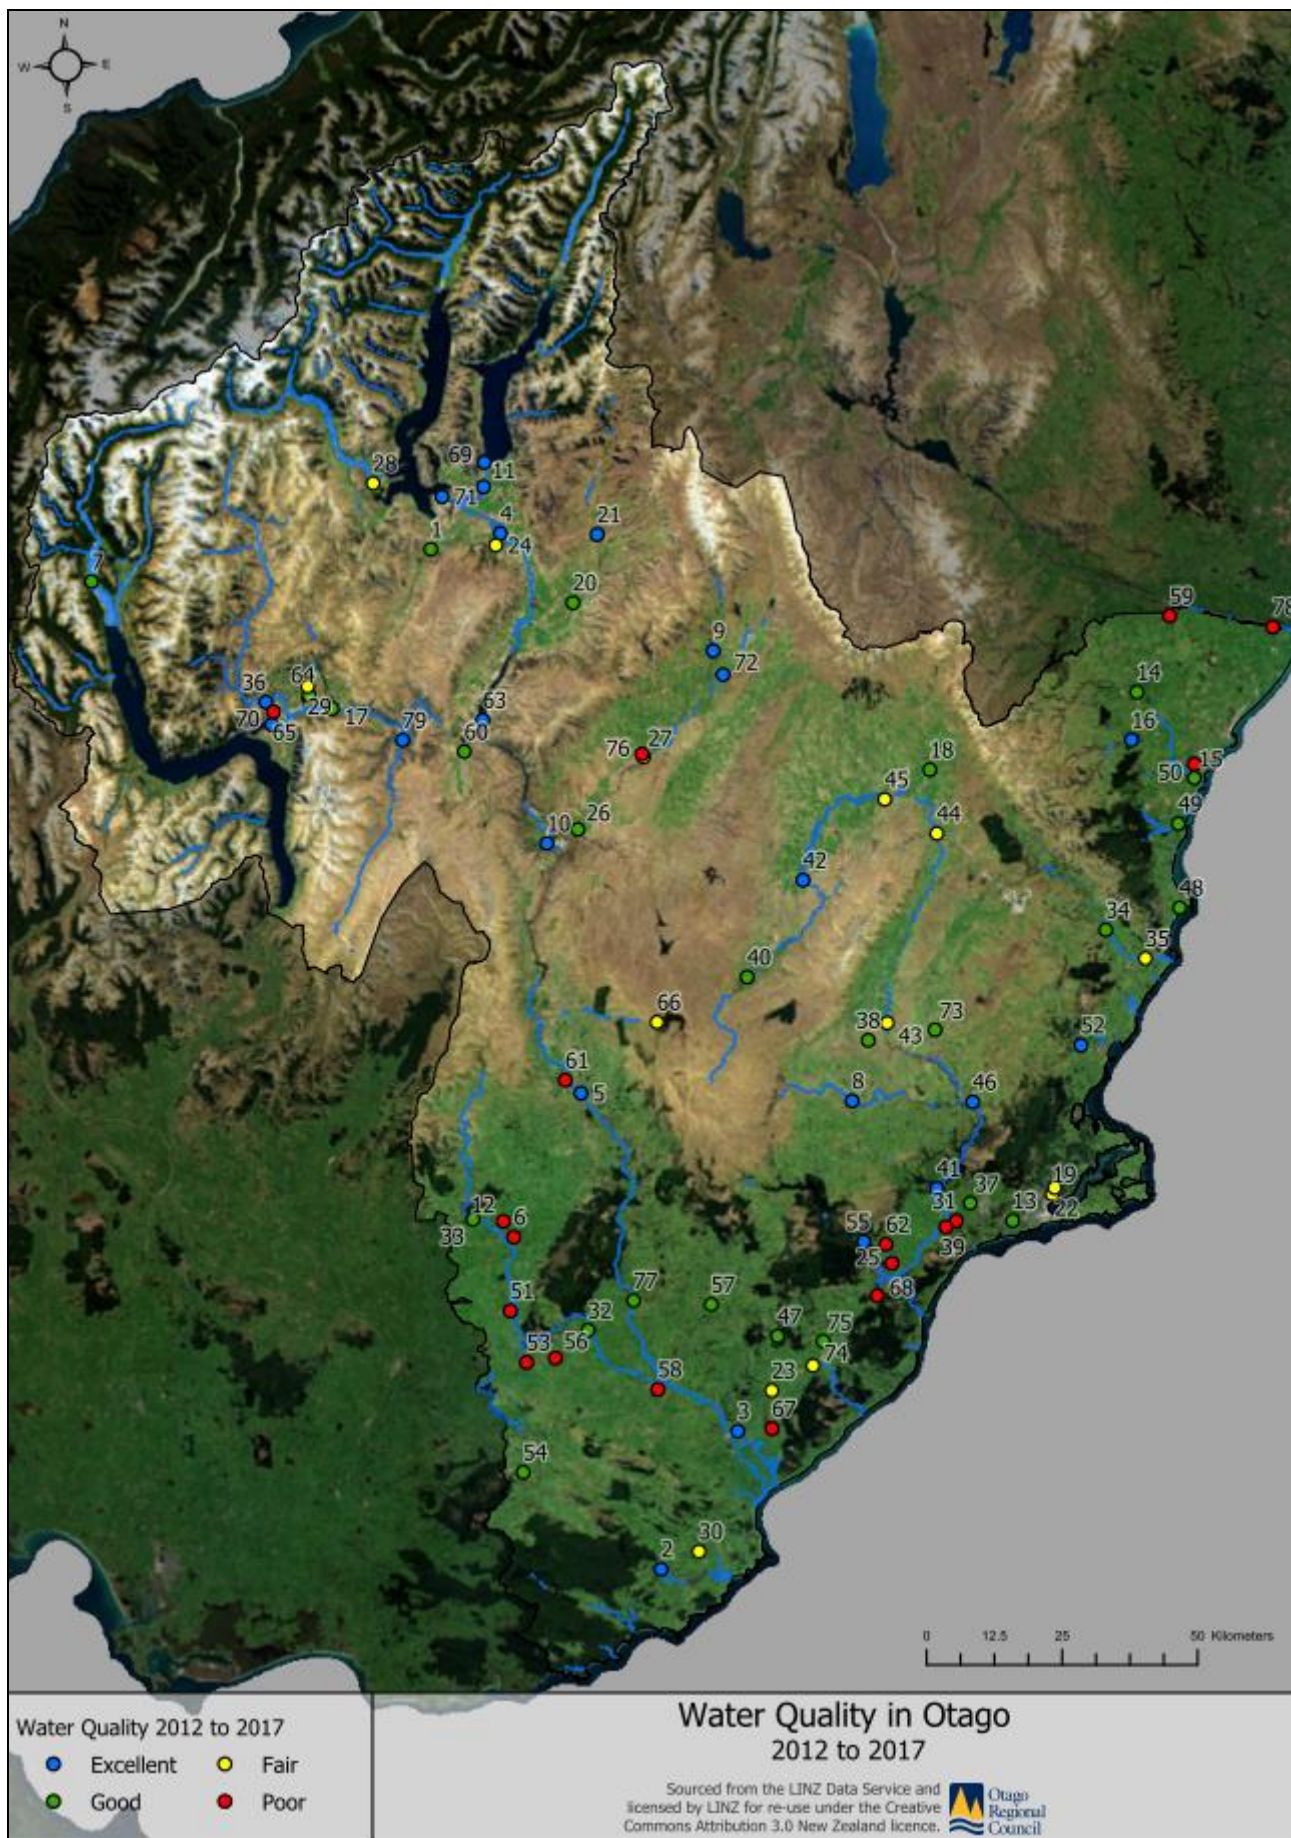
Figure 1: Results of five years of SOE water-quality monitoring. Site numbers refer to sites in Tables 3 and 4.

67 SOE sites were monitored every month, and a further eight were monitored monthly by NIWA (as part of the National River Water Quality Network). To enable classification of each site into one of four groups (Table 2), ORC uses a water quality index. Figure 1 shows the results.

Most the sites with 'excellent' river water quality were in Central Otago and the upper Clutha, where land-use tends to be low-intensity sheep farming and/or dominated by tussock lands. Poorer water quality was found in river catchments with higher-intensity farming or in streams draining urban environments.
