The Effect of Irrigation Runoff on Water Quality

May 2006

Foreword – The Effect of Irrigation Runoff on Water Quality

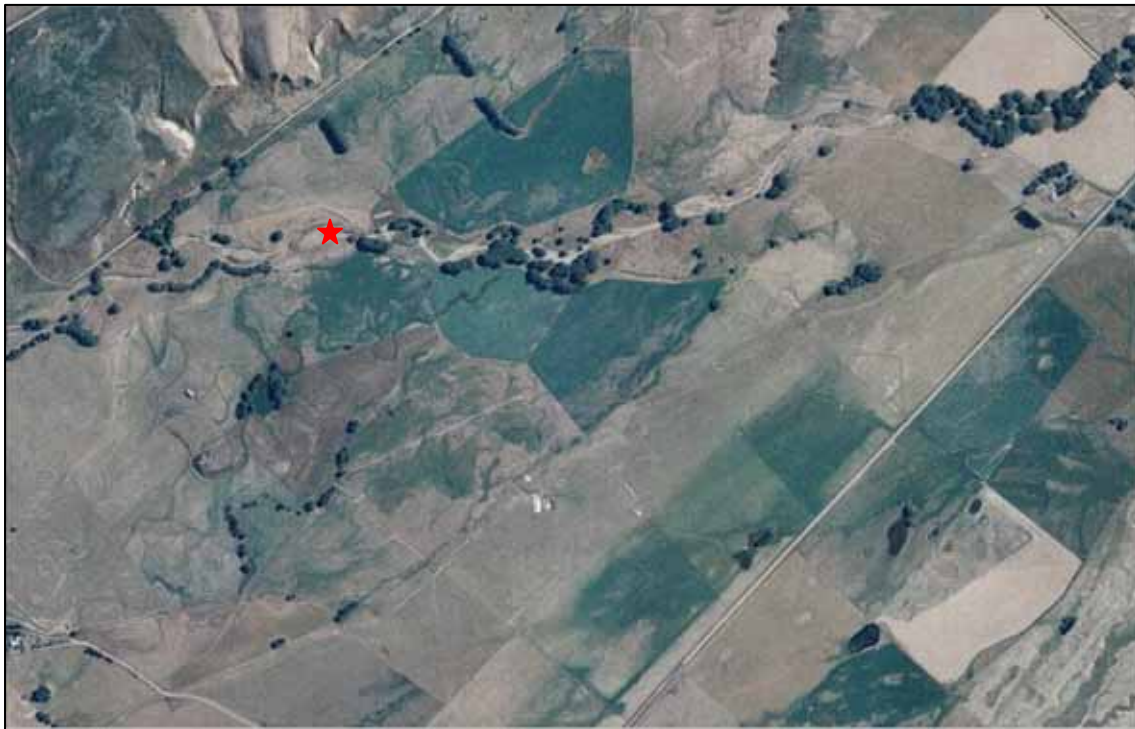
Figure 4.9 Aerial photograph of flood irrigation and drainage channels in area bounded by rectangle in Figure 4.8

Figure 4.9 shows the area bounded by the rectangle in Figure 4.8 - the Ida Burn is in the centre of the photograph, the red star indicates a take from the Ida Burn and irrigation channels and irrigated paddocks can be seen clearly.

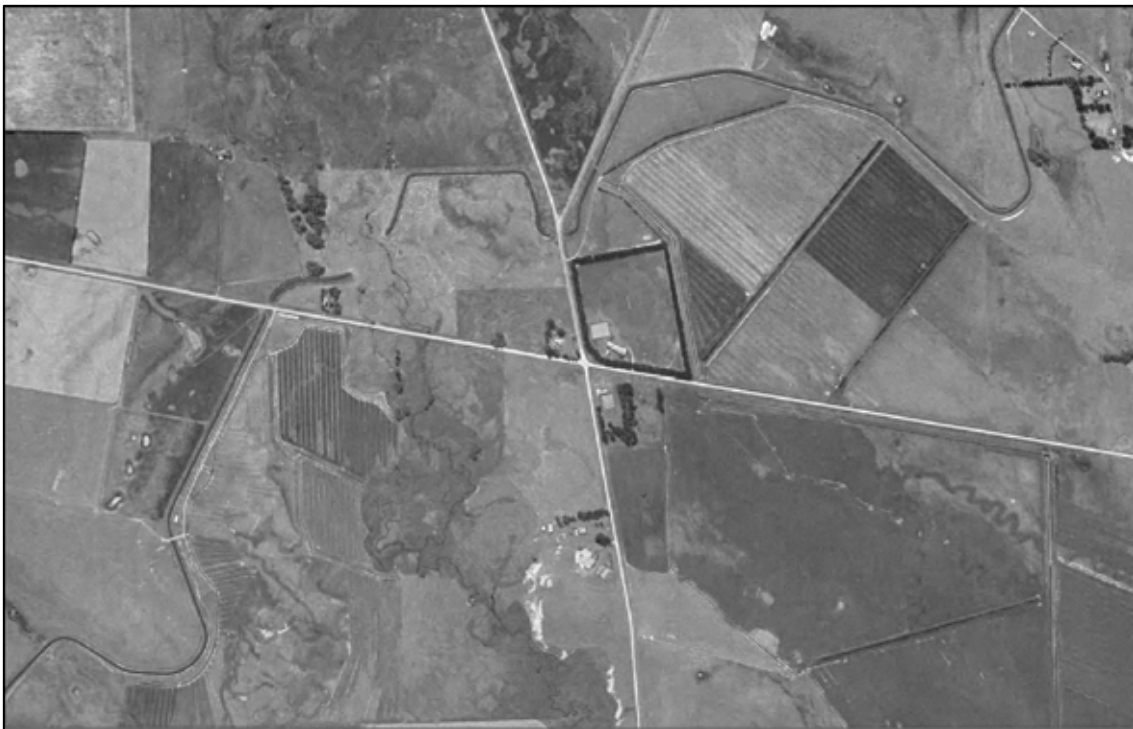
Figure 5.8 Aerial photograph of flood irrigation and drainage channels in area bounded by rectangle in Figure 5.7. The MIC scheme can clearly be seen as it passes under the Wether Burn

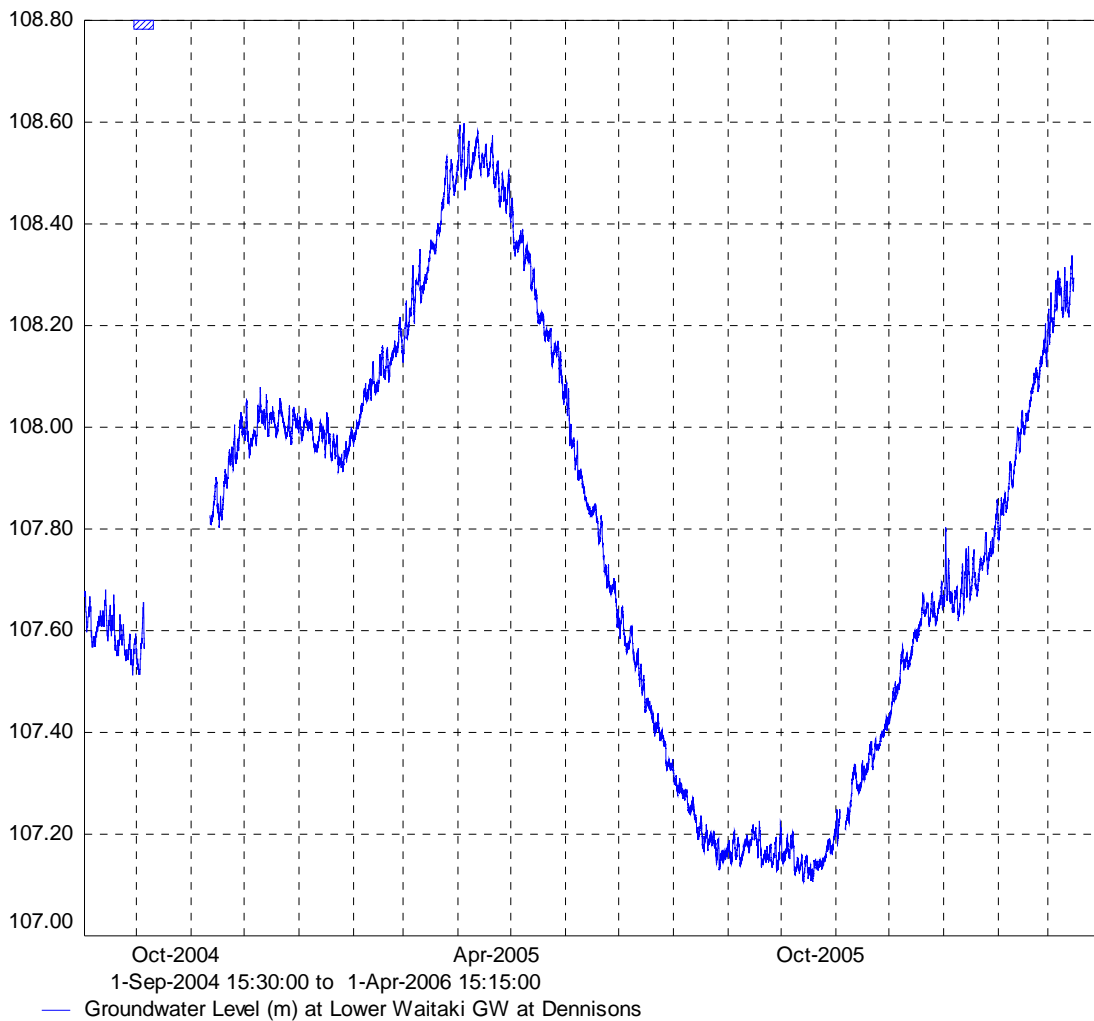
Figure 6.3 Groundwater hydrograph for Dennison's bore

Hamilton and Elliot (1994) reported that groundwater levels initially increased between 2m and 6m when large-scale irrigation commenced. With irrigation having such an effect on groundwater, it would be surprising if water quality did not show some sign of deterioration over the summer period due to irrigation runoff supplementing the groundwater levels.
