# **Report on the Surface Water Quality of the Lower Taieri River Catchment**

**March 2004**

## Executive Summary

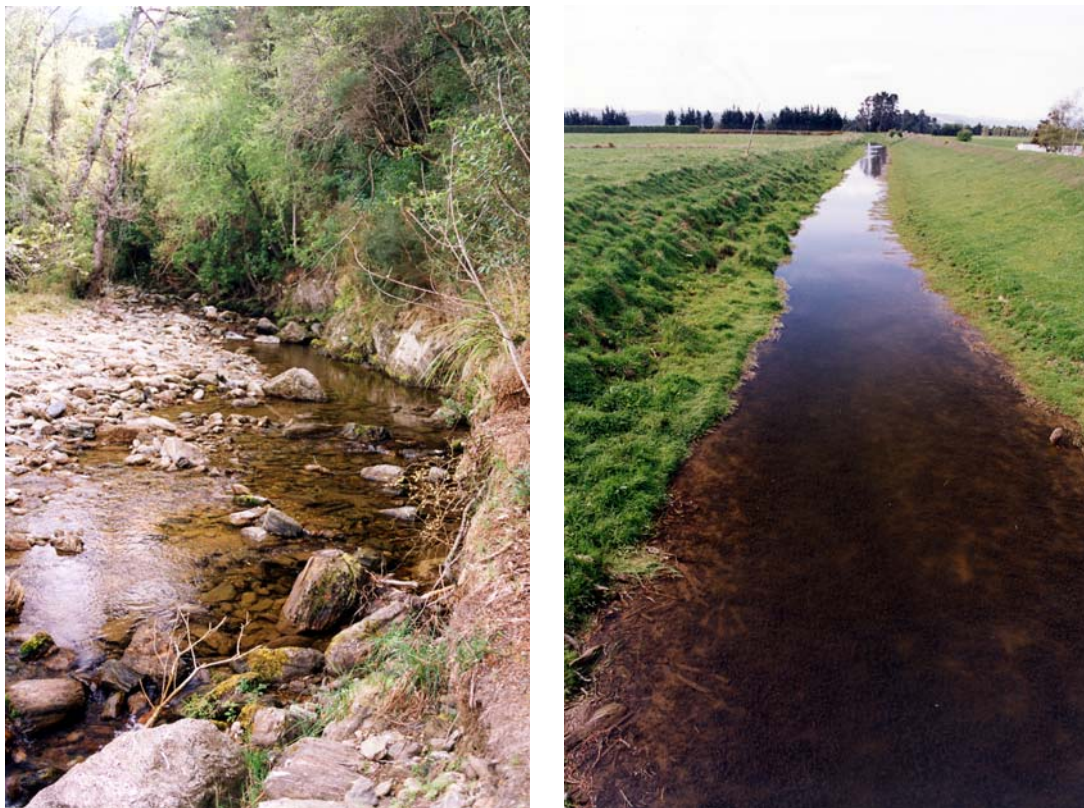
**Figure 3.6** Lee Creek at Woodside Glen (left) and the Contour Channel at Grainger Road

The Contour Channel is an artificial watercourse built by the Western Taieri Land Drainage Board between 1910 and 1920 (Otago Regional Council 2000a). It runs along the foot of the Maungatua Range, collecting runoff from the hill catchment to discharge to the Waipori River at Henley Berwick Road above Lake Waipori. During wet winter conditions when Lee Canal Drain water levels are too high to allow gravity drainage, runoff can be pumped into the Contour Channel at the Lake Ascot Pumping Station.

Lee Creek was monitored at Woodside Glen Recreation Reserve where it drains a largely bush catchment (Figure 3.6) and the Contour Channel was monitored at Grainger Road (Figure 3.6) and in the lower reaches above the Waipori River tidal influence at the No. 4 Bridge.

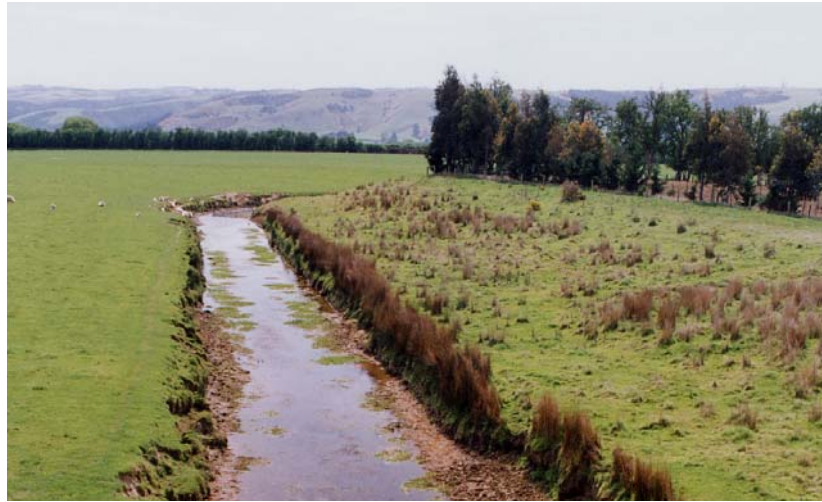
**Figure 3.10 A1 Drain from the Taieri River flood gates**

The A1 Drain is an Otago Regional Council maintained drain on the East Taieri. It drains predominantly dairying land between SH87 and the lower Mill Stream and discharges under gravity via flood gates to the Taieri River below Riverside Road. When the river is high and there is a build up of water in the drain following heavy rainfall, water can be pumped into the Silverstream at the Silverstream Pump Station.

Sampling sites were located at the outflow of McKays Triangle and immediately upstream of the A1 Drain's confluence with the Taieri River (Figure 3.10).

The A1 Drain also drains a portion of the East Taieri and the site at McKays Triangle had similar water quality to “Mill Stream” at McKays Triangle, including a surprisingly low median *E. coli* count of just 57 MPN/100 ml. However, there was a significant decline in water quality between the reserve site and the lower site at the confluence of the Taieri River (Figure 5.7). Water quality at the bottom site was characterised by high turbidity levels and *E. coli* counts (up to 46,100 MPN/100 ml). Nutrient concentrations were also significantly higher at this site.

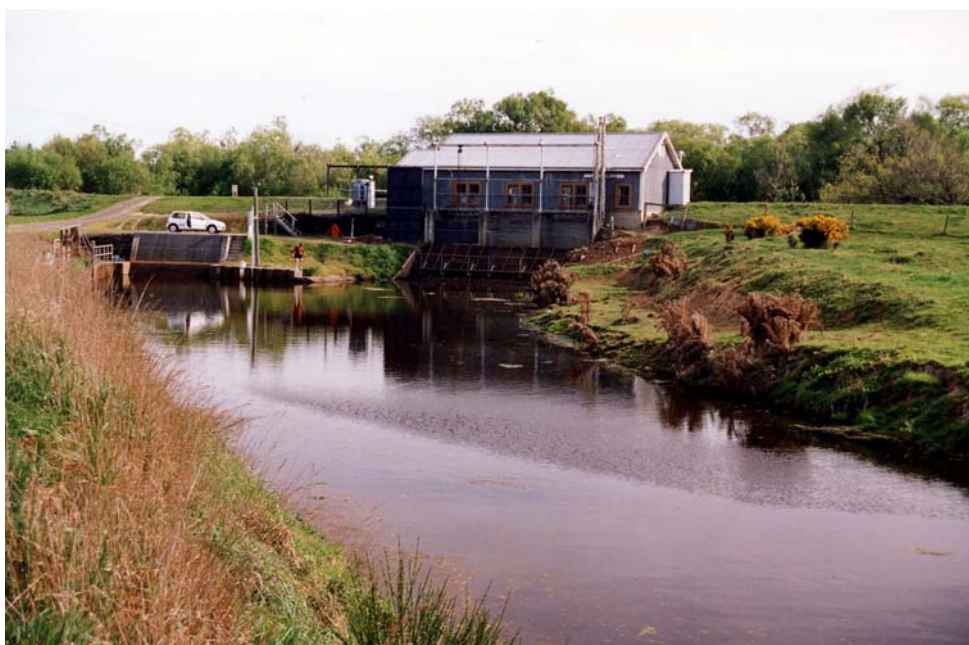
**Figure 3.12** Taieri Main Drain at the Waipori Pumping Station

The Main Drain collects water from the western Taieri Plain, including the Kirks Drain and Lee Canal Drain catchments. The Otago Regional Council operates and maintains the drainage system, which terminates at the Waipori Pumping Station from where the drainage water is pumped into Lake Waipori. The pumping station has been in operation since 1931, and has allowed the low lying western area of the Lower Taieri Plain to be developed (Otago Regional Council 1999).

Three monitoring sites were located on the Main Drain. The uppermost site was located at Miller Road above the treated sewage effluent discharge from Dunedin International Airport. A second site was located at Marshall Road immediately above the confluence of Kirks Drain and Lee Canal Drain. The third site was located at the Waipori Pumping Station and has been part of the Otago Regional Council's SOE surface water quality monitoring programme since 1994 (Figure 3.12).

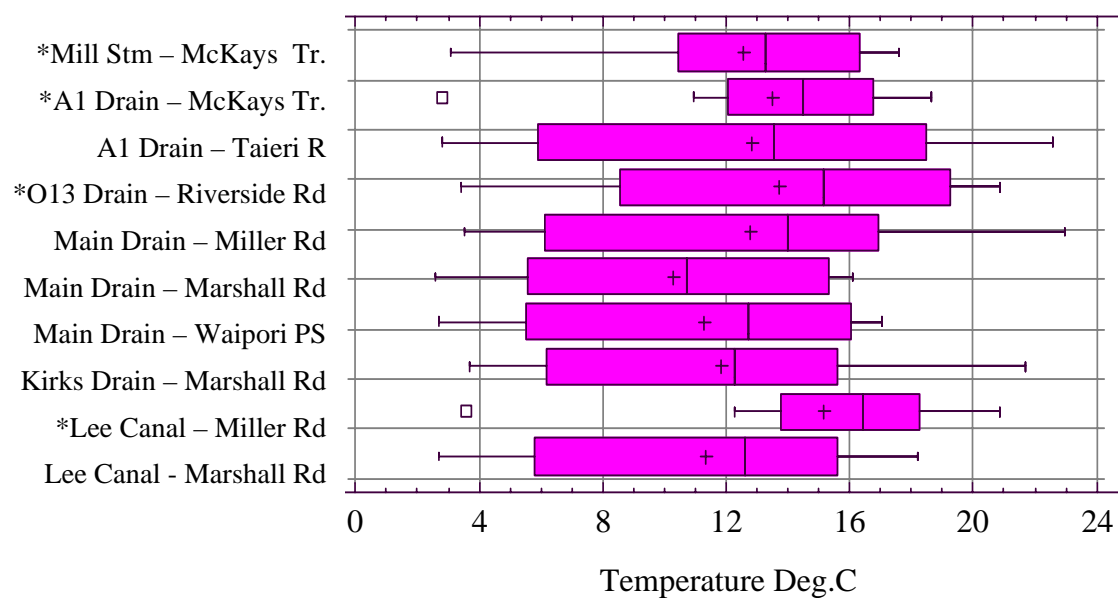
**Figure 4.2** Box plot summarising surface water temperatures recorded in various drains in the lower Taieri River catchment over October 2001 to September 2002 inclusive

Temperatures in the drains ranged from 2.6 to 22.9°C (Figure 4.2). As expected, median values tended to be several degrees warmer than median values in the larger watercourses.

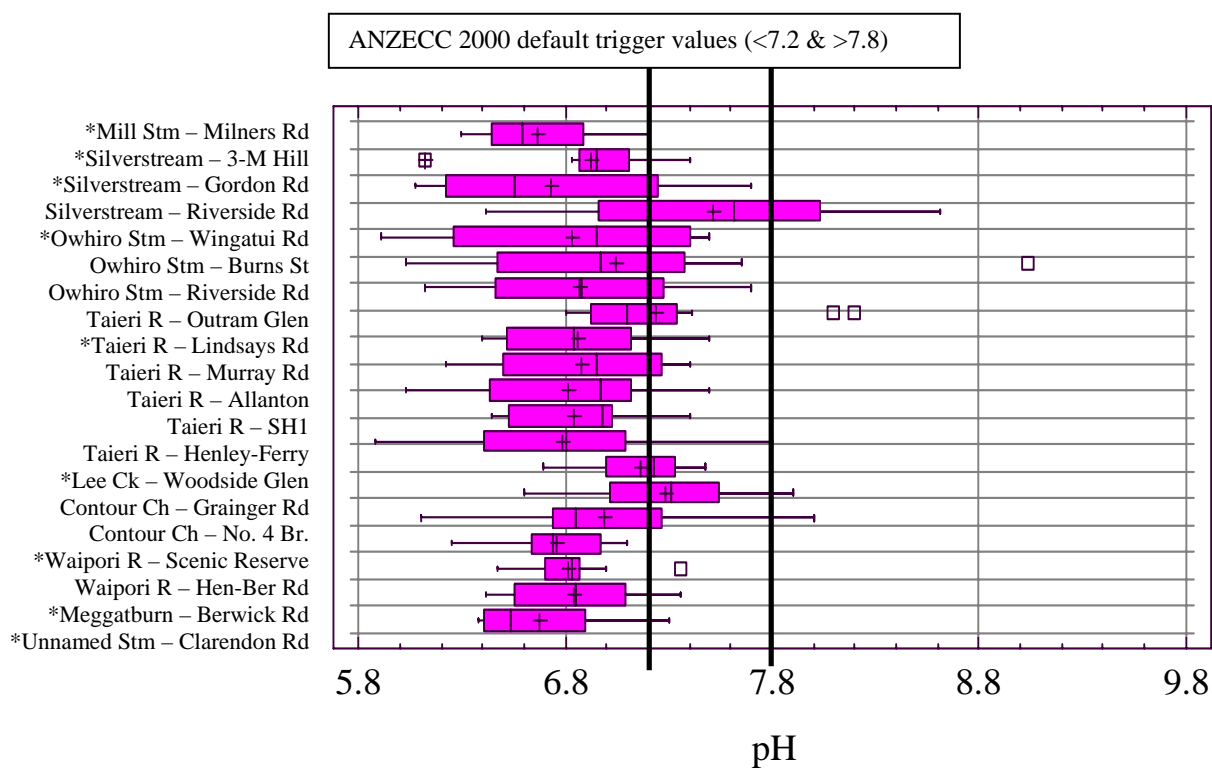
Figure 4.3 Box plot summarising pH values recorded in various waterways in the lower Taieri River catchment over October 2001 to September 2002 inclusive

The Silverstream at Riverside Road shows a slightly elevated pH relative to upstream values, the median value being 7.6. The maximum value recorded at this site was pH 8.6 on 24 September 2002 (Figure 4.3). A high pH value was also recorded in the Owhiro Stream at Mosgiel during the last sampling round in September 2002 (pH 9.04).

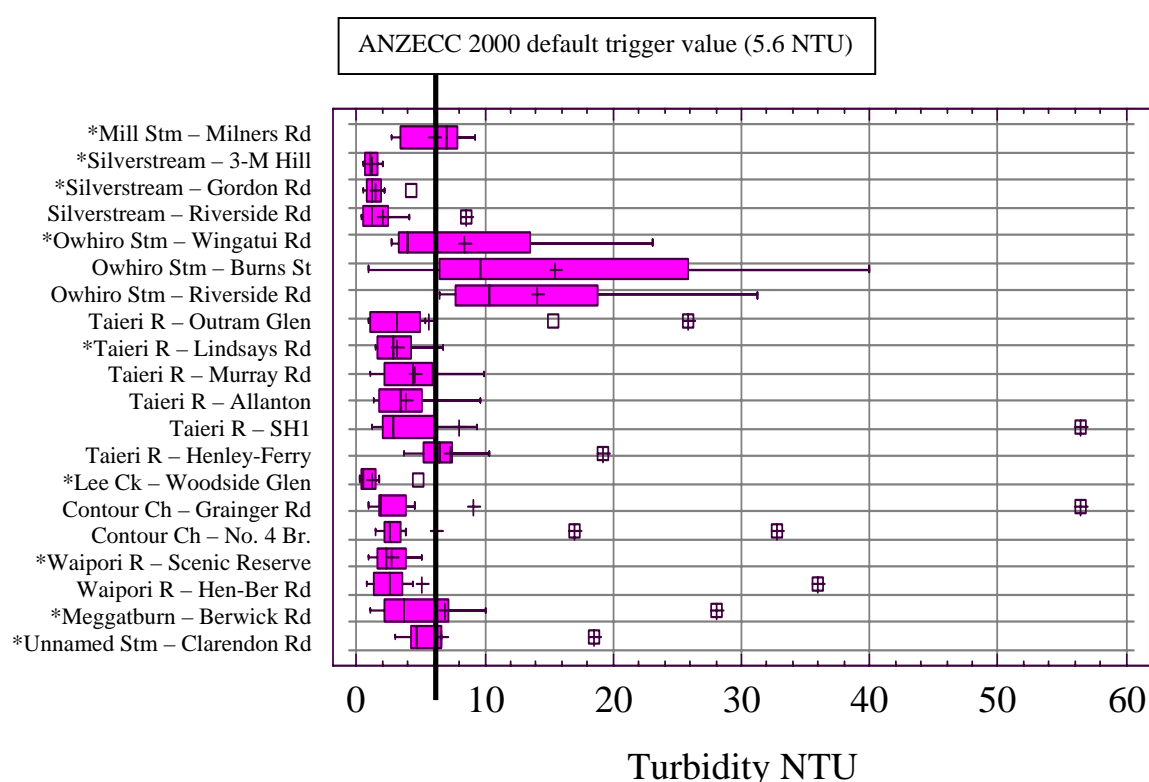
**Figure 4.5** Box plot summarising turbidity values recorded in various waterways in the lower Taieri River catchment over October 2001 to September 2002 inclusive

The Silverstream (Three-Mile Hill Road and Gordon Road) and Lee Creek at Woodside Glen recorded the lowest turbidity values (Figure 4.25). In contrast, Owhiro Stream consistently recorded elevated turbidity readings, indicating that the water was generally much dirtier than in other rivers and streams in the lower Taieri River catchment. The median values at Burns Street and Riverside Road significantly exceeded the ANZECC 2000 default trigger value of 5.6 NTU (9.6 NTU and 10.4 NTU respectively). The median value recorded in Mill Stream at Milners Road also exceeded the default trigger value (7.0 NTU) as did the Taieri River at Henley-Ferry (6.4 NTU). The latter exceedance is not surprising as Henley-Ferry receives the tidal outflow from Lake Waipori and Lake Waihola and the substrate is comprised of mud and fine sands which are easily “stirred up”.

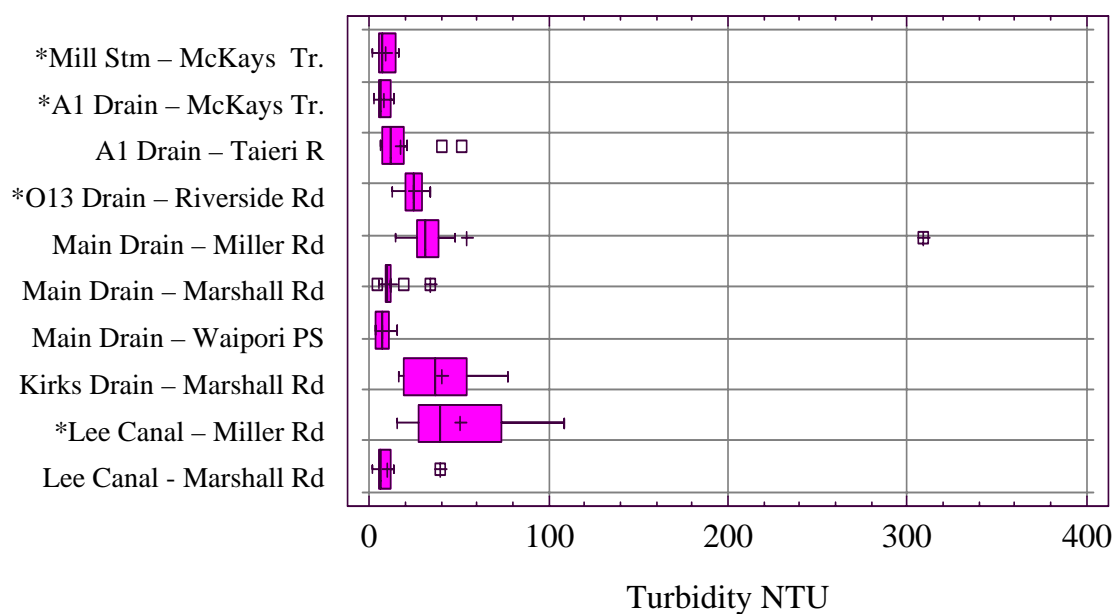
**Figure 4.6** Box plot summarising turbidity values recorded in drains in the lower Taieri River catchment over October 2001 to September 2002 inclusive

principally Lee Canal Drain at Marshall Road (39.8 NTU), Kirks Drain at Marshall Road (36.8 NTU), and the Main Drain at Miller Road (31.5 NTU).

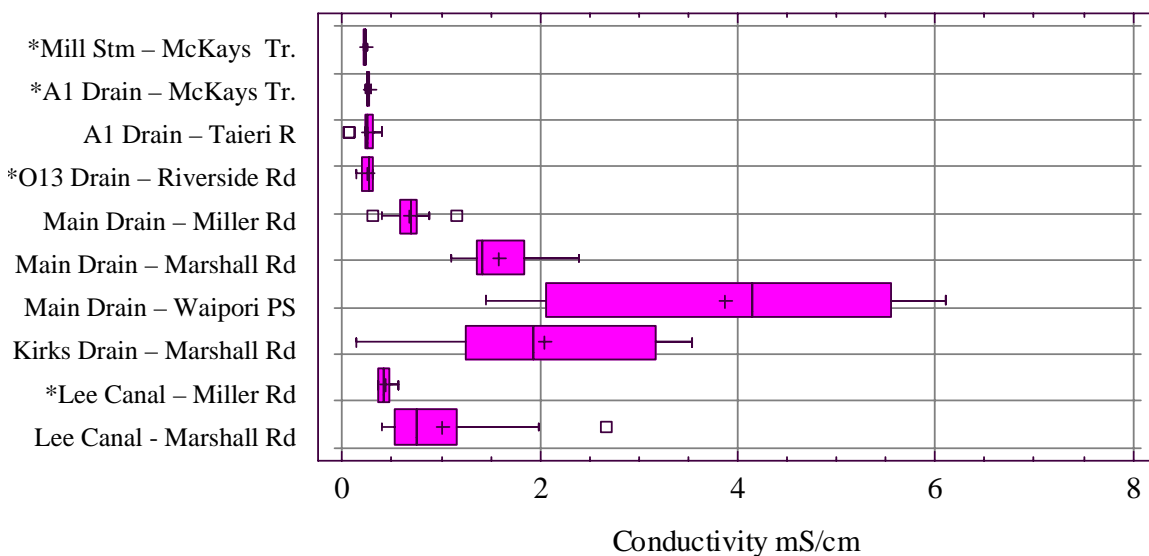
**Figure 4.9 Box plot summarising conductivity concentrations recorded in various drains in the lower Taieri River catchment over October 2001 to September 2002 inclusive.**

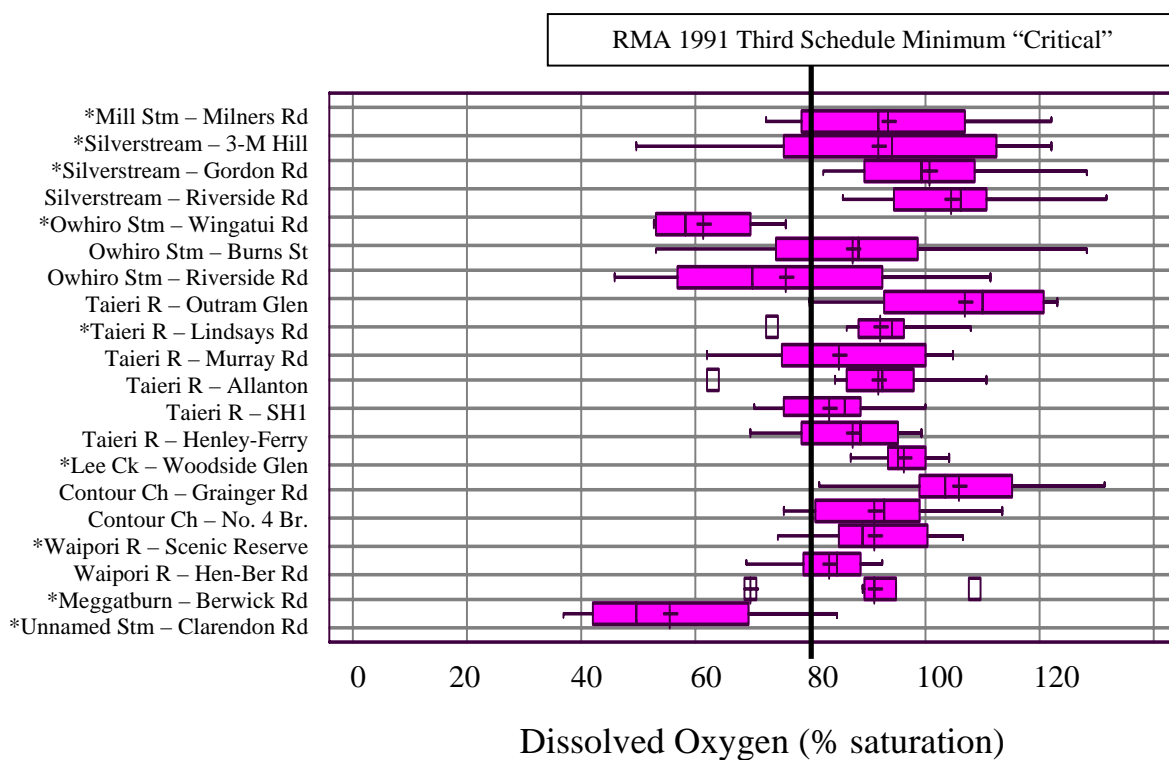
**Figure 4.10** Box plot summarising dissolved oxygen saturation data for various waterways in the lower Taieri River catchment over October 2001 to September 2002 inclusive

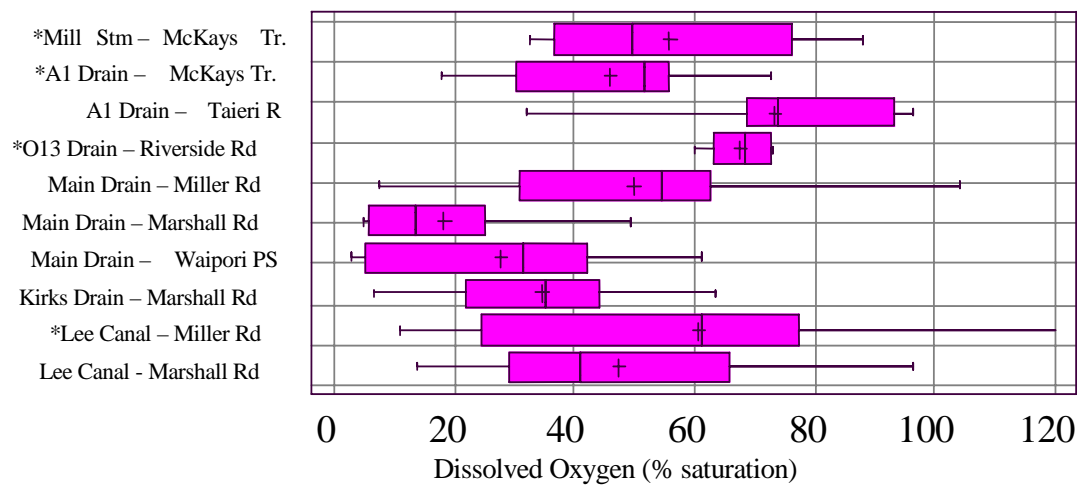
Figure 4.11 Box plot summarising dissolved oxygen saturation values for various drains in the lower Taieri River catchment over October 2001 to September 2002 inclusive

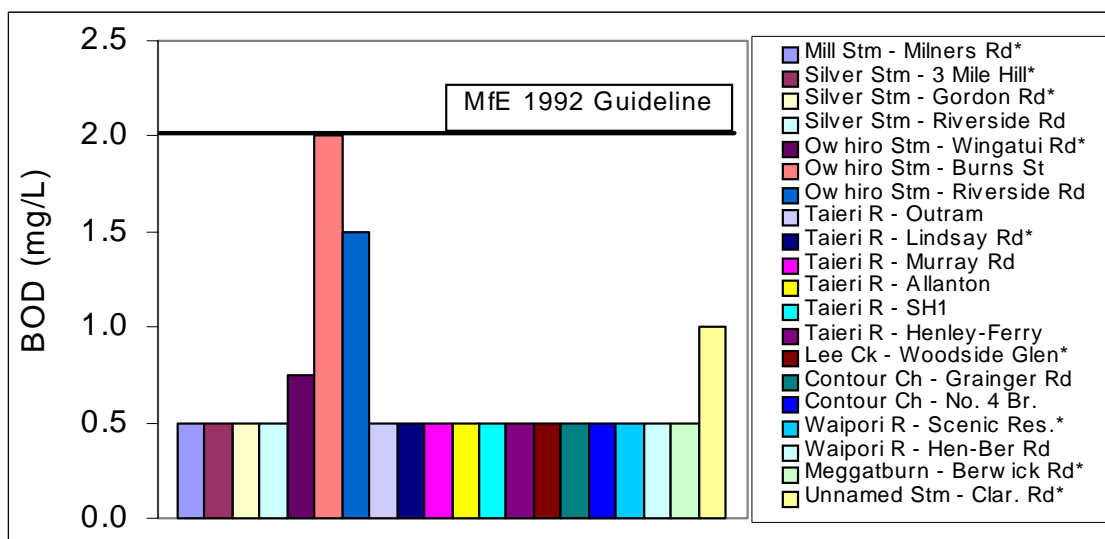
**Figure 4.13 Median BOD concentrations recorded in various waterways in the lower Taieri River catchment over October 2001 to September 2002 inclusive**

BOD concentrations were generally below detection levels at most river and stream monitoring sites (Figure 4.13). The main exception was Owhiro Stream which recorded BOD concentrations in excess of the MfE 1992 guideline of 2 mg/L on a number of occasions at both Burns Street and Riverside Road. The greatest concentration recorded during the monitoring programme was 4 mg/L (below Riverside Road) on 17 December 2001. BOD was also detected in the unnamed tributary of Lake Waihola and on one sampling occasion the result exceeded the MFE 1992 guideline.

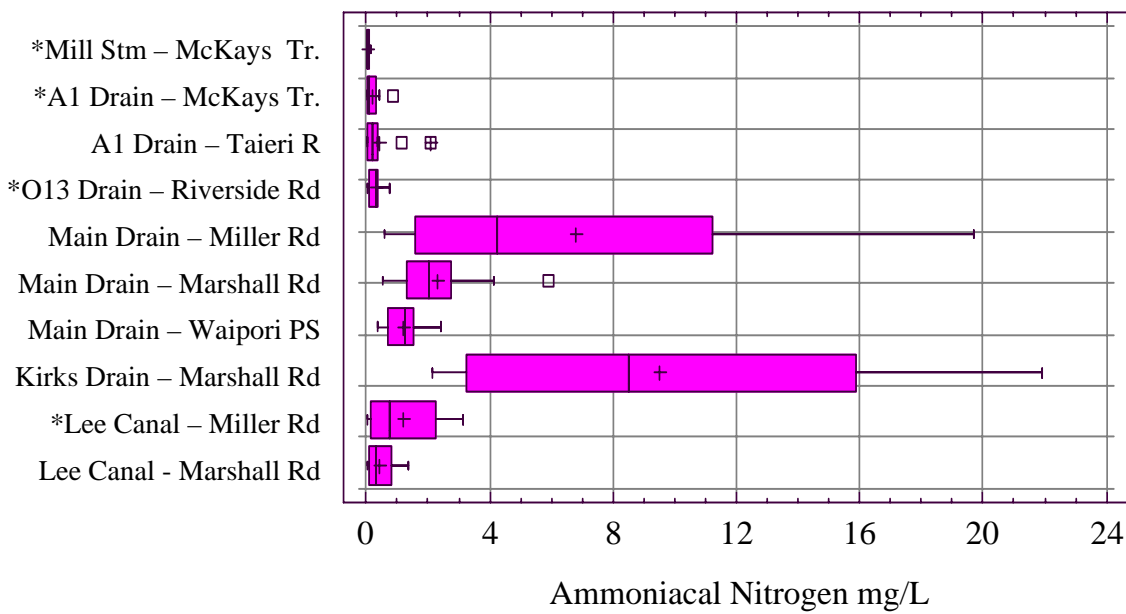
**Figure 4.16** Box plot summarising ammoniacal nitrogen concentrations recorded in various drains in the lower Taieri River catchment over October 2001 to September 2002 inclusive

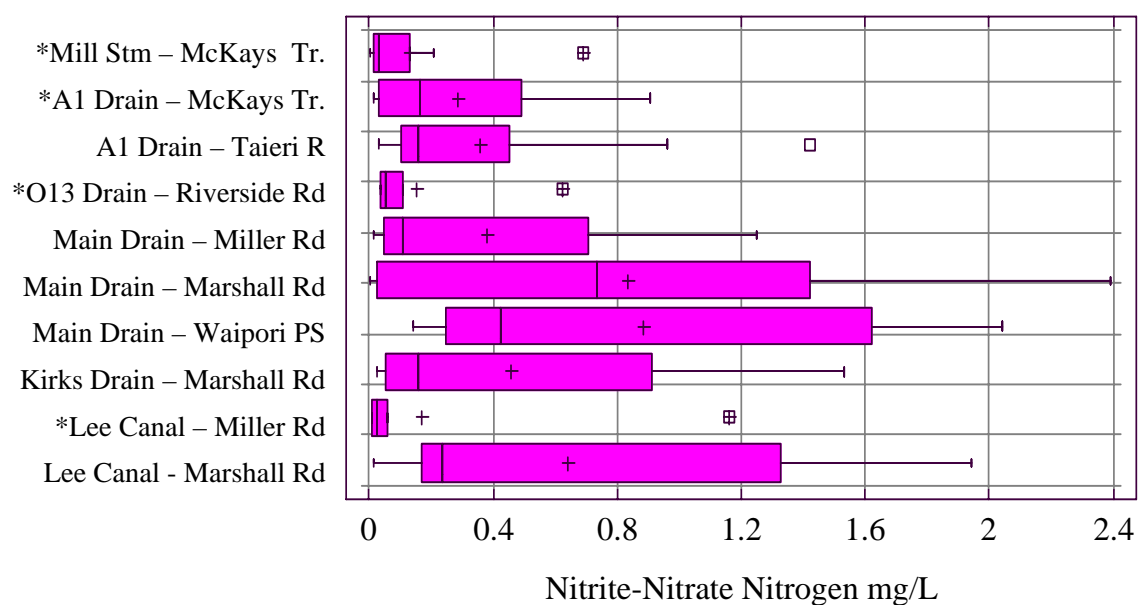
**Figure 4.18** Box plot summarising nitrite-nitrate nitrogen concentrations recorded in various drains in the lower Taieri River catchment over October 2001 to September 2002 inclusive

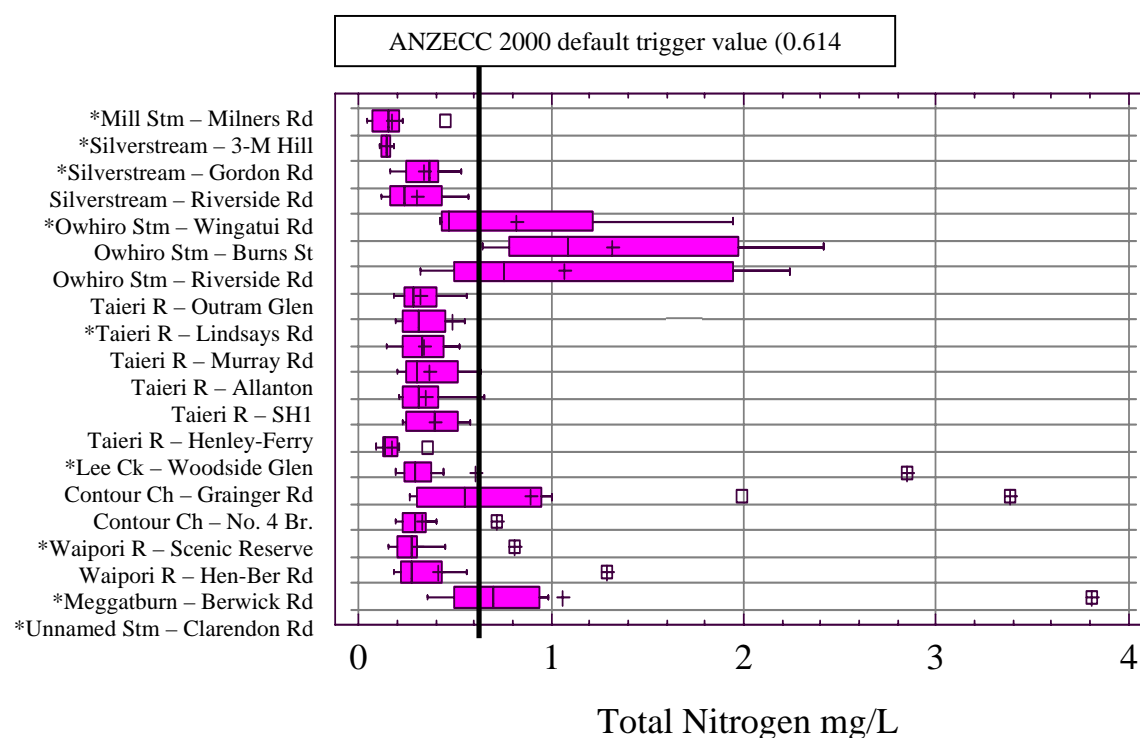
**Figure 4.19** Box plot summarising total nitrogen concentrations recorded in various waterways in the lower Taieri River catchment over October 2001 to September 2002 inclusive

Median total nitrogen concentrations were below the ANZECC 2000 default trigger level of 0.614 mg/L at all river and stream monitoring sites except Owhiro Stream at Burns Street and Riverside Road and the Unnamed Stream at Clarendon Road (Figure 4.19). Total nitrogen concentrations followed a similar seasonal pattern to ammoniacal nitrogen concentrations, with the highest concentrations being recorded in the winter months.

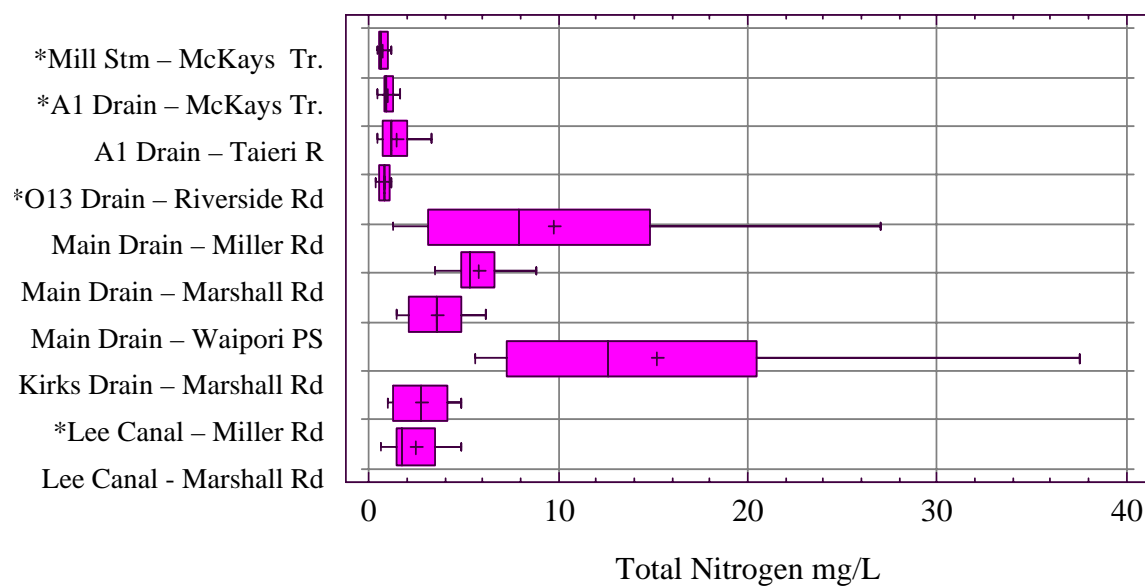
**Figure 4.20** Box plot summarising total nitrogen concentrations recorded in various drains in the lower Taieri River catchment over October 2001 to September 2002 inclusive

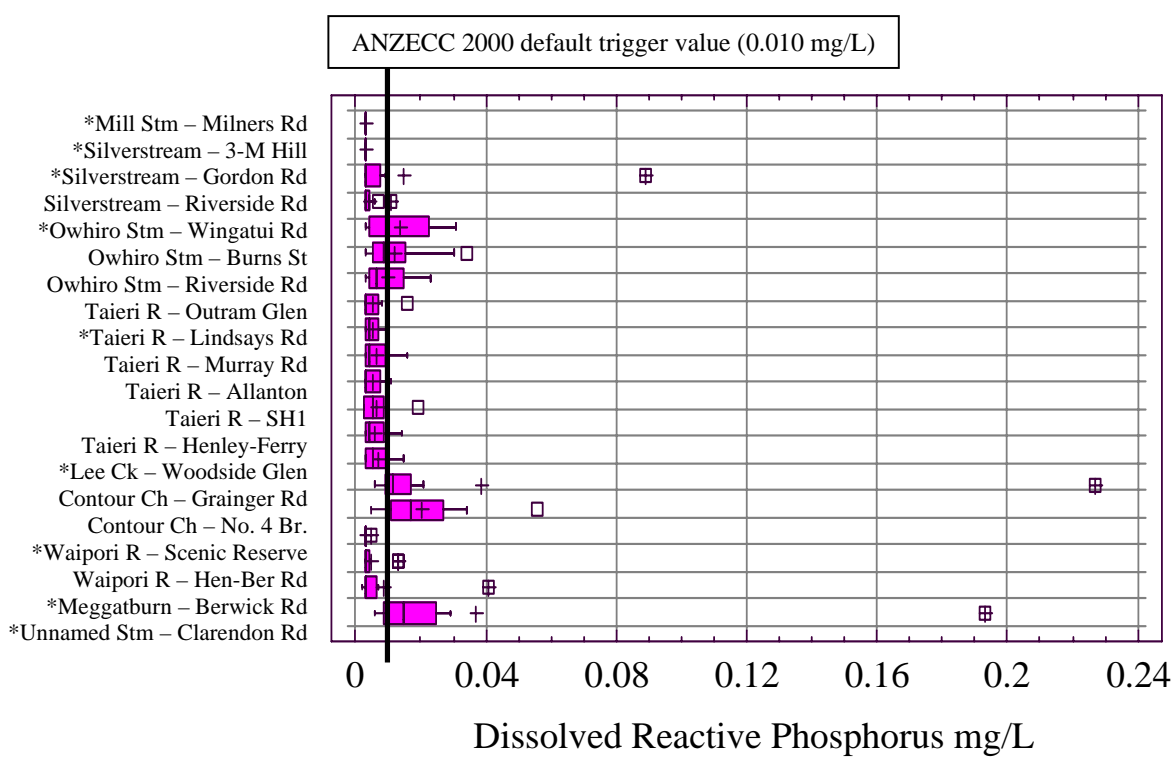
**Figure 4.21** Box plot summarising dissolved reactive phosphorus concentrations recorded in various waterways in the lower Taieri River catchment over October 2001 to September 2002 inclusive

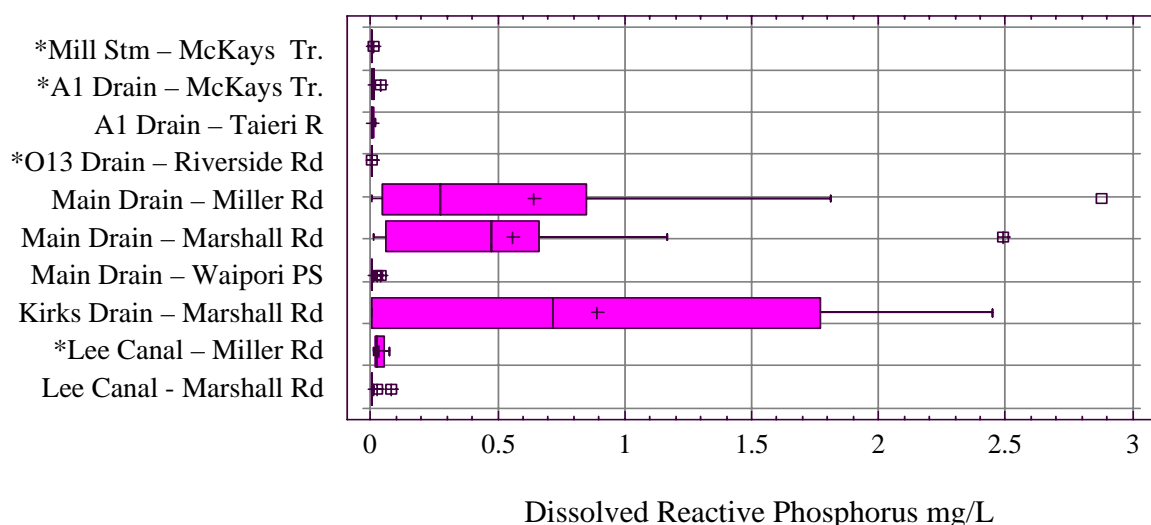
**Figure 4.22** Box plot summarising dissolved reactive phosphorus concentrations recorded in various drains in the lower Taieri River catchment over October 2001 to September 2002 inclusive

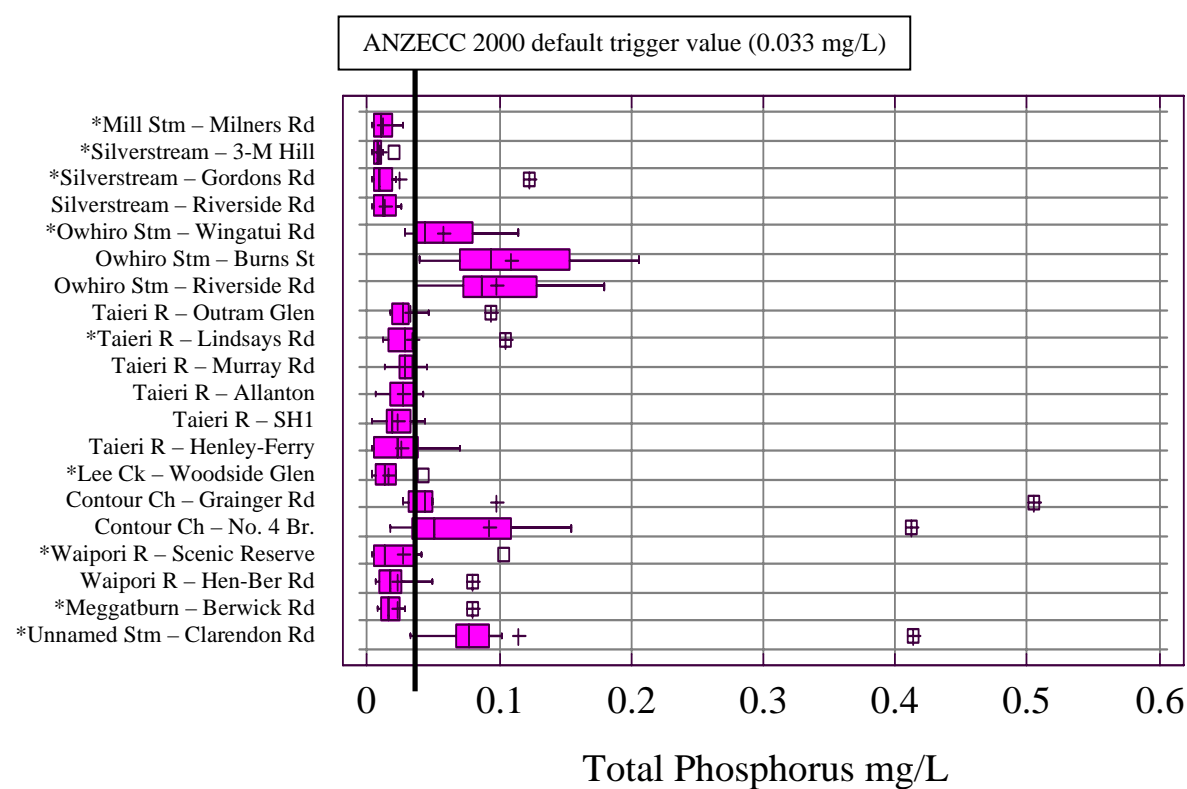
Figure 4.23 Box plot summarising total phosphorus concentrations recorded in various waterways in the lower Taieri River catchment over October 2001 to September 2002 inclusive

Total phosphorus concentrations exceeded the ANZECC 2000 default trigger value of 0.033 mg/L at several stream monitoring sites (Figure 4.23). The highest median was recorded in Owhiro Stream at Burns Street (0.094 mg/L) but the sites at Wingatui Road and Riverside Road also exceeded the ANZECC trigger value (0.045 mg/L and 0.087 mg/L respectively). The Contour Channel at both the No. 4 Bridge and Grainger Road, and the Unnamed Stream at Clarendon Road recorded median concentrations of 0.044 mg/L, 0.051 mg/L and 0.077 mg/L respectively.

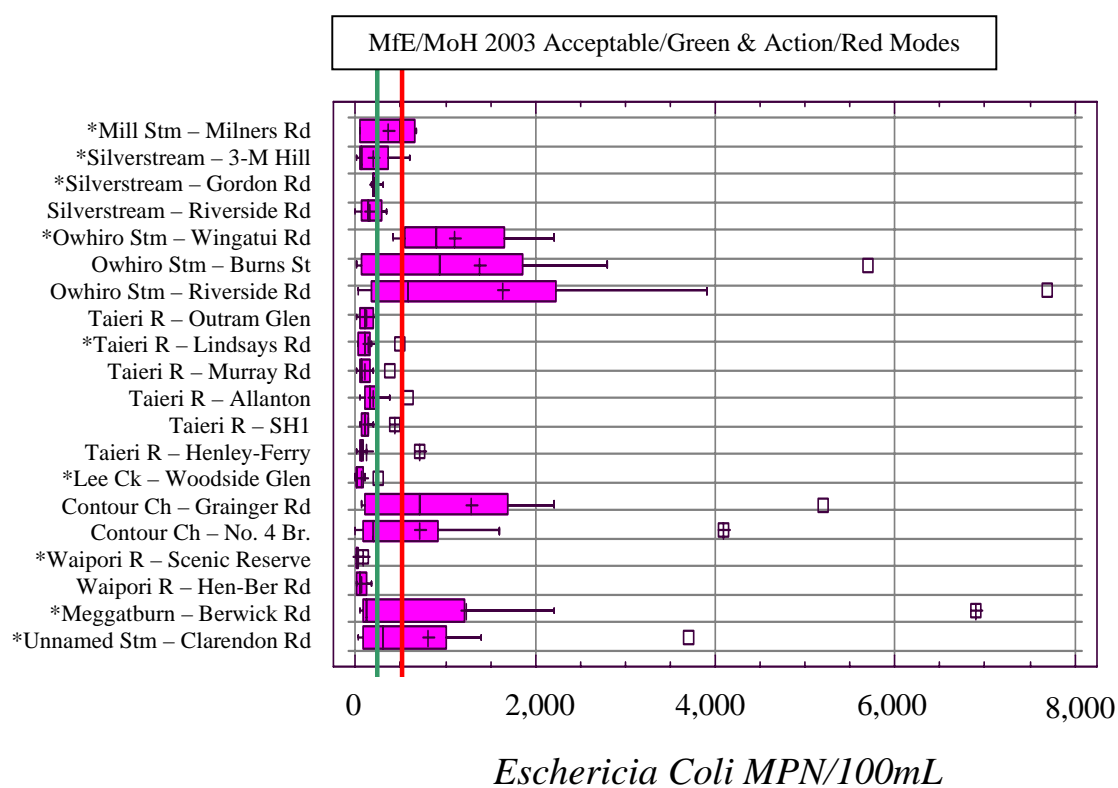
**Figure 4.24** Box plot summarising *E. coli* counts in various waterways in the lower Taieri River catchment over October 2001 to September 2002 inclusive. The MfE/MoH 2003 microbiological guidelines for freshwater recreational areas are indicative only as their application should be restricted to the summer bathing season (i.e., 1 November to 31 March)

Owhiro Stream recorded the highest median *E. coli* count (Figure 4.24), with results from the site at Burns Street ranging from 39 to 5,700 MPN/100 ml over the 12-month monitoring period. High counts were also recorded in the lower reaches below Riverside Road (up to 7,700 MPN/100 ml). Although it is difficult to apply recreational water quality guidelines to a short duration, low frequency sampling programme such as the Lower Taieri Catchment Monitoring Programme, it is clear from these results that Owhiro Stream is not suitable for primary contact recreation.

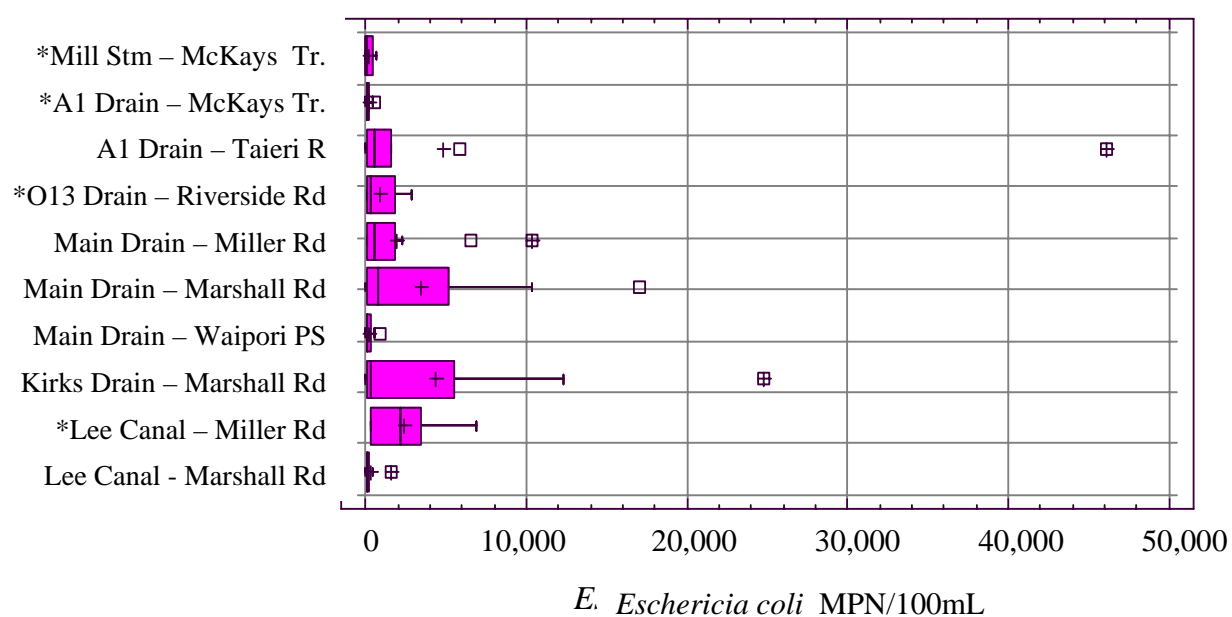
**Figure 4.26** Box plot summarising *E. coli* counts in various drains in the lower Taieri River catchment over October 2001 to September 2002 inclusive

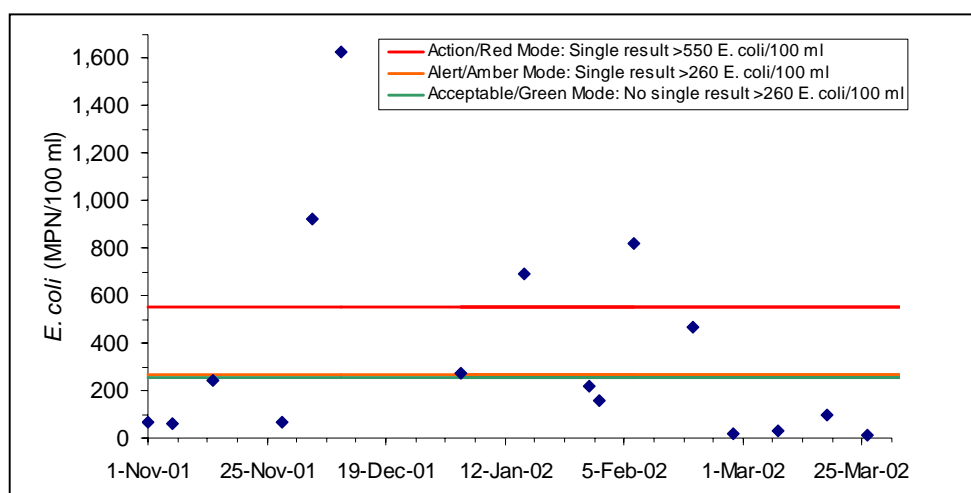
**Figure 4.27** *E. coli* counts recorded in the Taieri River at Outram Glen over 1 November 2001 to 31 March 2002 inclusive

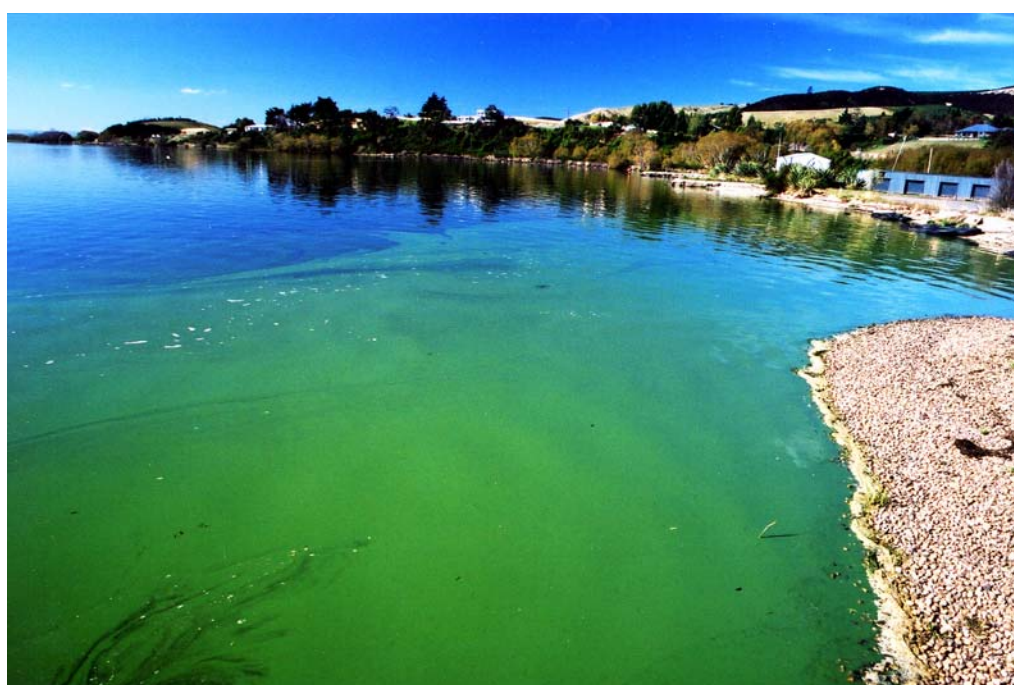
Figure 4.28 Blue-green algal bloom in Lake Waihola, February 2002

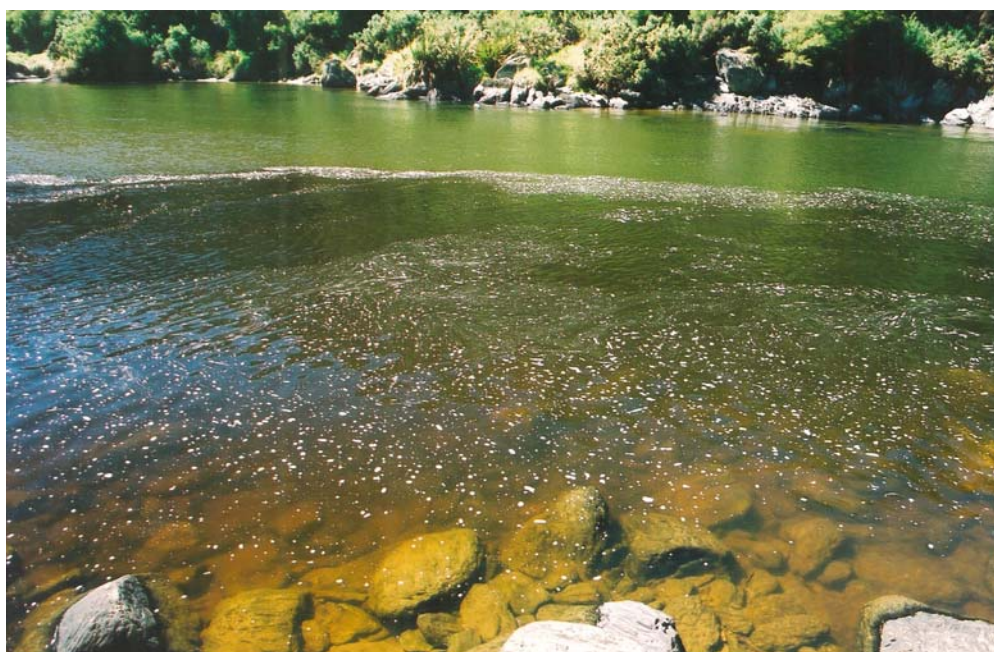
**Figure 5.1** Natural foams and tannin stained water entering the lower Taieri River from Lee Stream (February 2002)

Water quality in the lower Taieri River below Outram was found to be relatively good during the course of the monitoring programme, with very few analytes exceeding the ANZECC 2000 default trigger values. However, elevated *E. coli* counts were recorded on a number of occasions at all six sites. This probably reflects stock access at some sites (e.g., cattle below Outram Glen) and polluted tributary inputs (e.g., Owhiro Stream, A1 Drain). Activity higher in the catchment will also play a role. For example, agricultural modification of the Lee Stream catchment has at times contributed sediment to the Taieri River above Outram Glen. Lee Stream also carries natural foams and froths into the Taieri River which, when observed downstream on the Taieri Plain, are often reported to the Otago Regional Council as suspected pollution incidents (Figure 5.1).

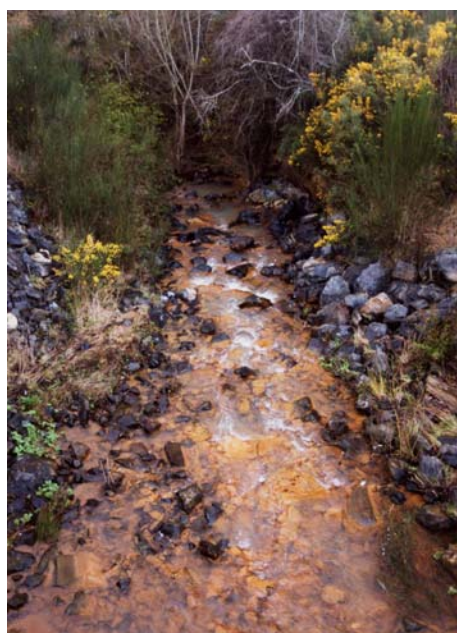
**Figure 5.3** Iron-bacteria slimes in Mill Stream at Milners Road

Over the monitoring period Mill Stream at Milners Road was characterised by high turbidity values and quite variable *E. coli* counts. In contrast, nutrient concentrations were consistently below the ANZECC 2000 default trigger values. The presence of a thick cover of iron-bacteria on the rocky substrate may have some impact on turbidity levels (Figure 5.3). The source of the *E. coli* contamination is unclear. Although Milners Road is an upper catchment site there is some agricultural activity located higher up in the catchment that may be having some impact.

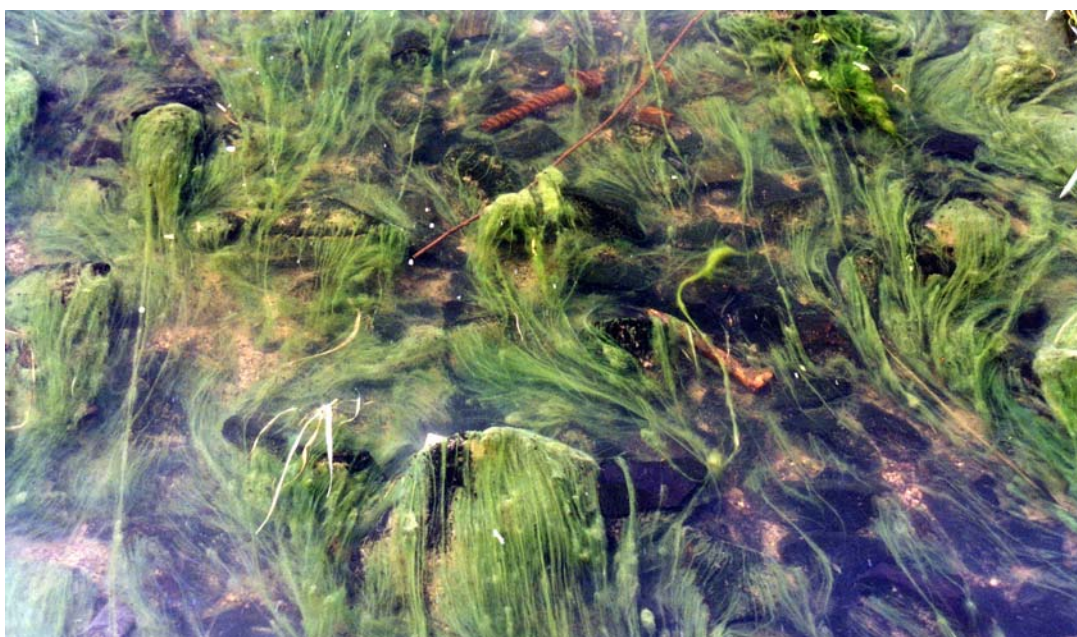
**Figure 5.4** Proliferous filamentous algae growth in Owhiro Stream at Burns Street

The Owhiro Stream at Burns Street was dominated by *Oedogonium*, an extremely common and widespread filamentous green algae. Only a few other taxa were found at this site.

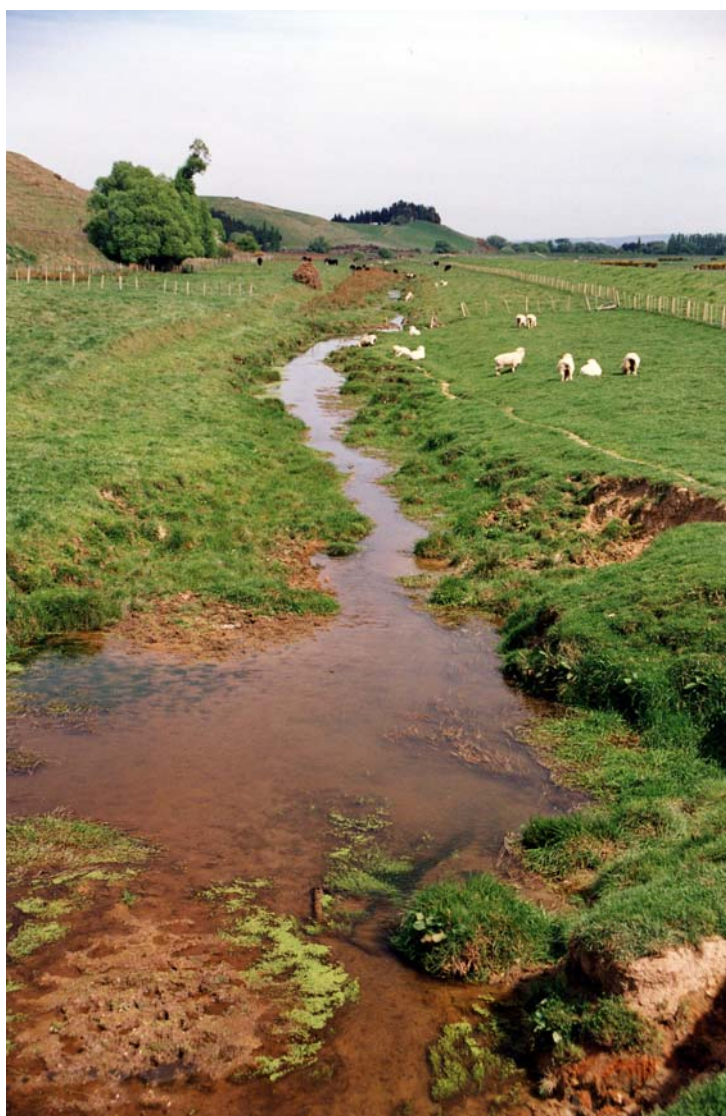
**Figure 5.5** Bank erosion, pugging, instream sedimentation and enrichment in Owhiro Stream below Riverside Road as a result of a stock access

Livestock, both sheep and dairy cows, had direct access to the water at a number of monitoring sites. This contributed to bank erosion, sedimentation and degraded water quality, particularly in the lower reaches of the Owhiro Stream and A1 Drain. In most cases the impact of stock access was reflected in elevated *E. coli* counts that at times rendered the water unsuitable for contact recreation.

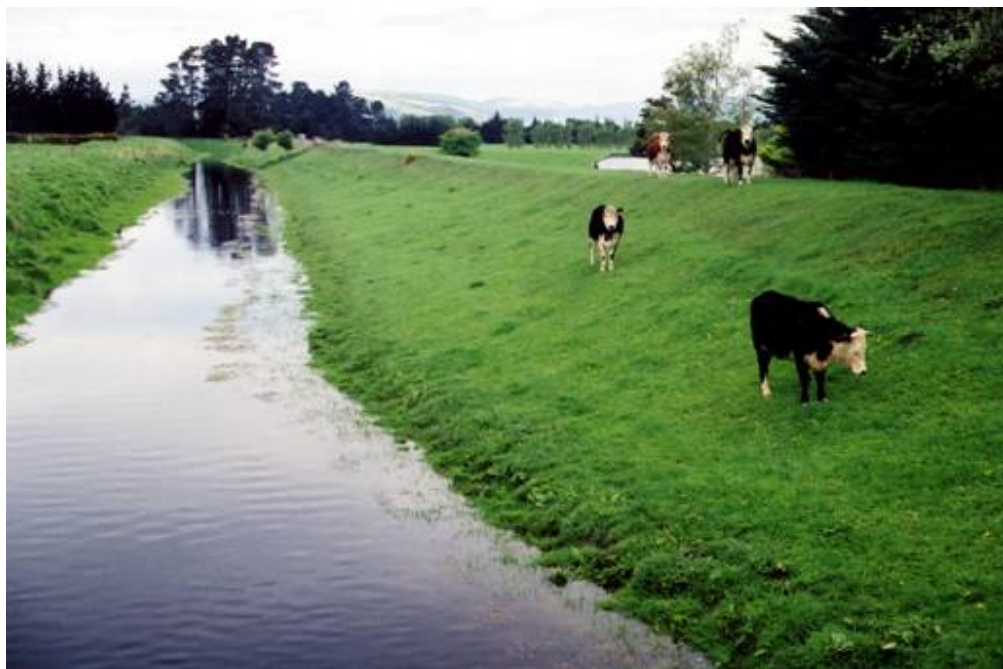
**Figure 5.6 Dairy cows on the banks of the Contour Channel near Grainger Road**

The main factor affecting water quality during dry weather events is likely to be stock access. Dairy cows were observed grazing on the banks of the Contour Channel at both Grainger Road (Figure 5.6) and the No. 4 Bridge. On several occasions at the latter site, a significant amount of faecal matter had been deposited adjacent to the water and only a minor rise in water level would result in water contamination.
