# **Report on the Surface Water Quality of the Lower Taieri River Catchment**

**March 2004**

## Executive Summary

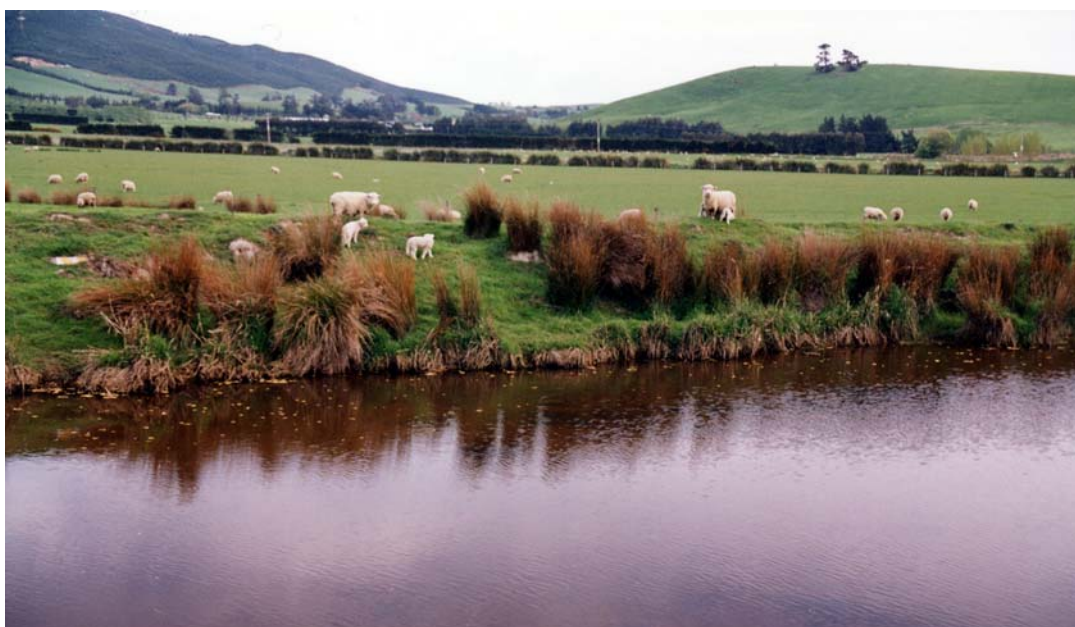
Figure 5.7 Sheep on the banks of the unnamed tributary at Clarendon Road

The stream appears to be one of several watercourses draining farmland on the southwestern hillslopes behind Lake Waihola. Further investigation is required to determine whether there are any point source discharges into the stream (e.g., farm drains). Geese and ducks were abundant at the sampling site and sheep can also access the stream (Figure 5.7), but it is likely that there are other sources of nutrients to the stream.

Monitoring results for the “unnamed tributary” indicate water quality is poor, with most forms of nutrients exceeding the ANZECC 2000 default trigger values, some by a significant margin. Some very high *E. coli* bacteria counts were also recorded at the Clarendon Road site.

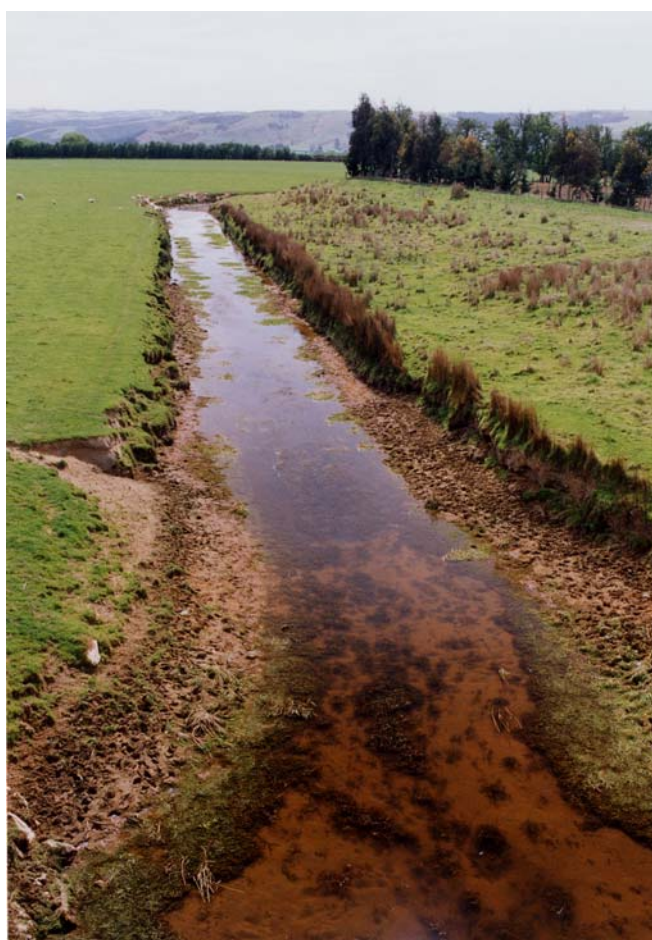
**Figure 5.8** The A1 Drain above the floodgates to the Taieri River, with obvious signs of recent stock access

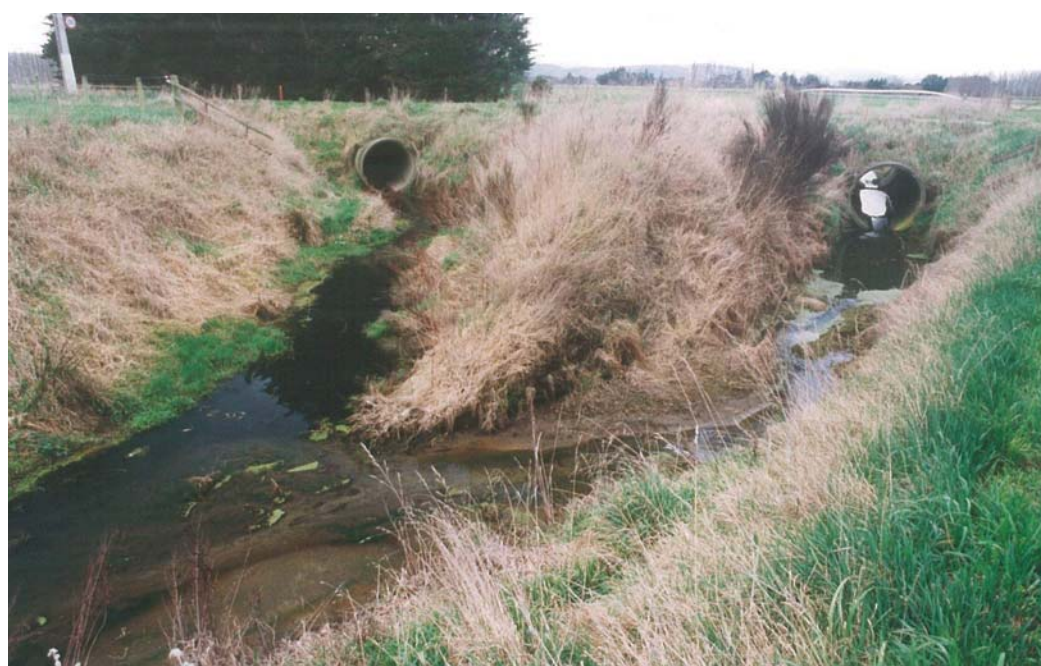
**Figure 5.9** Black enriched water from the #28 Drain (left) entering the Main Drain at Miller Road

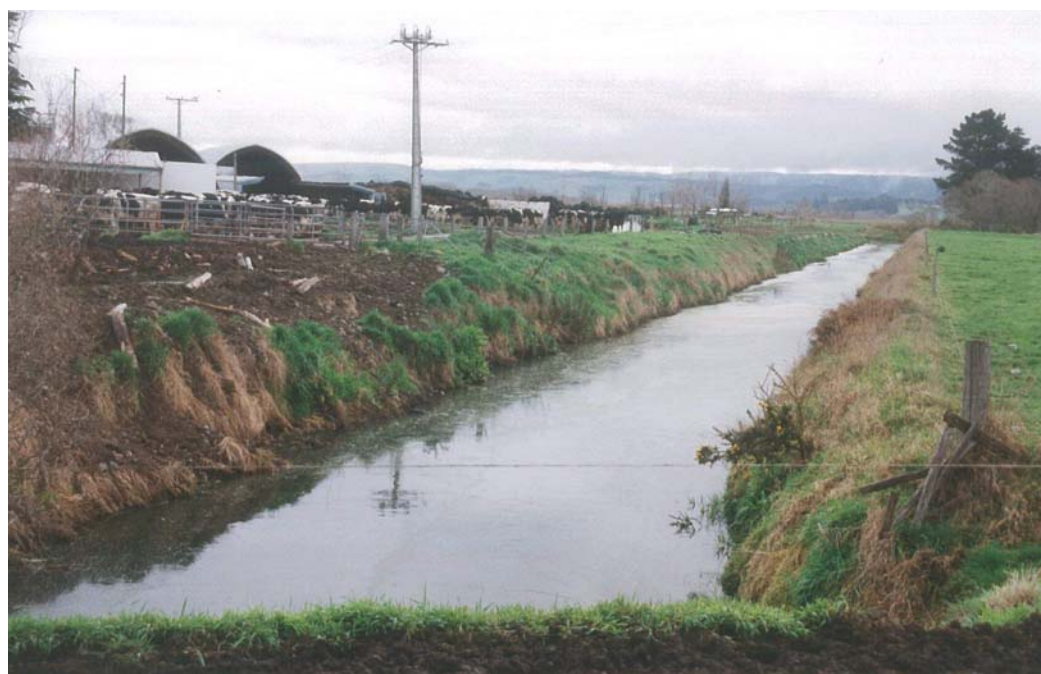
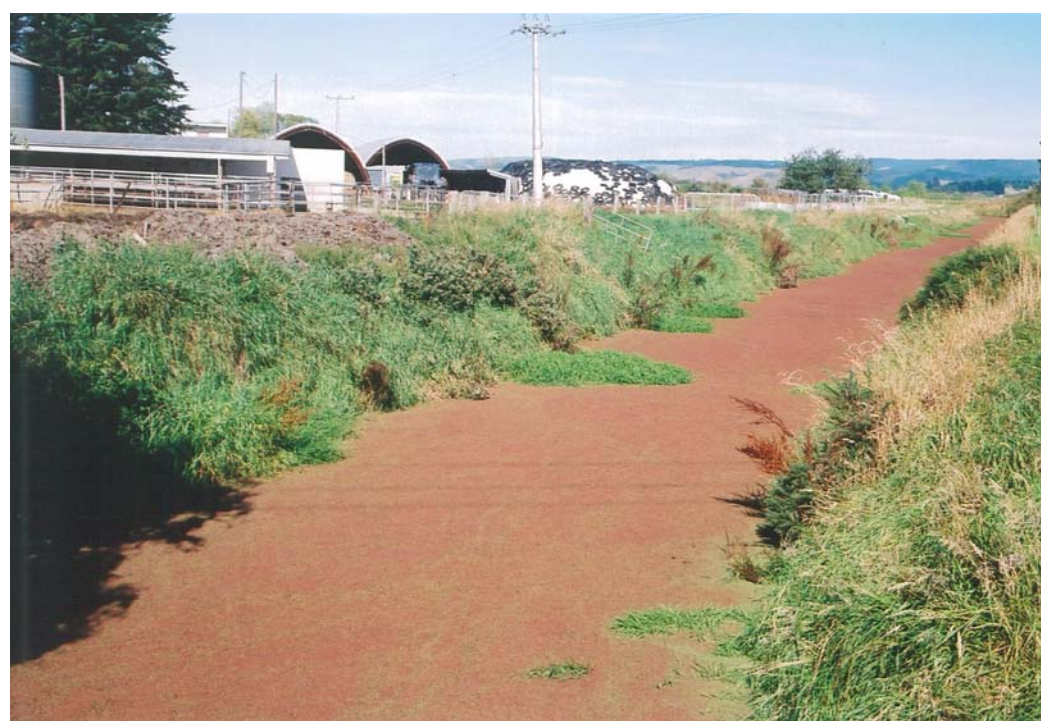
**Figure 5.10** The Main Drain at Marshall Road looking downstream in September 2001 (top) and in March 2002 (bottom) when the drain was smothered with *Azolla*

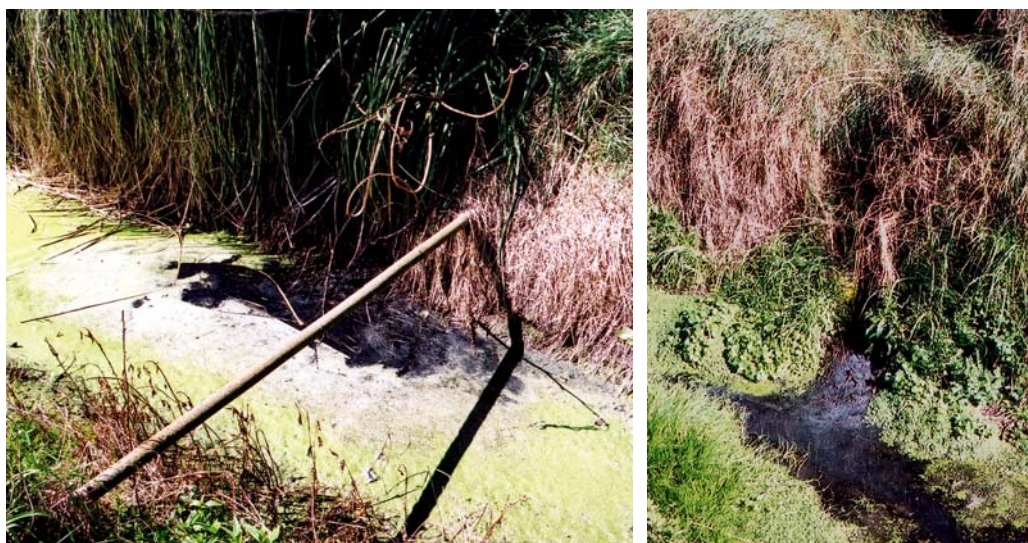
**Figure 5.11** Septic tank effluent discharges to Kirks Drain from two properties on Kirks Drain Road – the discharge on the right was located a short distance above the Marshall Road sampling site

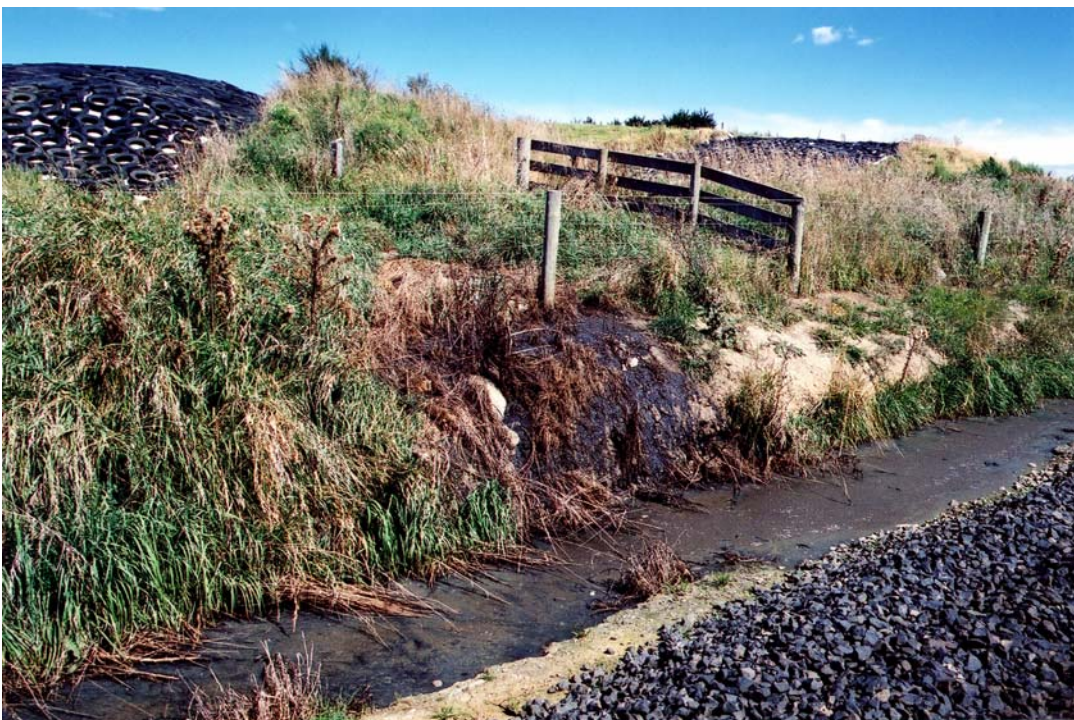
**Figure 5.12** Leachate runoff from a silage pit below Riverside Road, near Owhiro Stream

Farming practices are also likely to be contributing to degraded water quality in some areas. Silage pit leachate runoff was identified on several occasions, in one case from an inappropriately located pit, and the other from a deliberate diversion of the runoff into a drain. Poor management of stand-off pads and winter sacrifice paddocks may also be causing localised problems.

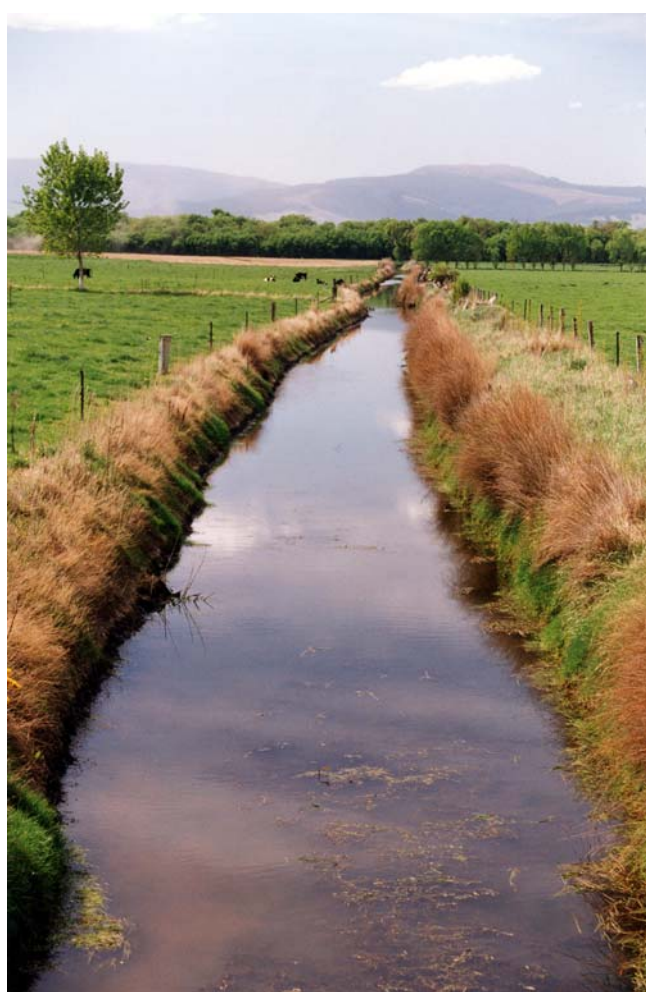
**Figure 5.13** The A1 Drain upstream of Riverside Road. The drain is fenced off preventing stock access and riparian vegetation has been allowed to grow
