## **Surface Water Quality in South West Otago**

**June 2004**

## Executive Summary

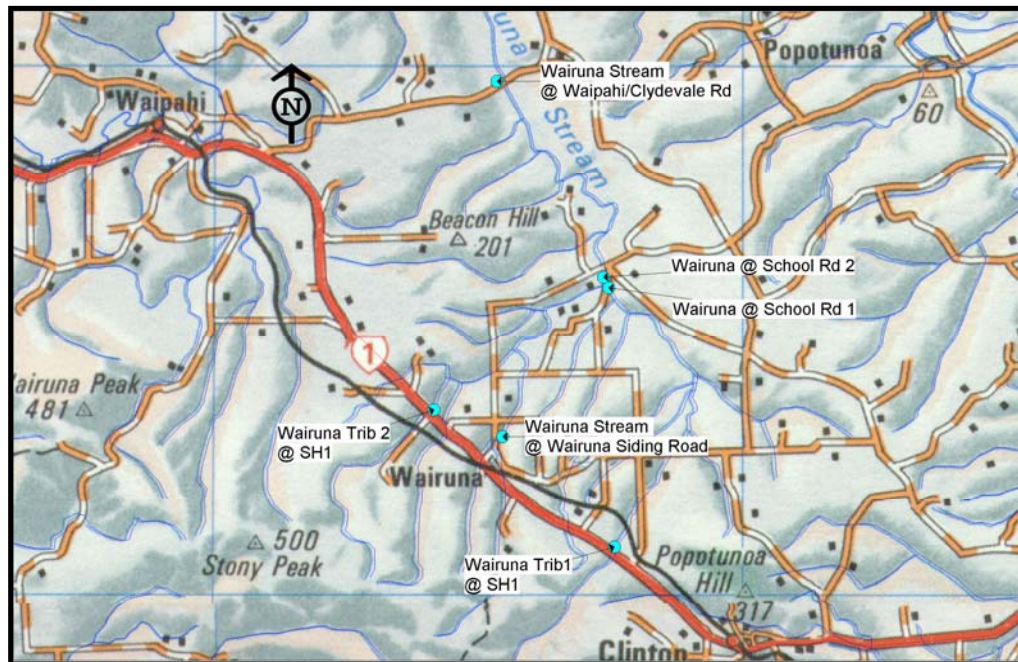
**Figure 2.1** Location of physico-chemical, microbiological and biological water quality monitoring sites. Tributaries 1 and 2 and School Road 1 and 2 were sampled for physico-chemical parameters only

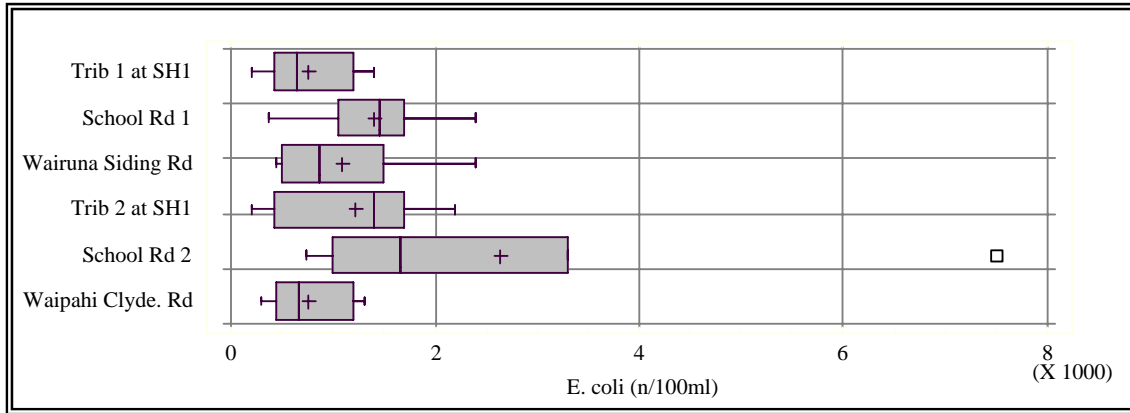
**Figure 2.2** Box and whisker plot of *E. coli* concentrations at various sites in the Wairuna catchment between April 2000 and February 2002

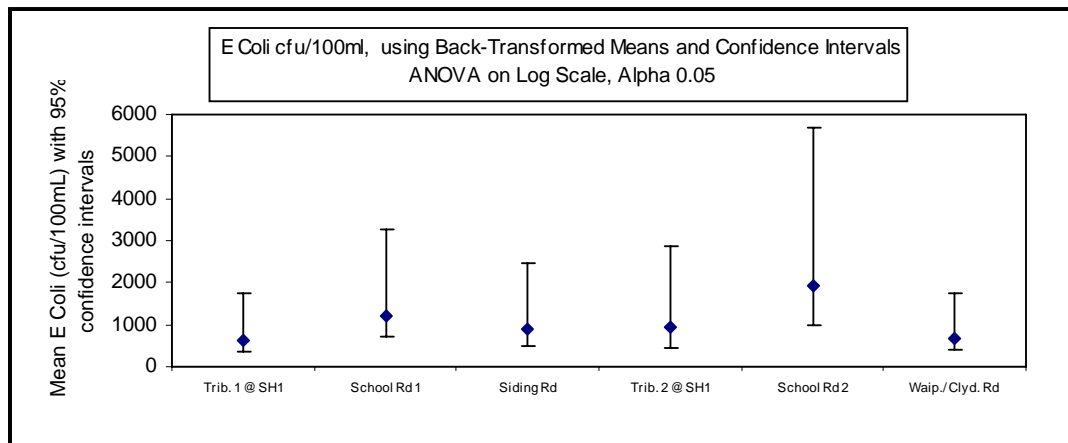
**Figure 2.3** *E. coli* bacteria concentrations (back transformed means and confidence intervals, using ANOVA on log scale, alpha 0.05) recorded at various locations in the Wairuna between April 2000 and February 2002

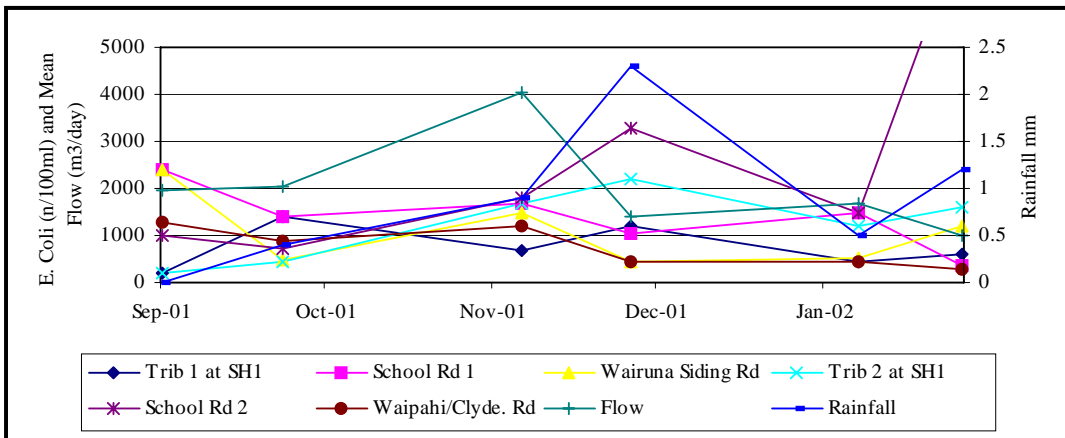
**Figure 2.4** *E. coli* bacteria concentrations recorded at various locations in the Wairuna between April 2000 and February 2002, total rainfall mm recorded at Warepa over the preceding 48 hours and total mean flow recorded in the Waipahi River at Waipahi

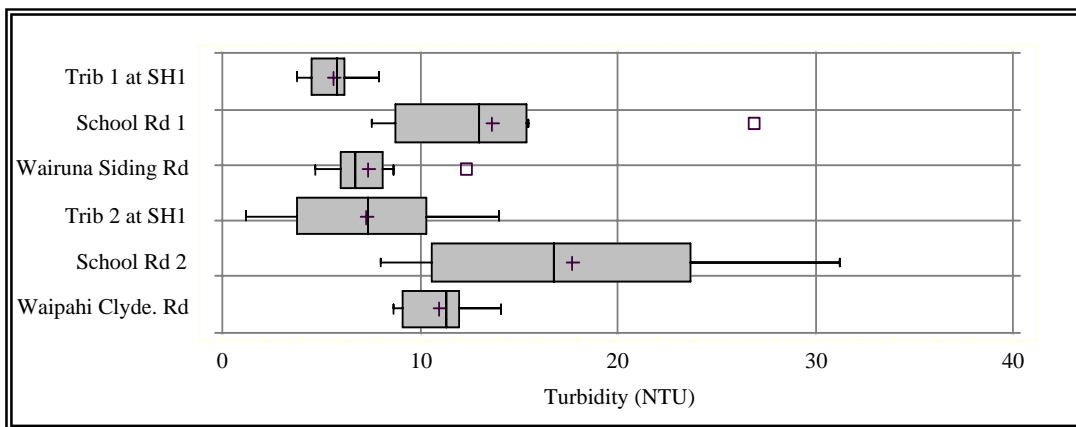
**Figure 2.5** Box and whisker plot of median turbidity concentrations recorded in the Wairuna catchment between April 2000 and February 2002

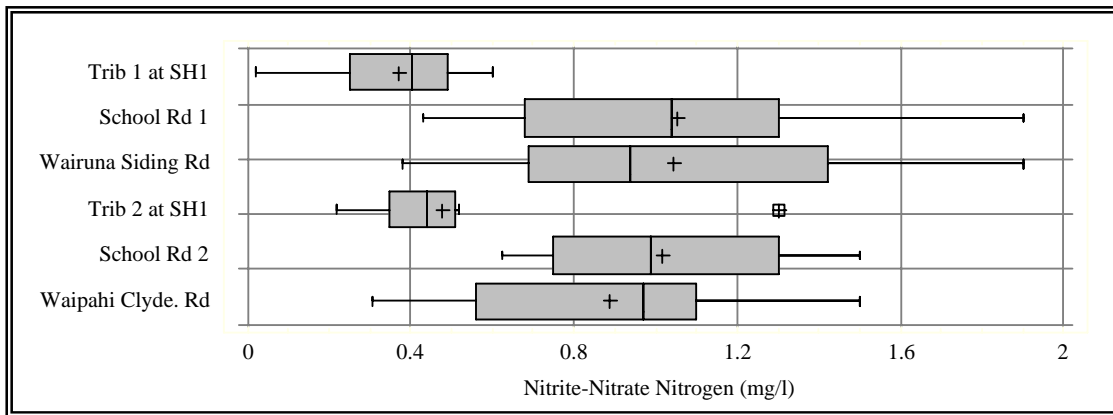
**Figure 2.6** Box and whisker plot of median nitrite-nitrate nitrogen concentration in the Wairuna catchment between April 2000 and February 2002

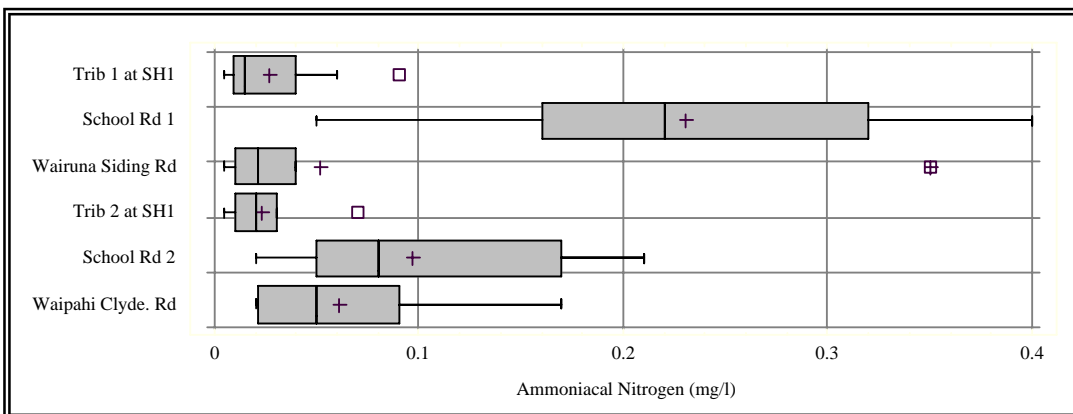
**Figure 2.7** Box and whisker plot of median ammoniacal nitrogen concentrations in the Wairuna catchment between April 2000 and February 2002

Figure 2.7 shows that School Road 1 has extremely high  $\text{NH}_4$  concentrations compared to the other sites, the lower concentration found at School Road 2 is due to the influence of the Wairuna Stream and Tributary 2 both of which have relatively low concentrations of  $\text{NH}_4$ .

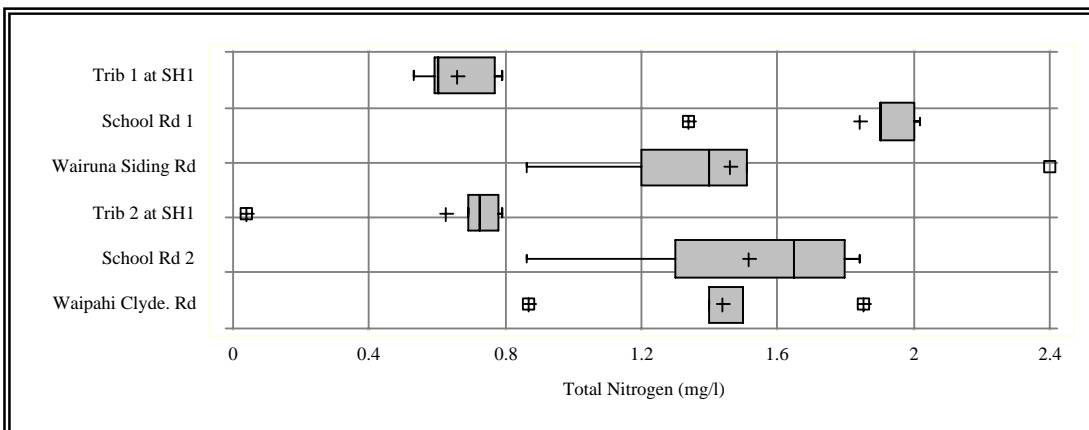
**Figure 2.8** Box and whisker plot of median total nitrogen concentration in the Wairuna catchment between April 2000 and February 2002

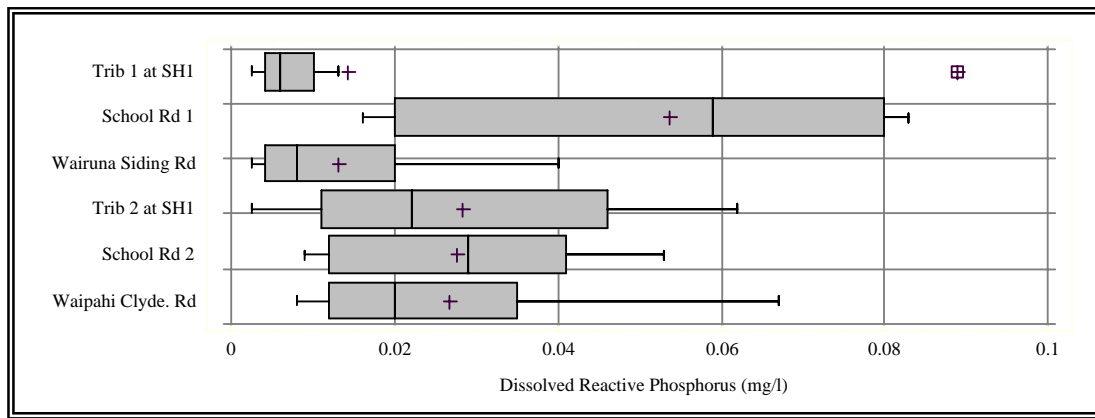
**Figure 2.9** Box and whisker plot of median dissolved reactive phosphorus concentration recorded in the Wairuna catchment between April 2000 and February 2002

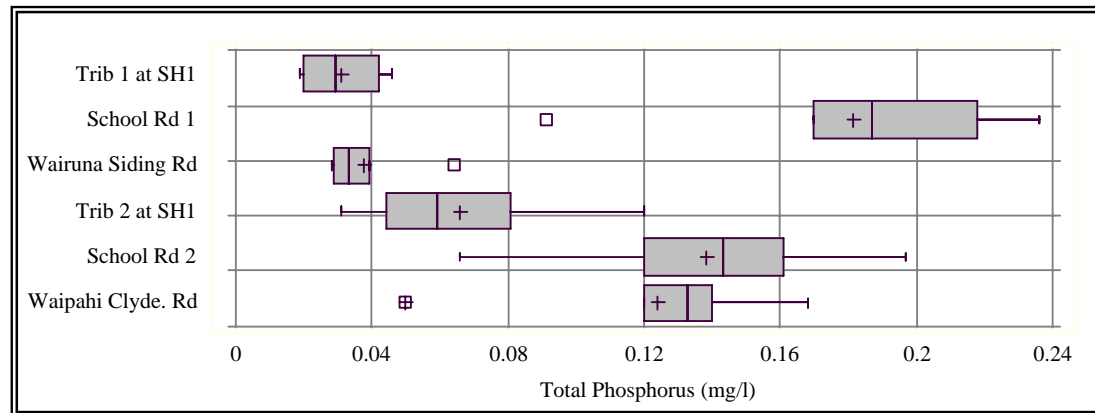
**Figure 2.10** Box and whisker plot of median total phosphorus concentration recorded in the Wairuna catchment between April 2000 and February 2002

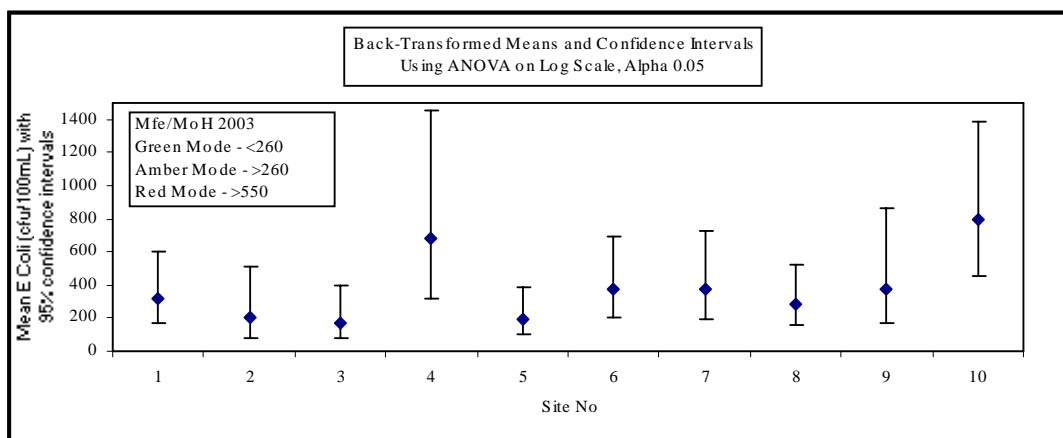
**Figure 3.2** *E. coli* bacteria concentrations (back transformed means and confidence intervals, using ANOVA on log scale, alpha 0.05) recorded at various locations in the Waipahi-Clydevale catchment (see Table 3.2) between May 2000 and May 2002

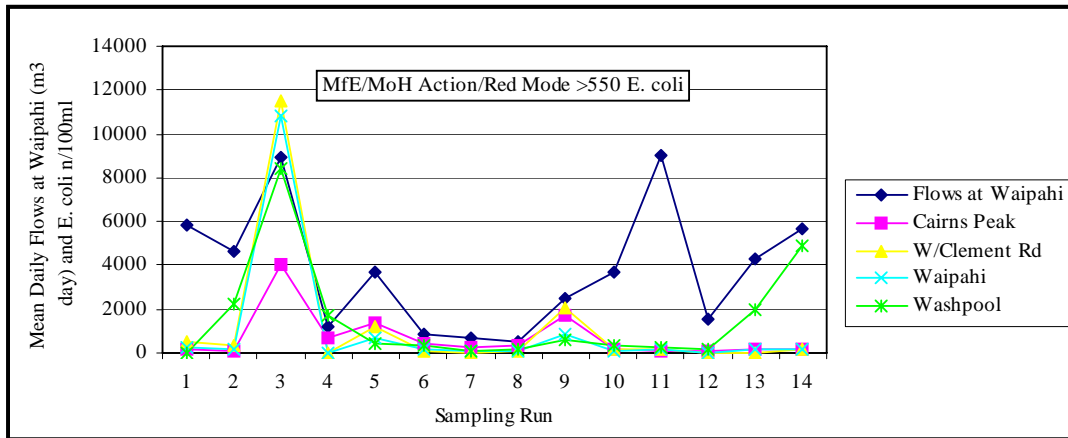
**Figure 3.3** Mean river flows in the Waipahi River at Waipahi and *E. coli* bacteria concentrations (see Table 3.3) in the Waipahi, Waiwera, Kaihiku and Washpool between October 2002 and October 2003

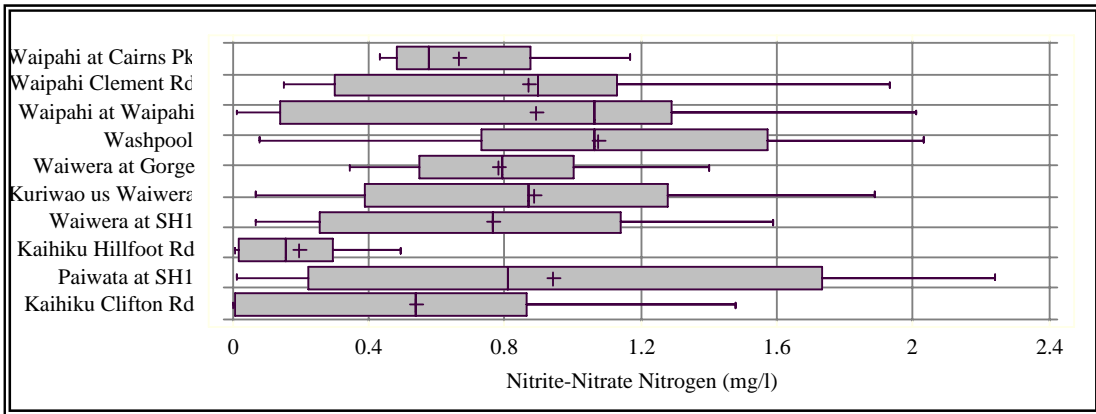
**Figure 3.4** Box and whisker plot of nitrite-nitrate nitrogen concentrations recorded at various locations in the Waipahi, Waiwera, Kaihiku and Washpool between October 2000 and October 2002

Table 3.1 shows that water quality is highest at the uppermost site (Cairns Peak) and deteriorates with increasing distance downstream. This trend is most evident in the median nitrite-nitrate nitrogen, ammoniacal nitrogen and total nitrogen concentrations recorded at each site. (Figure 3.4, 3.5, and Figure 3.6 respectively).

Water quality in the Washpool Stream is extremely poor. Figure 3.4 to Figure 3.9 clearly show that of all the streams monitored in the Waipahi-Clydevale area the Washpool is the most degraded.

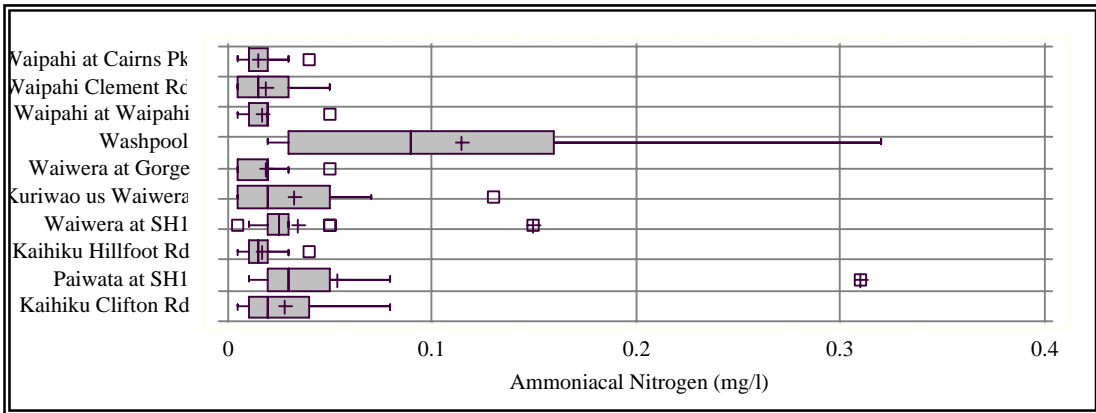
**Figure 3.5** Box and whisker plot of ammoniacal nitrogen concentrations recorded at various locations in the Waipahi, Waiwera, Kaihiku and Washpool between October 2000 and October 2002

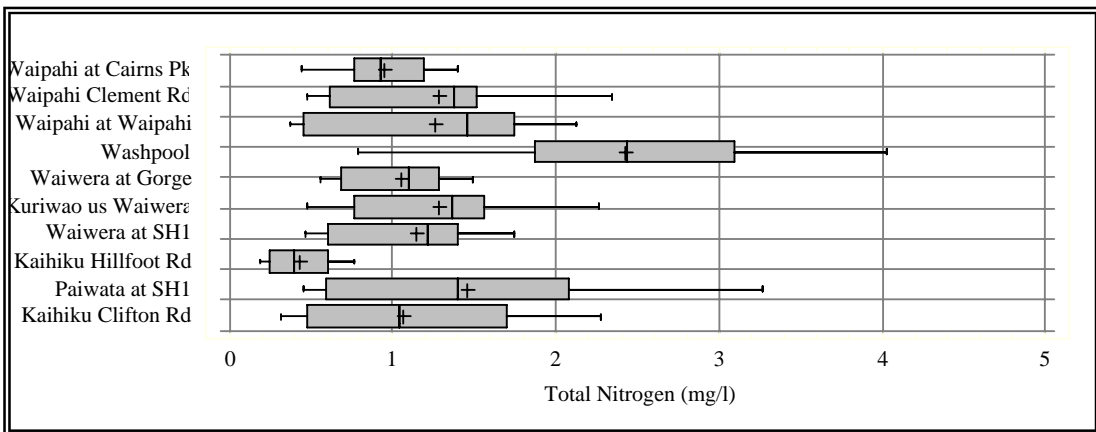
**Figure 3.6** Box and whisker plot of total nitrogen concentrations recorded at various locations in the Waipahi, Waiwera, Kaihiku and Washpool between October 2000 and October 2002

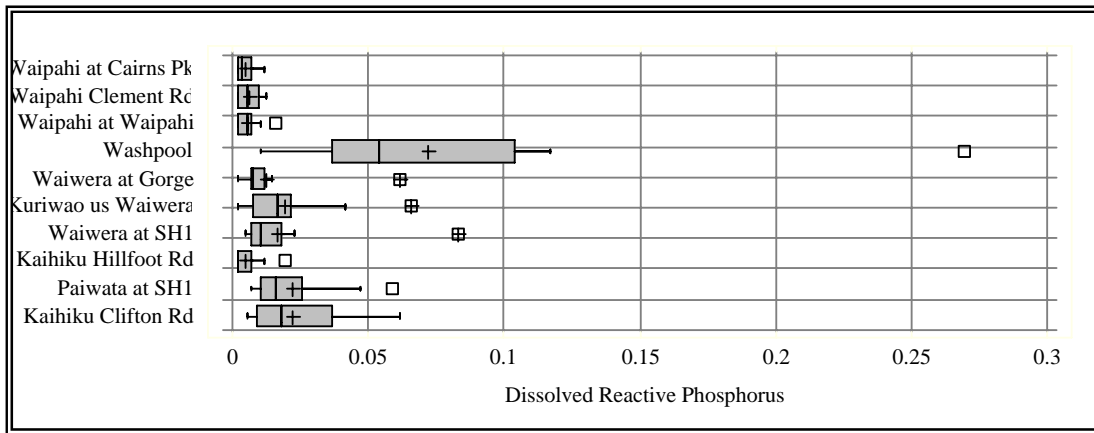
**Figure 3.7** Box and whisker plot of dissolved reactive phosphorus concentrations recorded at various locations in the Waipahi, Waiwera, Kaihiku and Washpool between October 2000 and October 2002

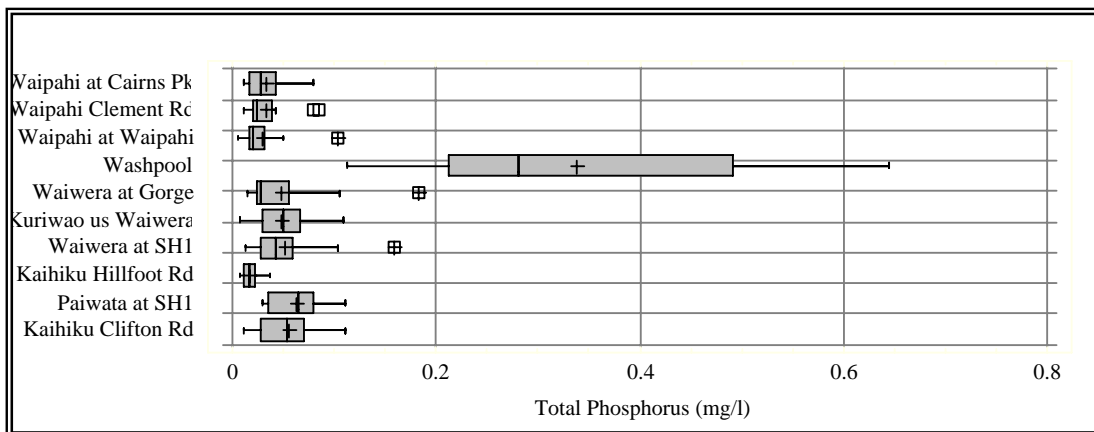
**Figure 3.8** Box and whisker plot of total phosphorus concentrations recorded at various locations in the Waipahi, Waiwera, Kaihiku and Washpool between October 2000 and October 2002

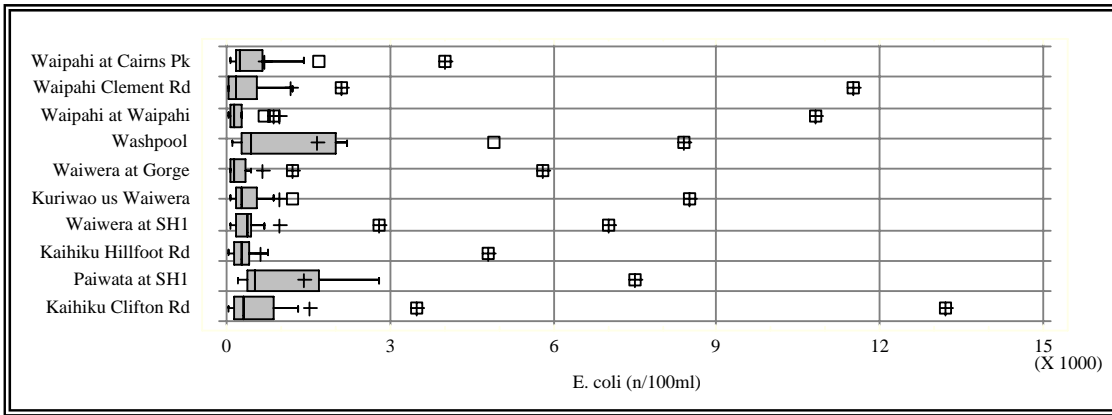
**Figure 3.9** Box and whisker plot of *E. coli* concentrations recorded at various locations in the Waipahi, Waiwera, Kaihiku and Washpool between October 2000 and October 2002

Figure 3.9 shows that *E. coli* concentrations are below the MfE/MoH Action/Red Mode level of the recreational water quality guideline at all sites (500 n/100ml). However the median level of *E. coli* in the downstream site (SH1) is over three times the median concentration found at the upstream site. Figure 3.2 shows that there is a marked increase in the mean concentration of *E. coli* between sites five (Waiwera at Gorge) and site seven (Waiwera at SH1), the Kuriwao recording a mean concentration at a similar level to the SH1 site. Figure 3.10 indicates that *E. coli* concentrations in the Waiwera catchment closely follow the rainfall recorded at Warepa during the previous 48 hours.

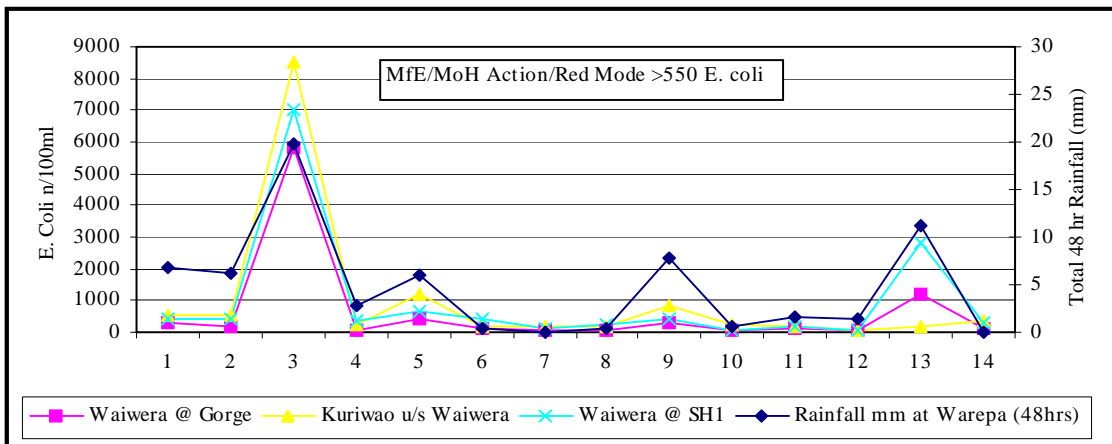
**Figure 3.10** Rainfall (mm) recorded during the previous 48 hours at Warepa and *E. coli* bacteria concentrations recorded in the Waipahi catchment between October 2002 and October 2003 (see Table 3.3). The 2003 MfE/MoH Action/Red Mode Recreational Water Quality Guideline is also shown

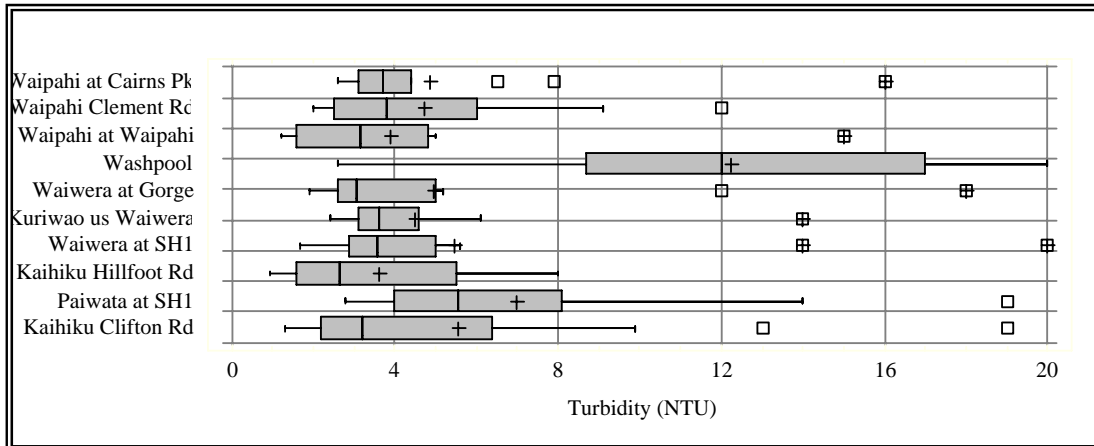
**Figure 3.11** Box and whisker plot of turbidity concentrations recorded at various locations in the Waipahi, Waiwera, Kaihiku and Washpool between October 2000 and October 2002

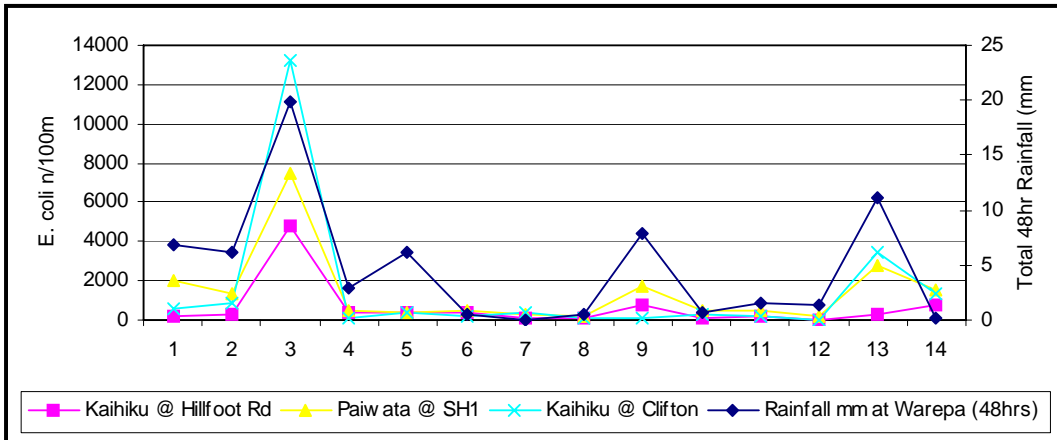
**Figure 3.12** Rainfall (mm) recorded during the previous 48 hours at Warepa and *E. coli* bacteria concentrations recorded in the Waiwera catchment between October 2002 and October 2003 (see Table 3.3)

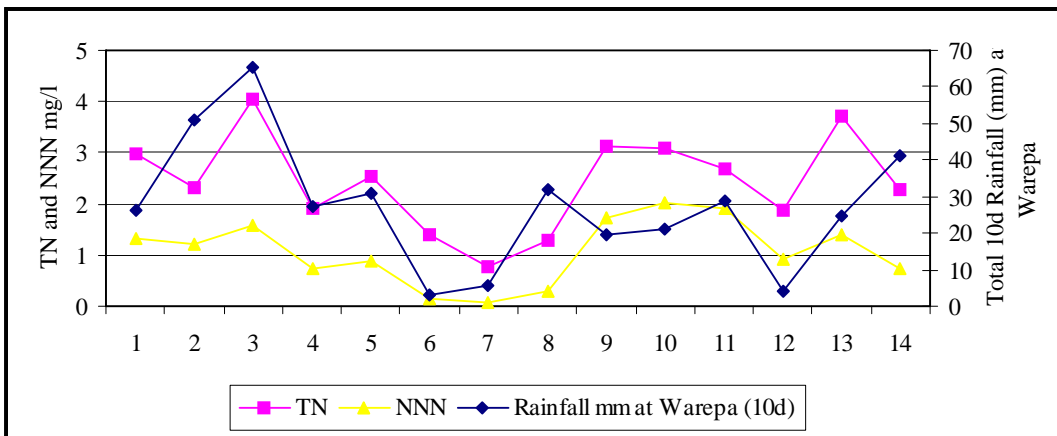
**Figure 3.13** Rainfall (mm) recorded during the previous 10 days at Warepa and total nitrogen and nitrite-nitrate nitrogen concentrations recorded in the Waiwera catchment between October 2002 and October 2003 (See Table 3.3)

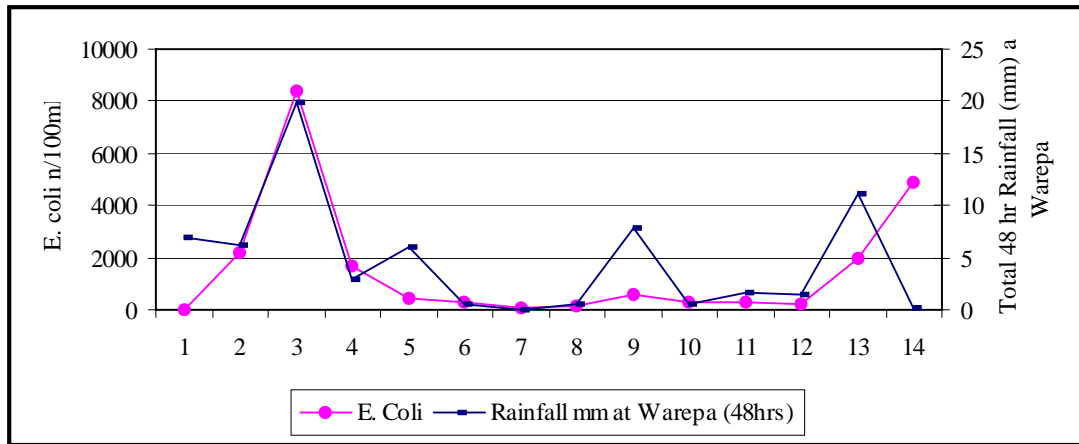
**Figure 3.14** Rainfall (mm) recorded during the previous 10 days at Warepa and *E. coli* concentrations recorded in the Waiwera catchment between October 2002 and October 2003 (See Table 3.3)

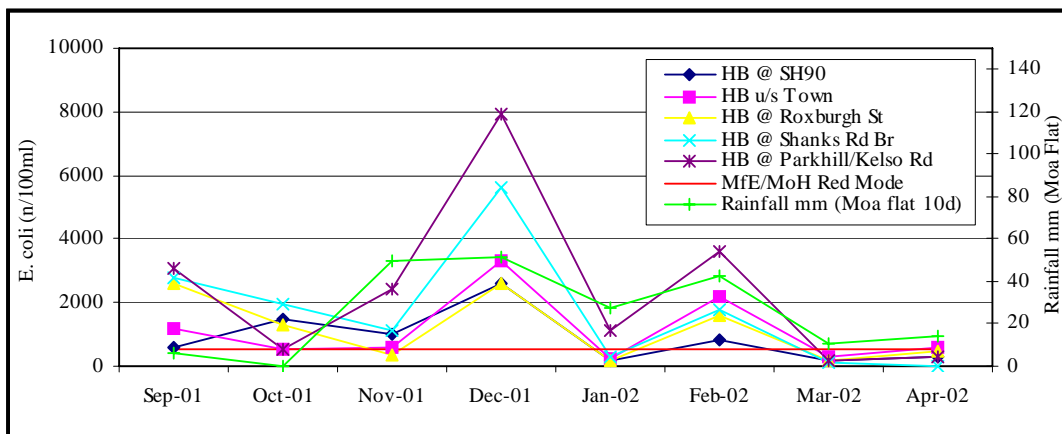
**Figure 4.2** *E. Coli* bacteria concentrations recorded at various locations in the Heriotburn between May 2000 and May 2002, total rainfall mm recorded at Moa Flat over the previous 10 days. The 2003 Ministry of Environment MfE/MoH Action/Red Mode Recreational Water Quality Guidelines are noted.

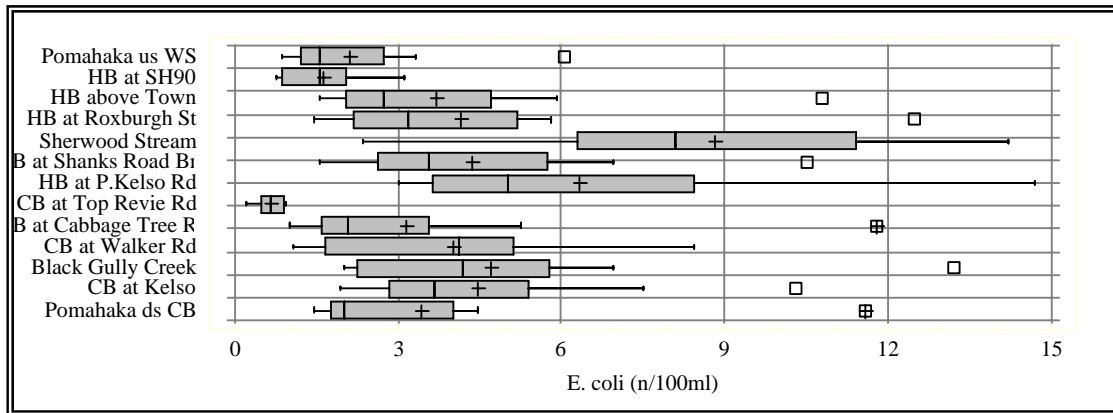
**Figure 4.4** Box and whisker plot depicting *E. coli* concentrations recorded at various locations in the Heriotburn and Crookstonburn between May 2000 and May 2002

Like the Heriotburn, water quality in the Crookstonburn is highest in the uppermost site (Top Levie Road) and generally deteriorates with distance downstream. This trend is clear with *E. coli* concentrations. Figure 4.4 and Figure 4.13 show that only the site at Top Revie Road is consistently safe for contact recreational activities such as swimming.

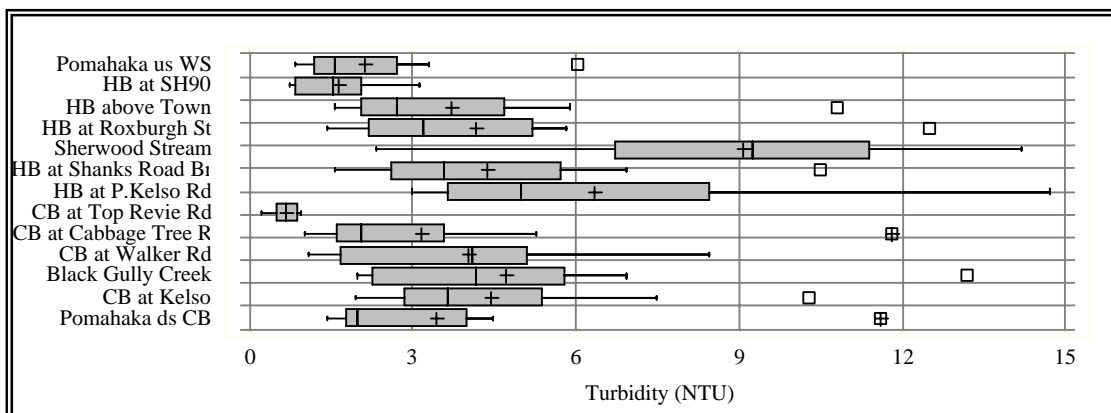
**Figure 4.5** Box and whisker plot of turbidity concentrations recorded at various locations in the Heriotburn and Crookstonburn between May 2000 and May 2002.

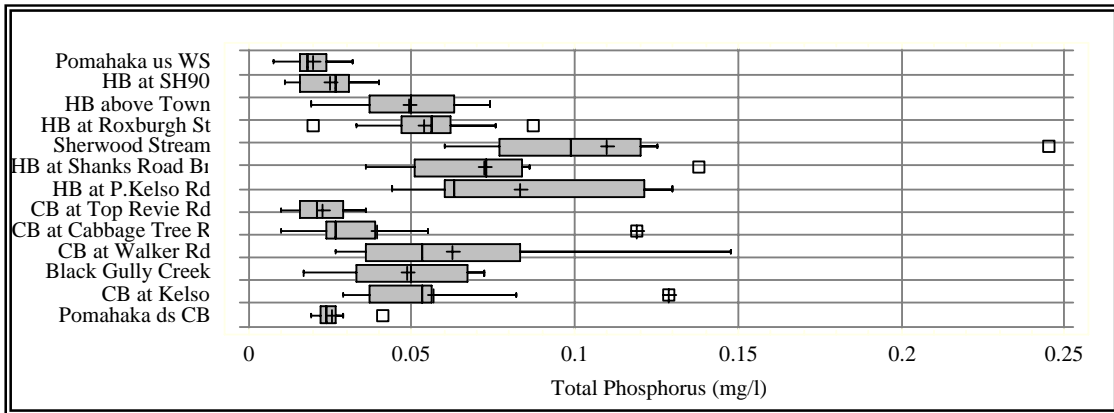
**Figure 4.6** Box and whisker plot of total phosphorus concentrations recorded at various locations in the Heriotburn and Crookstonburn between May 2000 and May 2002

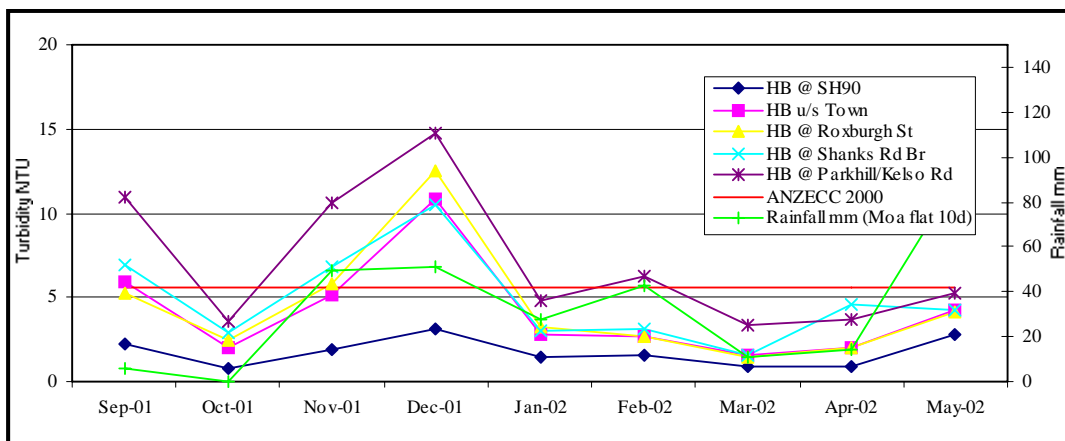
**Figure 4.7** Turbidity levels recorded at various locations in the Heriotburn between September 2001 and May 2002 and rainfall mm recorded at Moa Flat (10 day total prior to sampling). The ANZECC 2000 default trigger value for turbidity in slightly disturbed New Zealand lowland rivers is noted

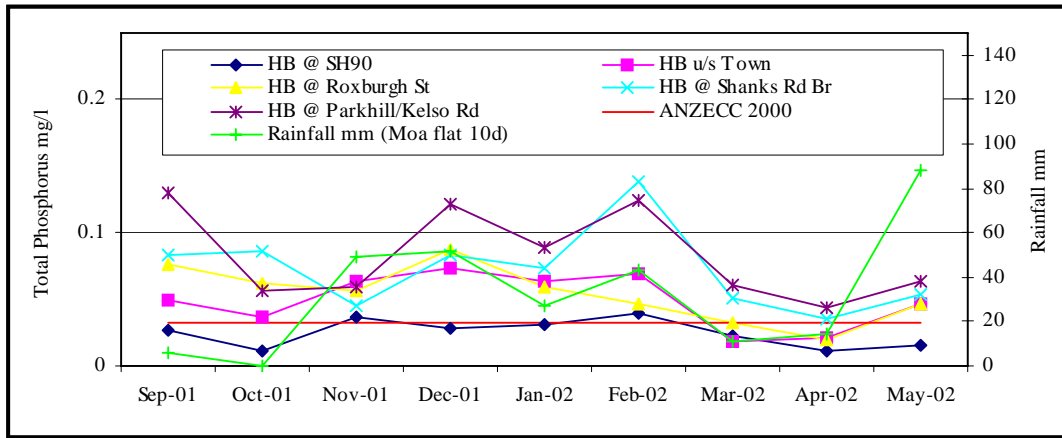
**Figure 4.8** Total phosphorus concentrations recorded at various locations in the Heriotburn between May 2000 and May 2002, and rainfall mm recorded at Moa Flat (10 day total prior to sampling). The ANZECC 2000 default trigger value for phosphorus in slightly disturbed New Zealand lowland rivers is noted

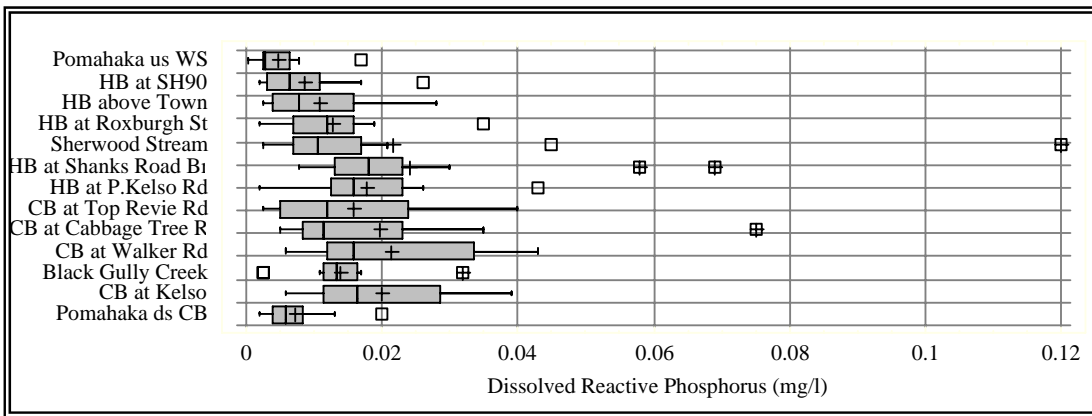
**Figure 4.9** Box and whisker plot of dissolved reactive phosphorus concentrations recorded at various locations in the Heriotburn and Crookstonburn between May 2000 and May 2002

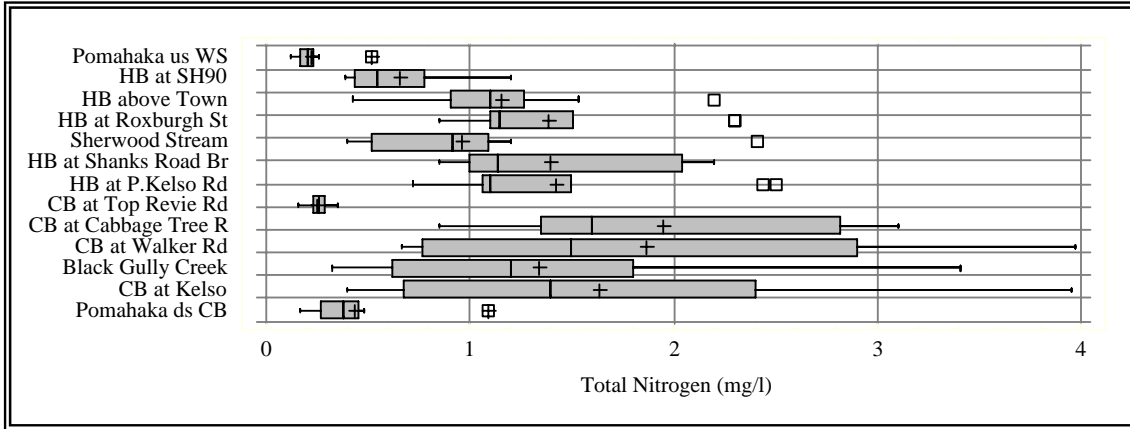
**Figure 4.10** Box and whisker plot of total nitrogen concentrations recorded at various locations in the Heriotburn and Crookstonburn between May 2000 and May 2002

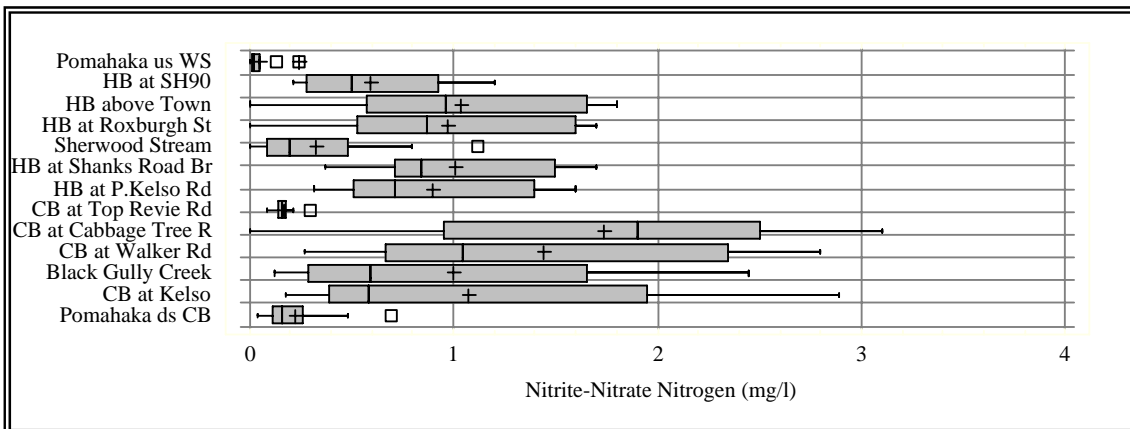
**Figure 4.11** Box and whisker plot of nitrite-nitrate nitrogen concentrations recorded at various locations in the Heriotburn and Crookstonburn between May 2000 and May 2002

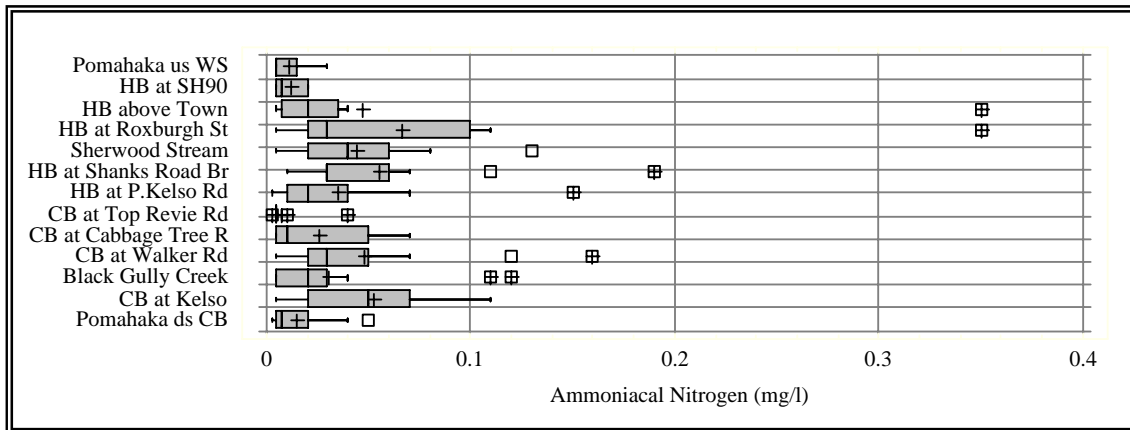
**Figure 4.12** Box and whisker plot of ammoniacal nitrogen concentrations recorded at various locations in the Heriotburn and Crookstonburn between May 2000 and May 2002

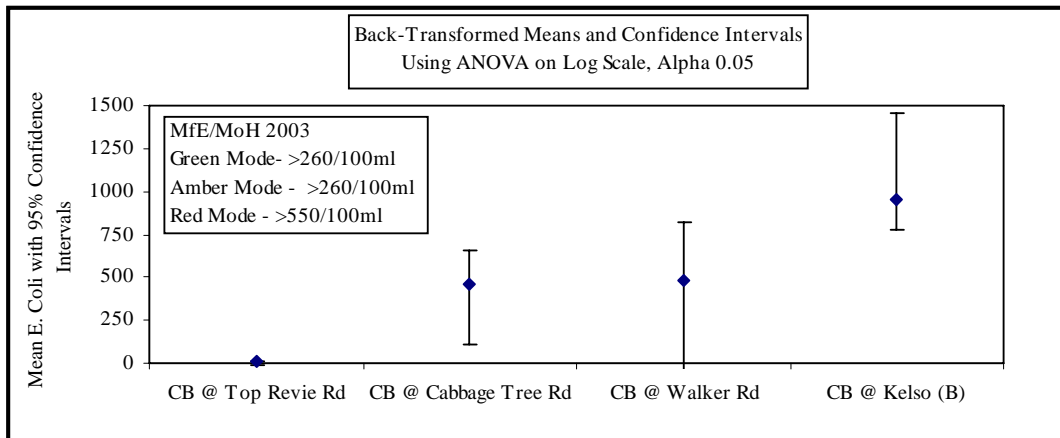
**Figure 4.13** *E. coli* bacteria concentrations (back transformed means and confidence intervals, using ANOVA on log scale, alpha 0.05) recorded at various locations in the Crookstonburn between May 2000 and May 2002

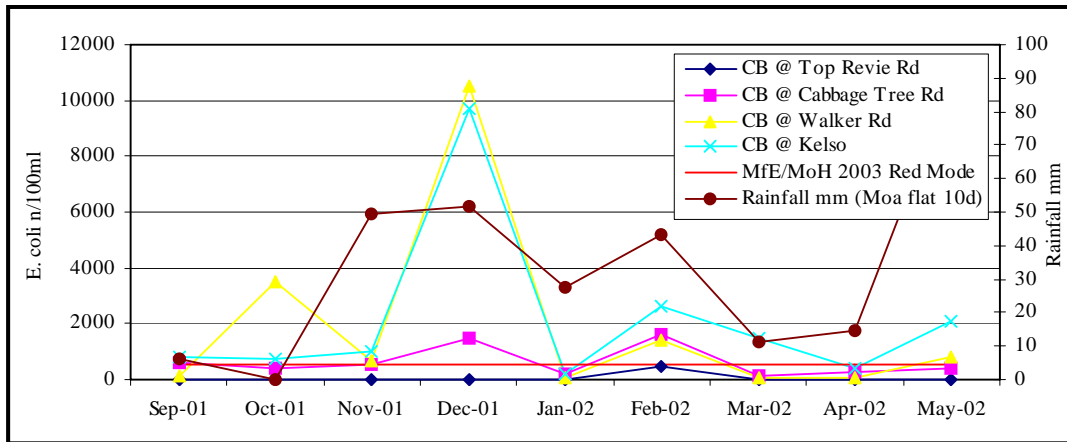
**Figure 4.14** *E. coli* concentrations recorded at various locations in the Crookstonburn between May 2000 to May 2002. The 2003 MfE/MoH Action/Red Mode Recreational Water Quality Guidelines are also noted

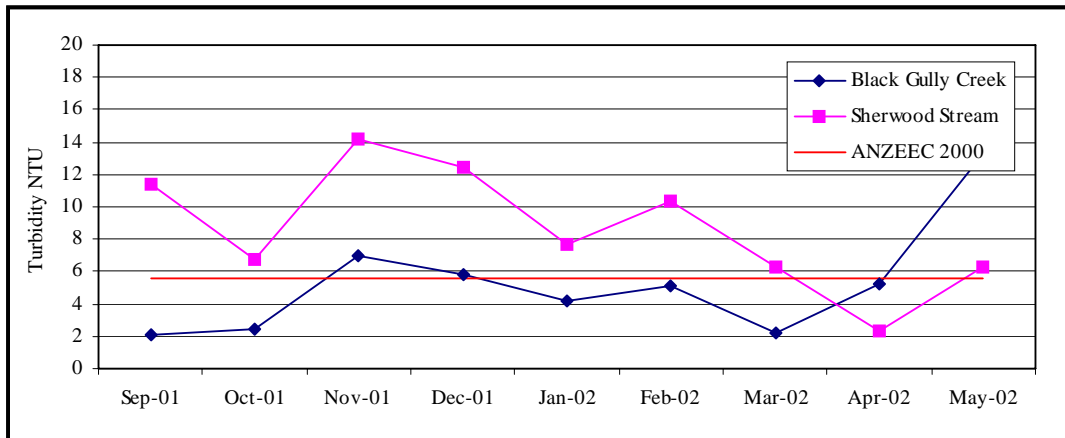
**Figure 4.15** Turbidity levels recorded in Sherwood Stream and Black Gully Creek between May 2000 to May 2002. The relevant ANZECC 2000 default trigger value for slightly disturbed New Zealand lowland rivers are also noted

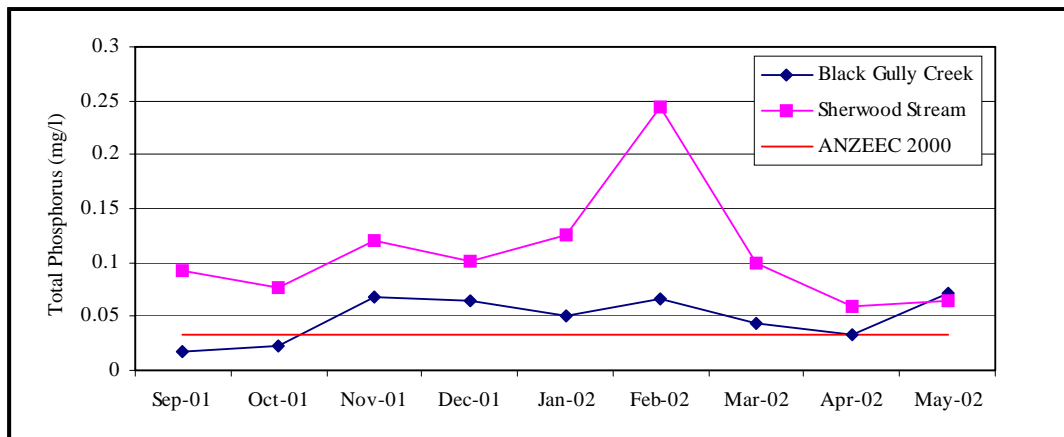
**Figure 4.16** Total phosphorus concentrations recorded in Sherwood Stream and Black Gully Creek between May 2000 to May 2002. The relevant ANZECC 2000 default trigger value for slightly disturbed New Zealand lowland rivers are also noted

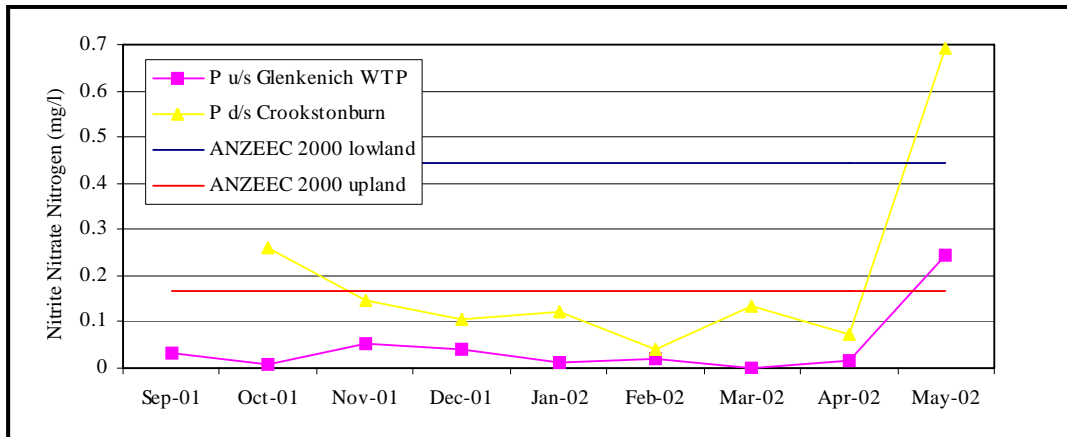
**Figure 4.17** Nitrite-nitrate nitrogen concentrations recorded in the Pomahaka River between May 2000 to May 2002. The relevant ANZECC 2000 default trigger values for slightly disturbed New Zealand upland and lowland rivers are also noted

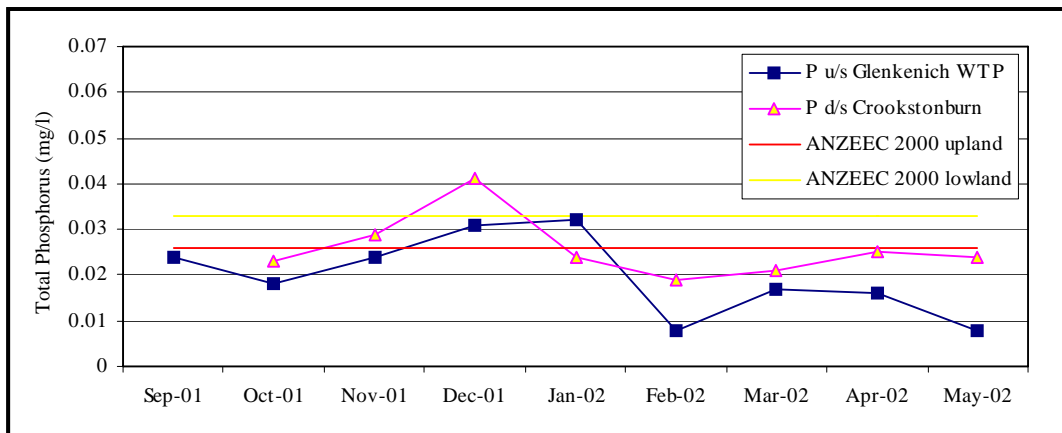
**Figure 4.18** Total phosphorus concentrations recorded in the Pomahaka River between May 2000 and May 2002. The relevant ANZECC 2000 default trigger values for slightly disturbed New Zealand upland and lowland rivers are also noted.

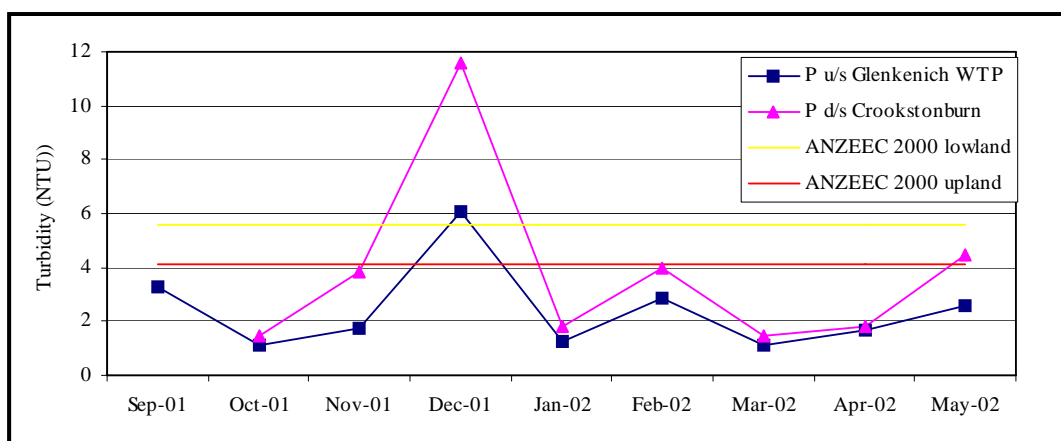
**Figure 4.19** Turbidity levels recorded in the Pomahaka River between May 2000 and May 2002. The relevant ANZECC 2000 default trigger values for slightly disturbed New Zealand upland and lowland rivers are also noted

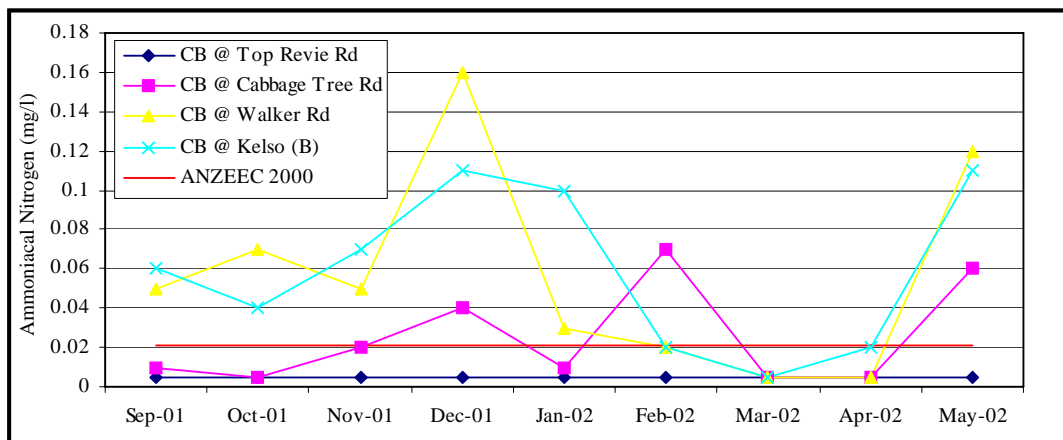
**Figure 4.20 Ammoniacal nitrogen concentrations recorded at various locations in the Crookstonburn between September 2001 to May 2002. The relevant ANZECC 2000 default trigger value for slightly disturbed New Zealand lowland rivers is also noted.**

The landuse maps (Figure 5.1 and Figure 5.2) indicate the abundance of dairy farms in the catchments, and therefore the potential for dairy effluent to effect watercourses. The nitrogen component of dairy effluent comprises largely of ammoniacal nitrogen which when applied to land, enters the soil and, under normal conditions, converts to nitrate nitrogen. Nitrates are very mobile in soil and can easily pass into the tile drainage system which discharge into adjacent streams. Rainfall resulting in saturated soils reduces the conversion of ammonia to nitrate nitrogen, meaning that a considerable amount of the nitrogen on the farm paddocks can drain straight down into the tile drainage system and out into the streams as ammonia (Figure 4.20).

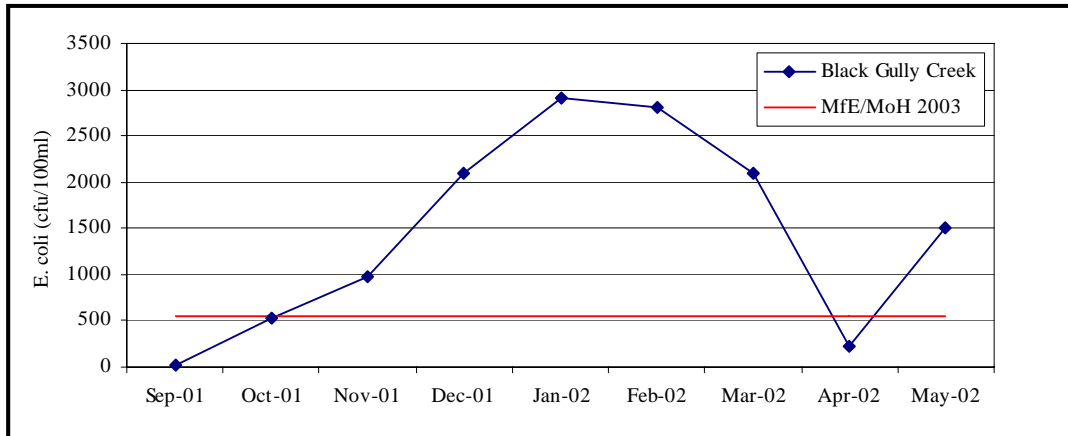
**Figure 4.21** *E. coli* concentrations recorded in Black Gully Creek at Walker Rd between May 2000 to May 2002. The 2003 MfE/MoH Action/Red Mode Recreational Water Quality Guideline is also noted.
