## **Surface Water Quality in South West Otago**

**June 2004**

## Executive Summary

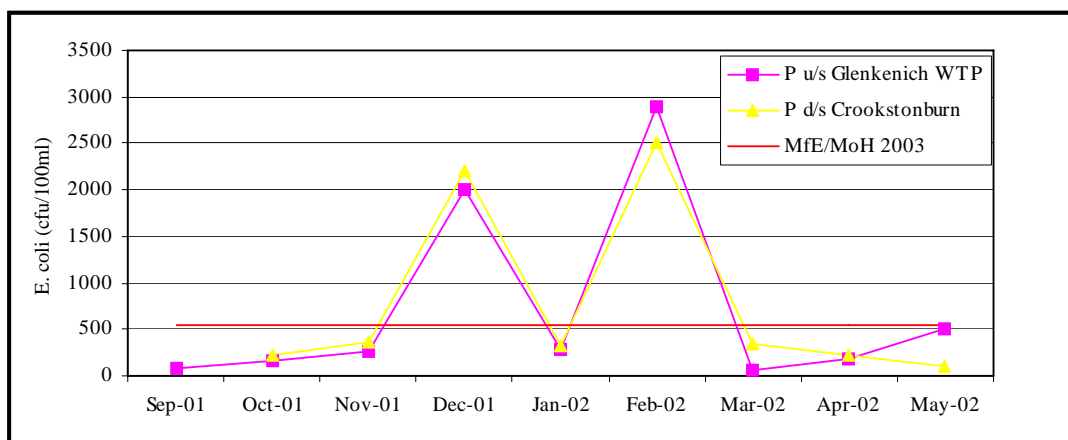
**Figure 4.22** *E. coli* concentrations recorded in the Pomahaka River at Glenkenich and downstream of the Crookstonburn confluence between May 2000 and May 2002. The 2003 MfE/MoH Action/Red Mode Recreational Water Quality Guidelines are also noted

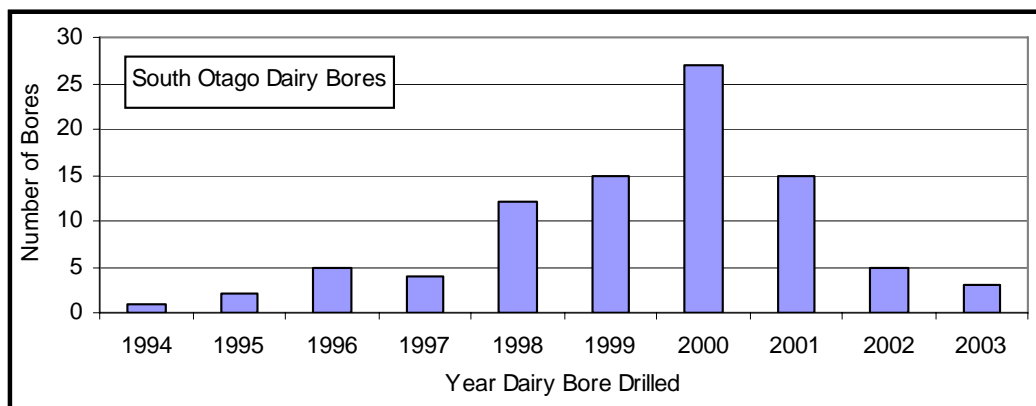
**Figure 5.3** Number of consents issued for dairy shed bores between 1994 and 2003
