**Water quality in the Tokomairiro  
catchment:  
Trends and comparison with water  
quality standards**

ISBN 978-0-478-37666-1  
Published October 2013  
Prepared by: Dean Olsen  
Reviewed by: Rachel Ozanne

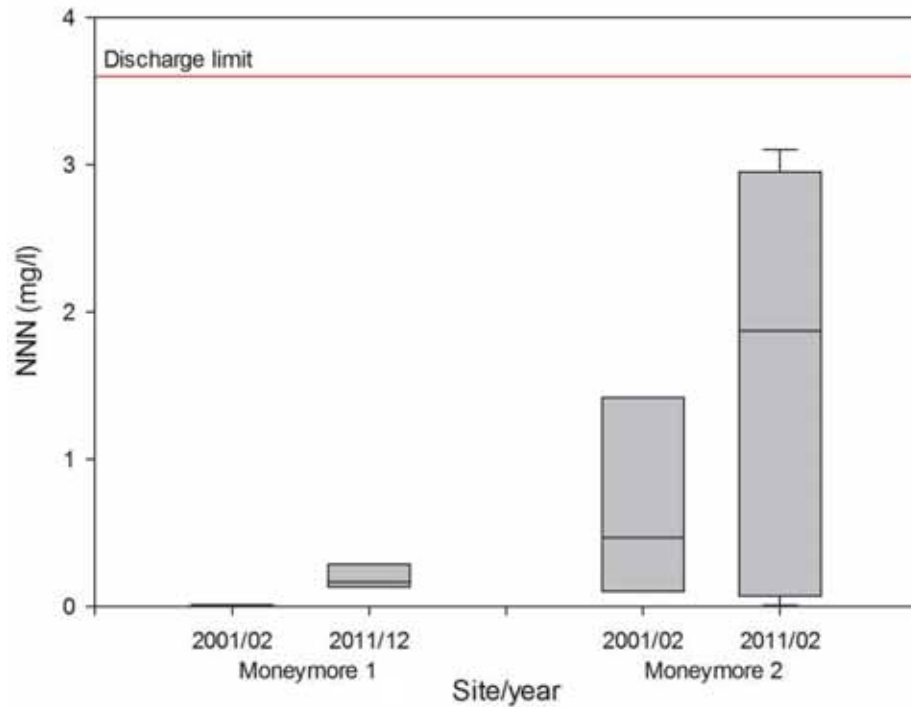
Concentrations of NNN measured in both drains in 2011/12 were higher than observed in 2001/02, but remained below the discharge limit in Schedule 15 (Figure 5.3.2).

**Figure 5.3.2** Nitrate-nitrite nitrogen concentrations in two drains in the Tokomairiro catchment when flows in the West Branch at the SH8 bridge are below the reference flow (440 l/s). The red line is the Plan Change 6A discharge limit (Table 3.2).

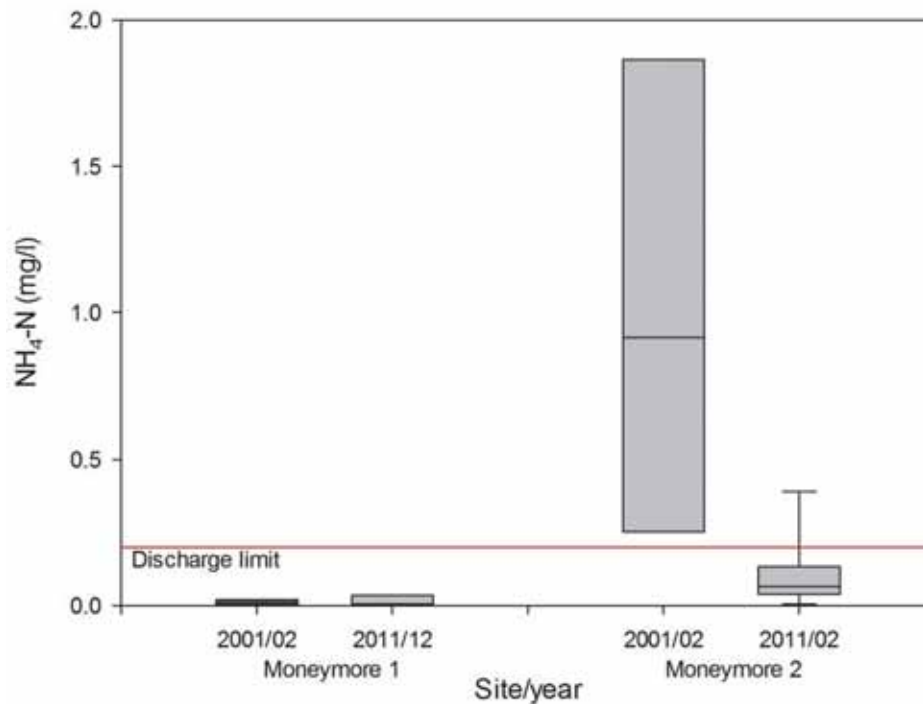
$NH_4-N$  concentrations measured in Moneymore 1 in 2011/12 were similar to those observed in 2001/02 and remained well below the discharge limits (Figure 5.3.3). In contrast,  $NH_4-N$  concentrations in Moneymore 2 in 2011/12 were much lower than observed in 2001/02 and generally within the limit (Figure 5.3.3).

**Figure 5.3.3** Ammoniacal nitrogen concentrations in two drains in the Tokomairiro catchment when flows in the West Branch at the SH8 bridge are below the reference flow (440 l/s). The red line is the Plan Change 6A discharge limit (Table 3.2).

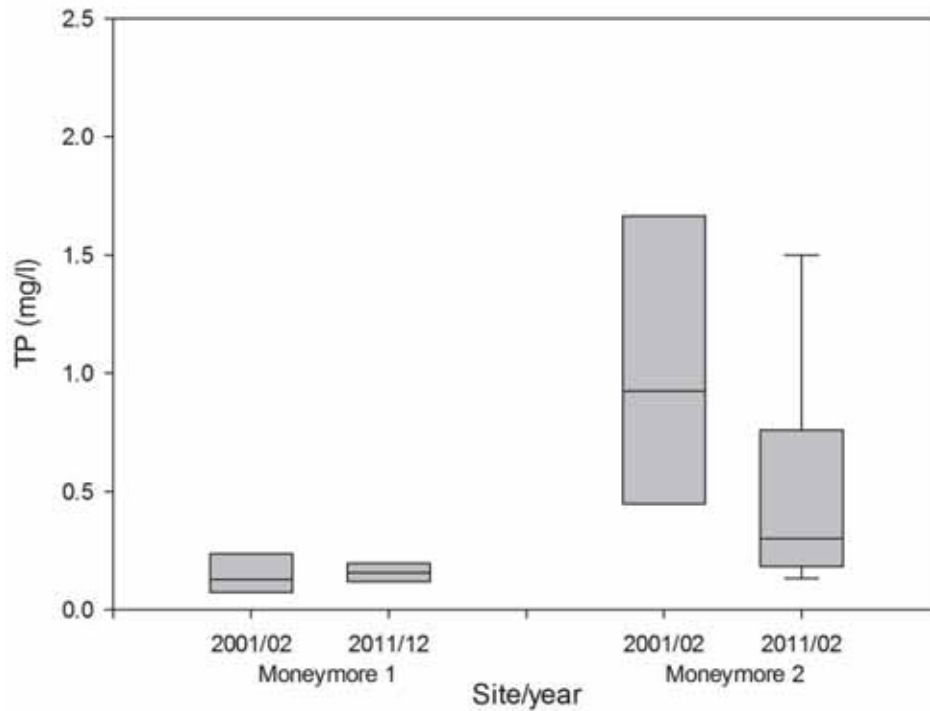
TP concentrations in Moneymore 1 in 2011/12 were similar to those measured in 2001/02, while TP concentrations in Moneymore 2 were lower than in 2001/02 (Figure 5.3.4)

**Figure 5.3.4 Total phosphorus concentrations in two drains in the Tokomairiro catchment when flows in the West Branch at the SH8 bridge are below the reference flow (440 l/s).**

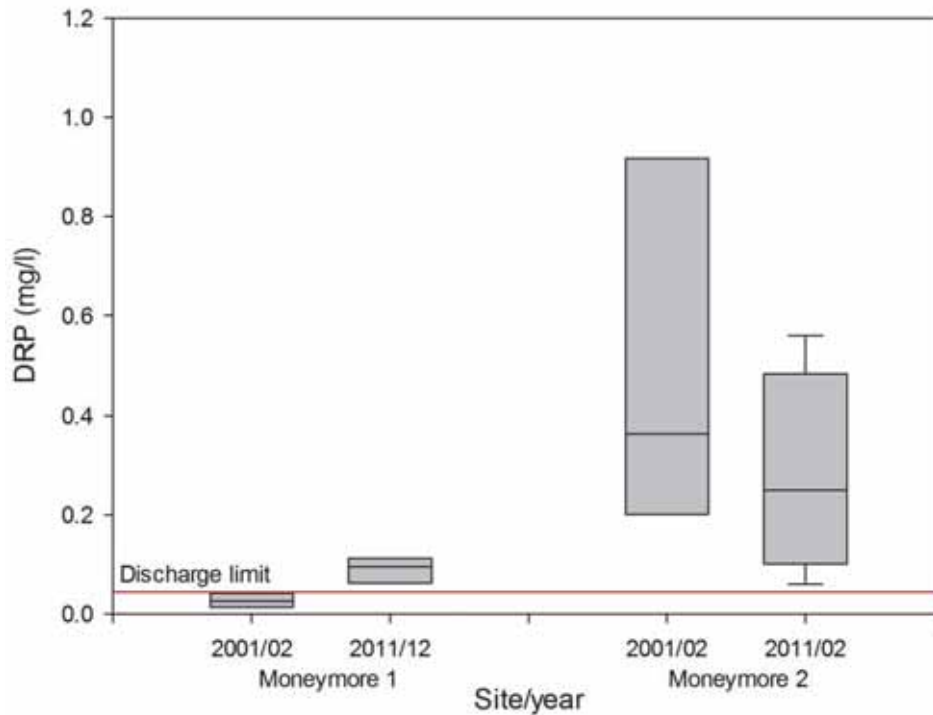
Concentrations of DRP measured in Moneymore 1 in 2011/12 were higher than in 2001/02, and most readings exceeded the discharge limit in Schedule 15 (Figure 5.3.5). Concentrations of DRP measured in Moneymore 2 in 2011/12 were slightly lower than in 2001/02, and all readings in 2011/12 exceeded the discharge limit in Schedule 15 (Figure 5.3.5).

**Figure 5.3.5** Dissolved reactive phosphorus concentrations in two drains in the Tokomairiro catchment when flows in the West Branch at the SH8 bridge are below the reference flow (440 l/s). The red line is the Plan Change 6A discharge limit (Table 3.2).

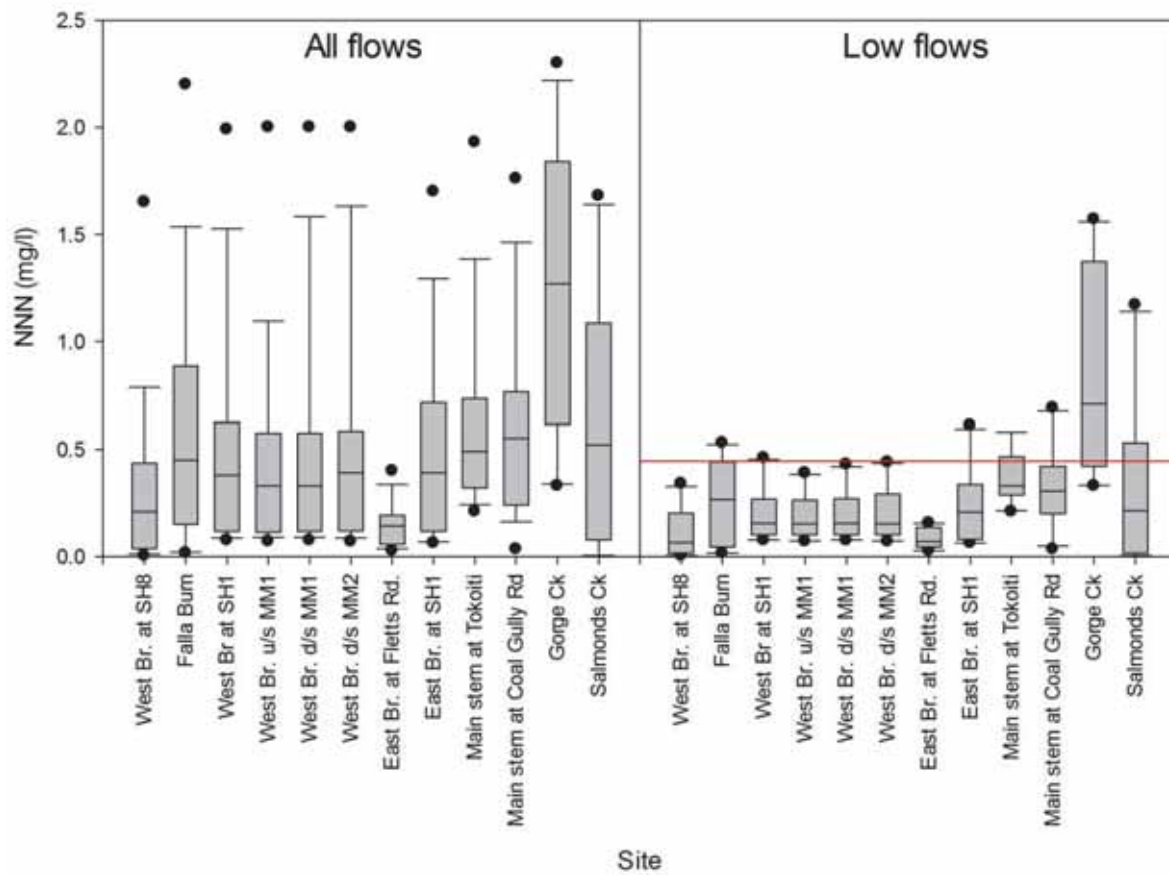
NNN concentrations were low at both sites in the upper catchment (West Branch at SH8 bridge and East Branch at Fletts Road). While they increased with distance downstream, the 80<sup>th</sup> percentiles of NNN concentrations at all sites in the West Branch and East Branch were below the Schedule 15 standard when flows were below median flow (Figure 6.2). Concentrations of NNN downstream of the confluence of the two branches were higher than in the two branches, probably due to discharge from the Milton WWTP. The highest NNN concentrations were found in Gorge and Salmond creeks, where the 80<sup>th</sup> percentile of NNN concentrations exceeded the Schedule 15 standard (Figure 6.2). Concentrations in the Falla Burn were higher than other sites in comparable positions in the catchment, and the 80<sup>th</sup> percentile of NNN concentrations in the Falla Burn approached the Schedule 15 standard (Figure 6.2).

**Figure 6.2** Box plots of nitrate-nitrite nitrogen concentrations at 12 sites in the Tokomairiro catchment during all flows and low flows (below the reference flow). The red line represents the Schedule 15 standard that applies when flows are below the reference flow (Table 3.1).

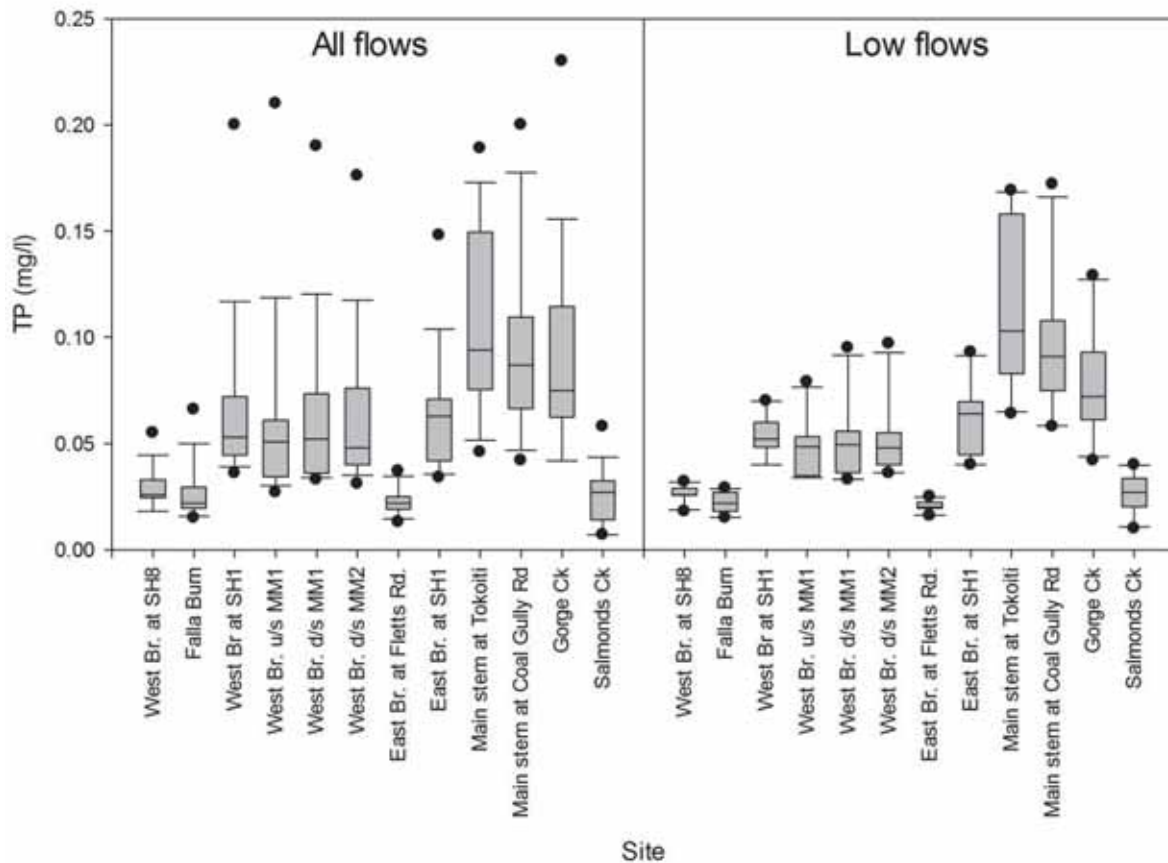
TP concentrations at upper sites were very low. However, higher concentrations were observed at other sites in each of the branches, and concentrations in the main stem were higher again (Figure 6.4). High concentrations of TP were observed in Gorge Creek, while concentrations in Salmonds Creek were relatively low (Figure 6.4).

**Figure 6.4** Box plots of total phosphorus concentrations at 12 sites in the Tokomairiro catchment during low flows (below the reference flow) and all flows. The red line represents the Schedule 15 standard that applies when flows are below the reference flow (Table 3.1).

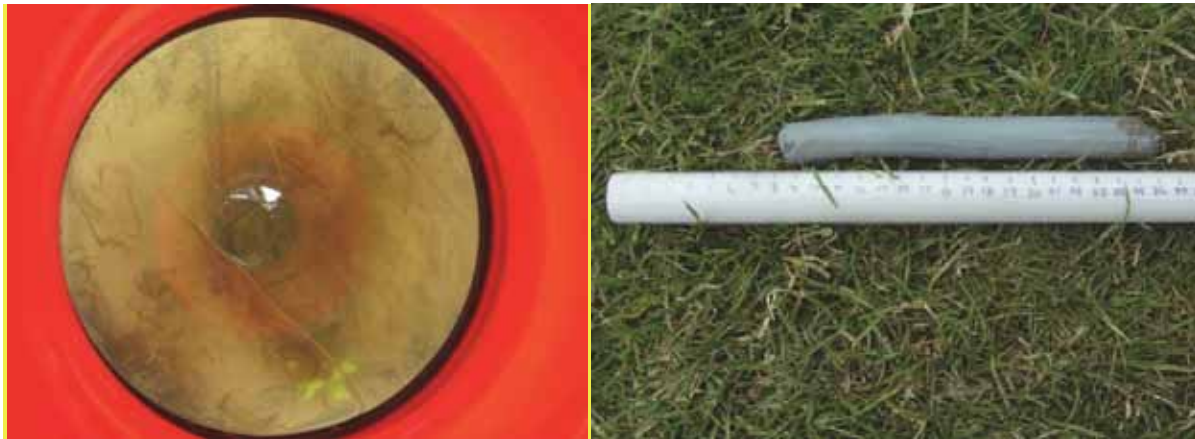
substrate between the upper site and the other sites in the West Branch is probably related, in part, to geology. The hills around Table Hill are dominated by the Taratu formation, which consists primarily of quartz sand and pebble conglomerate (Bishop 1994). This formation is easily erodible, and land clearance has probably increased the input of sand and pebbles from it into the middle reaches of the catchment. Because of the shallow gradient of much of the Tokomairiro River, it has limited capacity to transport sediment. As well as the natural load of fine sediment, land-use activities contribute a significant proportion of the fine sediment loads in many parts of the catchment.

**Figure 7.3.1** An example of the fine sediment smothering the stream bed of Gorge Creek (looking through an underwater viewer) and a sediment core collected from Gorge Creek

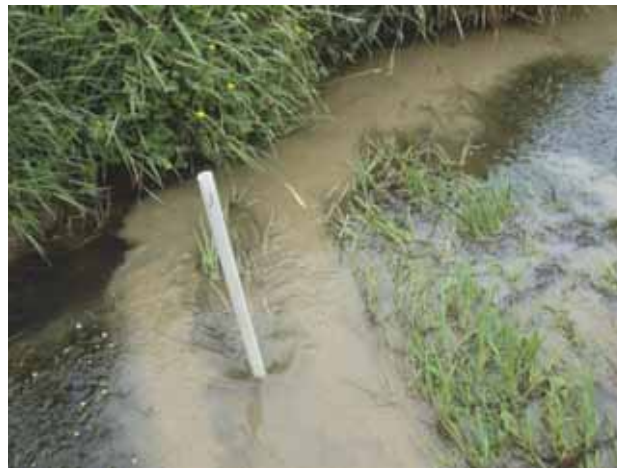
**Figure 7.3.2** Sediment plume after performing the Shuffle Index method to assess sedimentation
