# Water quality and ecosystem health in Otago

Water quality Ecosystem health July 2013 to June 2018

**Introduction** The Otago Regional Council (ORC) is responsible for managing Otago's surface-water resources and carrying out regular and extensive long-term water-quality monitoring, as part of its State of Environment (SOE) programme. This report card documents the results of water-quality (July 2013 to June 2018), macroinvertebrate, periphyton and fish (2018), monitoring.

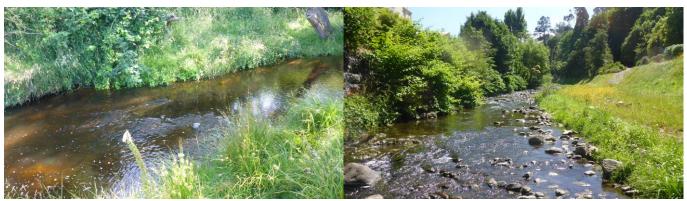
Figure 2 Tokomairiro at West Branch Bridge (left), Water of Leith (right)

Three sites in Group 1 (out of 20) had 'excellent' water quality (Balclutha, Catlins and Tokomairiro at West Branch Bridge); five had 'good' water quality (Kaikorai, Pomahaka at Burkes, Tokomairiro at Lisnatunny, Waipahi at Waipahi and Waitahuna); four had 'fair' water quality (Lovells Creek, Owaka, Tokomairiro at Blackbridge and Tuapeka); and the remaining 8 sites were classified as 'poor' water quality. Schedule 15 limits were most often exceeded for *E. coli* and NNN. Most of the 'poor' sites were in south-west Otago. Compared to last year, only Tokomairiro at West Branch Bridge improved one band, and Tuapeka, Lindsay's Creek and Waiwera degraded one band.

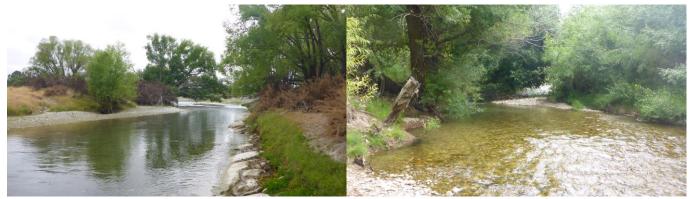
Figure 3 Manuherikia at Blackstone (left) and Cardrona River (right)

Two sites were affected by high NNN in groundwater, the Shag at Goodwood and Mill Creek. Compared to last year the Bannockburn at Lake Dunstan, Contour Channel and Taieri at Tiroiti have improved a grade from 'good' to 'excellent', 'poor' to 'fair' and 'fair' to 'good', respectively. Conversely, Manuherikia at Blackstone Hill, Silverstream, Taieri at Outram, and Waianakarua all dropped one grade.
