# TECHNICAL COMMITTEE AGENDA

### 10.1. General Manager Operations Report to Technical Committee

<b>Prepared for:</b>	Technical Committee
<b>Report No.</b>	EHS1856
<b>Activity:</b>	Flood Protection & Control Works
<b>Author:</b>	Jean-Luc Payan, Manager Natural Hazards Julie Everett-Hincks, Manager Science
<b>Endorsed by:</b>	Gavin Palmer, General Manager Operations
<b>Date:</b>	12 June 2019

## 10.2. Glendhu Forestry

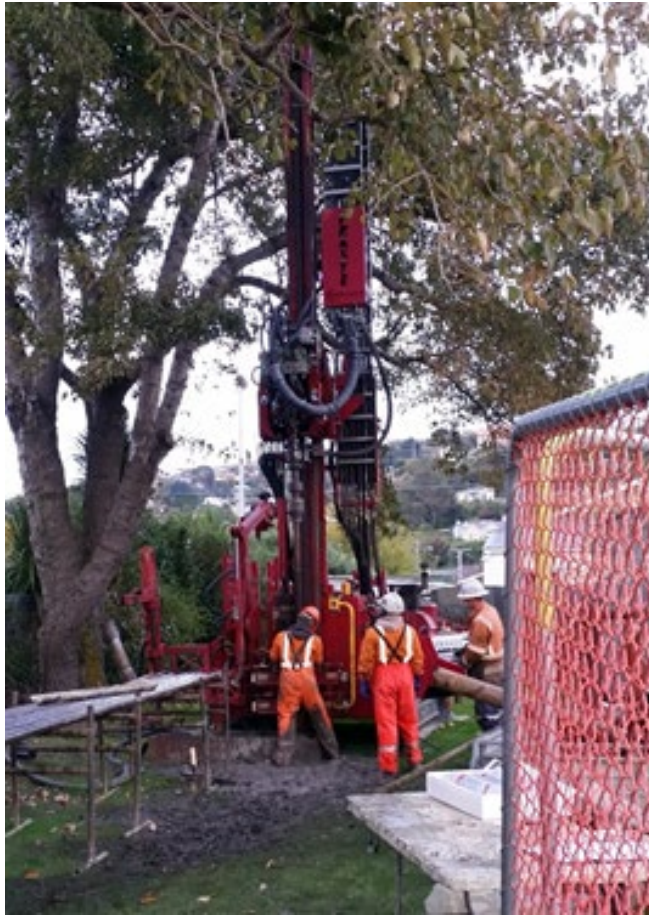
**Figure 1: Drilling to bedrock at Tonga Park (NZSR01), South Dunedin 22 May 2019.**

- [2] As of 28 May 2019, work on the South Dunedin and Harbourside drilling project is progressing well. The project (in association with GNS Science and Oceana Gold and with support from the Dunedin City Council and the University of Otago) is drilling and installing five groundwater monitoring bores in the coastal Dunedin Central Business District area (Harbourside) and drilling two deeper holes (to bedrock) in the South Dunedin area (Figure 1).

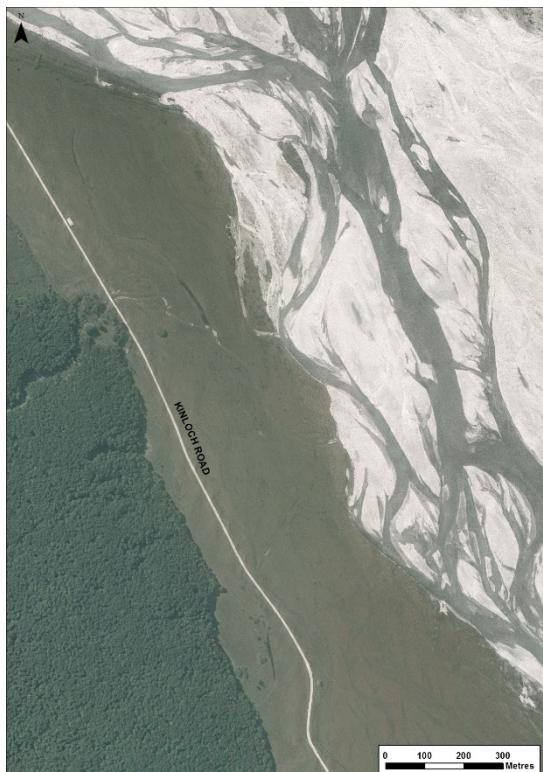
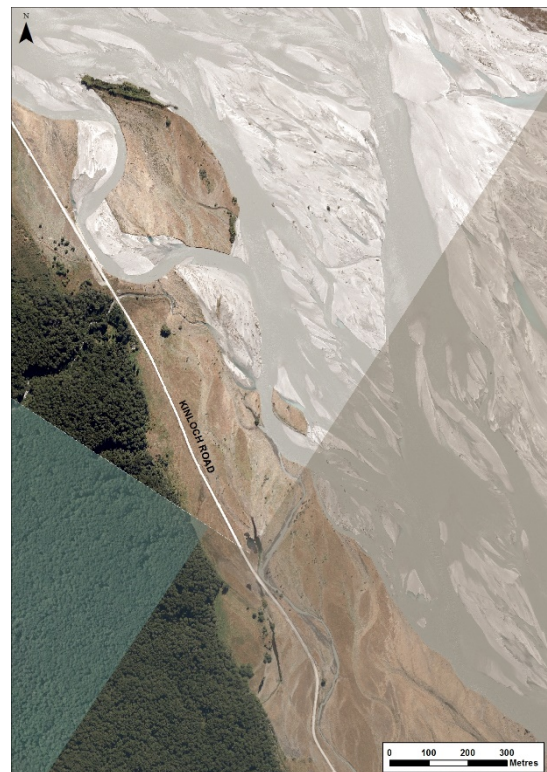
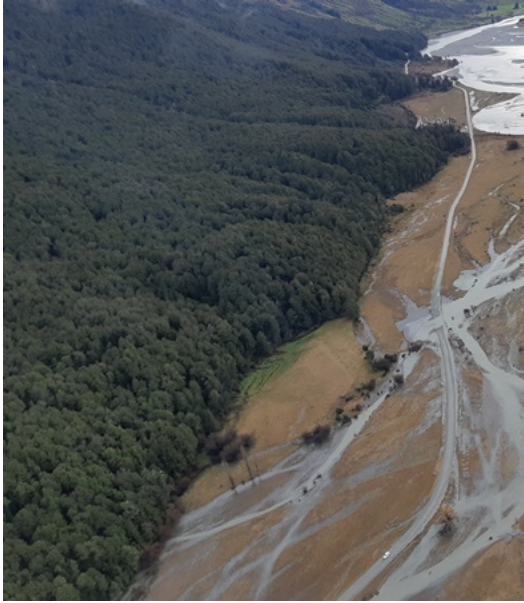
**Figure 6: Top: Channel position – 2007 (left) and 2019 post March 2019 high flows (right)  
Bottom: Kinloch Road flooding between Turner Creek and Glacier Burn – 31 May 2019**

- [11] The bund was reinstated twice by ORC before it was entirely washed away in the record (since 1996) Dart River flows in March 2019. One active channel is now flowing in proximity to this section of road and the threshold at which Kinloch Road between Turner Creek and Glacier Burn becomes inundated has lowered (Figure 6).

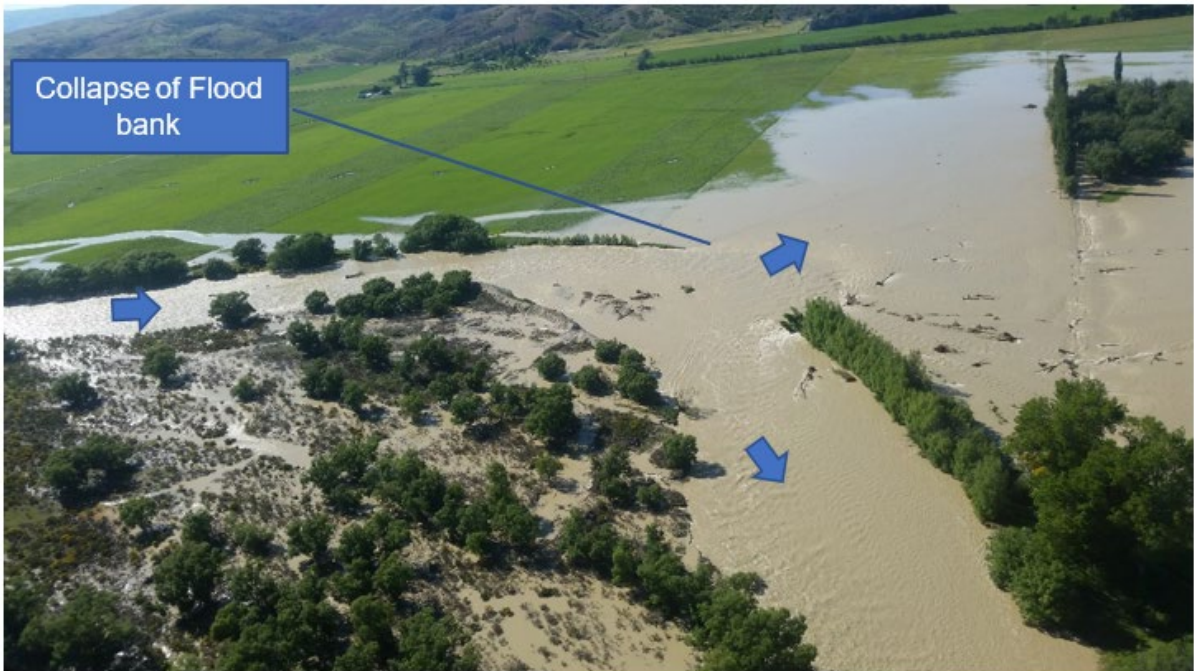
Figure 8: Manuherikia River – Left bank overflow – November 2018

- [19] Following the November 2018 high flow event in the Manuherikia River, this section was severely eroded resulting in bank damage. A low-level bund located at the same location also collapsed, resulting in significant overland flow (Figure 8). The purpose of the bund was to provide limited flood protection during small floods.

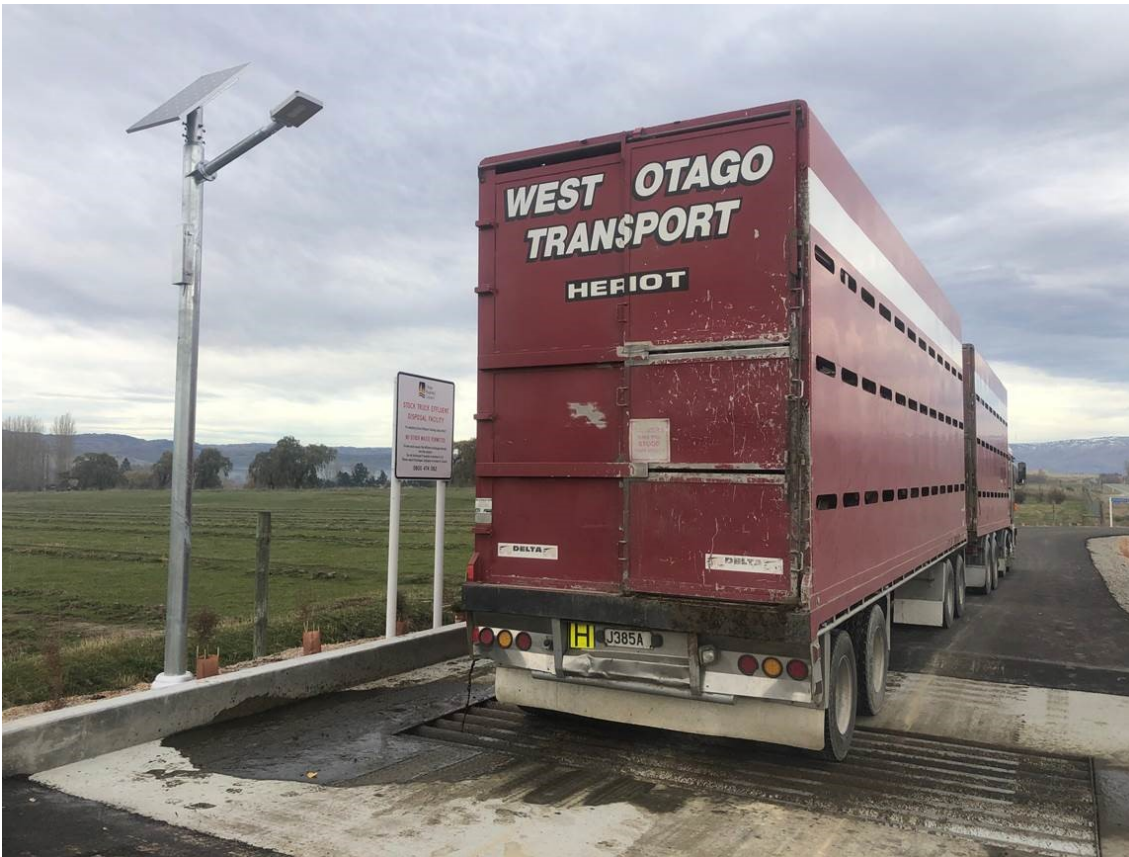
**Figure 11: Stock truck discharging effluent into the SH85 (Brassknocker Road) STED on 26 May 2019 (photograph courtesy Bruce Robertson, Road Transport Logistics Ltd, Tapanui)**

- [27] The SH85 (Brassknocker Road) stock truck effluent disposal facility (STED) is in service, bringing the number of STEDs in Otago to seven in total. Effluent collected within the facility will be removed by SJ Allen (Balclutha) Ltd and disposed at the Balclutha oxidation ponds owned by Clutha District Council. The contract with SJ Allen (Balclutha) Ltd has a term expiring in March 2021. The same company disposes the effluent that is collected within the other STED located in Central Otago (Raes Junction).
- [28] Figure 11 shows a stock truck discharging effluent into the SH85 (Brassknocker Road) STED on 26 May 2019. The truck had transported 42 dairy cows from Kelso (West Otago) to Lauder (Central Otago) for winter grazing. It had discharged effluent into the Raes Junction STED on the journey into Central Otago.

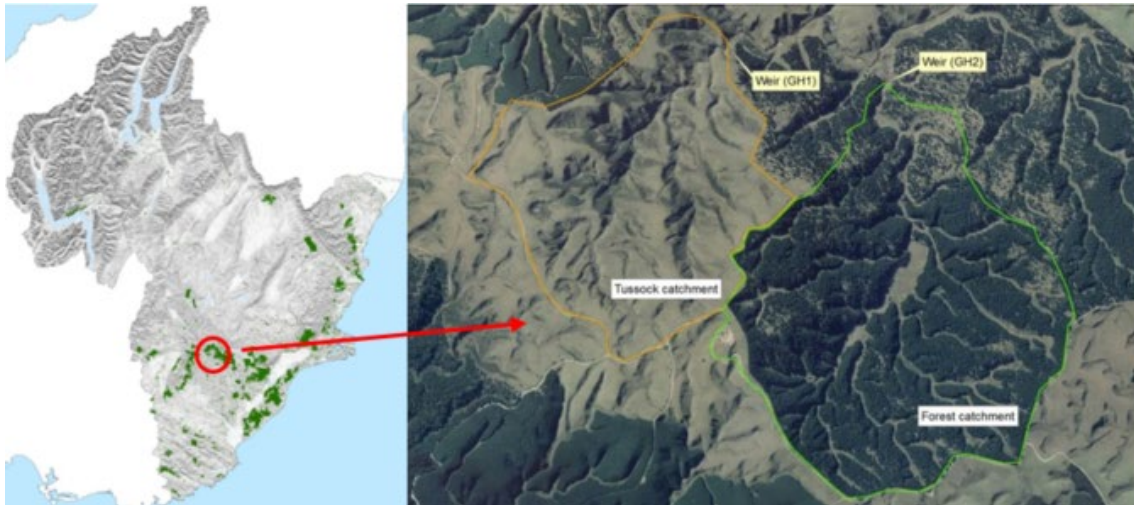
**Figure 1. Location of the Glendhu study. The ‘control’ Tussock catchment and the ‘treatment’ forest catchment are shown on the aerial photograph.**

pine forestry (*Pinus radiata*) in 1982. Figure 1 shows the location of the Glendhu catchments. The tussock catchment (GH1) covers 2.16km<sup>2</sup> and the pine plantation catchment (GH2) covers 3.10km<sup>2</sup>

- [8] Large v-notch weirs are located at the bottom of the tussock and pine catchments (Figures 1 and 2) where water level is continuously measured. A relationship between water level and discharge was used to provide an accurate estimate of flow<sup>1</sup>.
