Infrastructure Committee 11 March 2020

8.1. Update on February 2020 Flooding

Report No. OPS1003

Activity: Flood Protection & Control Works

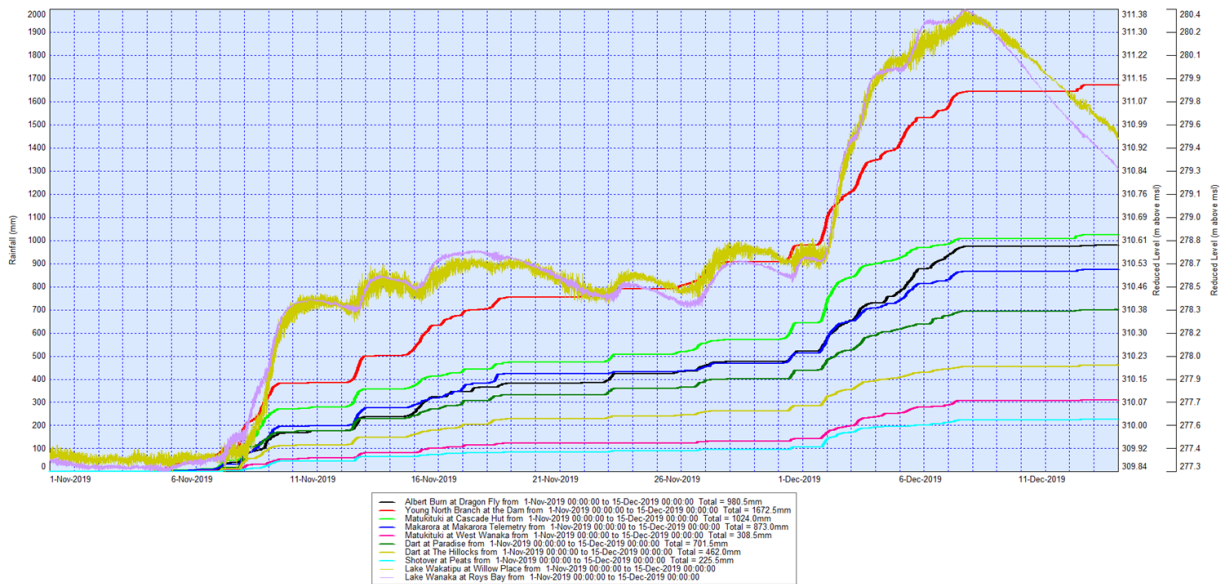
[12] During November 2019 and early December 2019 (from 1 November to 8 December) the headwaters of Otago (Clutha River catchment) received substantial amounts of rain in a succession of rainfall events of variable duration and intensities (Figure 1).

Figure 1. Cumulative rain at selected sites in the Clutha River catchment headwaters and Lake Wakatipu and Lake Wanaka water levels – 1 November 2019 to 15 December 2019. Steps in the cumulative rain indicate successive events.

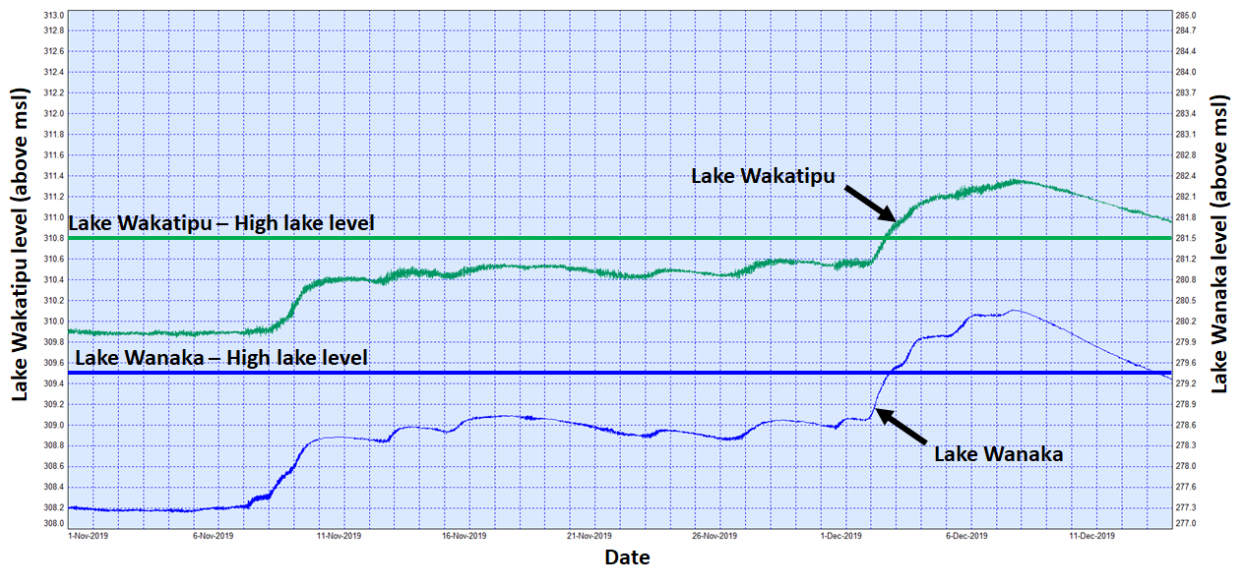
[13] The succession of rainfall events at close intervals caused the water levels in Lake Wakatipu and Lake Wanaka to rise steadily and significantly over several weeks (Figure 2).

Figure 2. Lake Wakatipu and Lake Wanaka water levels – 1 November 2019 to 15 December 2019

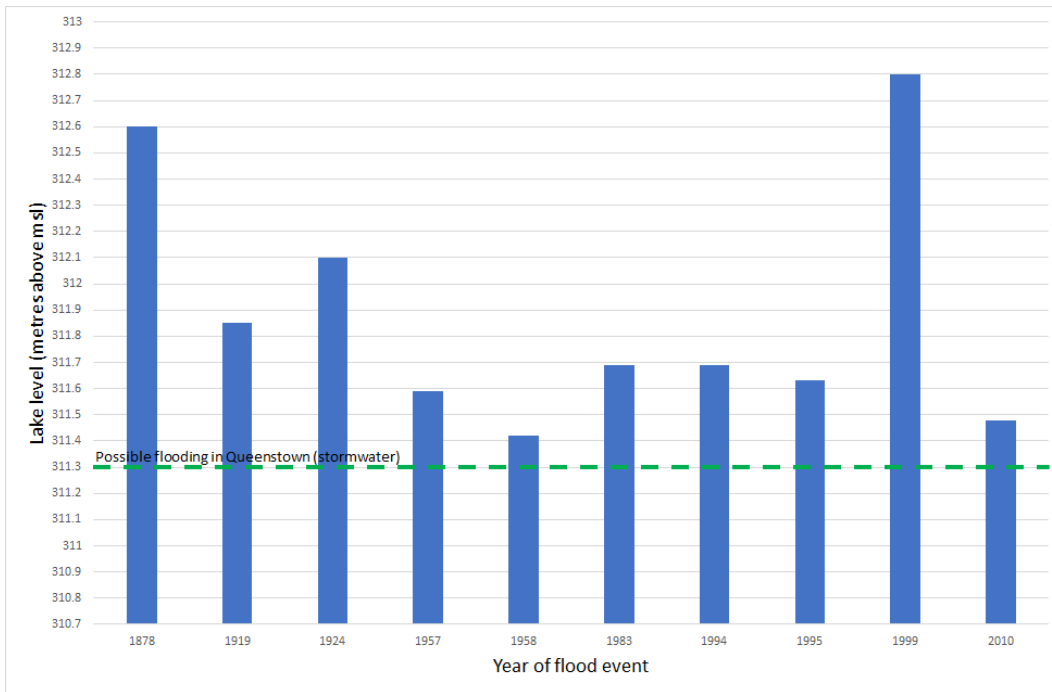
- [14] Within the period between November 2019 and early December 2019, two larger events (8-9 November 2019 and 2-8 December 2019) resulted in sharper increases of lake water levels.
- [15] Lake Wakatipu peaked at 311.37m (above mean sea level). This peak is not in the top ten highest water levels on records¹ (Figure 3). It is, however, the second highest since the November 1999 memorable flood event.

Figure 3. The 10 highest Lake Wakatipu levels since 1878

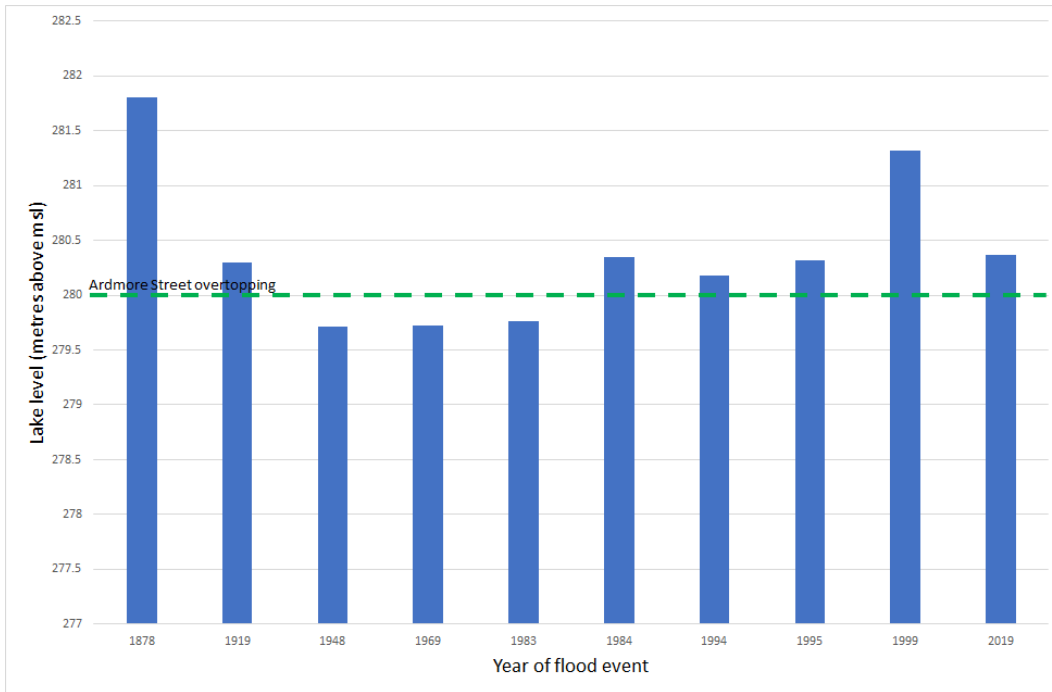
- [16] Lake Wanaka peaked at 280.37m (above mean sea level). This peak is the third highest water level on records² (Figure 4) and the highest since the November 1999 flood event. High lake levels inundated Ardmore Street on the Wanaka waterfront and were on the verge of flooding the lake front businesses.

Figure 4. The 10 highest Lake Wanaka water levels since 1878

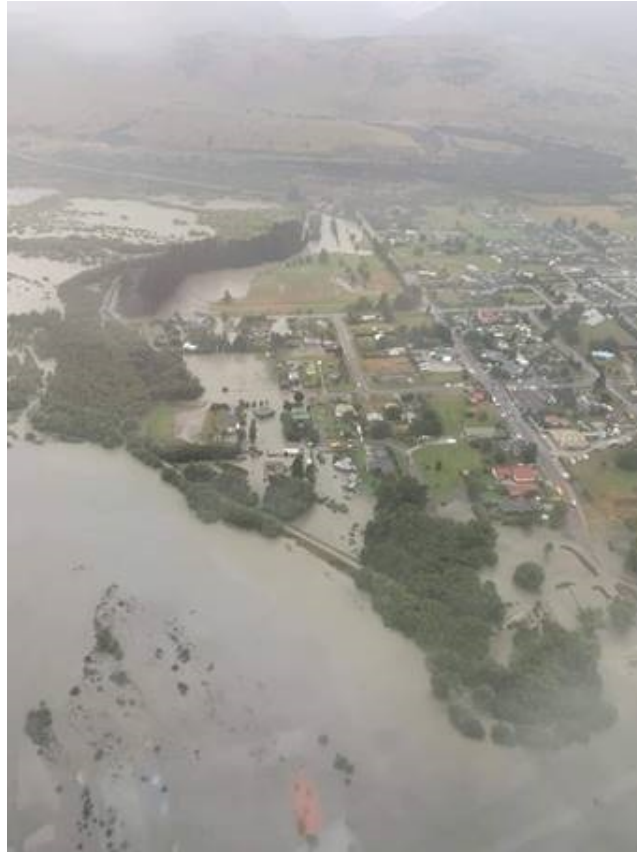
- [24] In the headwaters notable amounts of rainfall fell during this period causing the rivers feeding Lake Wanaka and Lake Wakatipu to rise. The Dart River peaked just below 1800m³/s, about 20m³/s below its highest flow since recording started in June 1996. This elevated flow affected Kinloch Road.
- [25] On 4 February a section of floodbank protecting parts of Glenorchy from flooding from the Rees River overtopped causing flooding to the recreation ground, the golf course and private properties (Figure 6).

Figure 6. Flooding in Glenorchy, 4 February 2020 around 6.30pm. Rees River Delta in the foreground and Lagoon to the left of the photograph (photo: Luke Hunter, Done Rite Contracting Ltd)

- [76] Areas where issues or damage were recorded during the flood events that are or will be addressed by current programmes of work are:
- The overtopping of the floodbank in Glenorchy. To be considered in the natural hazard strategy for the Head of Lake Wakatipu that is currently being developed by ORC and QLDC;

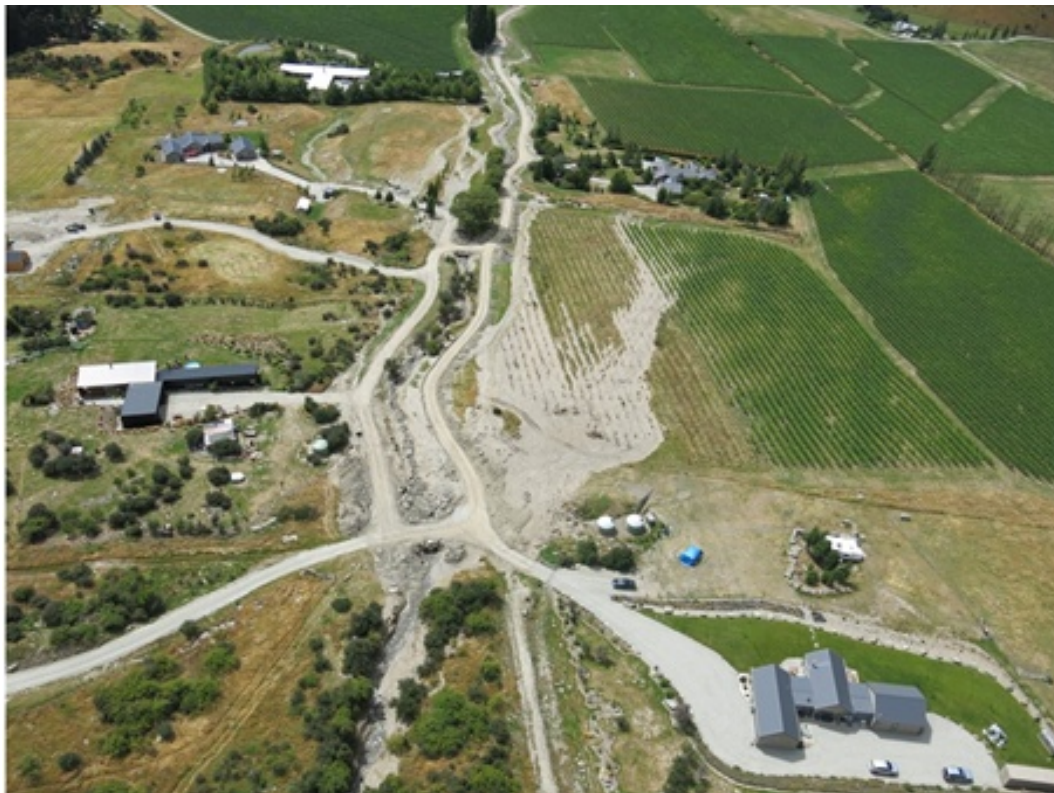
- [26] Lakes levels rose sharply (Lake Wakatipu rose approximately 1.5m and Lake Wanaka 1.8m in about 55 hours) not reaching, however, flooding levels.
- [27] During steady rain on 4 February a debris flow emanated from Grassy Stream in the eastern Gibbston Valley. The debris flow initiated high in the catchment, and stripped vegetation as it travelled down channel. 'Tussock Creek' subdivision is built upon the Grassy Stream alluvial fan at the foot of the range. Through the subdivision, the debris flow deposited rocks and sediment, blocked culverts, inundated some driveways and parts of a vineyard but there were no reports of buildings being affected by flows (Figure 7).

Figure 7. View north down Tussock Creek subdivision (Gibbston Valley) showing sediment deposited in and around the channel, and across part of a vineyard. Much of the sediment blocking the creek had been cleared at time of photo (12th February 2020, photo ORC).

- [39] Following both events specific natural hazards investigations have been initiated for the debris flow in Gibbston Valley (Tussock Creek) and the overtopping of the floodbank in Glenorchy. The purpose of those initial investigations is to evaluate the level of risk and recommend further actions.

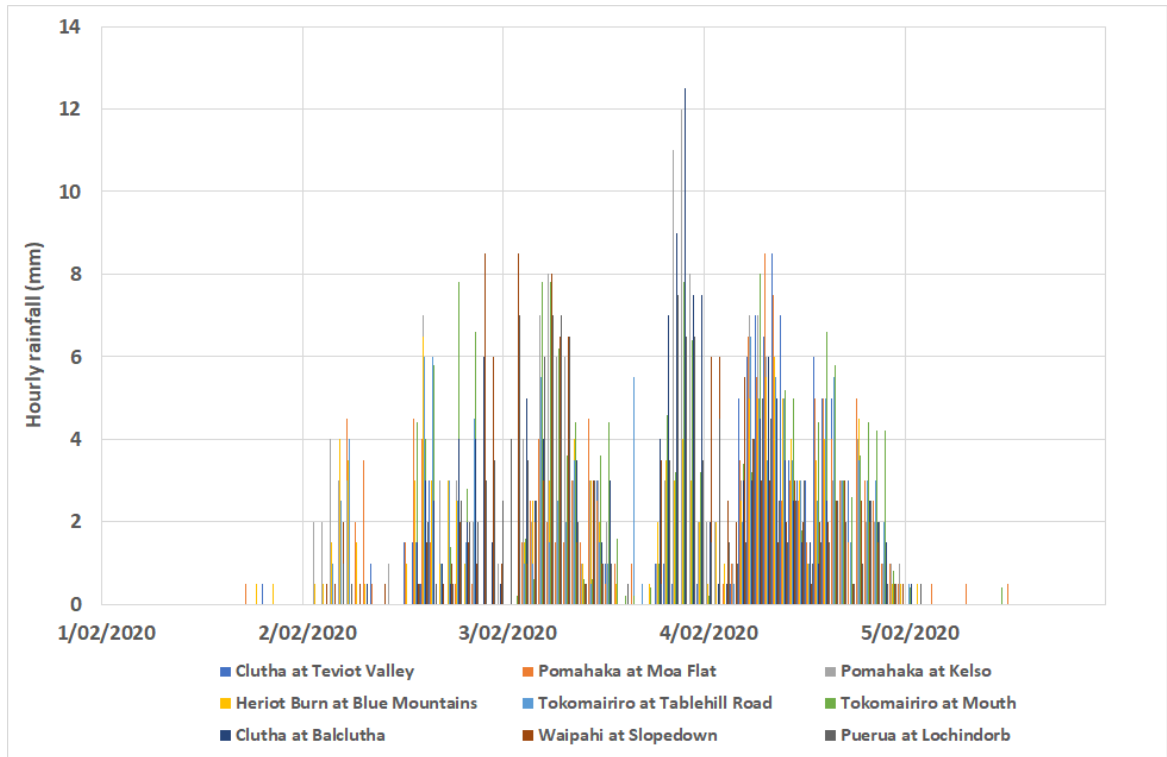
[28] In South Otago, although the rainfall intensities were not extremely high (usually not exceeding 8mm/h except in localised areas where a short two-hour burst of higher intensities up to 12mm/h was recorded on 3 February between 8pm and 10pm) the event was widespread and lasted up to approximately 72 hours with nearly continuous rainfall (Figure 8).

Figure 8. – Hourly rainfall at selected raingauges in the Lower Clutha, Tokomairao and Catlins areas

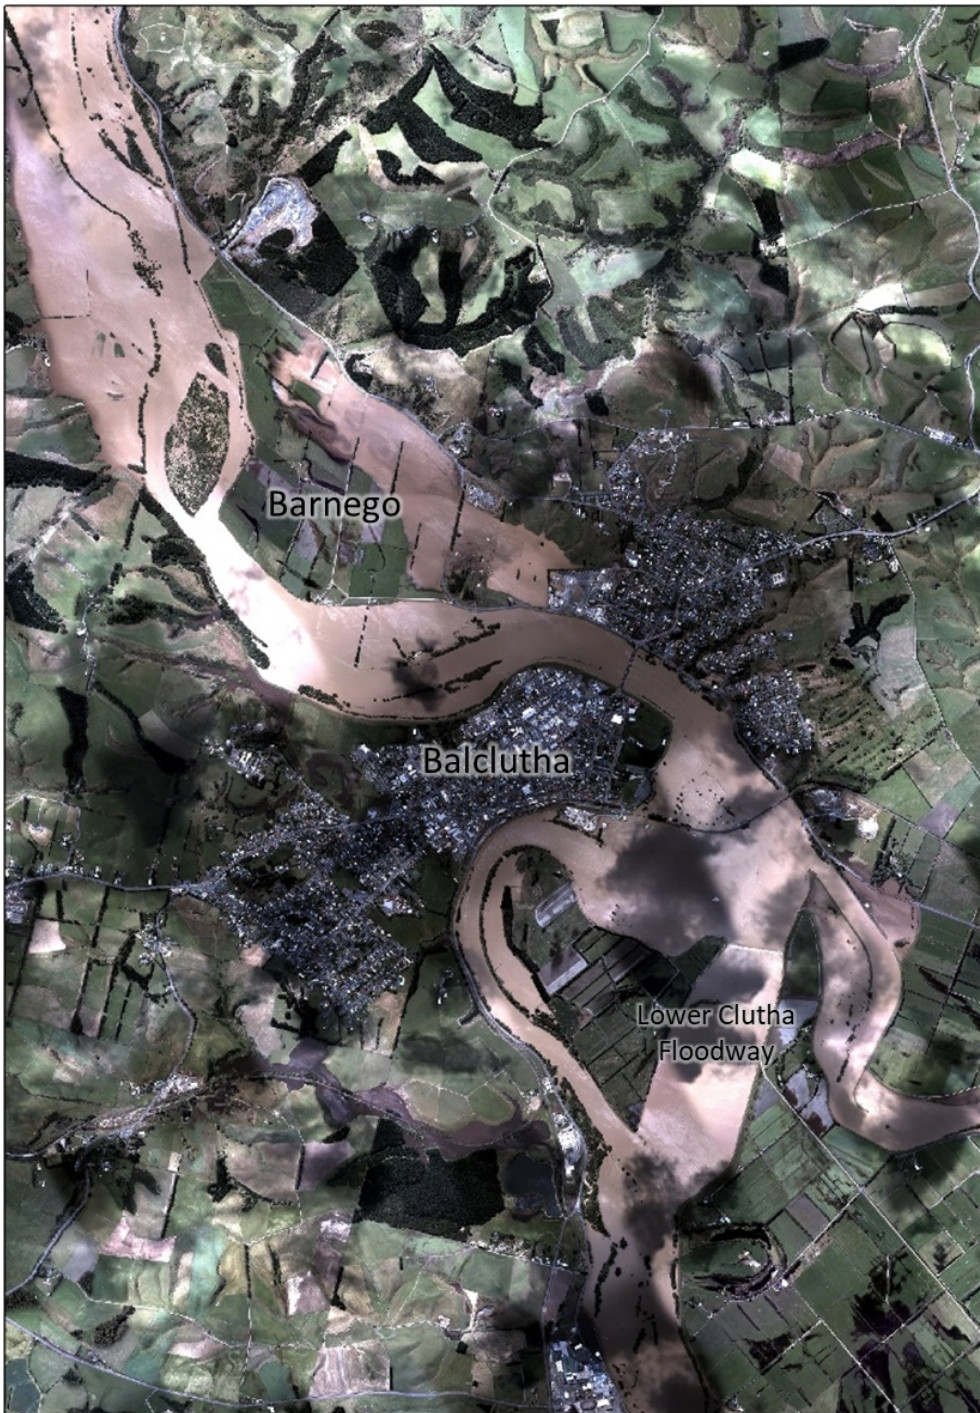
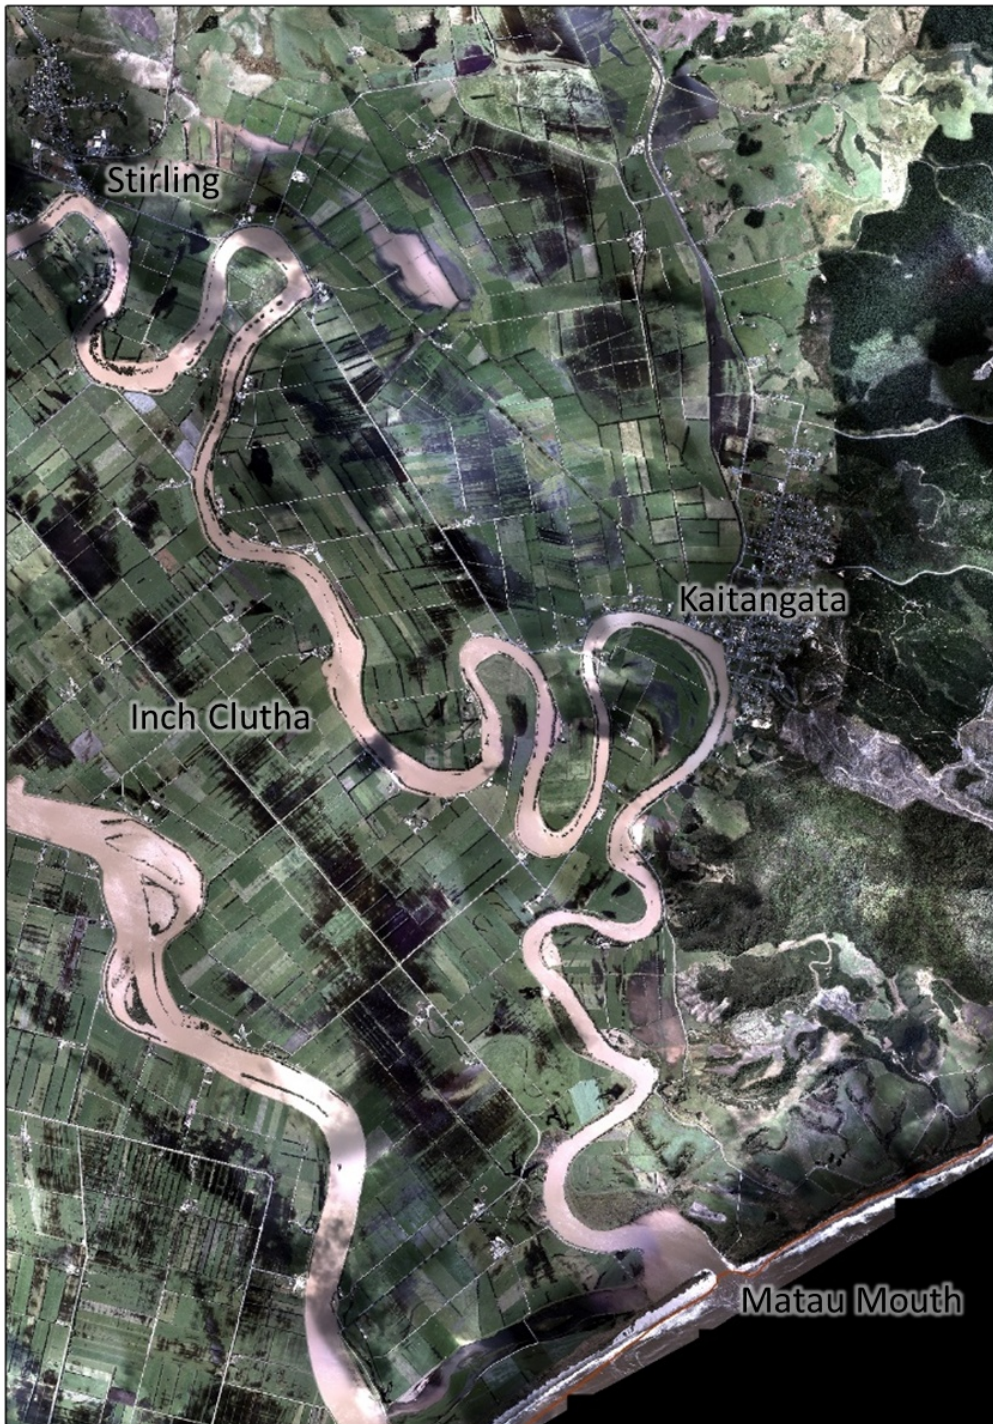
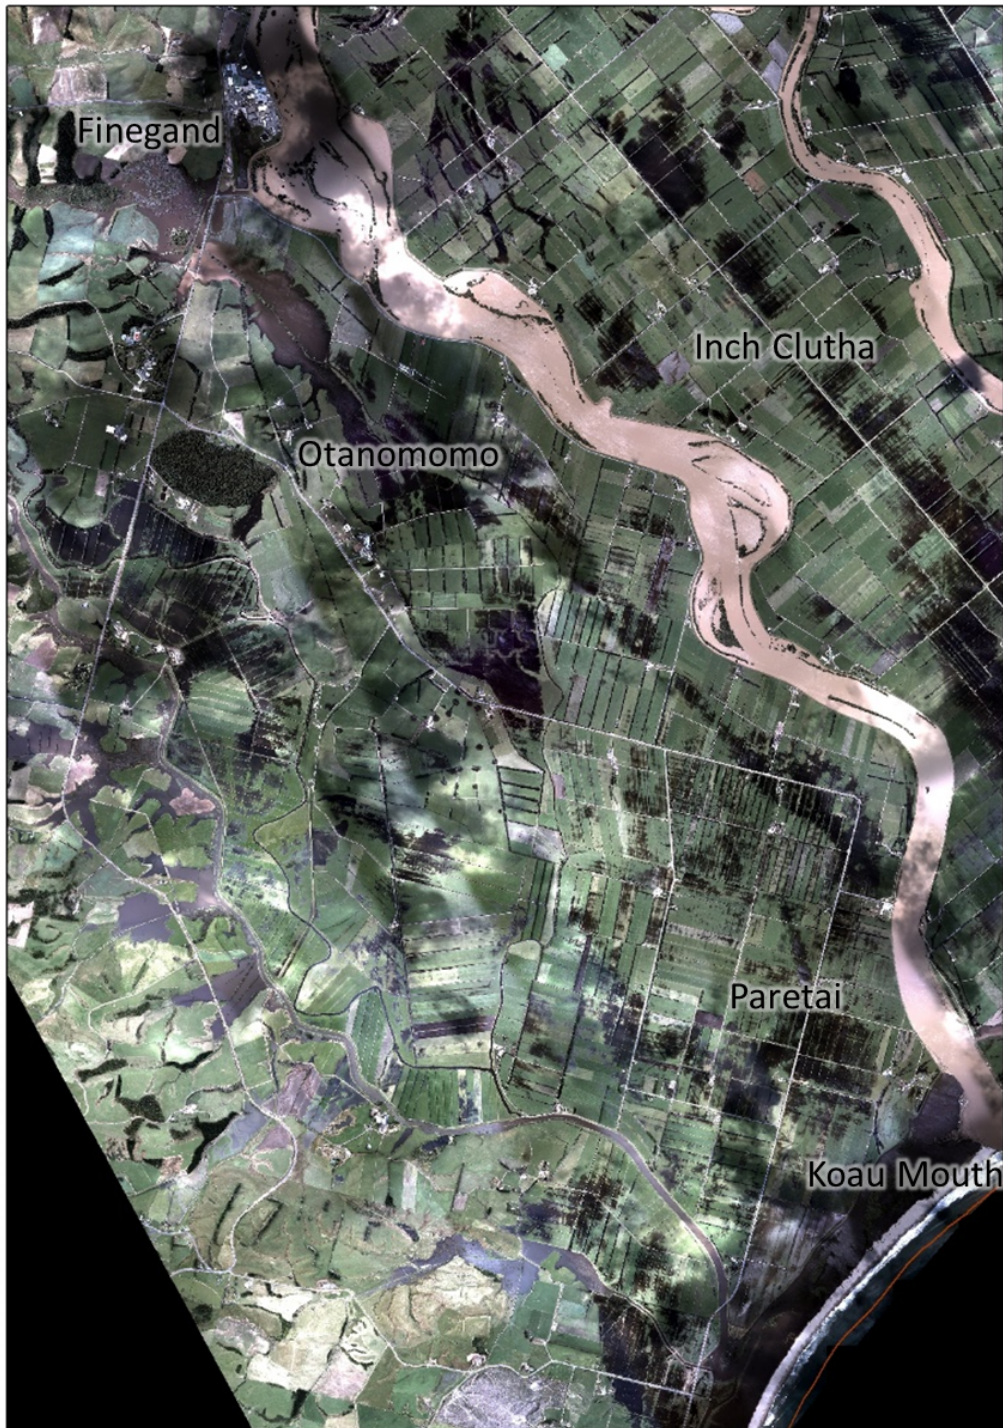
(a) Barnego and Balclutha

(b) Matau Branch, Inch Clutha, Stirling and Kaitangata

(c) Koau Branch, Otanomomo and Paretai

Figure 10. Aerial photos captured for ORC on Wednesday 5 February 2020 between 2.37pm and 5.39pm. Flows in the Clutha River were between 3,100m³/s and 2,980m³/s approximately (the river peaked at 3,179m³/s on Wednesday 5 February 2020 at 10am approximately). Darker water on land indicates surface runoff and ponding.

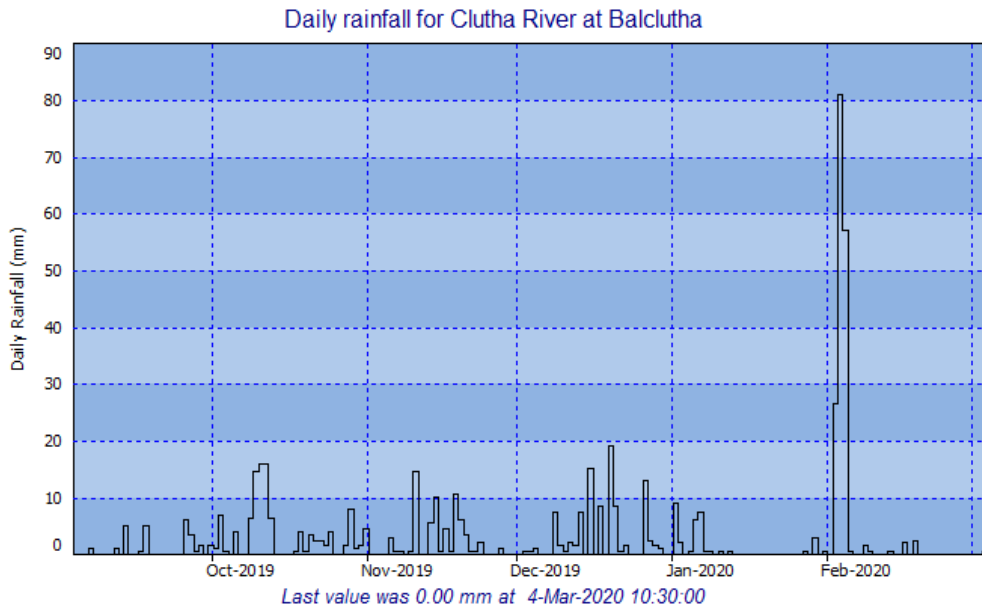
- [62] The scheme also provides a level of service to a rural standard through a drainage network which is shown in Figure 12 to convey surface water to the pump stations.
- [63] This event as mentioned earlier in this paper contributed to a prolonged period of rainfall which contributed to > 80 mm of rain in the areas of Paretai which in comparison to our rainfall site “Clutha at Balclutha”, the average annual rainfall is about 670 mm/year.

Figure 12. Daily rainfall for Clutha River at Balclutha

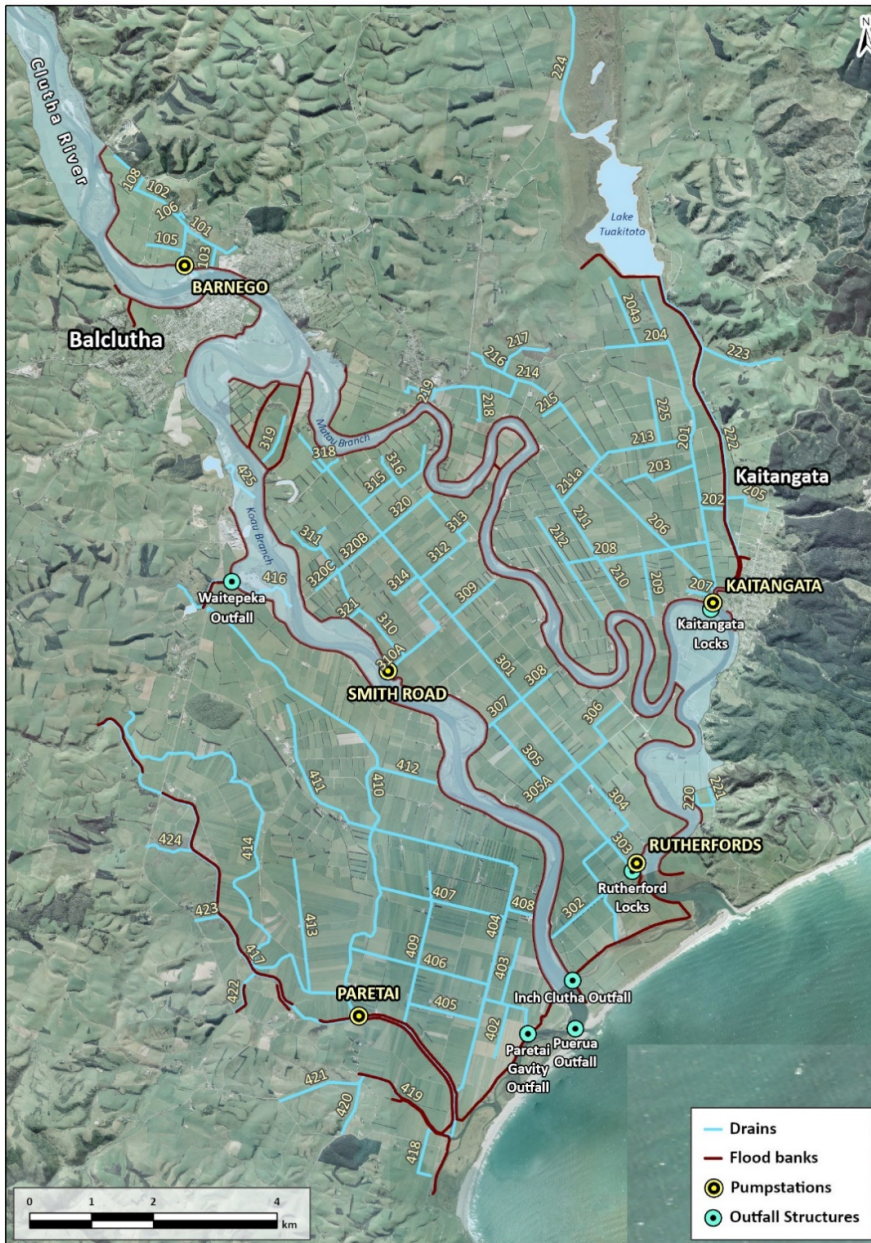
- [64] The Level of Service provided by the Drainage system and Pumping stations is as follows (Figure 12):
 - Drainage protection standards are measured in mm/day pumping capacity.
 - Inch Clutha is nominated at 9 mm/day (Rutherfords and Smith Rd Pump Stations)
 - Otanomomo and Paretai District 10 mm/day (Paretai Pump Station)
 - Barnego 11 mm/day (Barnego Pump Station)
 - Matau District 7.5mm/day (Kaitangata Pump Station)

Figure 13. Overview of Drainage network to Pump Stations

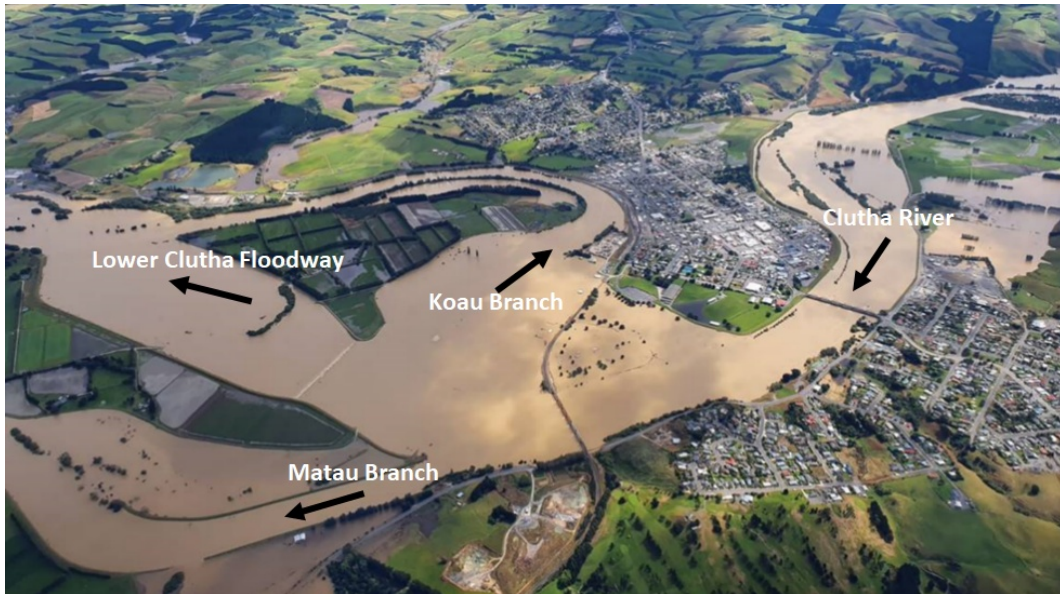
Figure 14. Impact on Lower Clutha Flood Protection and Drainage Scheme in vicinity of Balclutha (5 February 2020, flow in the Clutha River was 3,058m³/s approximately (the river peaked at 3,179m³/s on 5 February 2020 at 10am approximately) (Photo: Landpro)

[66] Impacts of these combined factors on the Lower Clutha Scheme were as follows:

1. The heavy localised rainfall inundated the drainage system which in turn flushed a huge amount of weed and debris through drains, blocking pump stations initially;
2. The Clutha River rose rapidly which also caused outflows from drainage into the Clutha to close;
3. The surrounding catchment rainfall and subsequent runoff caused in a short timeframe, less than 8 hours, volumes of ponding/stored water behind floodbanks (Waitepeka) and detention ponding (Hospital Creek Road) to reach near capacity, and;
4. Localised surface rainfall and ponding put pressure on rural communities to drain into drainage networks and pump stations.

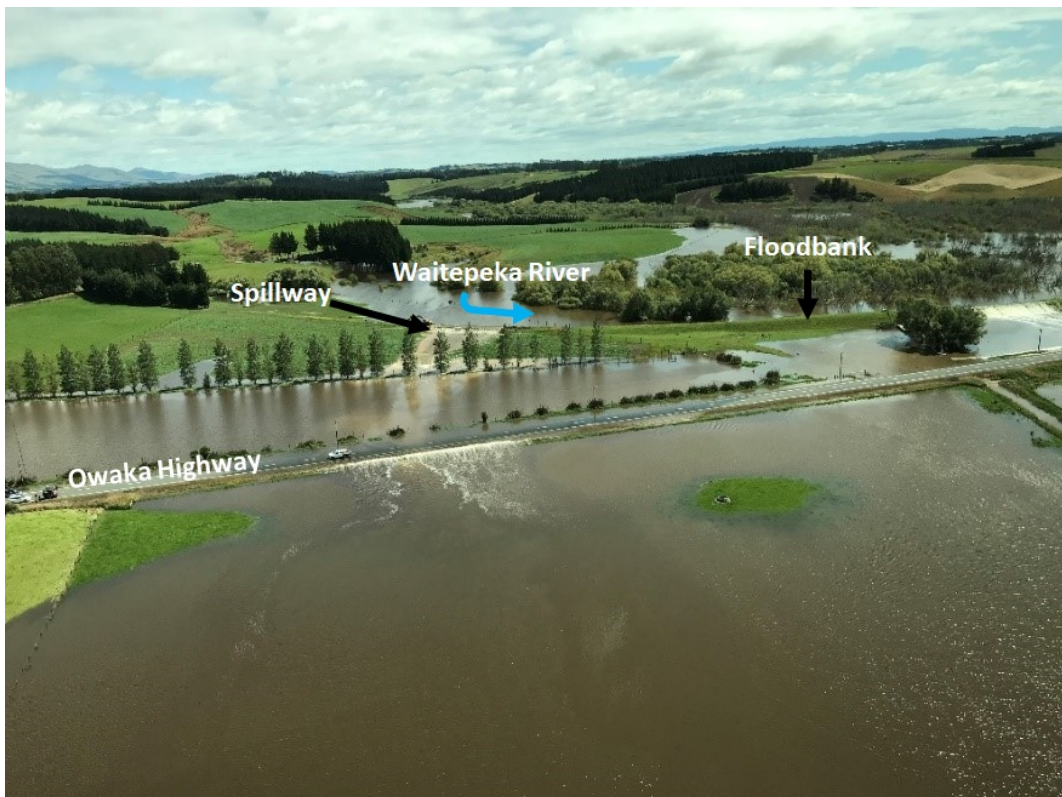
[69] The ORC did recognise in mitigating the safety and protection of Owaka State Highway and preservation of the Waitepeka Bank, that lowering the spillway had an increased water effect into the overland path downstream of the spillway. Pumps were authorised for an approved period to assist drainage by the Manager of Engineering which has been documented.

Figure 15. Waitepeka Floodbank showing the areas of piping 5th February 2020
