WRS Geotechnical Assessments

Ref: 8528

9 March 2020

Deepdell East Waste Rock Stack Design Report Section 92 Response

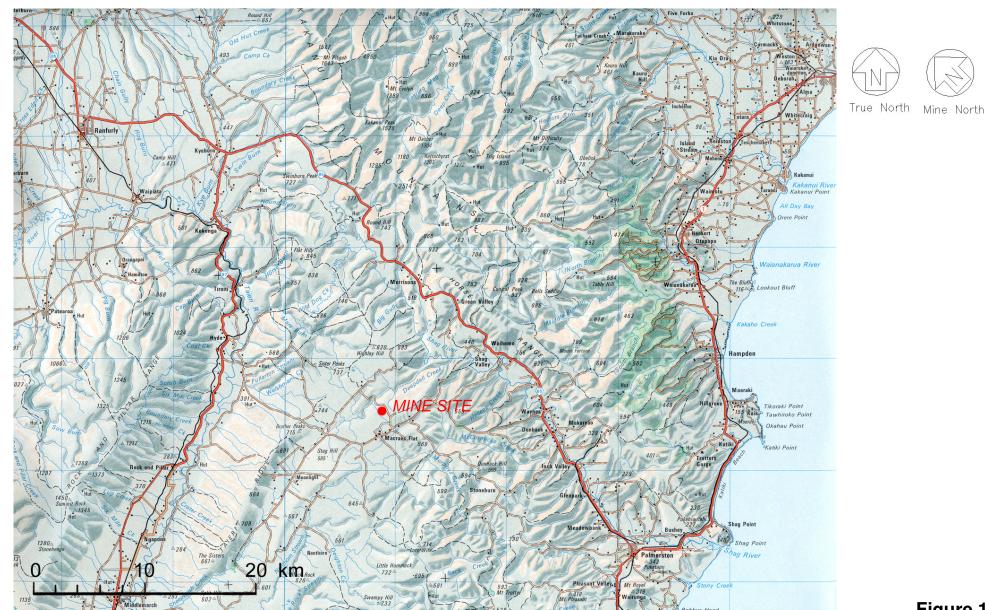
Engineering Geology Ltd 2 Esmonde Rd, PO Box 33-426, Takapuna Ph (09)486-2546 Fax (09)486-2556 OCEANA GOLD (NEW ZEALAND) LTD Macraes Gold Project Locality Plan Figure 1

Source: NZMS Sheet 15 Waitaki.

Oceana Gold (New Zealand) Ltd (OceanaGold) operates the gold mine, known as the Macraes Gold Project (MGP), at Macraes Flat in East Otago. The mine is located between Middlemarch and Palmerston as shown in Figure 1. Gold extraction from the current mining operation involves mining of open pits and underground (Frasers Underground). Associated with the MGP are waste rock stacks for disposal of pit overburden material and tailings storage facilities for disposal of tailings.

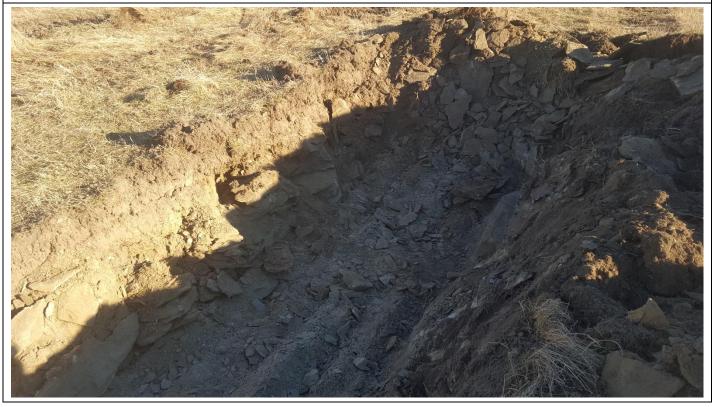
LTC)			Т		T F OG		TESTPIT No.: TP3 SHEET 1 OF 1 Job No.: Job No.: 8528
	DJECT: Deepdell East WRS CATION: Deepdell East WRS, Oceana Gold Macraes Mine, Macra	oo Elot	Otogo							
cod	DRDINATES: East 71003.1 North 17547.6	RL GR	OLAGO COUND: 4 MI: Mine							DATE: 27/06/2019 TESTPIT DEPTH: 2.0m
GEOLOGICAL UNIT	SOIL MATERIAL DESCRIPTION	DEPTH / RL	GRAPHIC LOG	DEPTH (m)	MOISTURE CONDITION	CONSISTENCY / DENSITY	SAMPLES	WATER CONTENT (%)	WATER LEVEL	CORRECTED VANE SHEAR STRENGTH (kPa) • Field Vane (BS 1377) · Remoulded Field Vane 50 100 150
s	Organic SILT, minor clay; grey brown. Very stiff, moist, low plasticity	473.2 0.2	<u>∞∞</u> <u>∞∞</u> ∞ TS : . <u>∞∞</u> TS			VSt				
	SILT, some clay, gravelly (f-c); orange brown, light grey. Hard, mist, low plasticity	473.0 0.4				VOL				
pewasu	clasts of schist up to 50mm, Bag sample 1, 0.45m	472.8		-						(SV: 0.5m, 200+ kPa
	Bag sample 2, 0.7m	1.3		- 1 -	M	н				(SV: 0.7m, 200+ kPa

Completely weathered, orange brown, SCHIST, extremely weak; weathered to a gravelly SILT, hard; Bag sample 3, 1.4m	471.9 1.5		-					019	(SV: 1.4m, 200+ kPa
Schist	Moderately weathered, grey, orange brown, SCHIST; very weak	471.7		-		vw			2.00m, 27/06/2019	
	sl. weathered, weak, Foliation 144°/23° NE Joints 260°/80° S, 131°/80° NE, tight, smooth, discontinuous, saturated, seepage at 2.0m	471.4 2.0	2.00 m		S	w			2.0

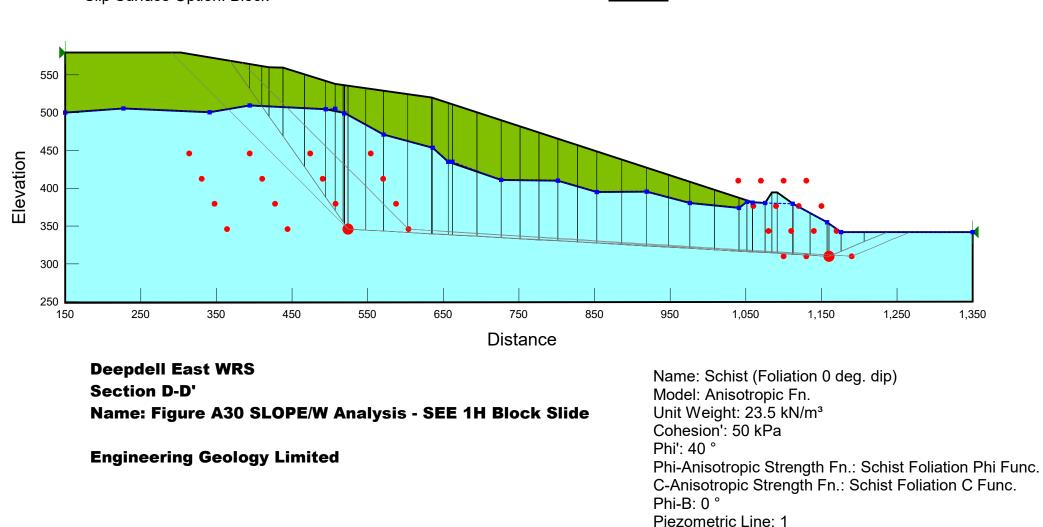
Method: Janbu Slip Surface Option: Block

<u>1.001</u>
