## **APPENDIX J**

Geotechnical Assessment Reports for  
Pit and WRS

**RE: GEOTECHNICAL REVIEW OF DEEPDELL PIT STAGE 3 DESIGN**

**GEOTECHNICAL REVIEW  
DEEPDELL STABILITY ASSESSMENT**

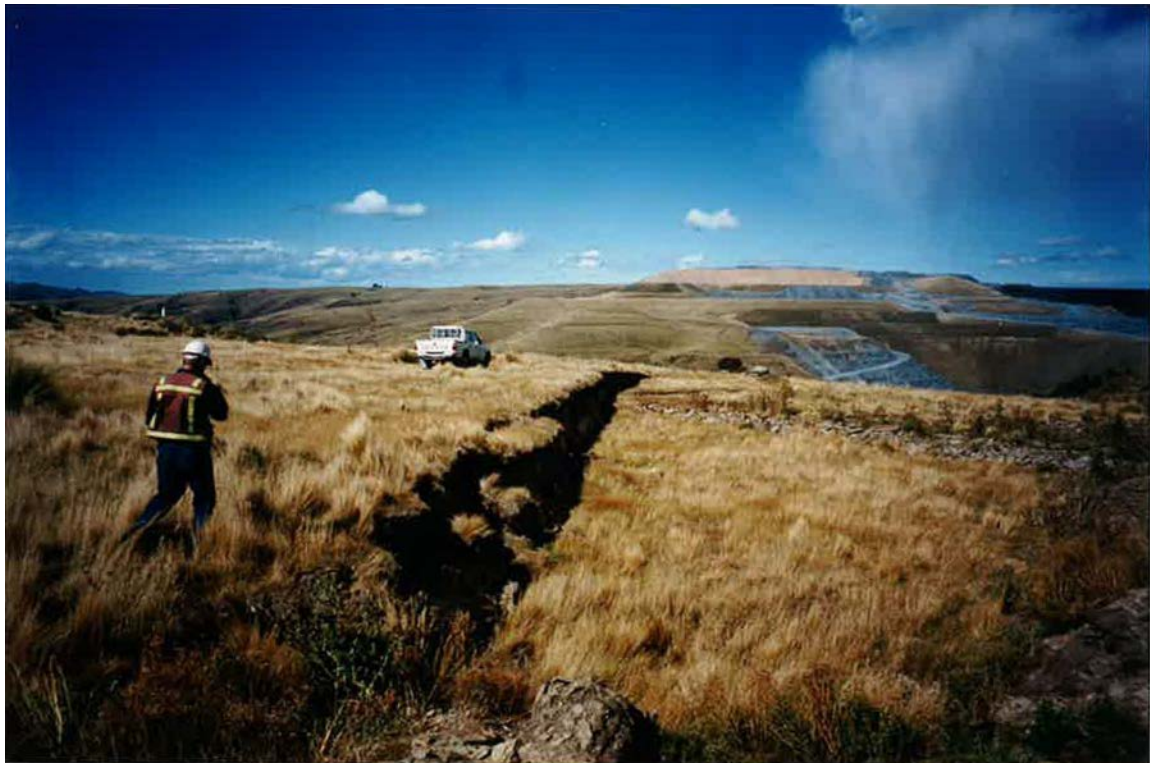
**Photograph 1: View of failure head scarp looking south**

Photographs 1 and 2 illustrate the site condition at the time of failure.

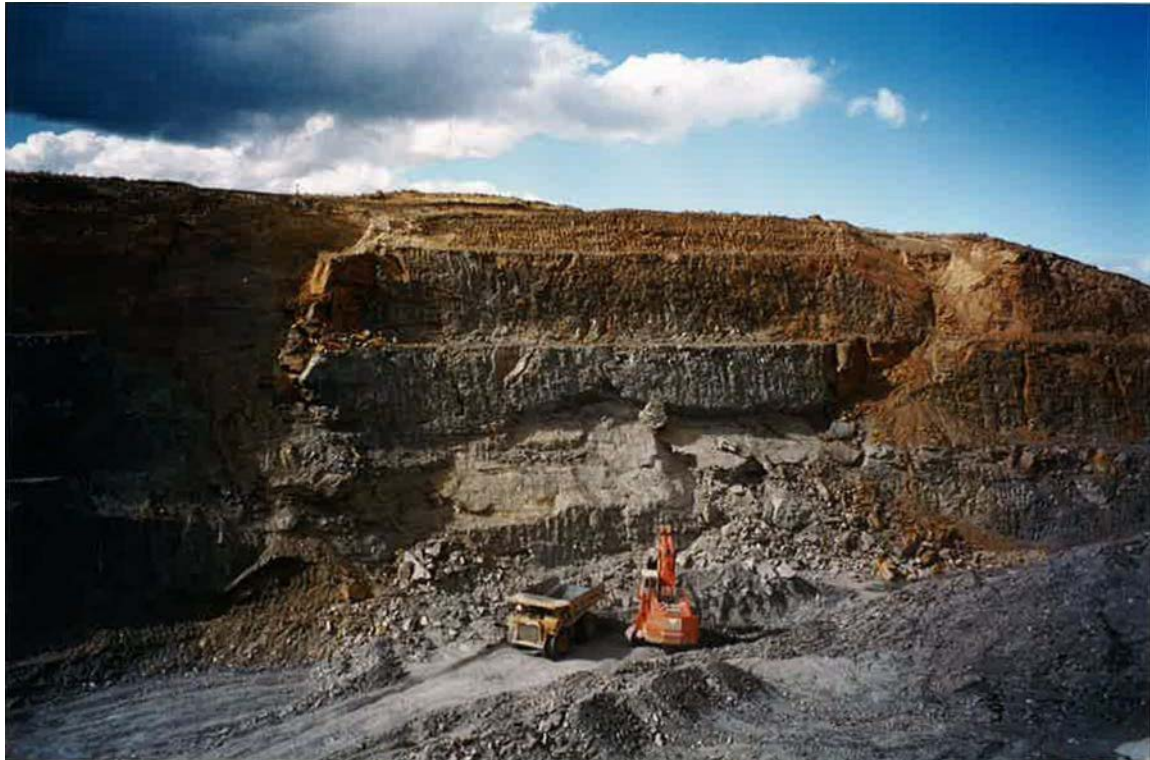
**Photograph 2: View of east wall multi bench failure at Deepdell**

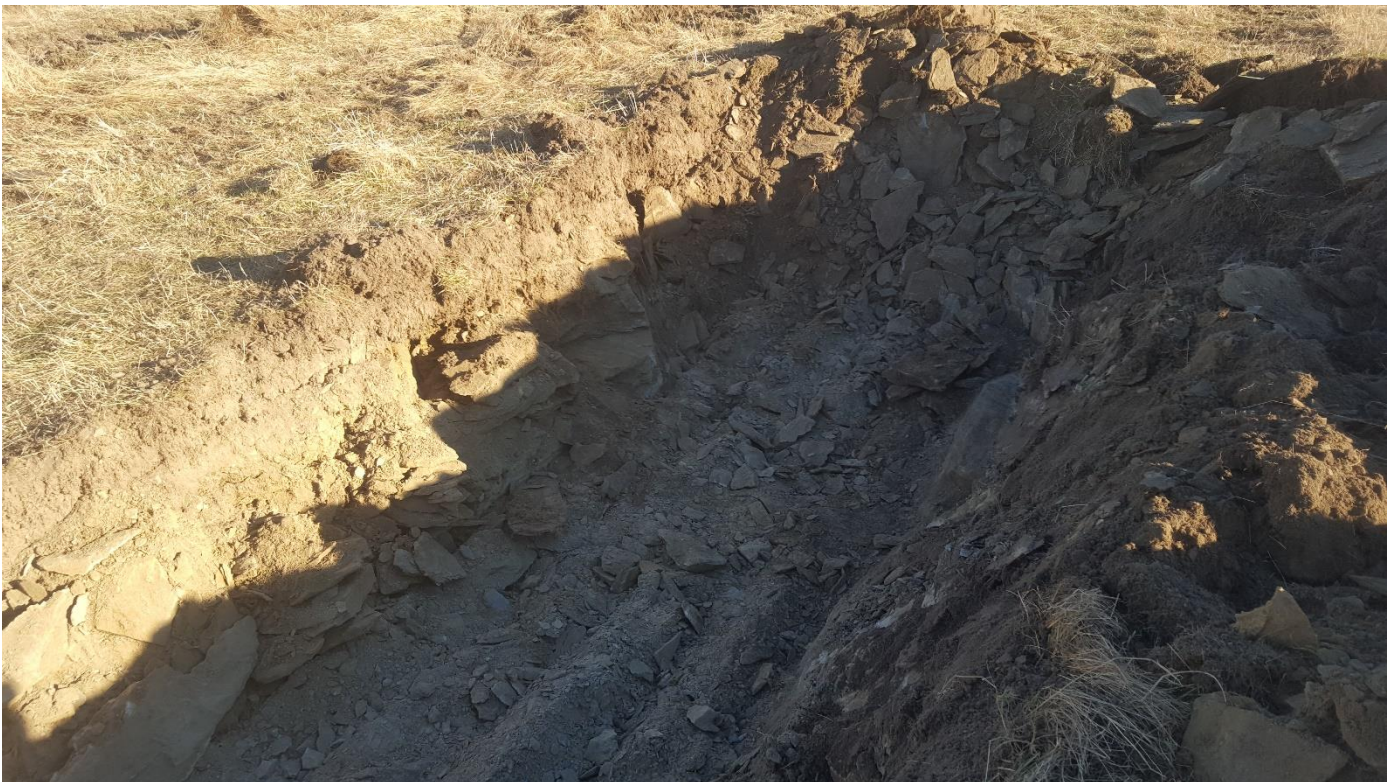
Test Pit 2

**PROJECT:** Deepdell East WRS  
**LOCATION:** Deepdell East WRS, Oceana Gold Macraes Mine, Macraes Flat, Otago  
**COORDINATES:** East 71003.1 North 17547.6      **RL GROUND:** 473.2m      **DATE:** 27/06/2019  
**GRID:** MMG      **DATUM:** Mine      **TESTPIT DEPTH:** 2.0m

GEOLOGICAL UNIT	SOIL MATERIAL DESCRIPTION	DEPTH / RL	GRAPHIC LOG	DEPTH (m)	MOISTURE CONDITION	CONSISTENCY / DENSITY	SAMPLES	WATER CONTENT (%)	WATER LEVEL	CORRECTED VANE SHEAR STRENGTH (kPa)			FIELD TESTS
										50	100	150	
TS	Organic SILT, minor clay; grey brown. Very stiff, moist, low plasticity	473.2

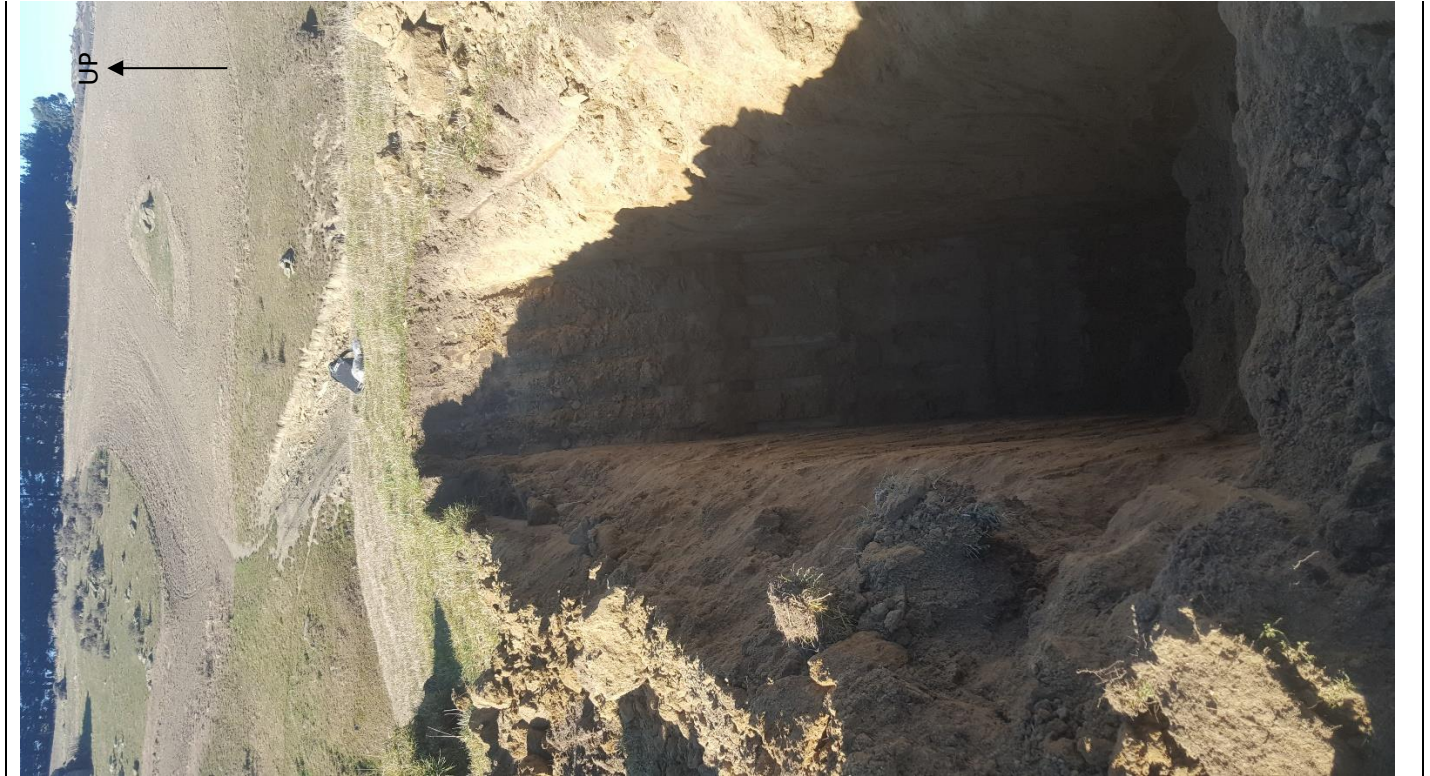
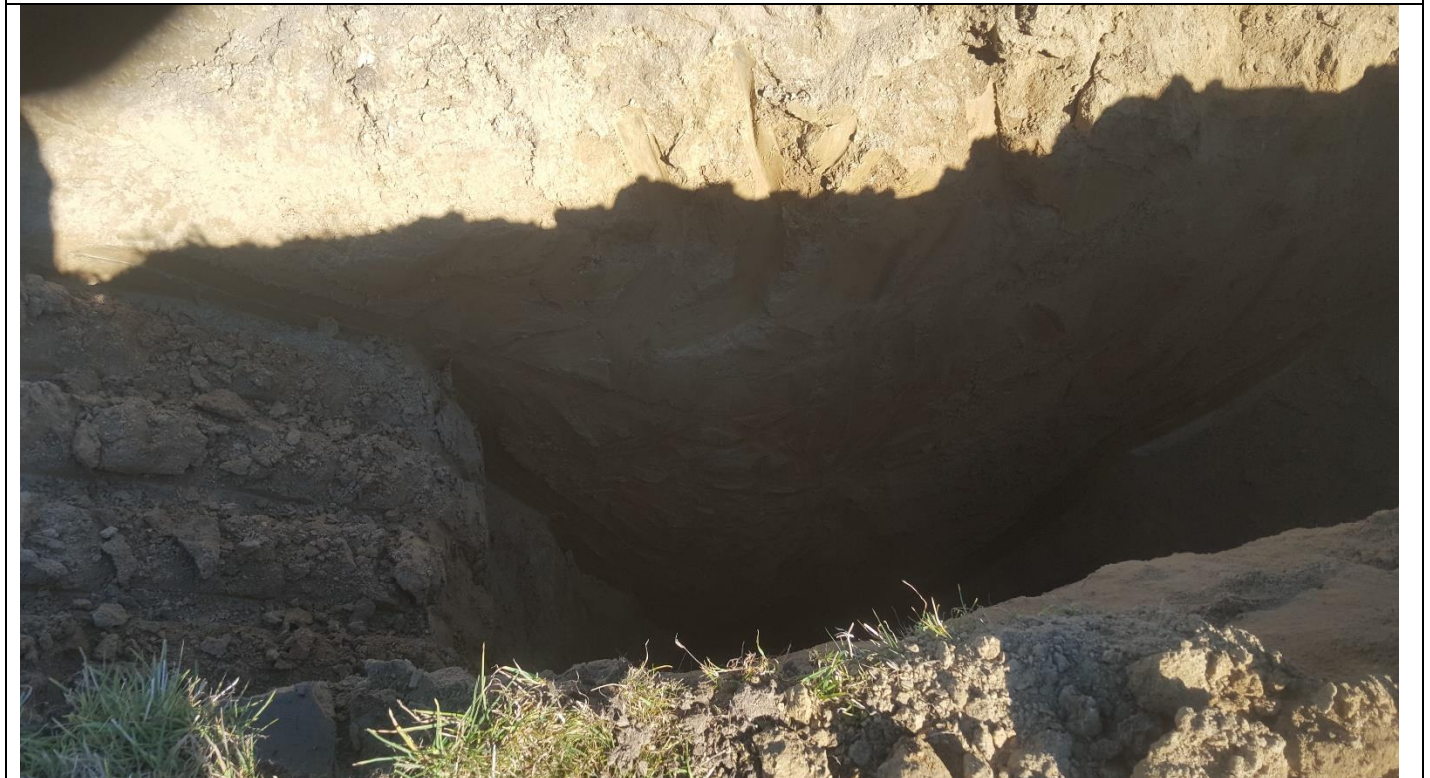
**Test Pit 4**

**PROJECT:** Deepdell East WRS  
**LOCATION:** Deepdell East WRS, Oceana Gold Macraes Mine, Macraes Flat, Otago  
**COORDINATES:** East 70989.3 North 17232.4      **RL GROUND:** 492.9m      **DATE:** 28/06/2019  
**GRID:** MMG      **DATUM:** Mine      **TESTPIT DEPTH:** 1.2m

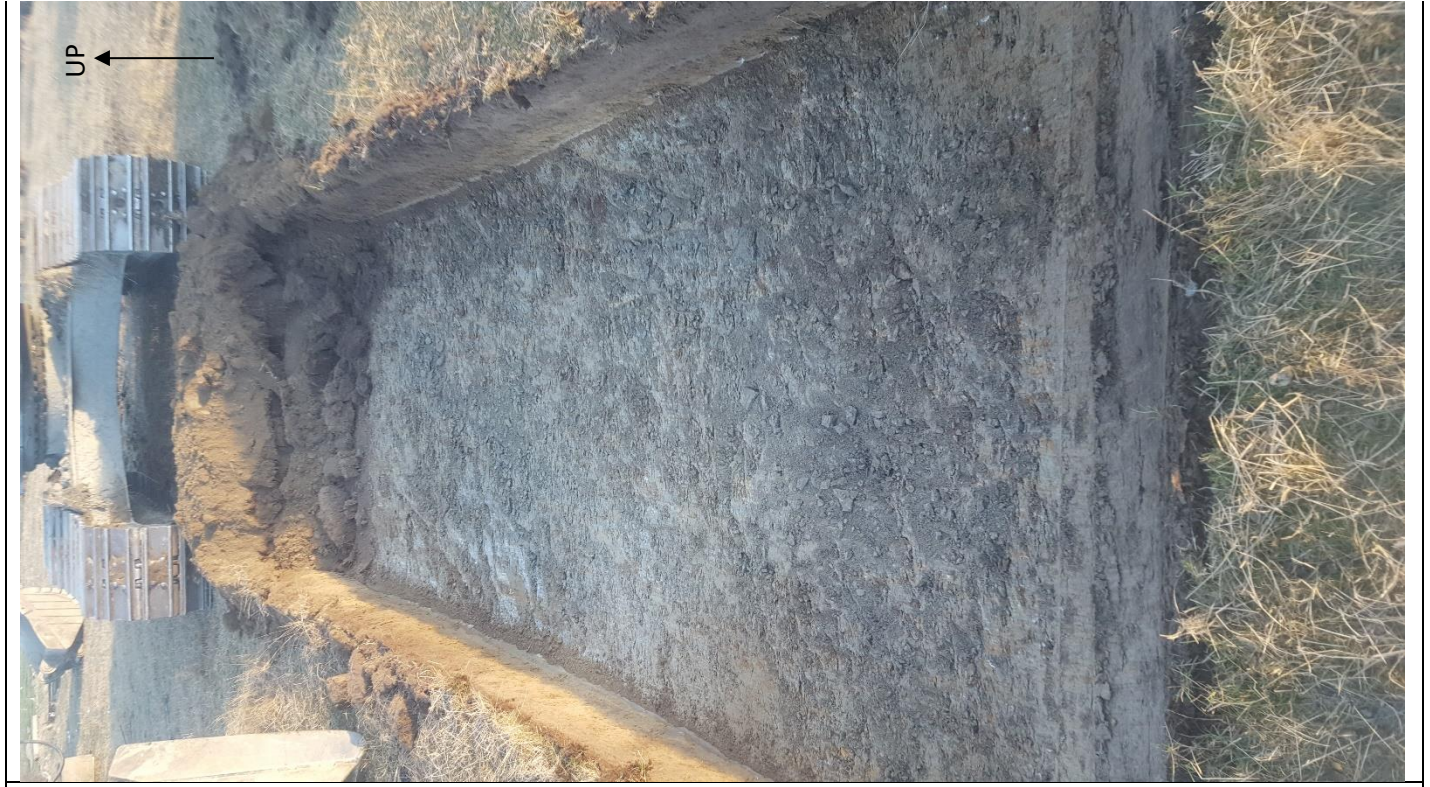
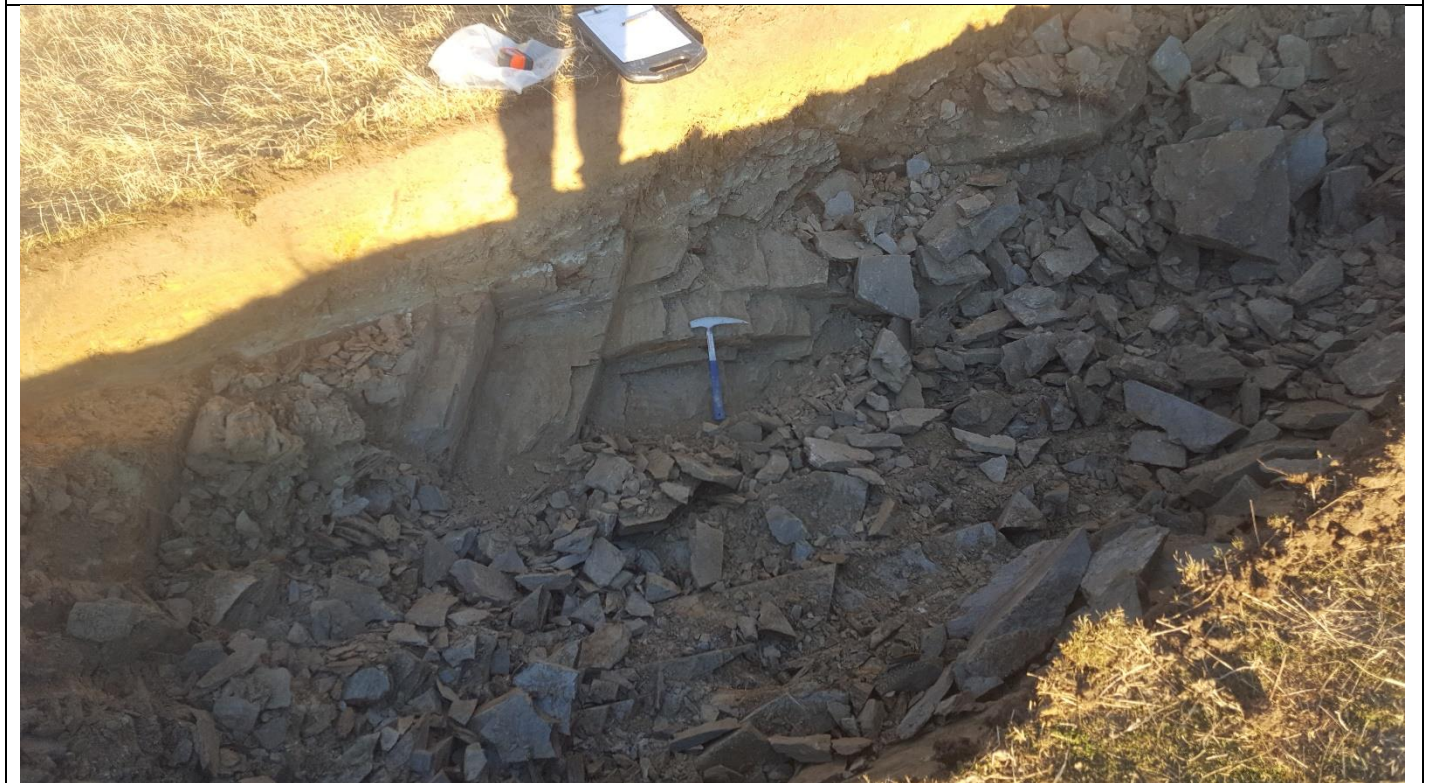
Test Pit 5

**PROJECT:** Deepdell East WRS  
**LOCATION:** Deepdell East WRS, Oceana Gold Macraes Mine, Macraes Flat, Otago  
**COORDINATES:** East 70876.9 North 17042.2      **RL GROUND:** 506.4m      **DATE:** 28/06/2019  
**GRID:** MMG      **DATUM:** Mine      **TESTPIT DEPTH:** 2.0m

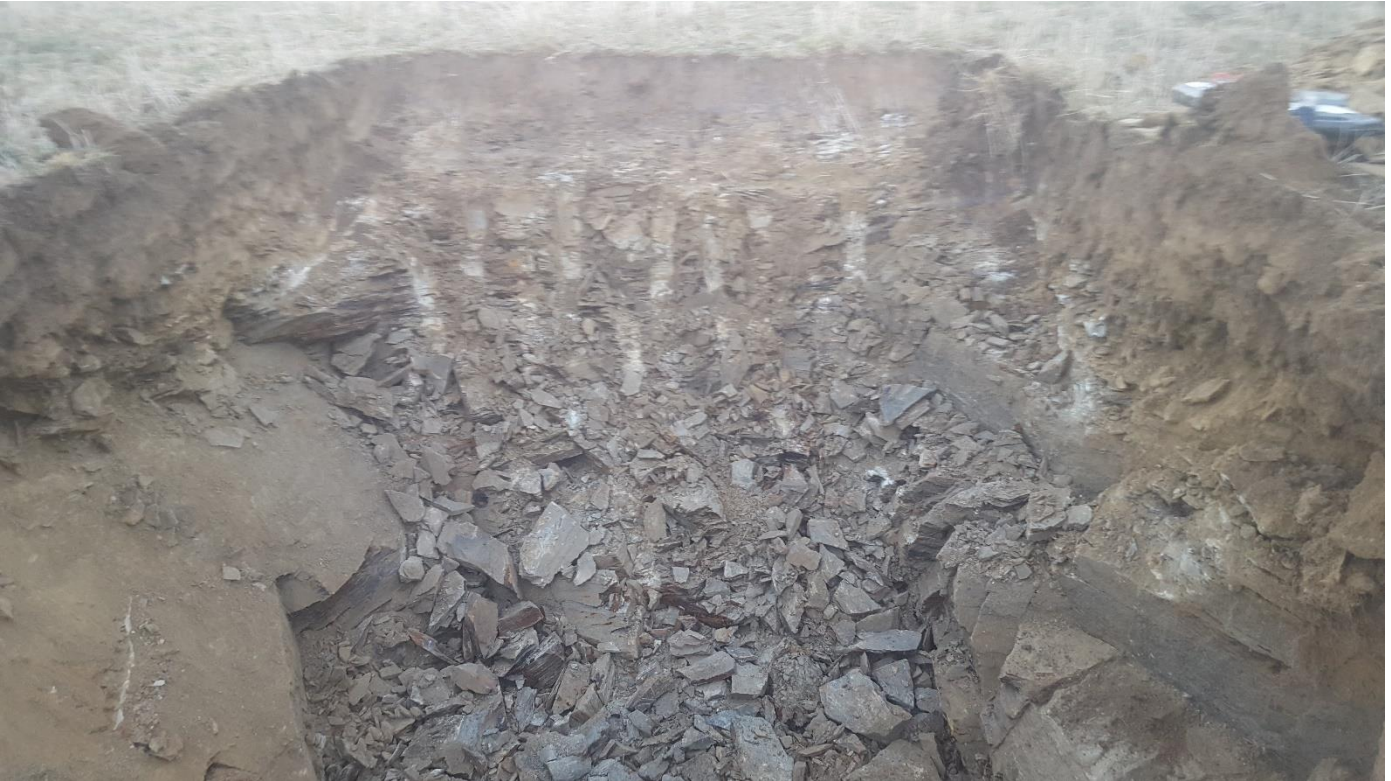
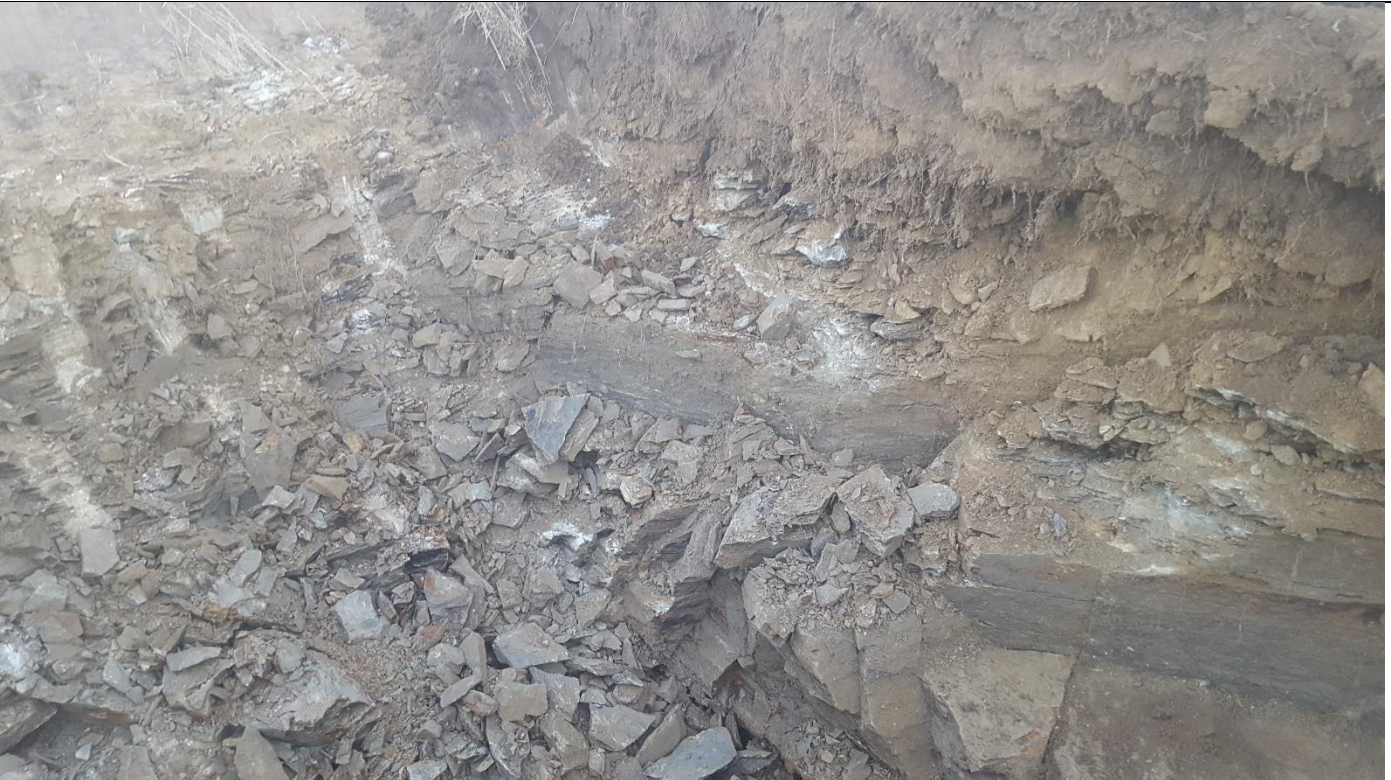
Test Pit 9

**PROJECT:** Deepdell East WRS  
**LOCATION:** Deepdell East WRS, Oceana Gold Macraes Mine, Macraes Flat, Otago  
**COORDINATES:** East 70262.6 North 17206.6      **RL GROUND:** 499.8m      **DATE:** 27/06/2019  
**GRID:** MMG      **DATUM:** Mine      **TESTPIT DEPTH:** 1.1m

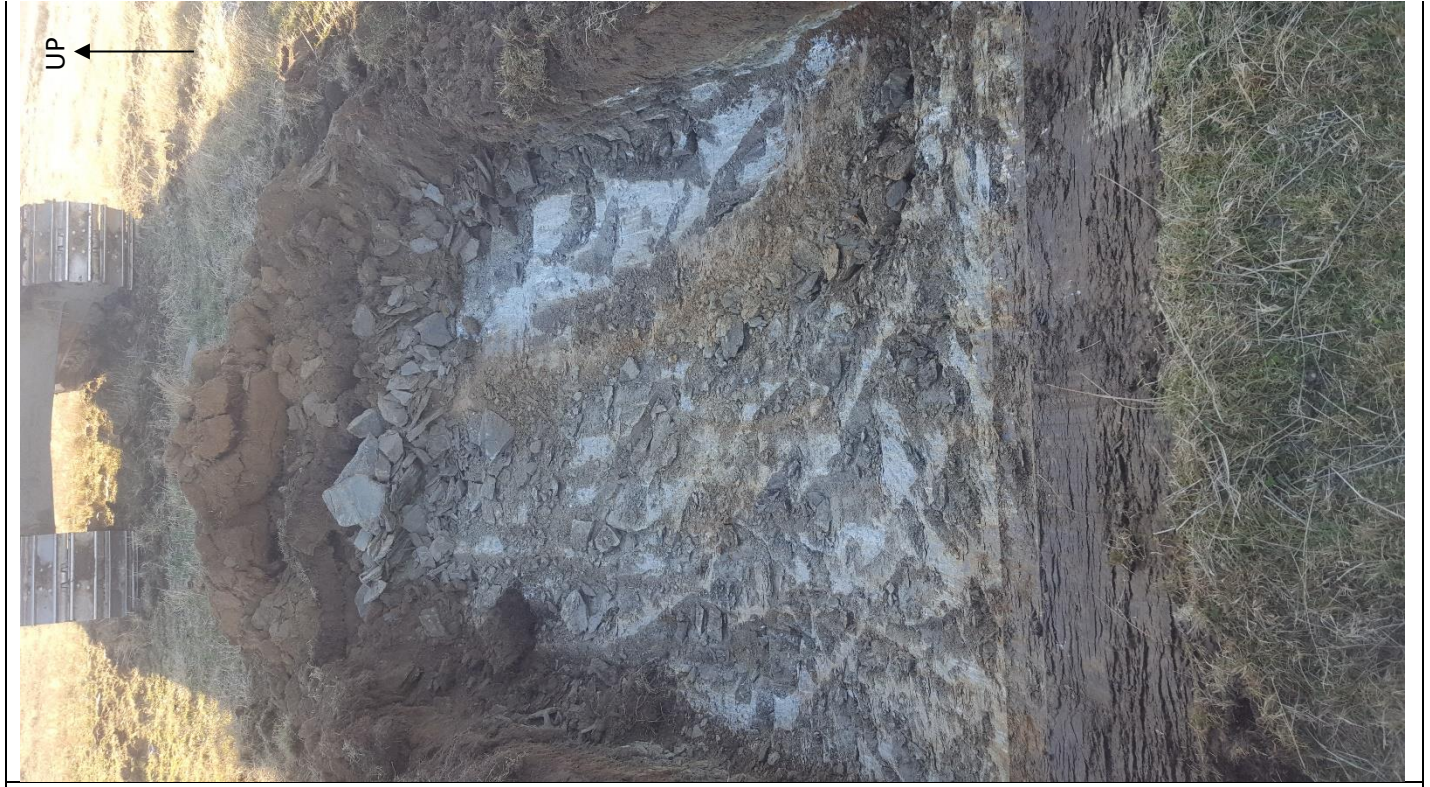
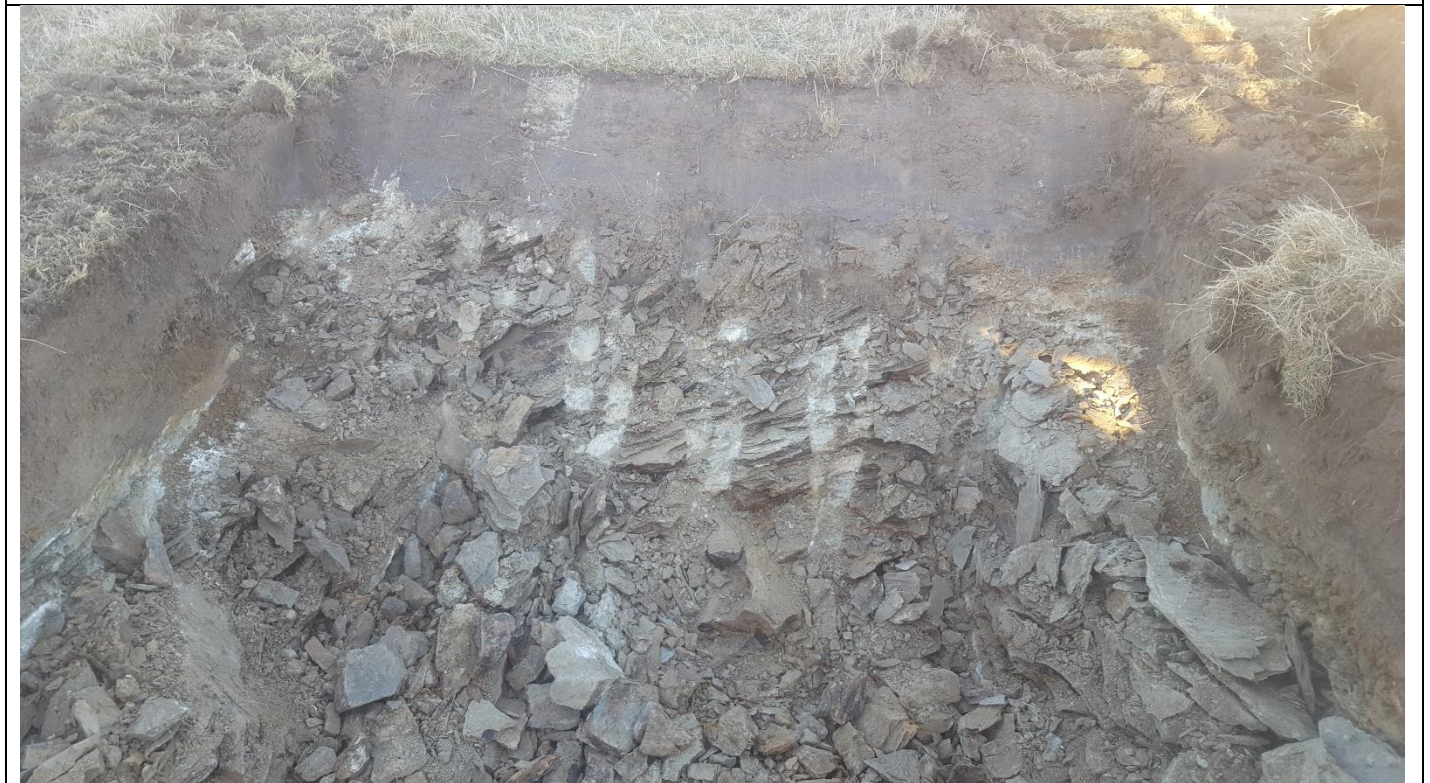
Test Pit 11

**PROJECT:** Deepdell East WRS  
**LOCATION:** Deepdell East WRS, Oceana Gold Macraes Mine, Macraes Flat, Otago  
**COORDINATES:** East 70435.4 North 17565.2      **RL GROUND:** 495.0m      **DATE:** 27/06/2019  
**GRID:** MMG      **DATUM:** Mine      **TESTPIT DEPTH:** 1.1m
