Falls Dam

Manuherikia River

Rock Fill Concrete faced dam	
Completed	1935
Height Above Stream bed	110ft
Length of Crest	510ft

This account is compiled from the Construction Report by J. T. Gilkison to the Society of Civil Engineers 1936-7, and the Public Works Department Files held by NZ Archives in Dunedin

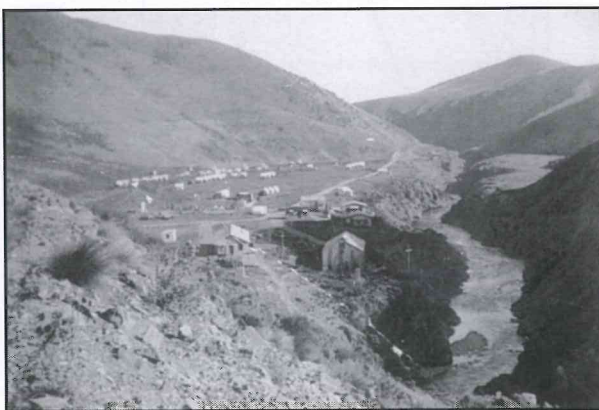
The camp and construction buildings in the 1930s. In the foreground is the diesel generator on the right, and cookhouse on the left. Behind these buildings are two houses and the workers tents are at the rear left.

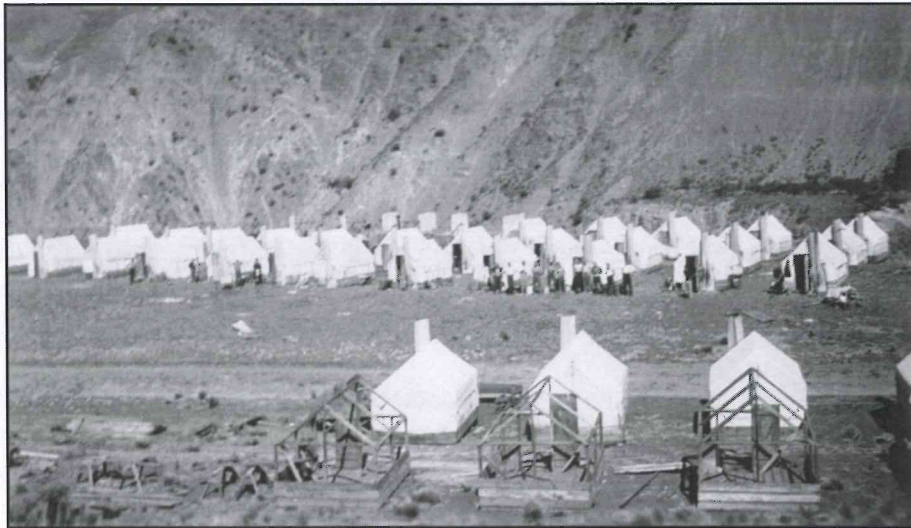
Hocken Collections Uare Taoka o Hakena University of Otago SO8-227e

The accommodation for workers at Falls Dam. The standard of huts had improved from the Upper Manorburn days. Though still with canvas roofs and sides, the huts now have wooden floors. Huts are shown being assembled in the foreground. The camp had some married accommodation which joined two huts with a porch in the centre.

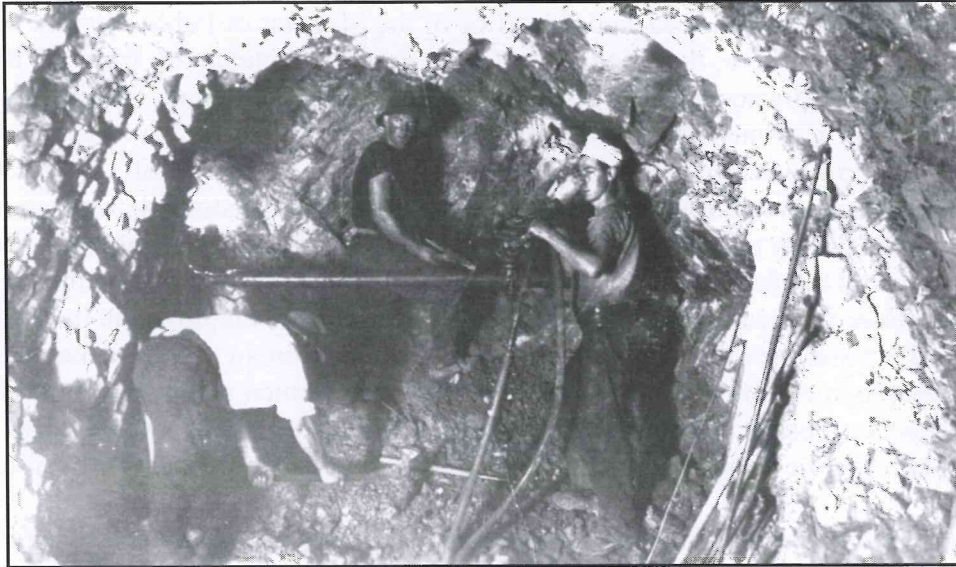
Hocken Collections Uare Taoka o Hakena University of Otago SO8-227d

Working in the diversion tunnel. Conditions were very difficult with hard and broken rock delaying progress. The rate of progress was so slow that the tunnellers went on strike. The dress was very casual in those days and drilling without ear protection must have been very harmful in the confined space.

There is no progress report on the dam in the Engineering Report but it seems likely, with the delay in tunnelling, and the subsequent concrete lining and grouting, it would have taken until 1933 to complete the tunnel and divert the river. It is stated that the concreting of the tunnel closely followed the excavation due to the blocky and fractured nature of the hillside.

The tunnel excavation was timbered and the spoil was trucked out by horses in two cubic yard trucks on the downstream end and winched out up the 1 in 4 grade access ramp at the inlet end. The horseshoe section tunnel had a grade of 1 in 100 with an area of 227sq ft and a 16ft 6 inch diameter. This provided for a 5000 cusec flood flow during the construction period. To enable this flow to be handled with little heading up, the invert of the inlet portal was set about 4 ft below the river bed which required a 35ft cut and a 1 in 4 slope to the river bed. The outlet was set 13ft above water level and as the hillside was dangerously overhanging, a concrete portal was required before tunnelling commenced.

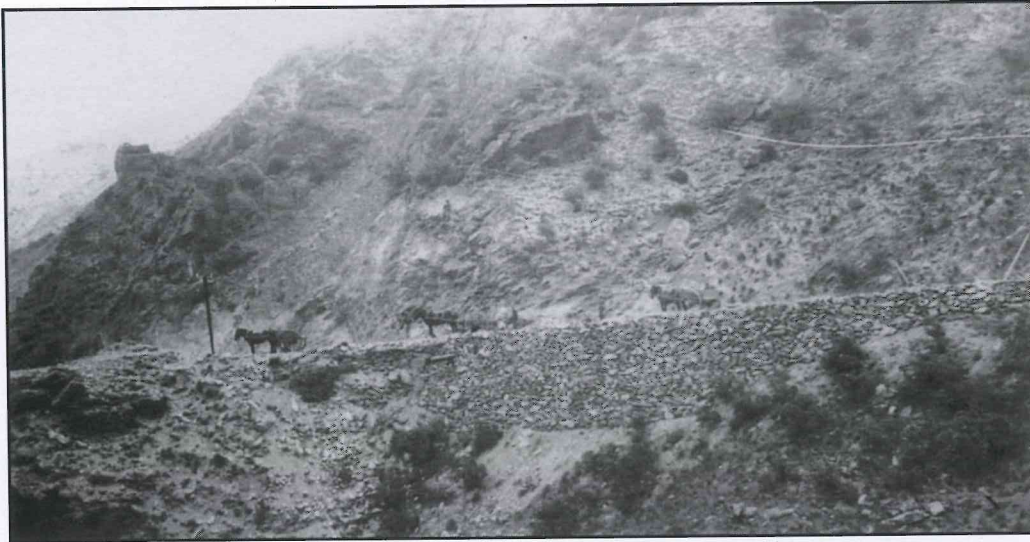
Horse and carts transporting rock from the right abutment quarry to the dam. A roadway has been made with rock quarried from the hillside.

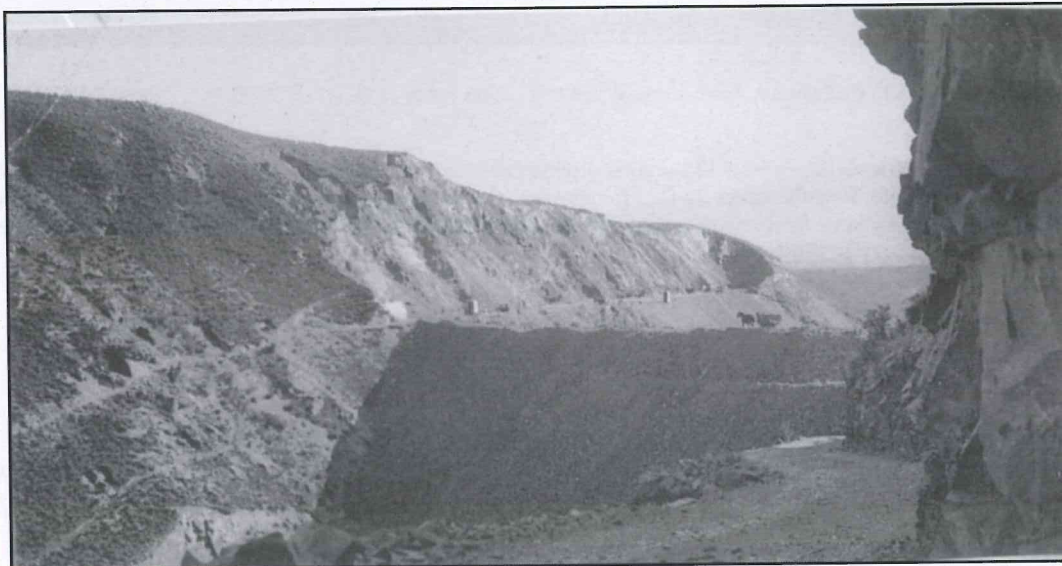
View of quarry on the right hand abutment. Horse drawn trucks are shown transporting rock onto the dam. There was road access on the left side of the dam with foot tracks on the right.

Horses hauled the 2 cubic yard trucks carrying rock to be tipped on the dam, and any material under 2½ inch was rejected. Selected stone from the tunnel and the river channel was used for the lowest section of the dam. At no time were two tips allowed to run more closely together than 20ft. This distance was maintained by hand-packing the stones in level courses between the tips and thus preventing any arching in between with consequent loss of density and stability. This must have been a very labour intensive process.

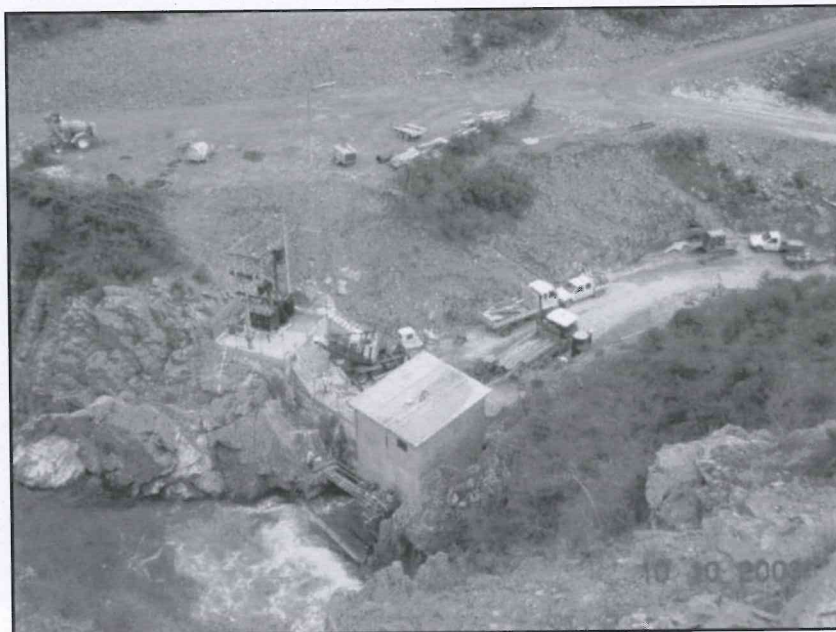
The new power house under construction in 2003.

The Kaplan water turbine operates at a nominal head of 105ft or 32 metres, and water is obtained through a 1200mm siphon and a 900mm pipe connection to the lower discharge pipe. These combine to feed a 1400mm penstock to the turbine.

The station discharges water adjacent to the diversion tunnel outlet. The peak output of the machine is 1320 KVA, producing 9 million kWhr per annum.

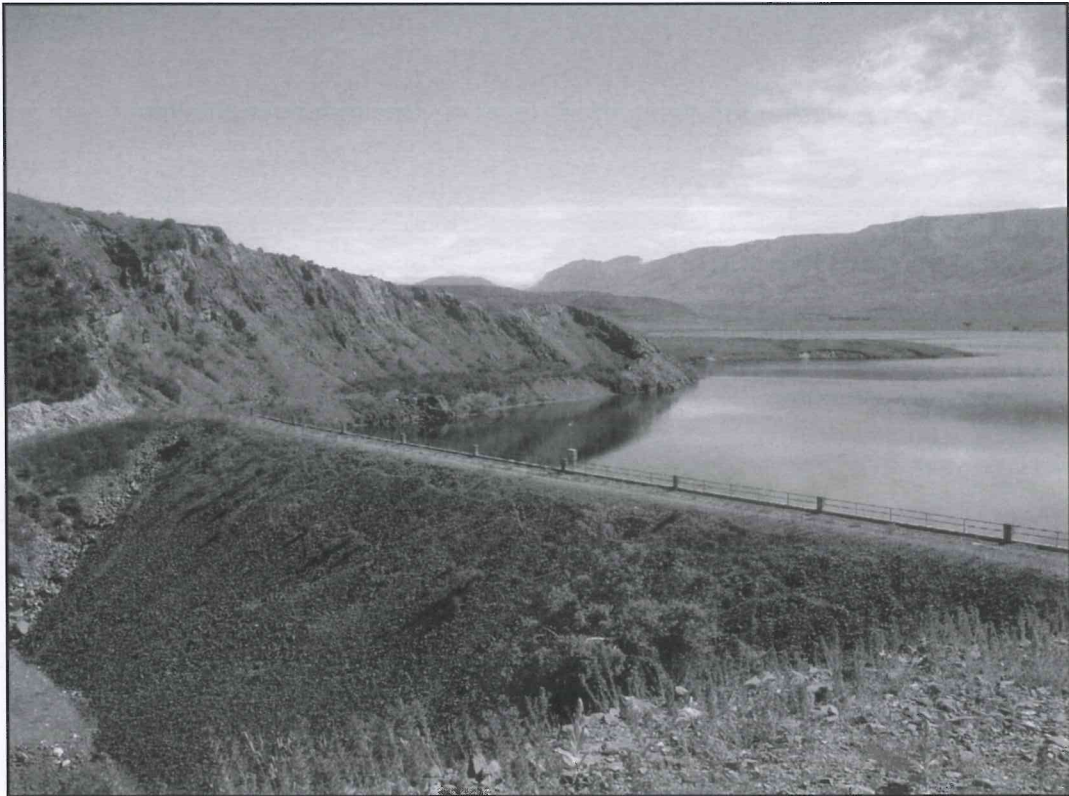
A recent view of the downstream face of the dam with the old quarry along the right abutment. Beyond the lake, at the rear, is the Hawkdun Range.

J. T. Gilkison reported that the rock for the dam was mainly obtained from the east and west quarries located upstream of the dam. The east quarry was finished at the level which allowed the spillway to be constructed. The west quarry was taken down to the crest level of the dam. These quarries are shown on the construction photographs. The drilling of rock in all the quarries was difficult because of the fissured nature of the rock. Drill holes for blasting were limited to 12ft deep, and no mechanical aids were used to load the stone onto the trucks. Very little popping was needed to reduce it to a size for hand loading.
