**Re: Royal Burn – Gauging results for work completed 22 February 2021**

NIWA Alexandra were engaged to complete flow gauging measurements within the Royal Burn catchment to enable determination of flow losses or gains in this reach, as requested by the client.

NIWA Project:                      WRM21901

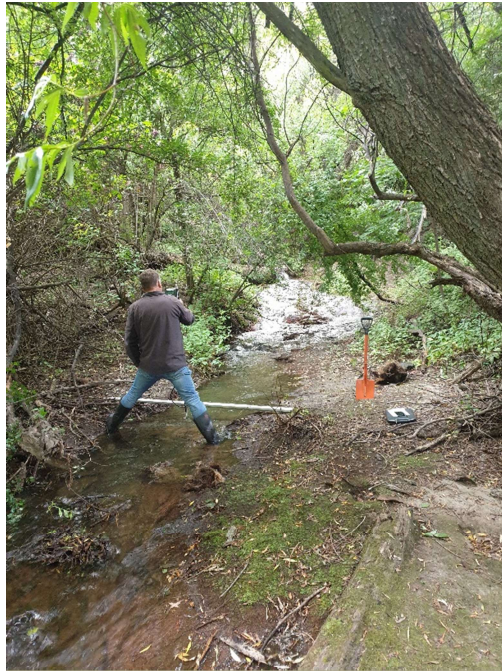
Figure 1: Site 100 view upstream

| Date | Time (NZST) | Site Number | Site Name | Waypoint | Location NZTM | Stage (mm) | Flow (L/s) |
|---|---|---|---|---|---|---|---|
| 22/02/2021 | 7:53 | 100 | Royal Burn at SH 6 | 504 | E1295458<br>N5007801 | N/A | 25.5 |

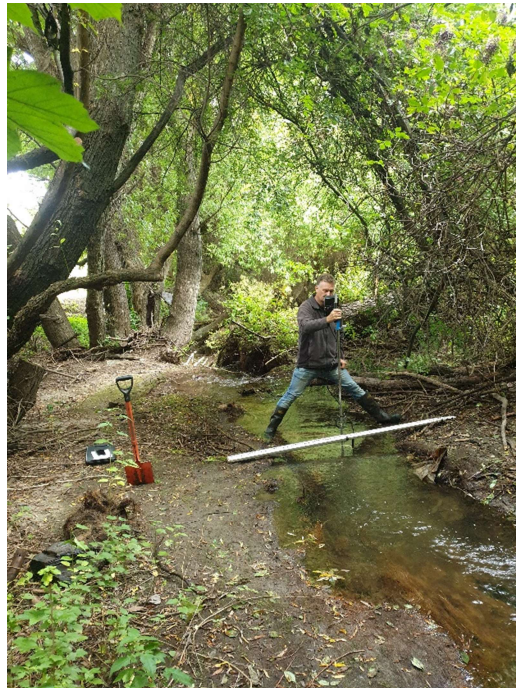
Figure 2: Site 100 view downstream

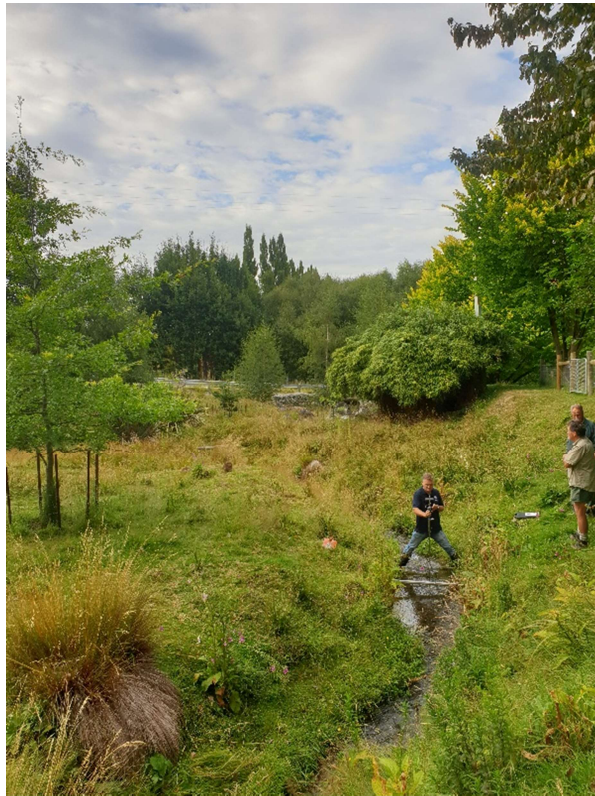
Figure 4: View downstream

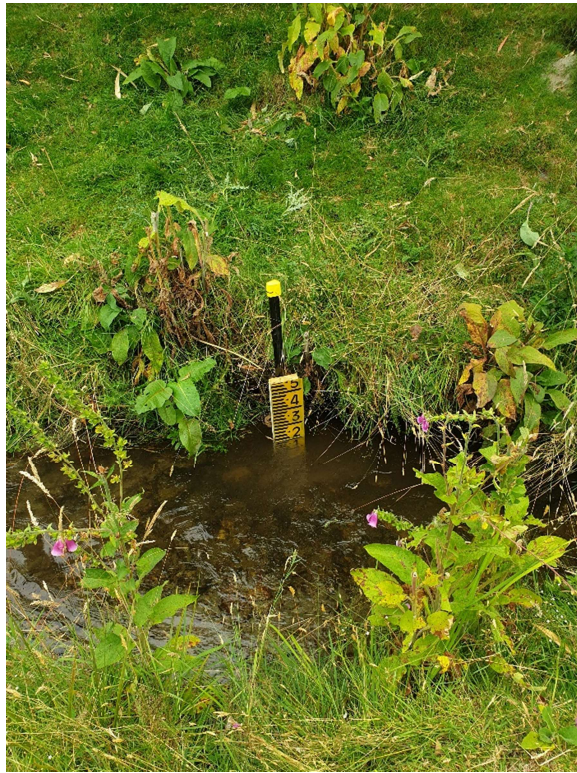
Figure 4: Site 200 External Staff Gauge

| Date | Time (NZST) | Site Number | Site Name | Waypoint | Location NZTM | Stage (mm) | Flow (L/s) |
|---|---|---|---|---|---|---|---|
| 22/02/2021 | 8:37 | 200 | Royal Burn at Crown Rd Bridge | 505 | E1274718<br>N5011356 | 200 | 44.3 |

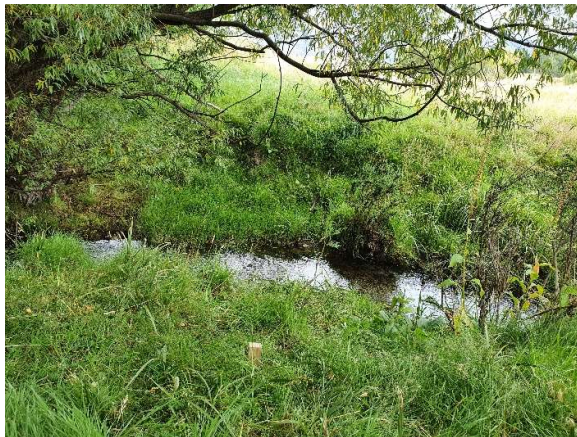
Figure 5: Site 300 view from true right bank

| Date | Time (NZST) | Site Number | Site Name | Waypoint | Location NZTM | Stage (mm) | Flow (L/s) |
|---|---|---|---|---|---|---|---|
| 22/02/2021 | 9:20 | 300 | Royal Burn at Swamp | 506 | E1275292<br>N5011779 | N/A | 12.4 |

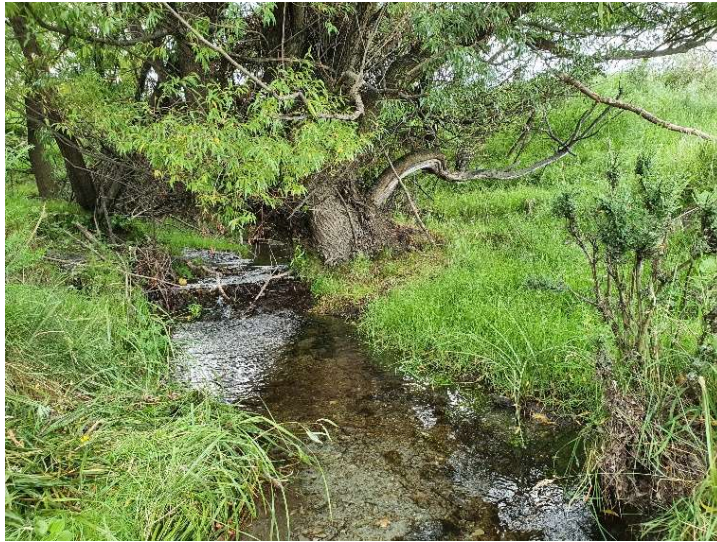
Figure 6: Site 300 view upstream

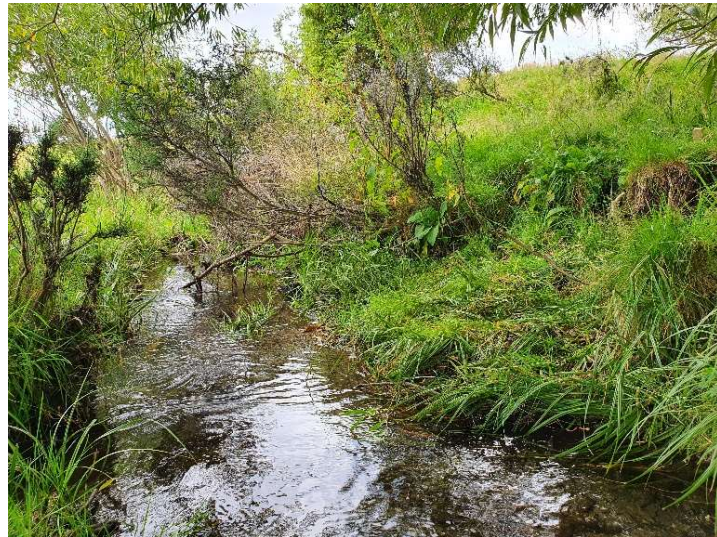
Figure 7: Site 300 view downstream

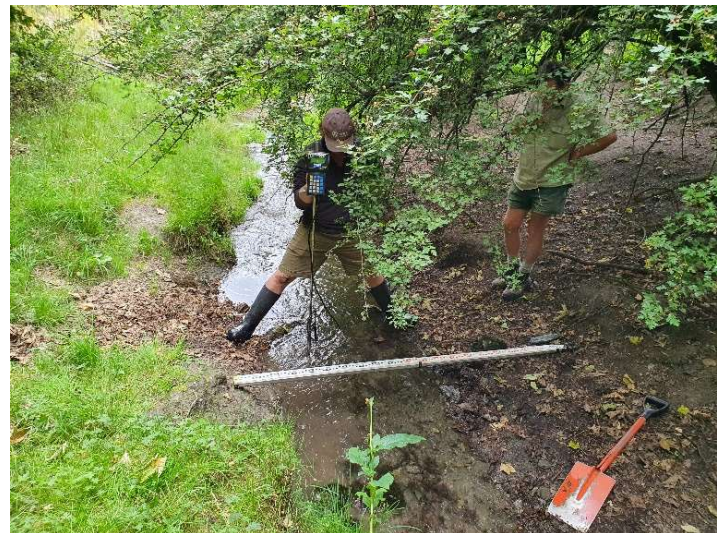
Figure 8: Site 400 view downstream

| Date | Time (NZST) | Site Number | Site Name | Waypoint | Location NZTM | Stage (mm) | Flow (L/s) |
|---|---|---|---|---|---|---|---|
| 22/02/2021 | 9:54 | 400 | Royal Burn North Branch at below Glencoe Rd culvert | 507 | E1275363<br>N5011898 | N/A | 9.0 |

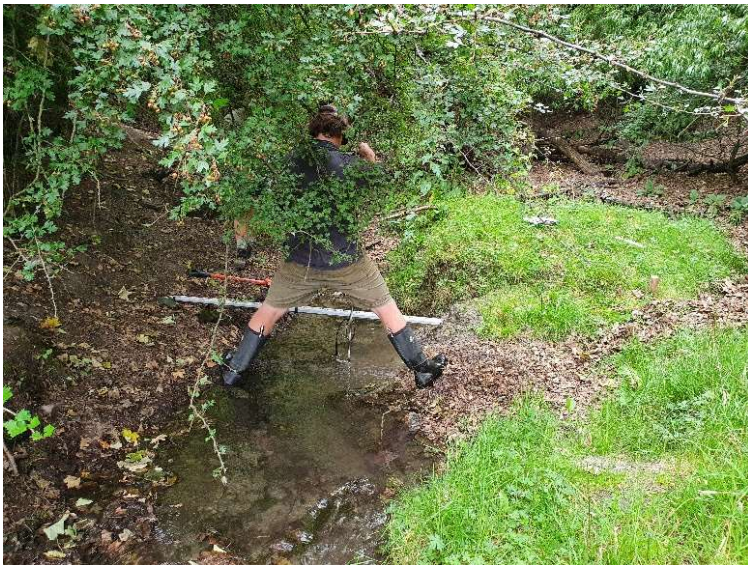
Figure 9: Site 400 view upstream

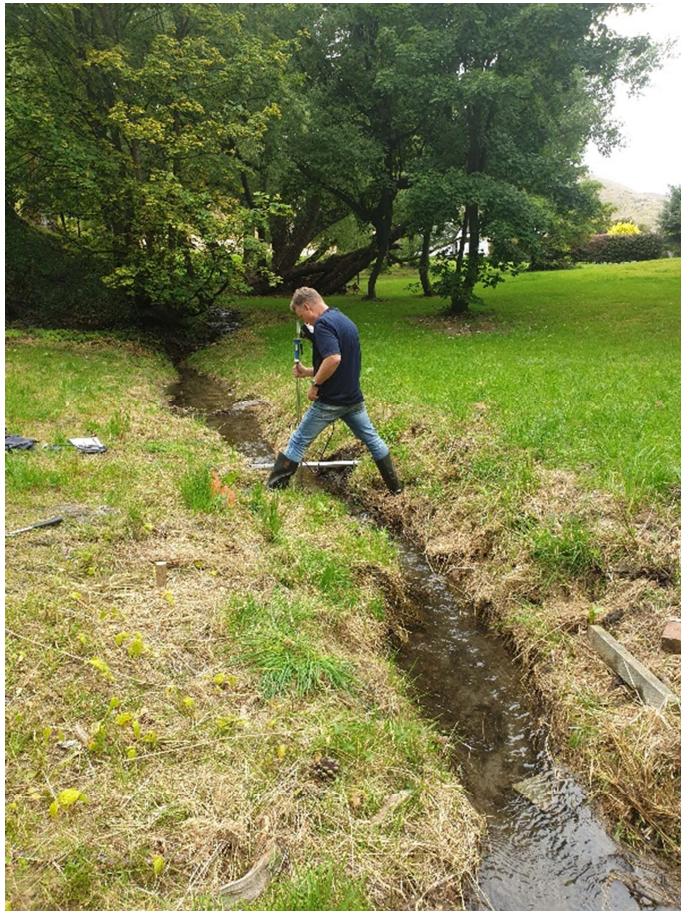
Figure 10: Site 500 view upstream

| Date | Time (NZST) | Site Number | Site Name | Waypoint | Location NZTM | Stage (mm) | Flow (L/s) |
|---|---|---|---|---|---|---|---|
| 22/02/2021 | 10:26 | 500 | Royal Burn South Branch at above Glencoe Rd culvert | 508 | E1275433<br>N5011882 | N/A | 8.8 |

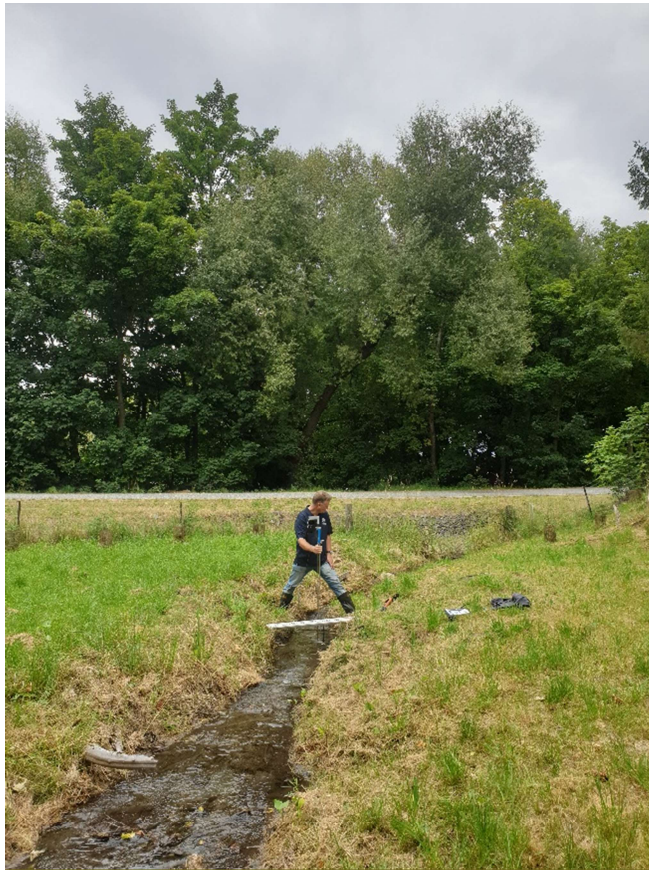
Figure 11: Site 500 view downstream

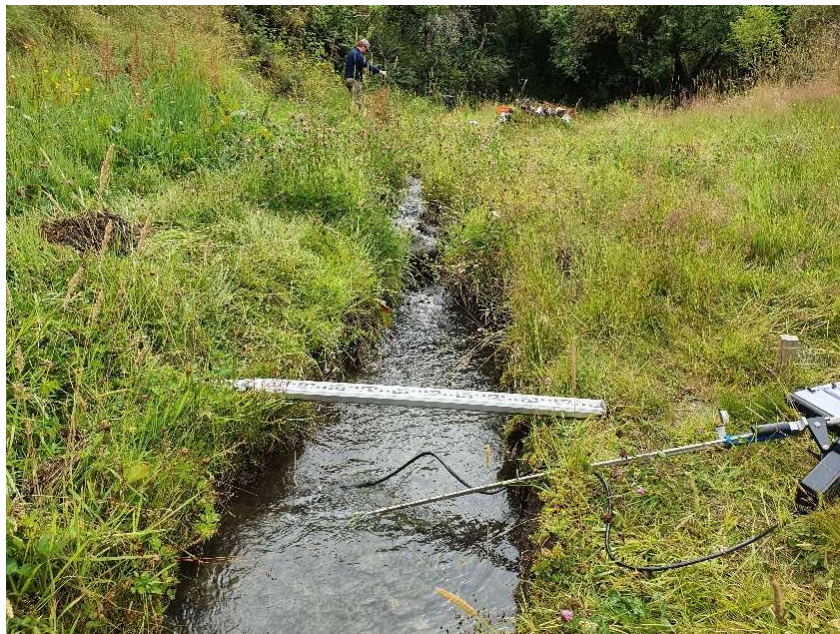
Figure 12: Site 600 view upstream

| Date | Time (NZST) | Site Number | Site Name | Waypoint | Location NZTM | Stage (mm) | Flow (L/s) |
|---|---|---|---|---|---|---|---|
| 22/02/2021 | 11:17 | 600 | Royal Burn at Below Brodie Race | 509 | E1275636<br>N5012388 | N/A | 16.8 |

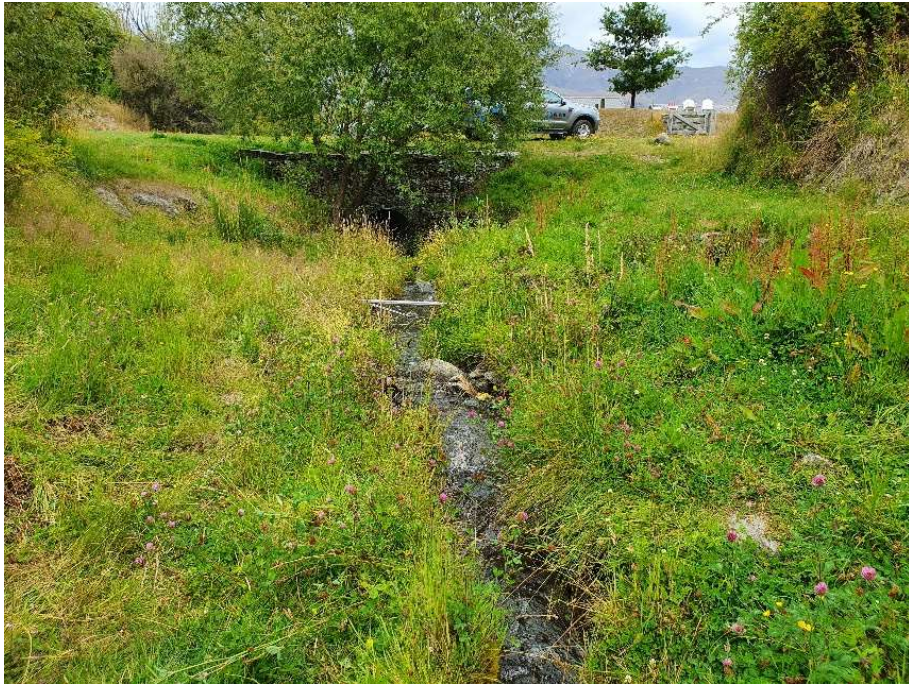
Figure 13: Site 600 view downstream

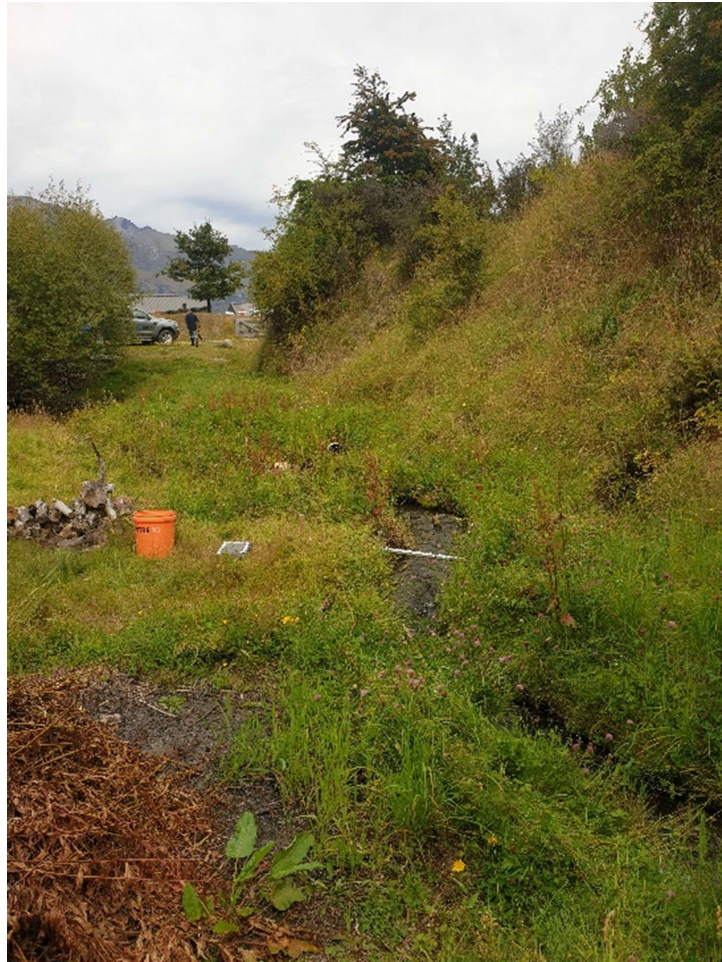
Figure 14: Site 700 view downstream

| Date | Time (NZST) | Site Number | Site Name | Waypoint | Location NZTM | Stage (mm) | Flow (L/s) |
|---|---|---|---|---|---|---|---|
| 22/02/2021 | 12:20 | 700 | Royal Burn at above Brodie Race | 510 | E1275639<br>N5012403 | N/A | 25.4 |

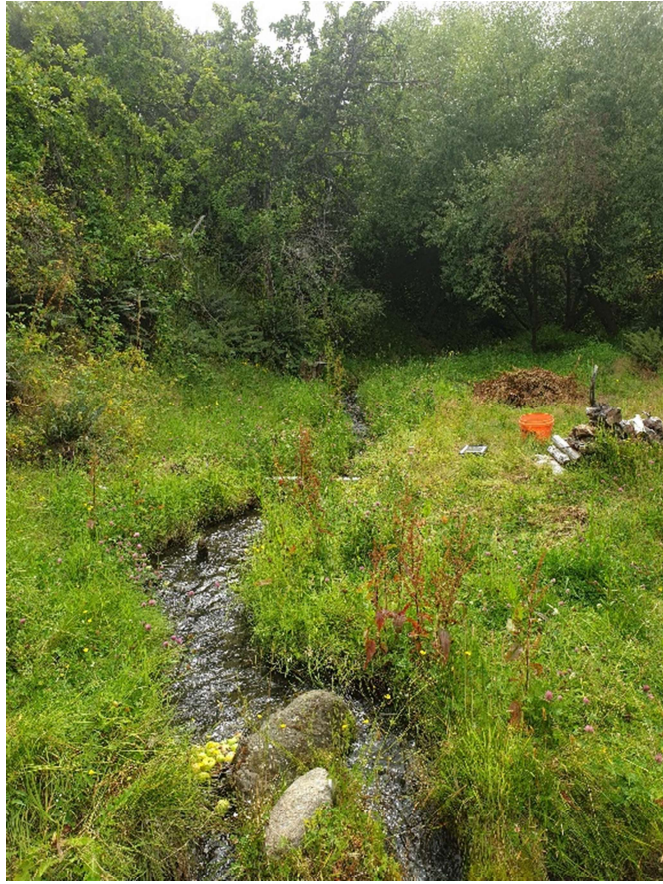
Figure 15: Site 700 view upstream

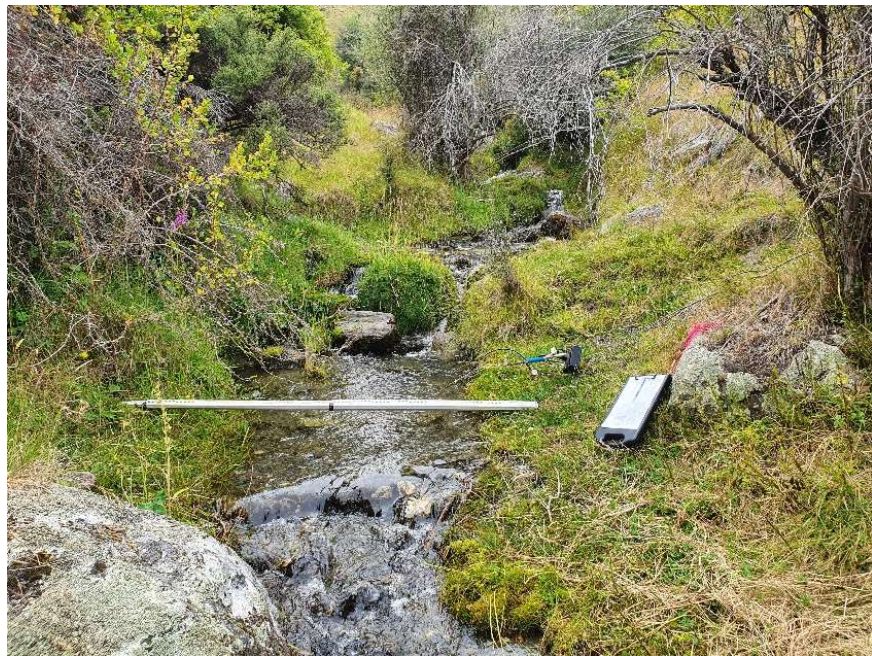
Figure 16: Site 800 view upstream

| Date | Time (NZST) | Site Number | Site Name | Waypoint | Location NZTM | Stage (mm) | Flow (L/s) |
|---|---|---|---|---|---|---|---|
| 22/02/2021 | 12:16 | 800 | Royal Burn at below top intake | 512 | E1275632<br>N5012970 | N/A | 20.0 |

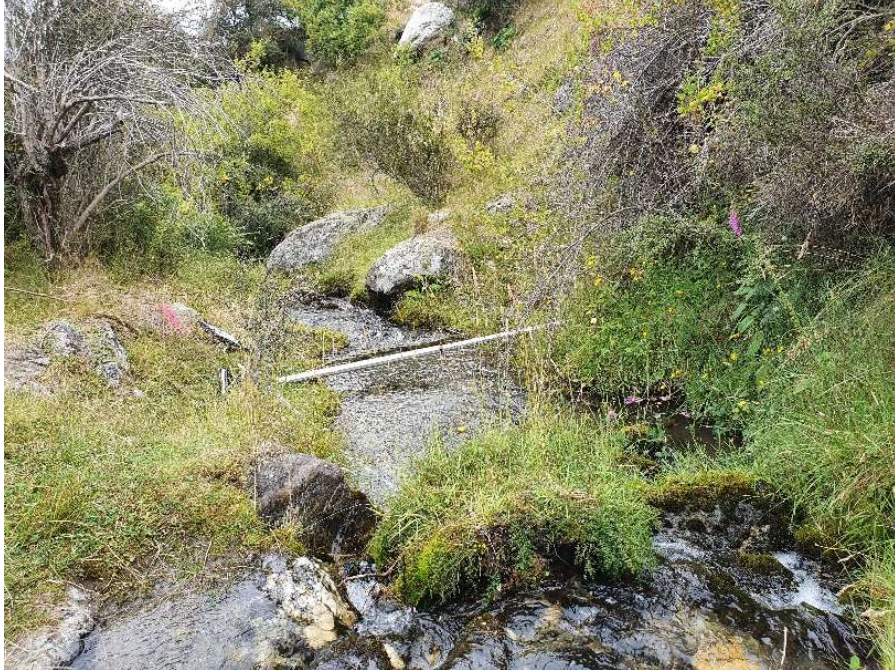
Figure 17: Site 800 view downstream

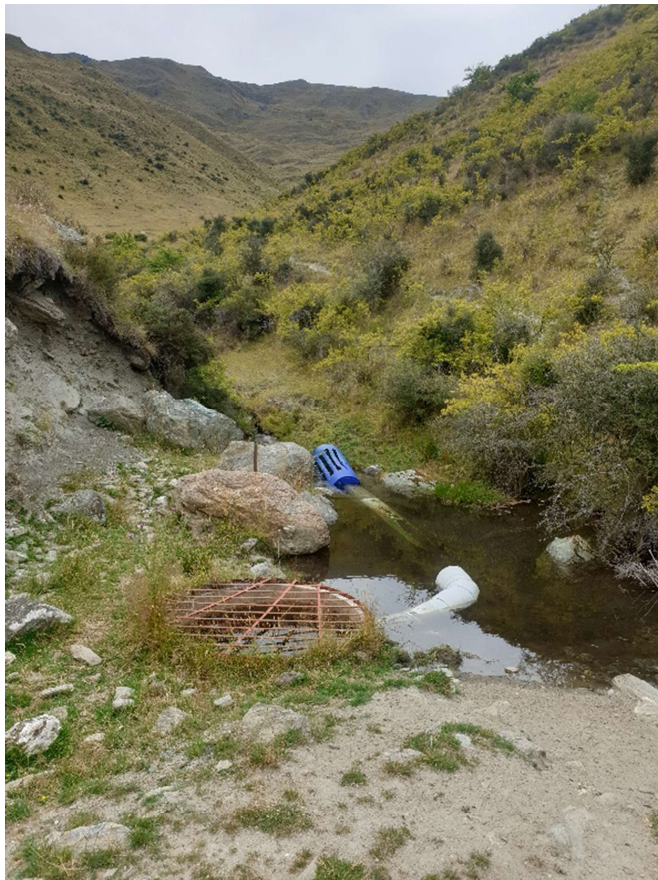
Figure 18: Dam intake

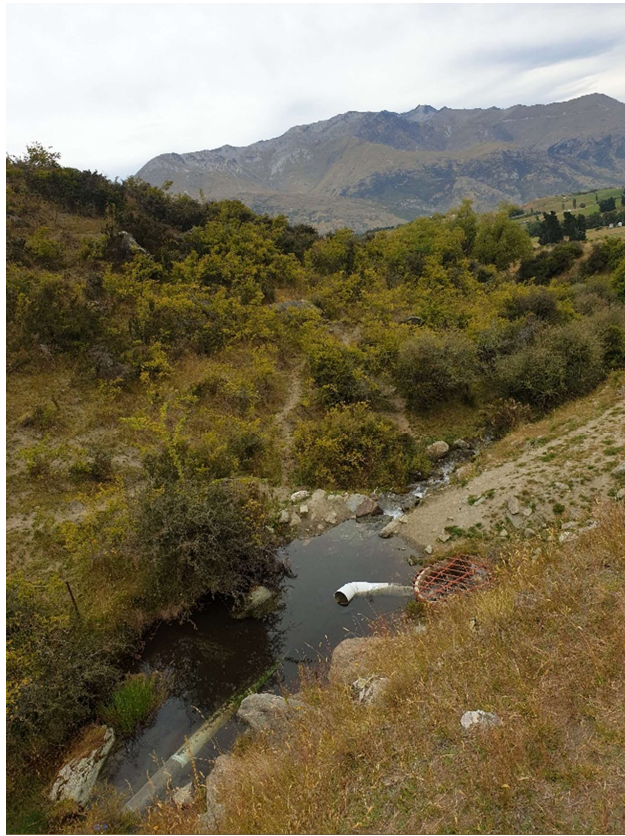
Figure 19: Dam intake from bank

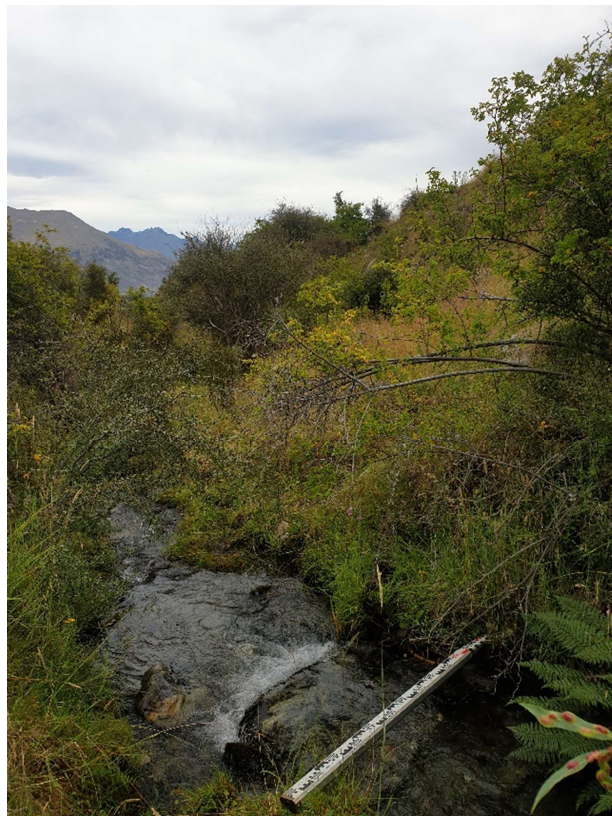
Figure 20: Site 900 view downstream

| Date | Time (NZST) | Site Number | Site Name | Waypoint | Location NZTM | Stage (mm) | Flow (L/s) |
|---|---|---|---|---|---|---|---|
| 22/02/2021 | 13:13 | 900 | Royal Burn at above top take | 511 | E1275710<br>N5013048 | N/A | 19.2 |

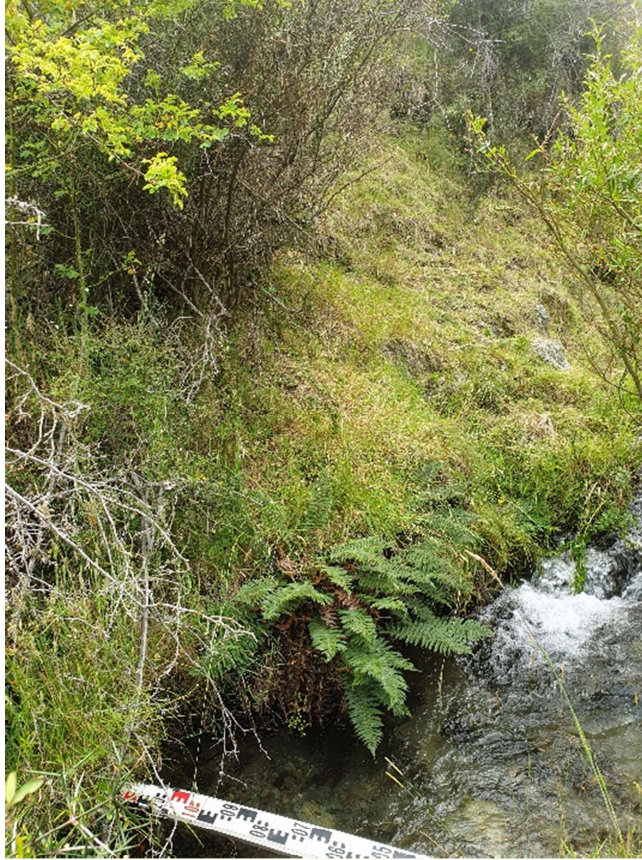
Figure 21: Site 900 view upstream
