Natural Character, Riverscape & Visual Amenity Assessments

Clutha/Mata-Au Water Quantity Plan Change – Stage 1 Prepared for Otago Regional Council

15 October 2018

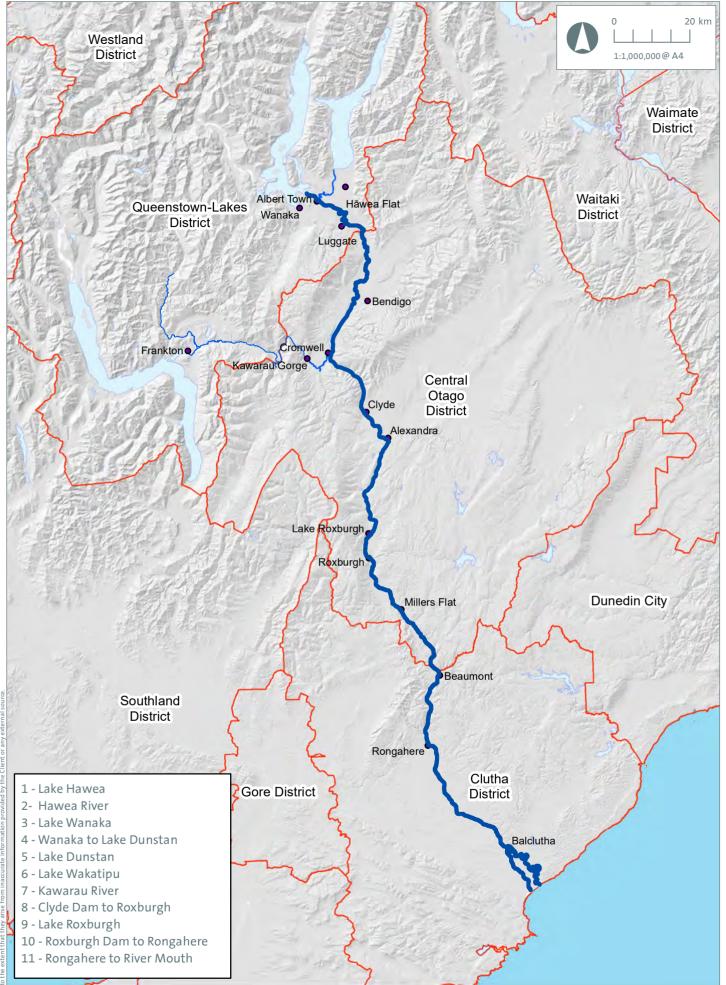
clutha mata-au river study Study Reaches: Figure 1

The study area for these assessments was identified by ORC and divided into 11 'reaches' listed below; (refer **Figure 1**)

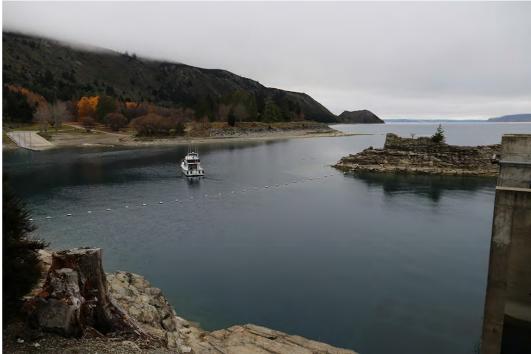
Lake Hāwea control gate - Lake Hāwea levels can fluctuate by up to 8.0 m resulting in changing exposure of the shoreline

NATURAL CHA	RACTER – Lake Hāwea	Degree of Natural Character
Active bed	Outfall has been artificially controlled since 1958. The previous uncontrolled water level was 326.42 m. The original minimum controlled level was set at 328.87 m and a maximum of 345.32 m above datum. These levels have been adjusted to today's typical 8 m operating range between 338 m-346 m above datum but can be exceeded under the Flood Management Plan (Dam Water Permit, Consent No. 2001.384).	High
	 Inflows remain a natural process - Nor-westerly storms tend to provide the most significant inflows, particularly in spring and summer, when rapid snow melt can exacerbate flood flows. One consented groundwater take at the lake. Besides the water level and resulting artificial shoreline and the floating booms associated with the outfall, there are few other modifications. Overall the active bed is subject to legible, predominantly natural processes - alluvial and glacial – such as the obvious colluvial slopes and fans that extend into the lake. Silver Island, located within the lake, is clad with regenerating indigenous vegetation and has a highly natural character. The lake supports significant areas for development of juvenile trout and salmon, and significant presence of eel, trout, and salmon identified in Schedule 1A of the ORC Regional Plan: Water. Koaro have also been identified (NIWA Freshwater Fish map). The dams obstruct migratory fish species. No major threats from exotic pest plants. A 1986 survey for the NZ Journal of Marine and Freshwater

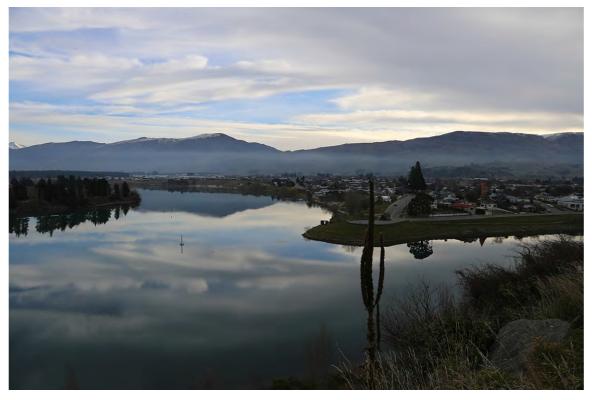
Cromwell urban area at the confluence of the two major arms of Lake Dunstan, the flooded river valleys of the Kawarau River and Clutha River/Mata-Au.

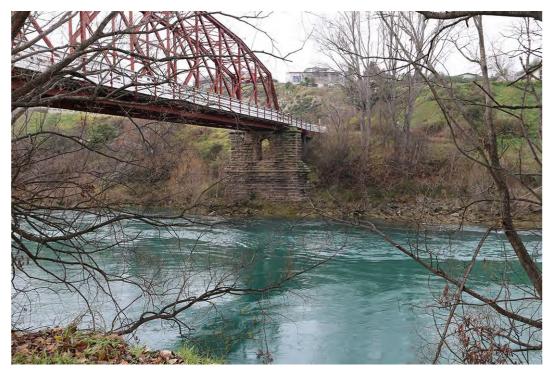
Flowing under the historic bridge at Clyde - river flows in this reach are regulated by the Clyde Dam upstream.

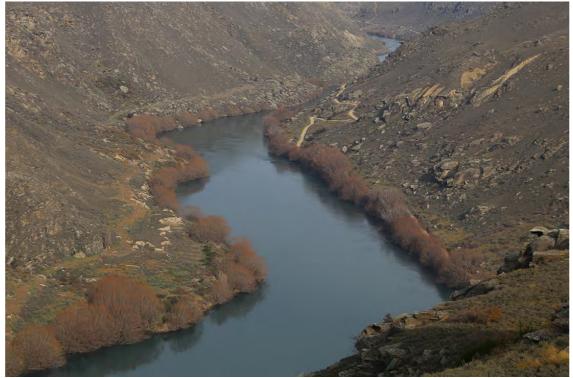
The long narrow form of Lake Roxburgh snakes its way through steep rocky and sparsely vegetated hill country.

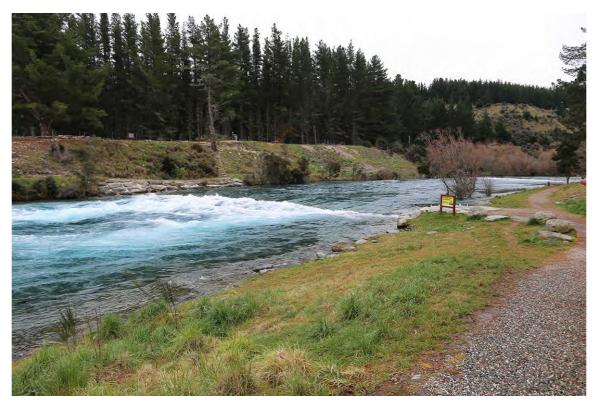
Hāwea River - the river bed has been modified to create the standing wave at the whitewater park at Camphill Bridge.

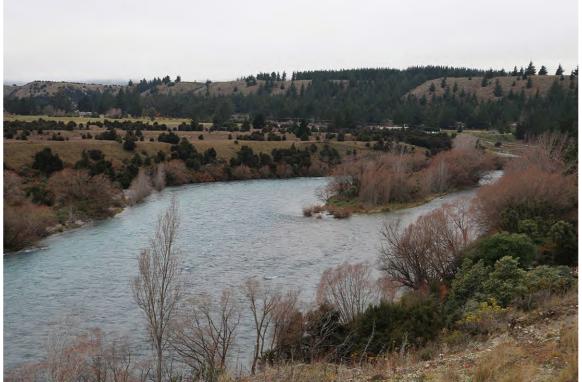
Clutha River/Mata-Au just above the Luggate bridge - with river margins dominated by exotic vegetation and kanuka prominent on the series of old river terraces.

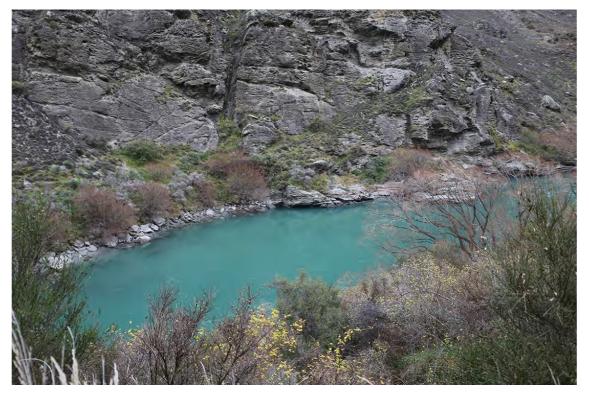
The Kawarau River cuts through the dramatic steep sided rocky gorge. The cloudy water is a result of the Shotover River sediments.

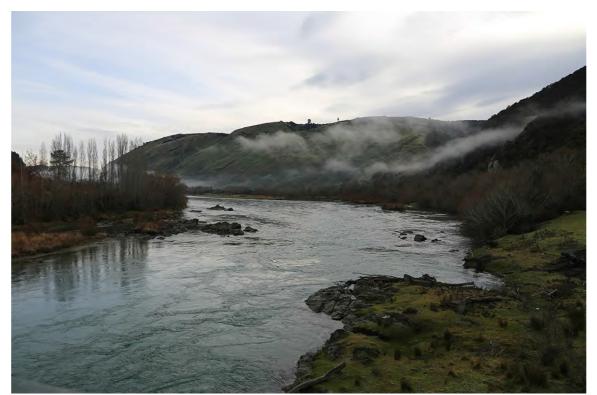
At Beaumont the river cuts through the hill country, flowing between rocky banks.

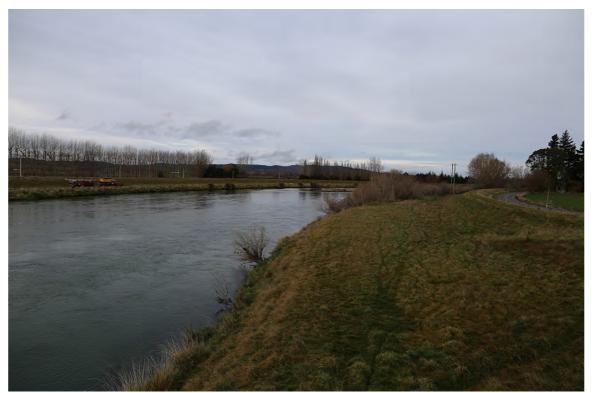
Matau Branch of the river at Stirling bridge - the lower reaches of the river flow across flat land and old floodplains, largely contained by stopbanks and lined with willow.
