# **Green Island – Resource Recovery Park Precinct**

**Stormwater Management Plan and  
Assessment of Effects**

<b>Project name</b>	
<b>Document title</b>	Green Island – Resource Recovery Park Precinct   Stormwater Management Plan and Assessment of Effects
<b>Project number</b>	
<b>File name</b>	12593786 – SW Discharge Application Report All Site V2_230919.docx

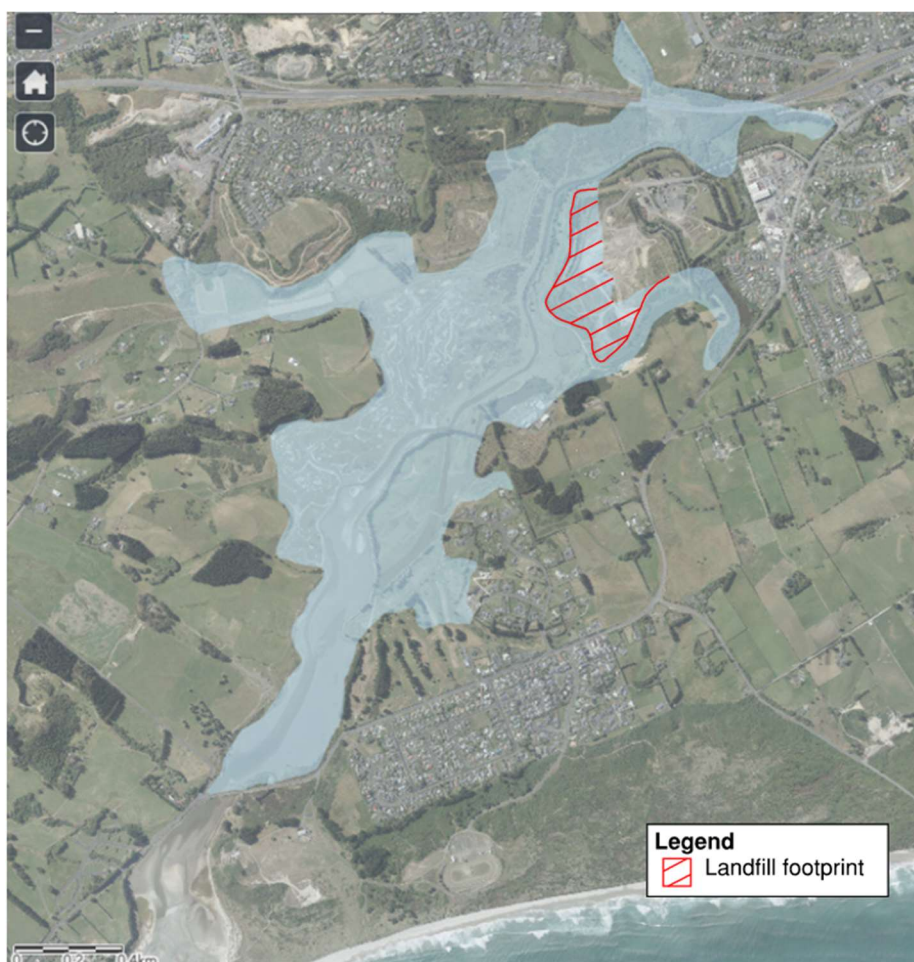
The ORC hazard maps for flood risk associated with river-based flooding for the Kaikorai Estuary catchment is shown in Figure 4 below.

**Figure 4** Fluvial flood risk area (Source: ORC Online Natural Hazards Portal, [www.maps.orc.govt.nz](http://www.maps.orc.govt.nz))

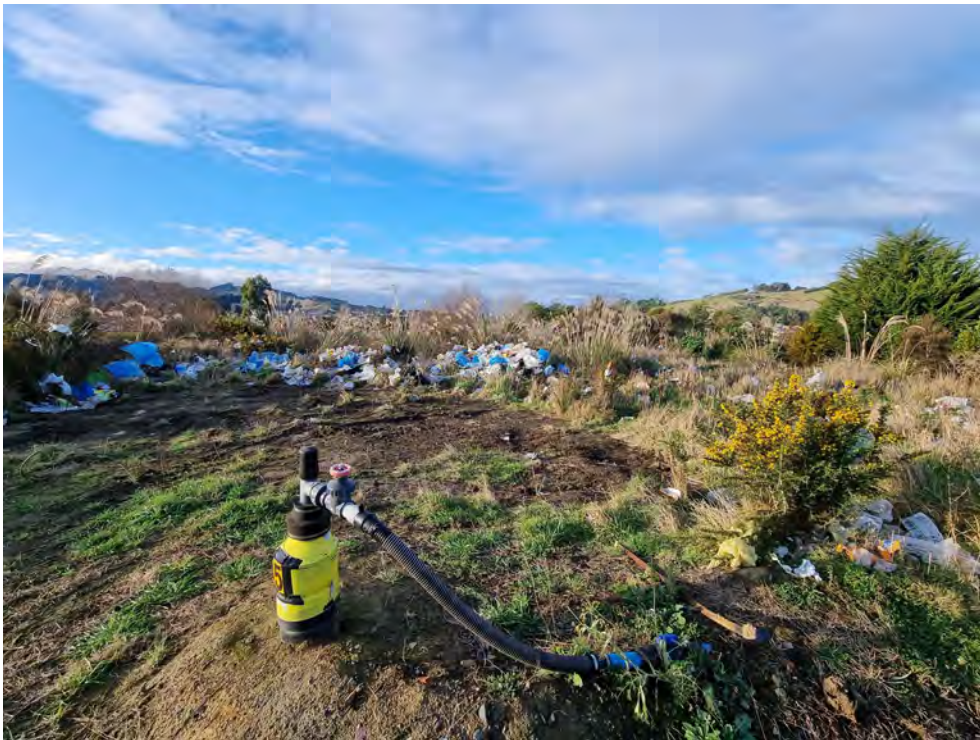
*Photograph 1: Large volume of wind blown waste within the 'final cap' area outside of the litter fence.*

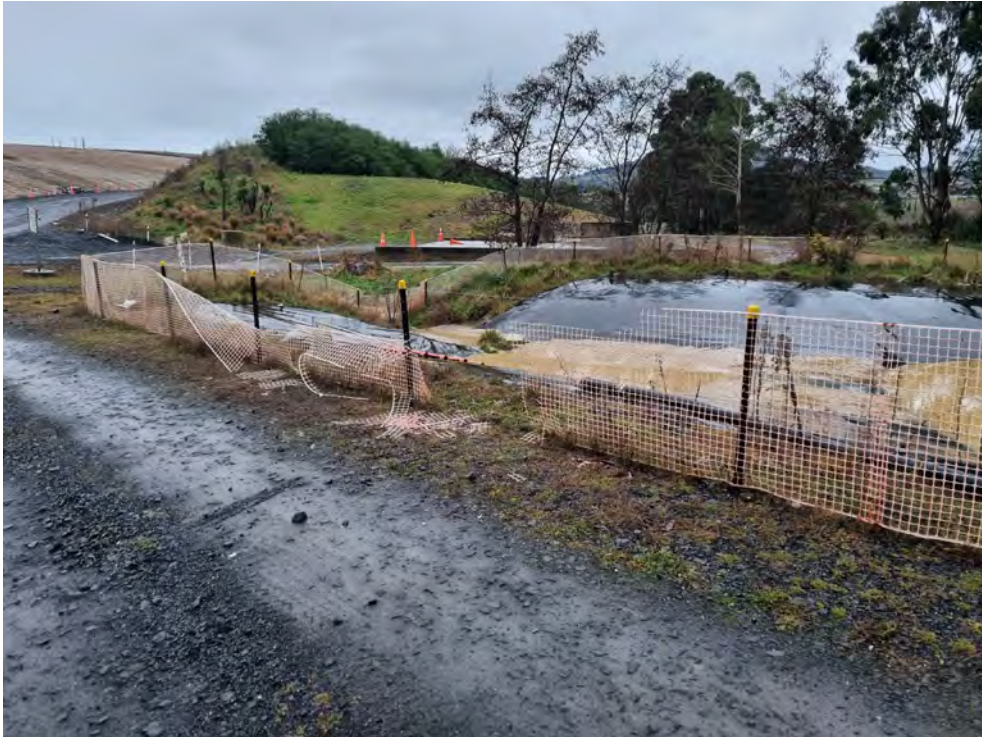
**Photograph 15:** Orange netting to be replaced around the silt pond, adjacent to the previous tyre storage location.

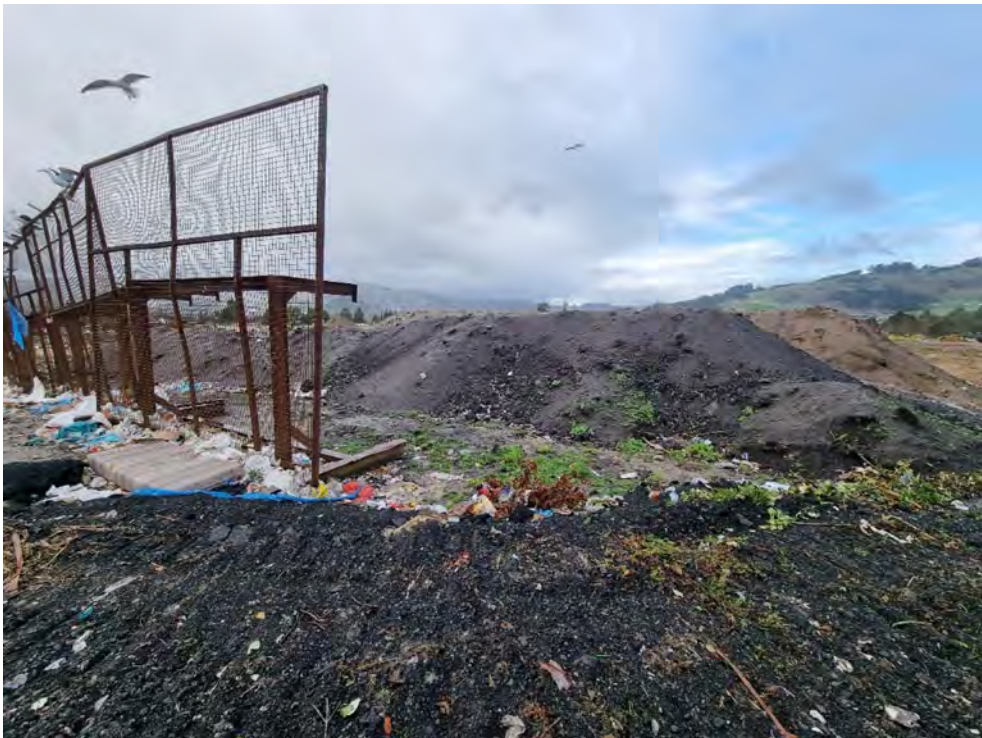
**Photograph 16:** The litter fence and stockpiled material within the vicinity of the tip face which will be utilised as final capping material.

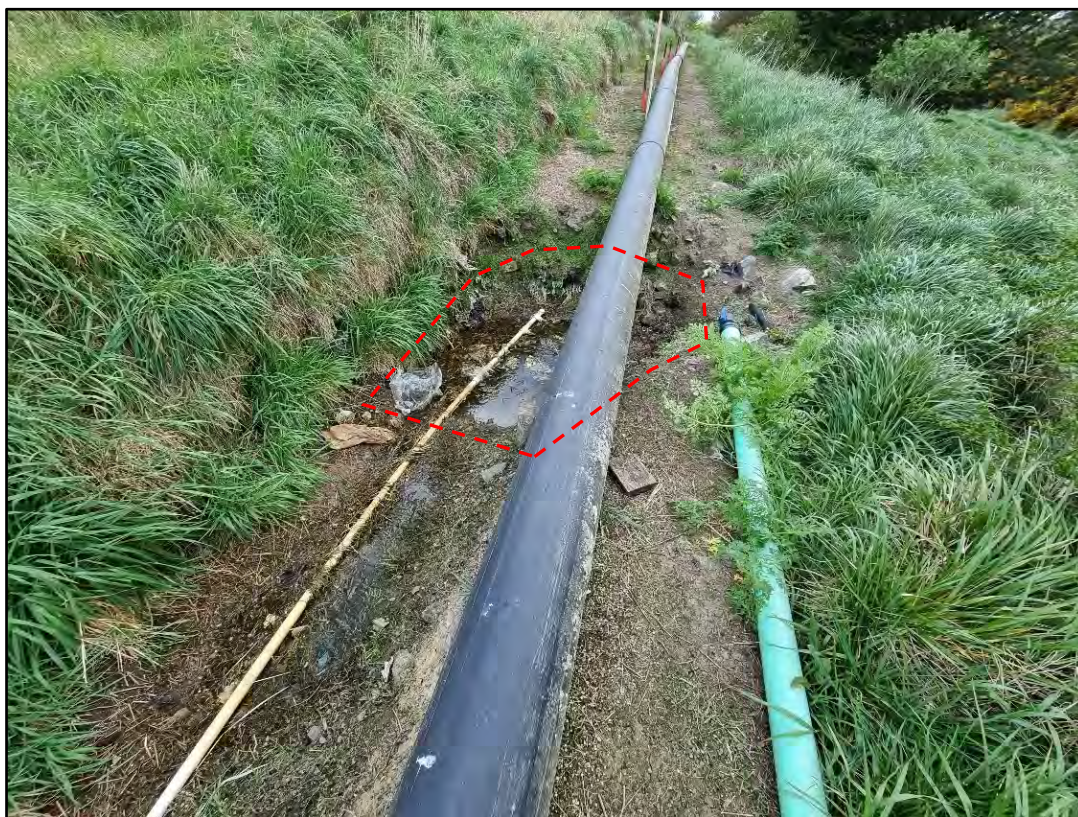
Photograph 1: A slight hole is present in the ground surface beneath the gas line to the east of line MW0.

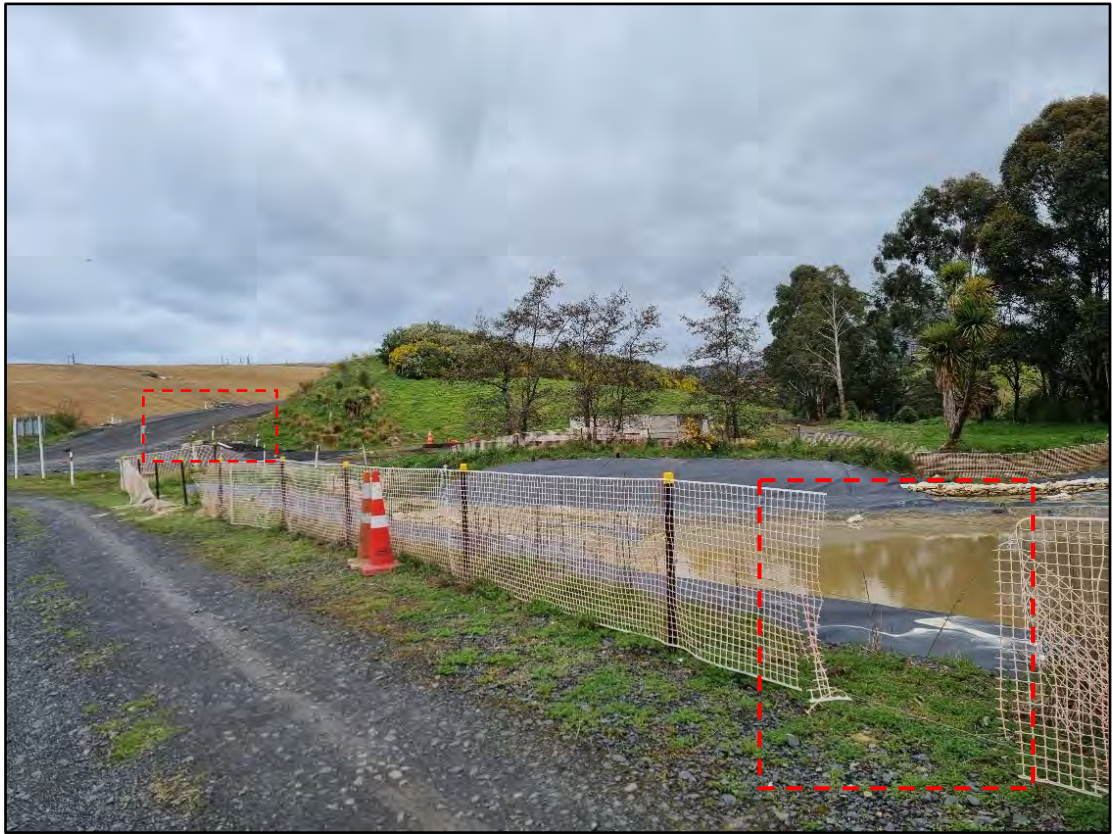
**Photograph 3: Orange netting which requires replacement around the northern stormwater detention / sedimentation pond.**

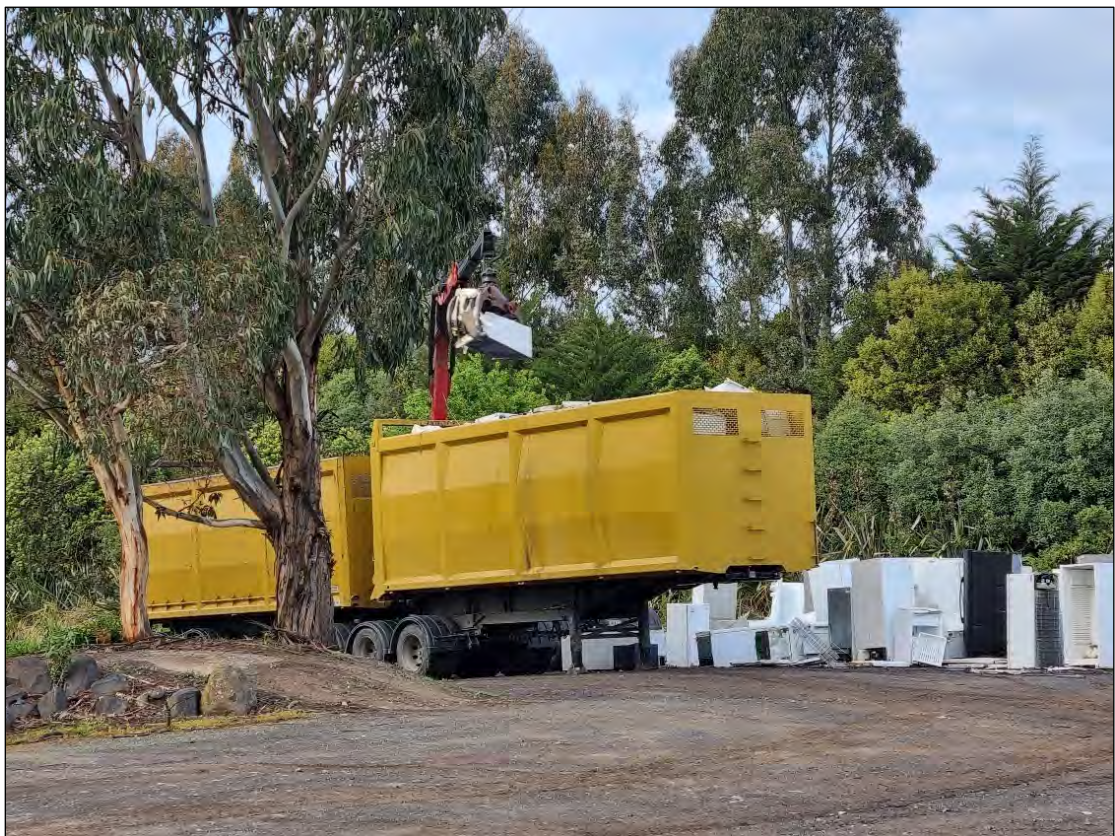
**Photograph 4: Removal of whiteware from site.**

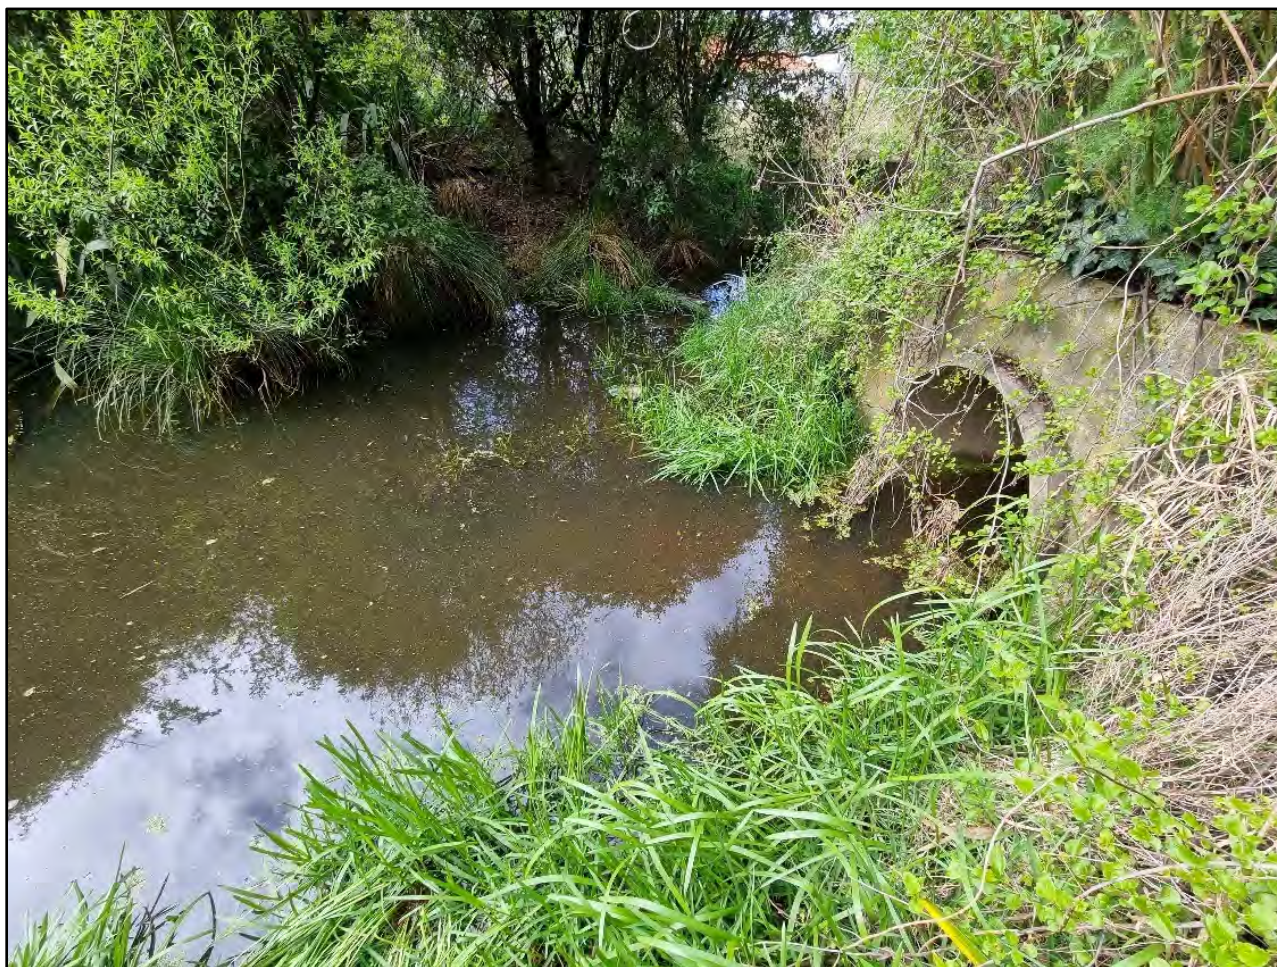
**Photograph 17: The north eastern wetland, with outflow pipe from south eastern wetland to the right of picture. High water levels can be noted.**

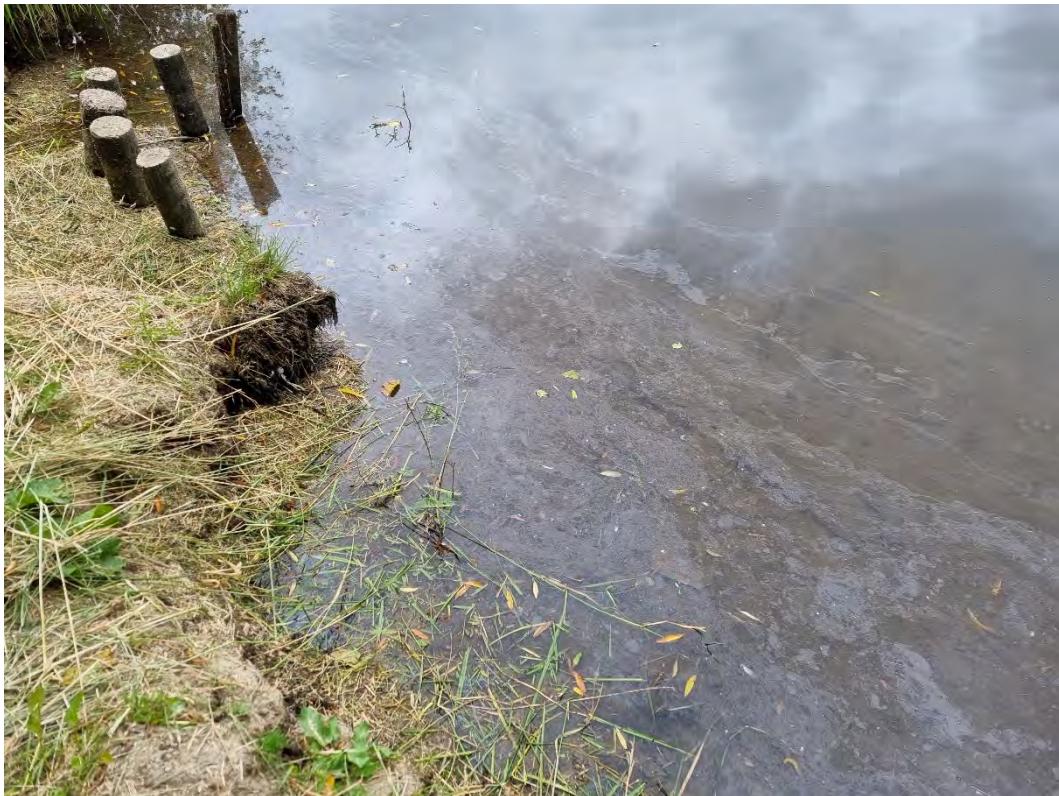
**Photograph 12: Biological sheen noted on the surface water adjacent to GI3 in the Kaikorai Stream.**

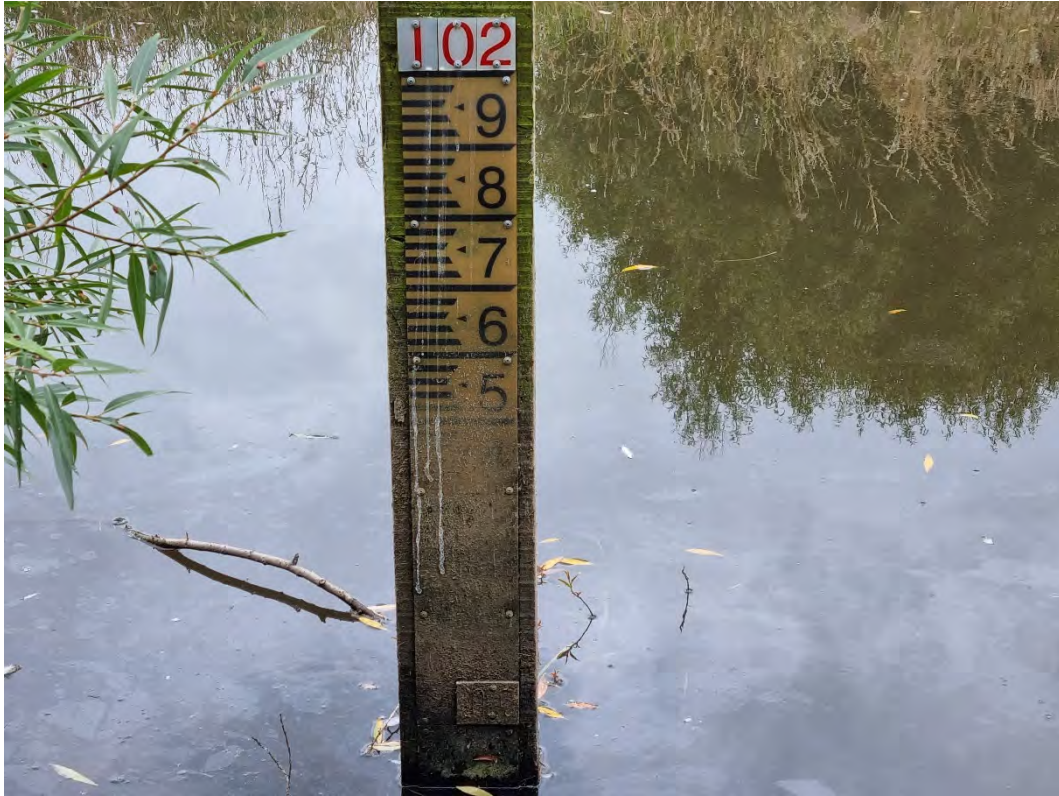
**Photograph 13: All staff gauges require cleaning to make the numbers and ticks legible.**

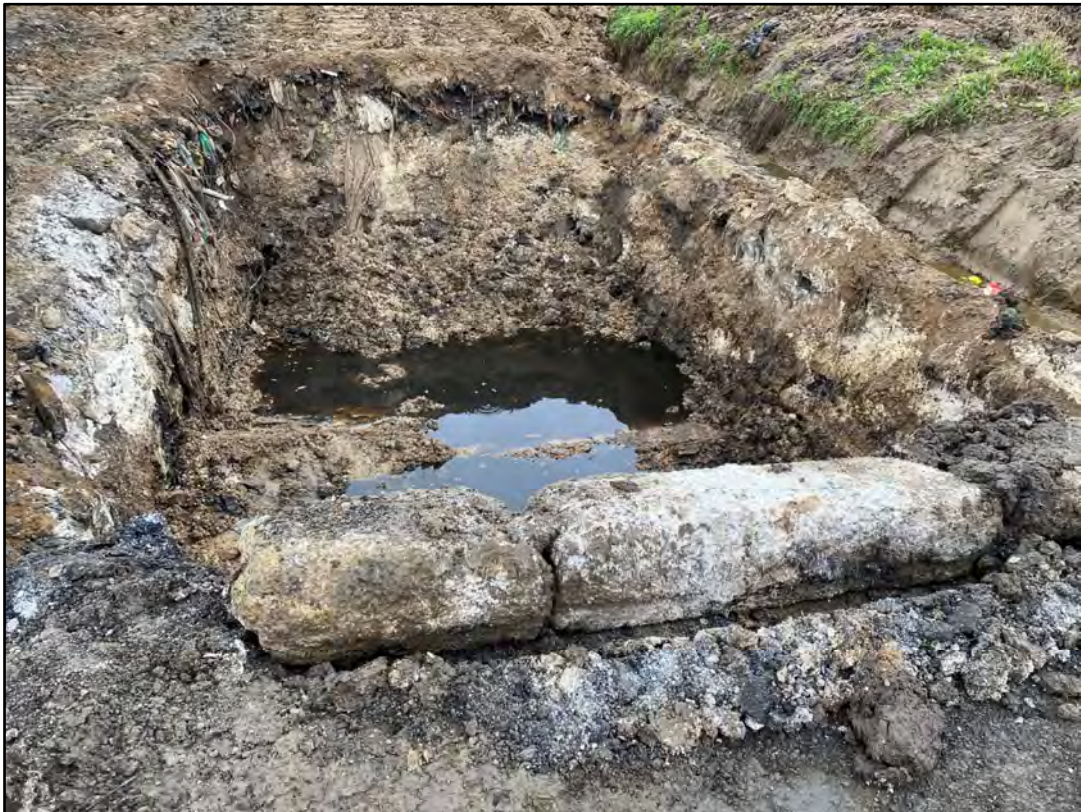
*Photograph 1: New sludge pit located east of old sludge pit.*

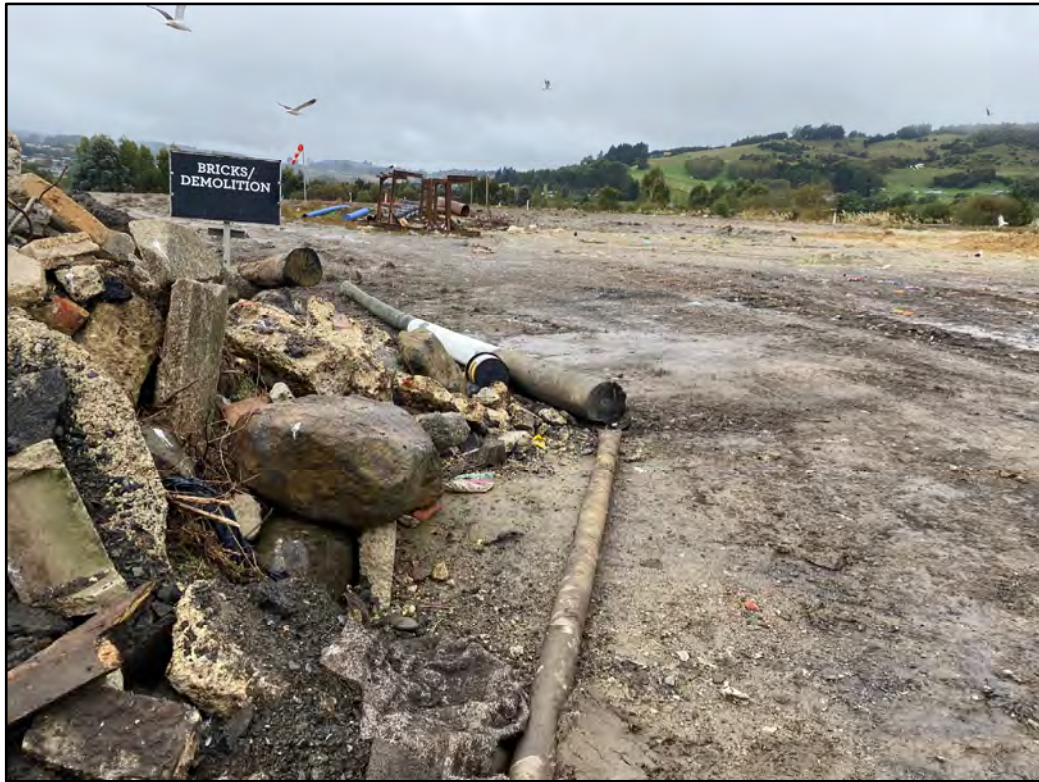
**Photograph 5:** Timber and buckets noted present in the bricks / demolition waste stockpile.

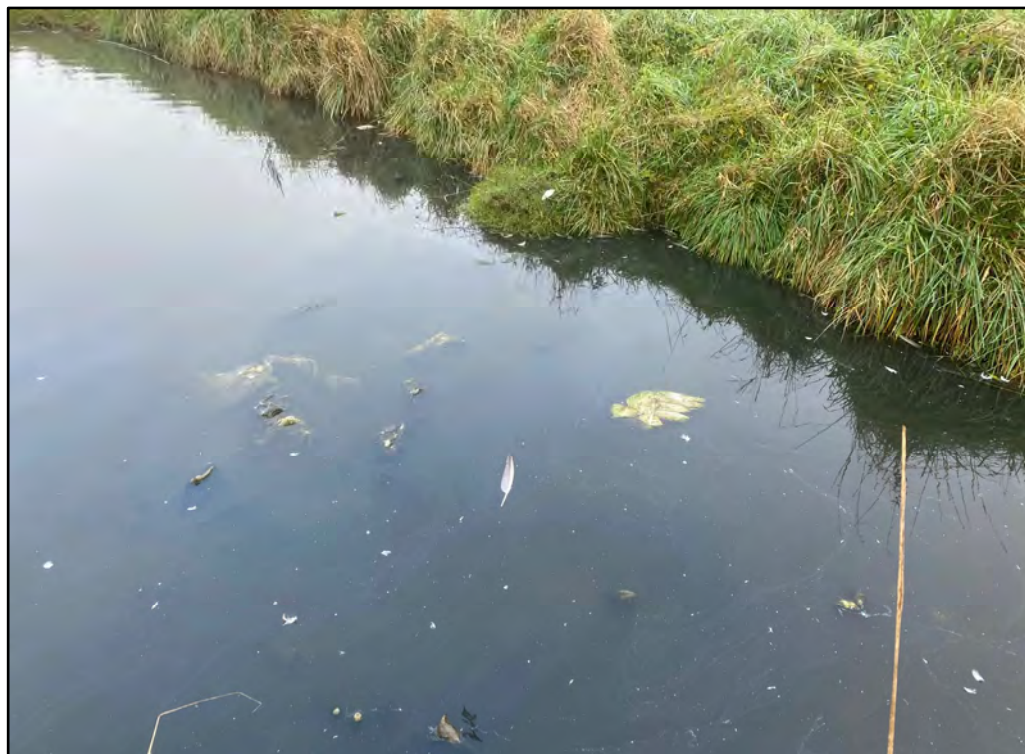
**Photograph 6:** Wind-blown litter present on the surface and base of the Western Sedimentation Pond
