Taieri Flood Protection Scheme

Floodbank Risk Assessment

Prepared for
Otago Regional Council

Prepared by
Tonkin & Taylor Ltd

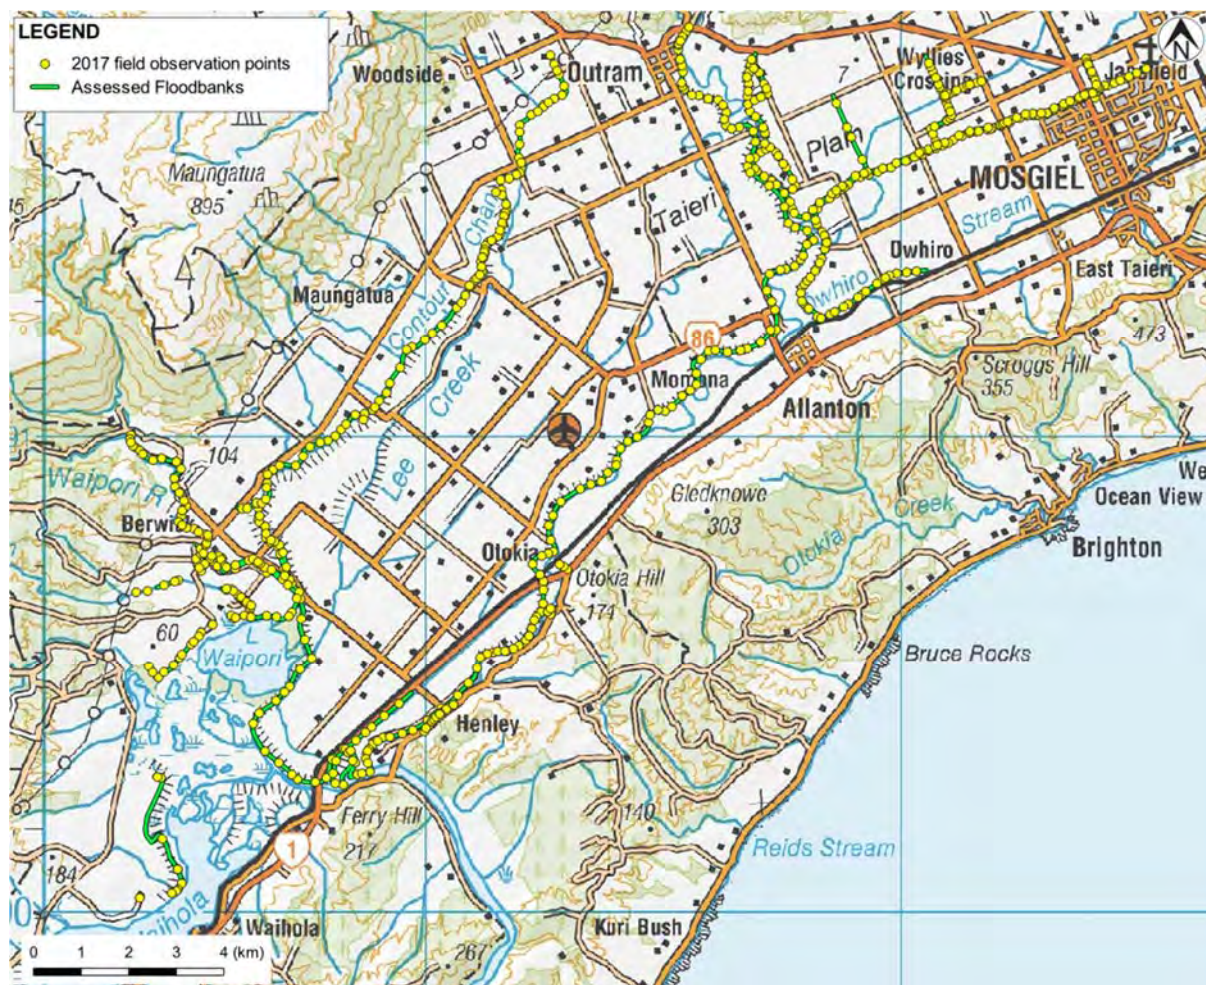
Figure 5: 2017/2018 condition observation points

The 2017/2018 condition assessment comprised of walking the crest of the Scheme floodbanks and recoding field observations points for a range of condition criteria. In total, 401 observation points were recorded along the Taieri and Silver Stream reaches as shown in Figure 5. Each field observation point corresponds to a floodbank section as described in Section 3.2.

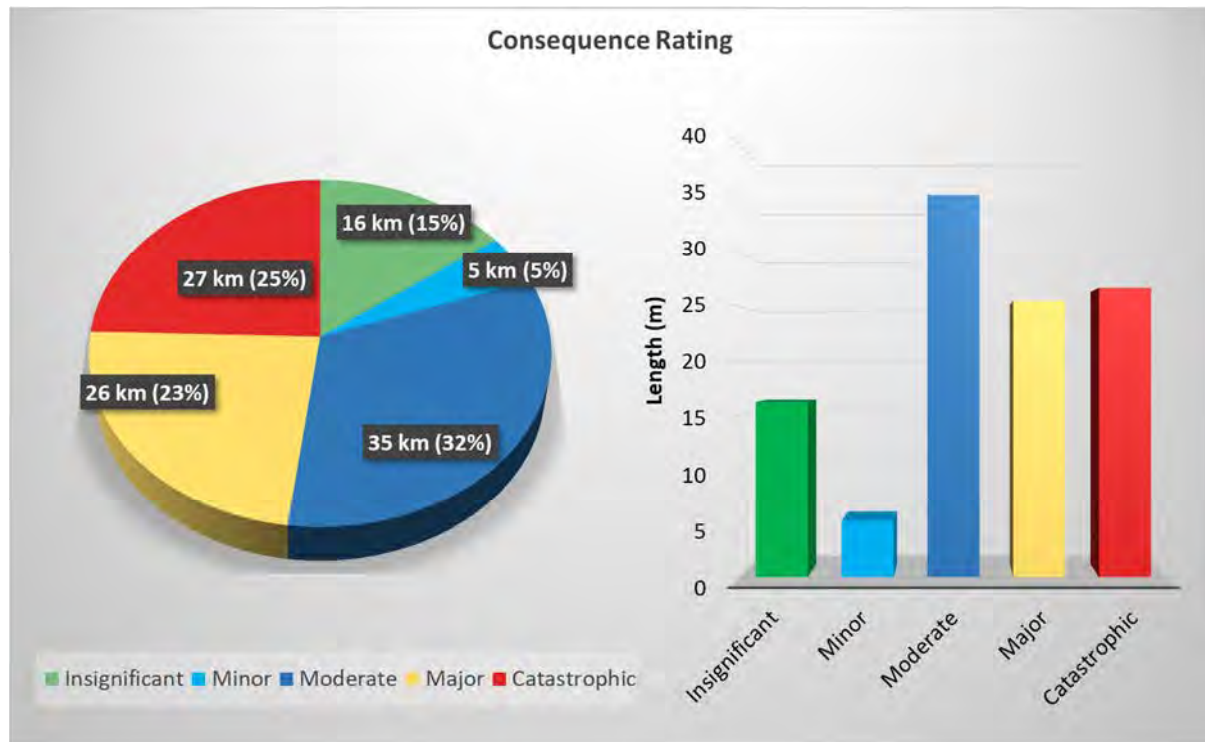
Figure 11: Consequence rating summary

Figure 11 shows that 38 km (35%) of the assessed floodbank sections have a catastrophic consequence rating, and 26 km (23%) of the sections have a major consequence rating. The remaining sections have a moderate or lower consequence rating.

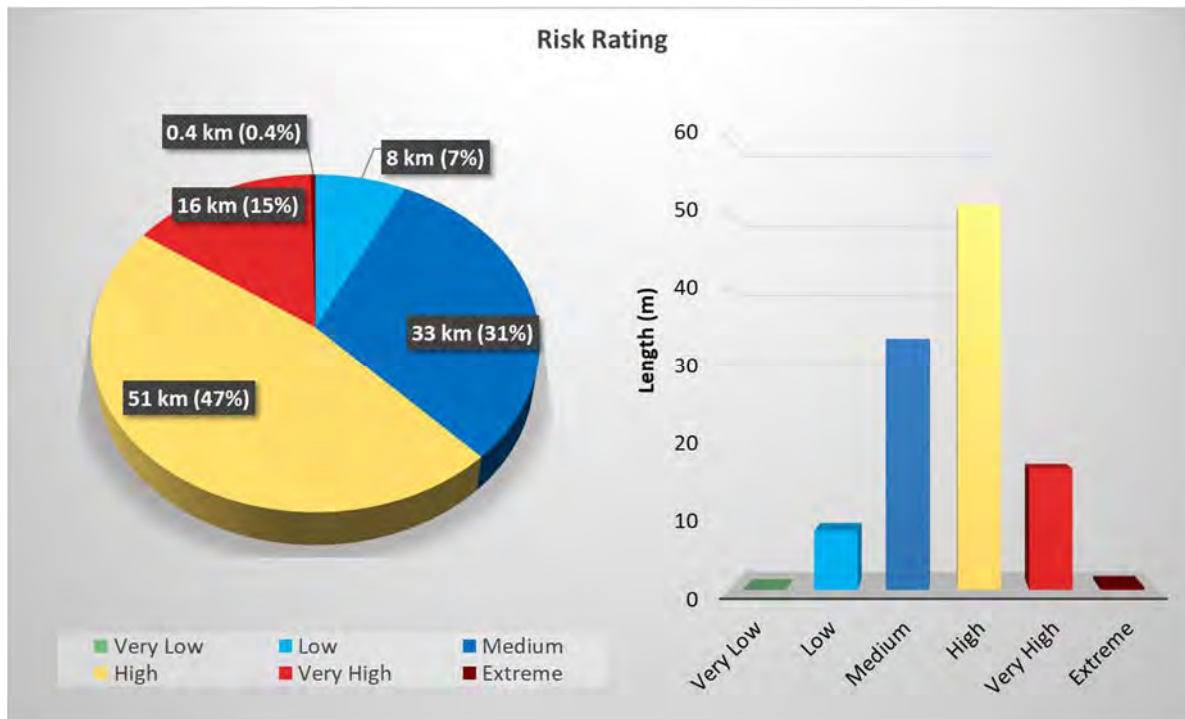
Figure 12: Risk rating summary

Figure 12 shows that 0.4 km (0.4%) of the assessed floodbank sections have an extreme risk rating, and 16 km (15%) have a very high risk rating. 51 km (47%) have a high risk rating. The remaining sections have a medium or lower risk rating.

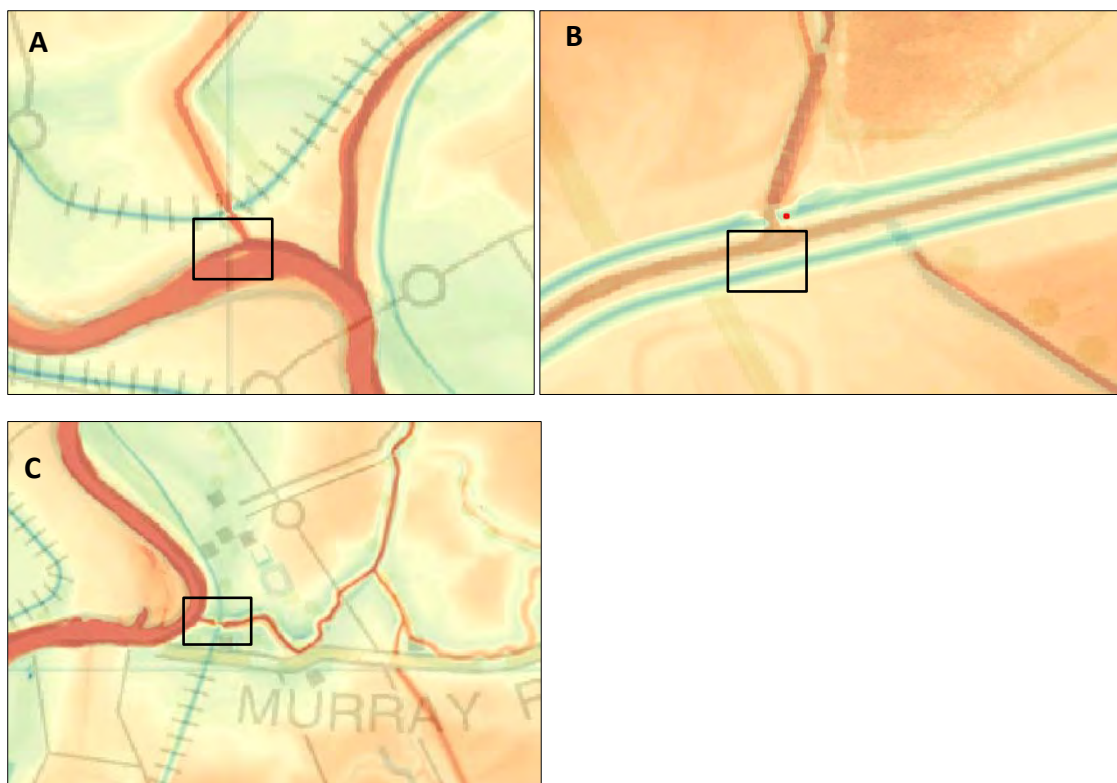
Figure 2: Model topography corrections

Corrections were made to the model topography at three locations shown on Figure 2 including the A1 gate outfall, Silverstream pumpstation and Mill Creek pumpstation. At these locations, the LiDAR incorrectly represents actual ground levels, allowing water to artificially enter the ponding areas from the river. Correction involved increasing the ground level to match the floodbank level either side. For the A1 Gate Outfall, it is assumed that the water level within the Taieri River during the breach is high enough that water is prevented from flowing out of the upper ponding area via the flap gates.
