Channel morphology of the Waianakarua River, North Otago

Technical Summary

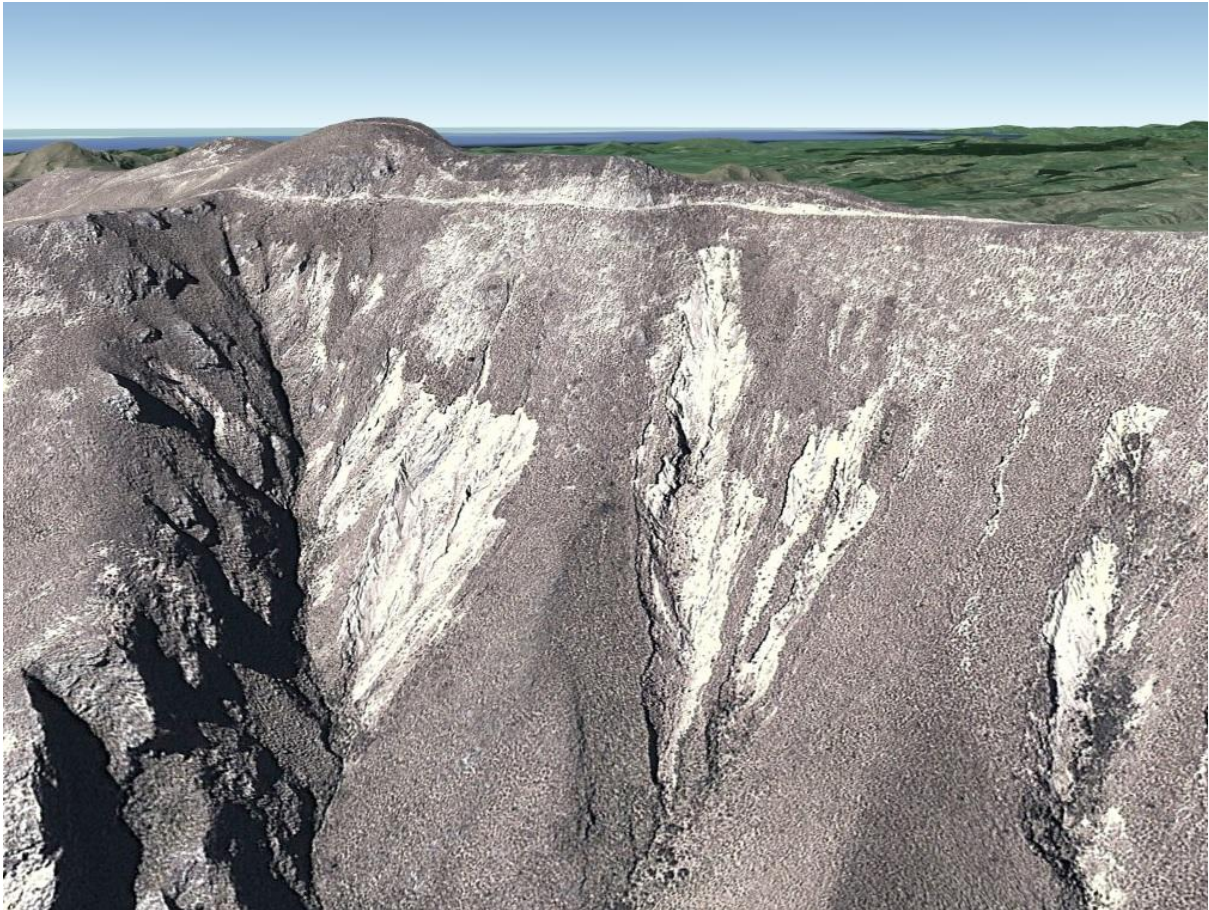
Figure 2-Evidence of land instability in the upper reaches of the North Branch of the Waianakarua River image date June 2012 (Google Earth). This location is shown on Figure 1 (red circle).

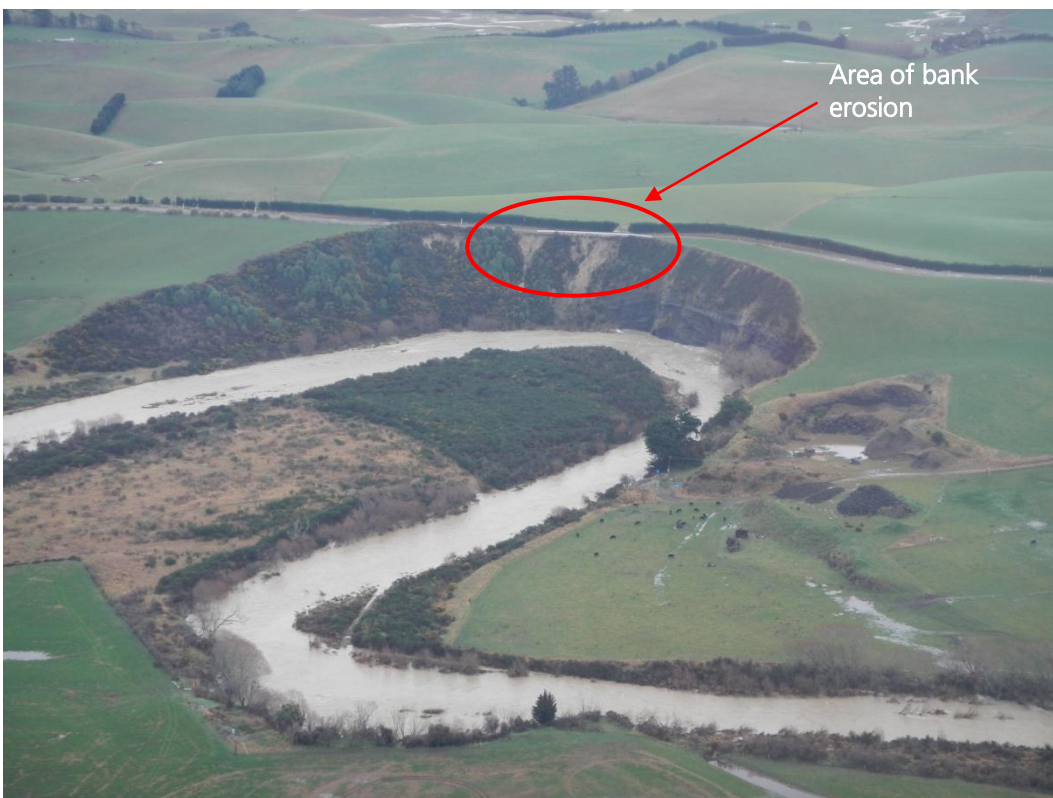
In the main stem of the Waianakarua River the channel switches between areas of braiding and single thread channels. The river is actively eroding the bank below Waianakarua Road, approximately 2km from the river mouth (Figure 6 and Figure 7). Between February 2008 and October 2013 survey data shows that the main stem of the Waianakarua has shown erosion of both the true left and true right banks (Figure 10). The upstream sites (WA3 - Figure 25, and WA4 - Figure 27) show aggradation of the bed and widening of the main channel (WA3) and the creation of multiple flow channels (WA4) during this period. The main channel became wider and shallower at the most downstream site (WA1, Figure 21) and narrower and deeper at WA2 (Figure 23) between 2008 and 2013. Cross-sections WA3 and WA4 are affected by gravel extraction activities.

Figure 7-Aerial view of the Waianakarua River looking upstream during a period of high flow in August 2012. The location of Figure 6 is circled in red.

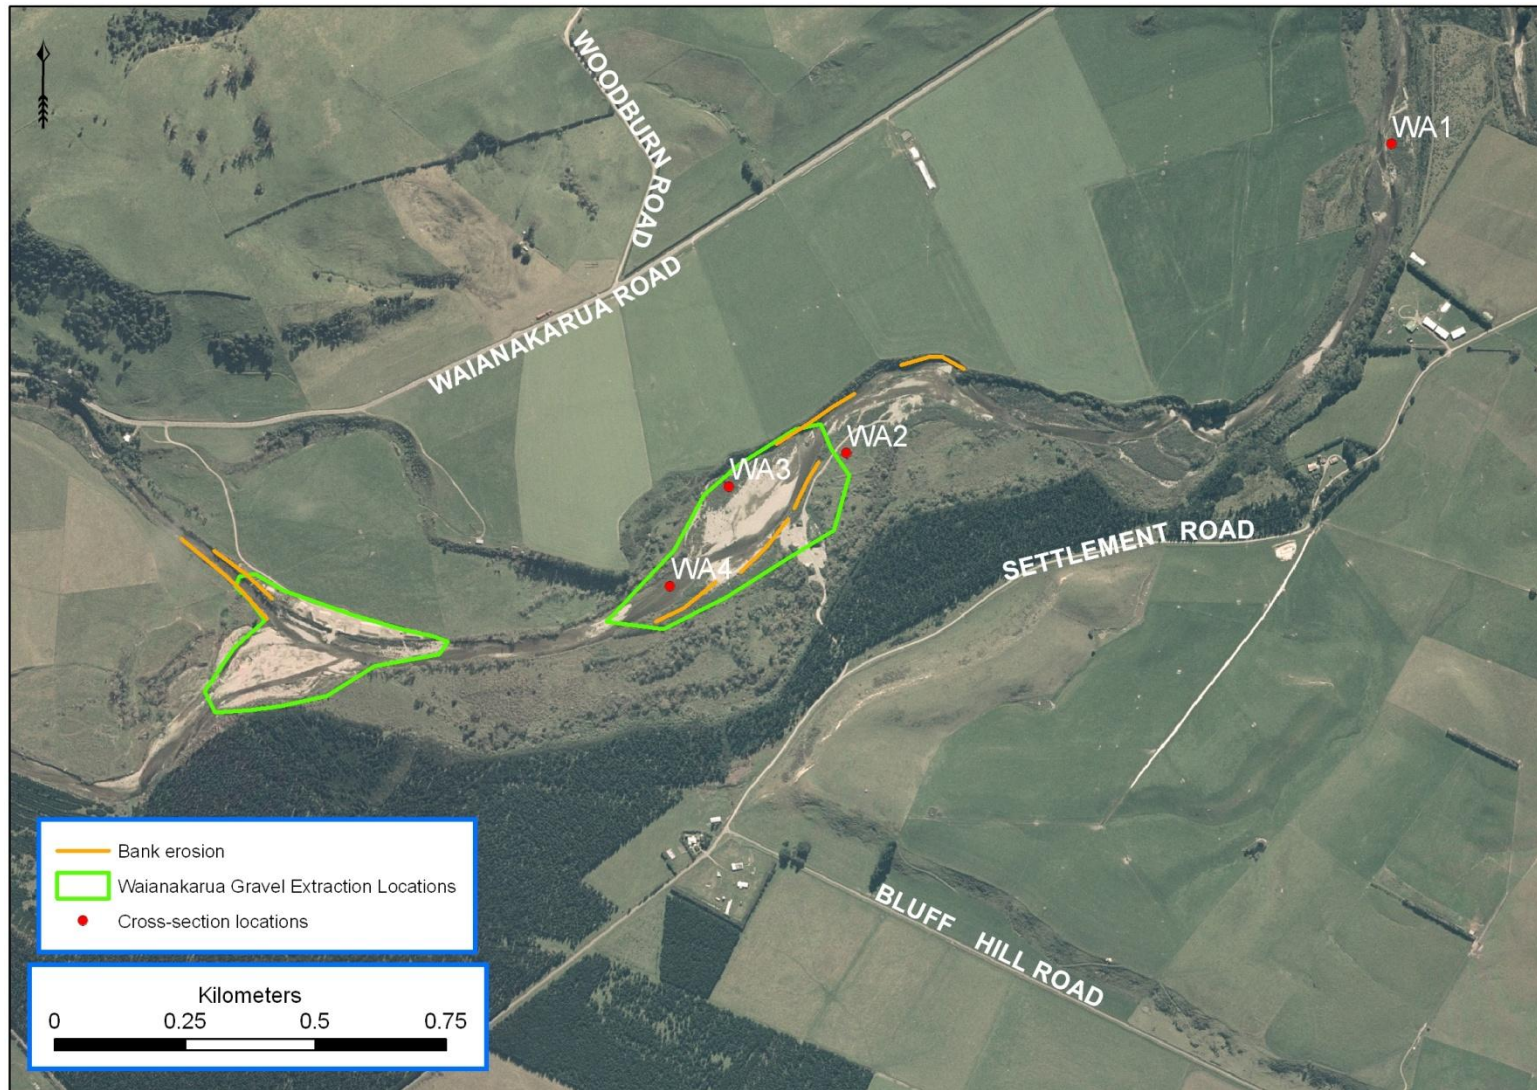
Figure 10-Location of surveyed cross-sections on the main stem of the Waianakarua River, areas where significant bank erosion was observed are shown as orange lines. Locations where gravel extraction has historically taken place are shown as green lines.

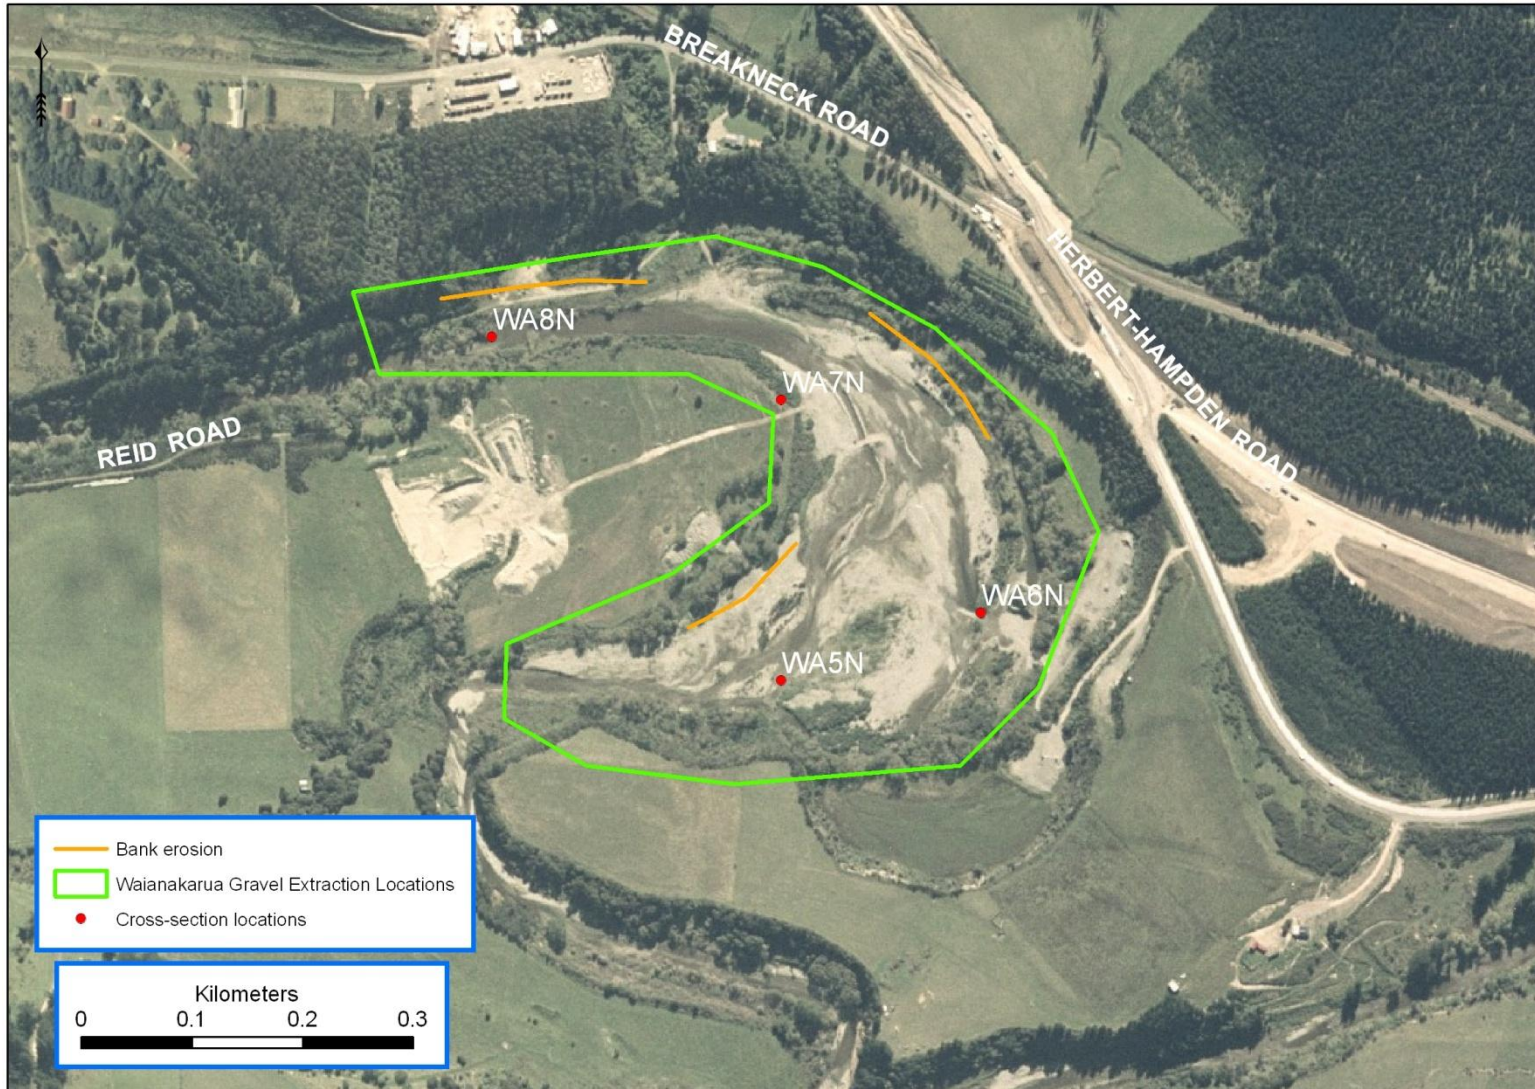
The North Branch of the Waianakarua River has shown bank erosion of both the left and right banks between February 2008 and October 2013. The surveyed reach exhibits areas of both aggradation and degradation with changes in morphology affected by gravel extraction at Sharps Bend (Figure 11).

Figure 11-Location of surveyed cross-sections on the North Branch of the Waianakarua River near Sharps Bend. Areas where significant bank erosion was observed are shown as orange lines. Locations where gravel extraction has historically taken place are shown as green lines.

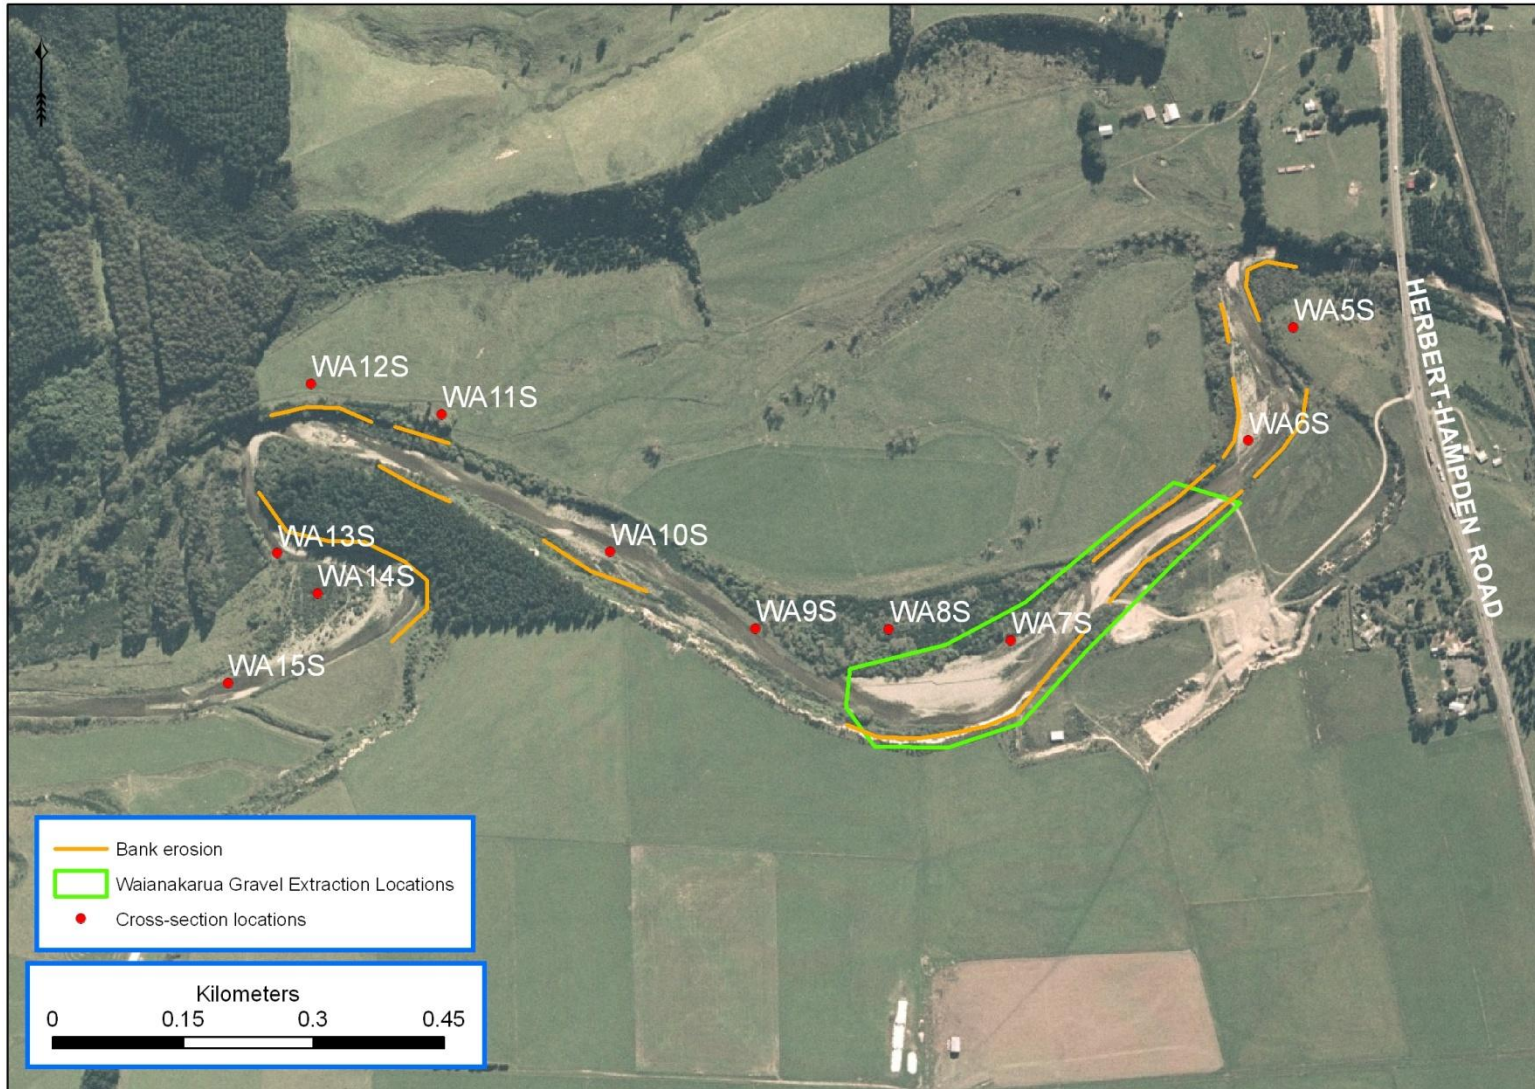
Figure 12-Location of surveyed cross-sections on the South Branch of the Waianakarua River, areas where significant bank erosion was observed are shown as orange lines. Locations where gravel extraction has historically taken place are shown as green lines.

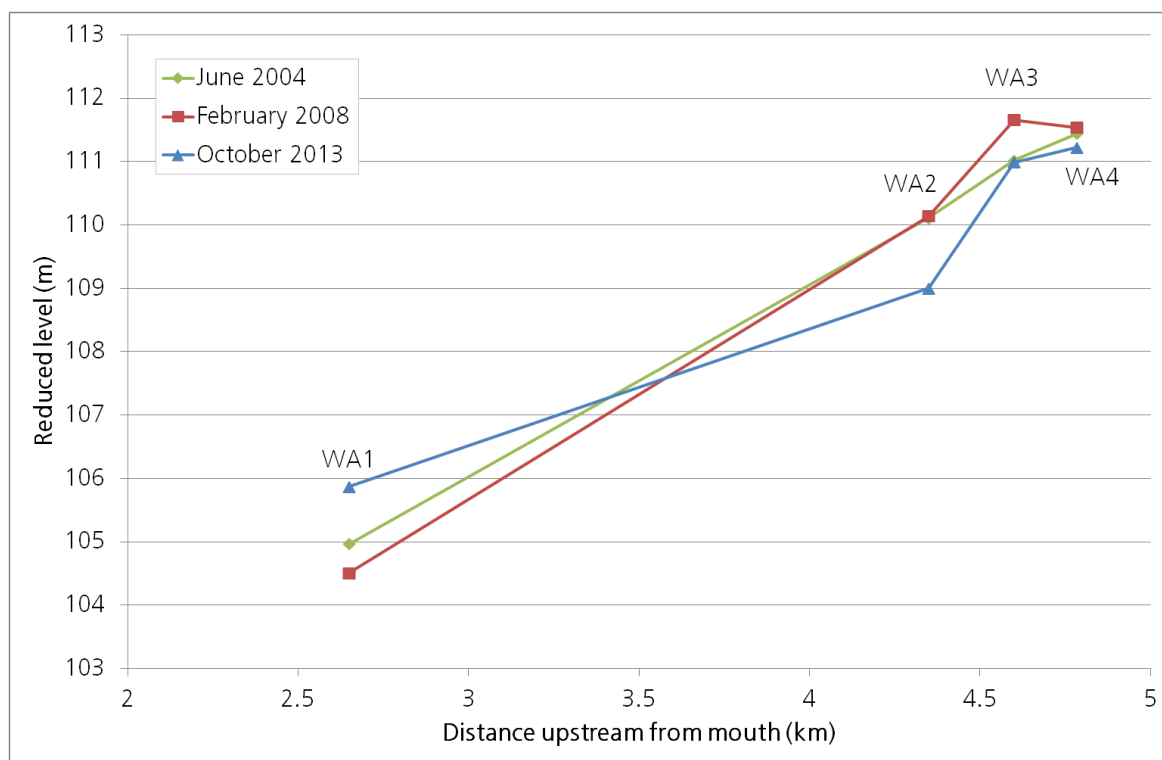
Figure 13-Longitudinal profile showing the thalweg level at cross-section in the main stem of the Waianakarua River

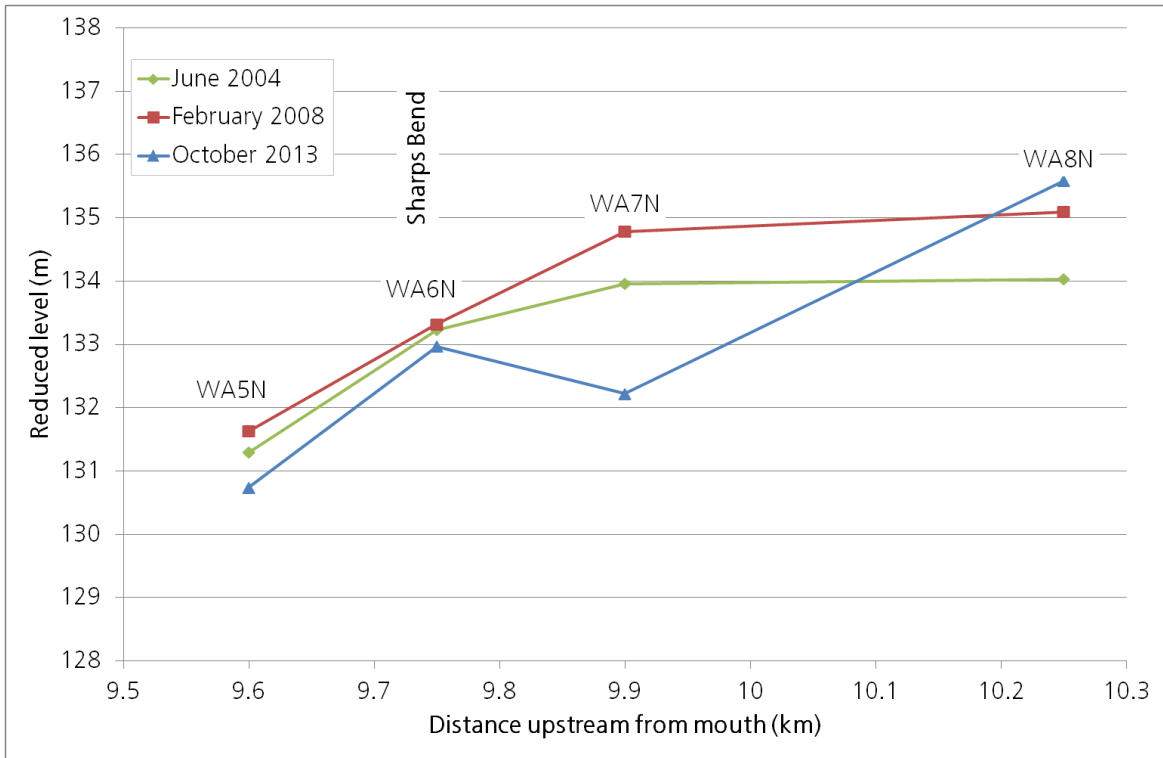
Figure 14-Longitudinal profile showing the thalweg level at cross-section in the North Branch of the Waianakuru River

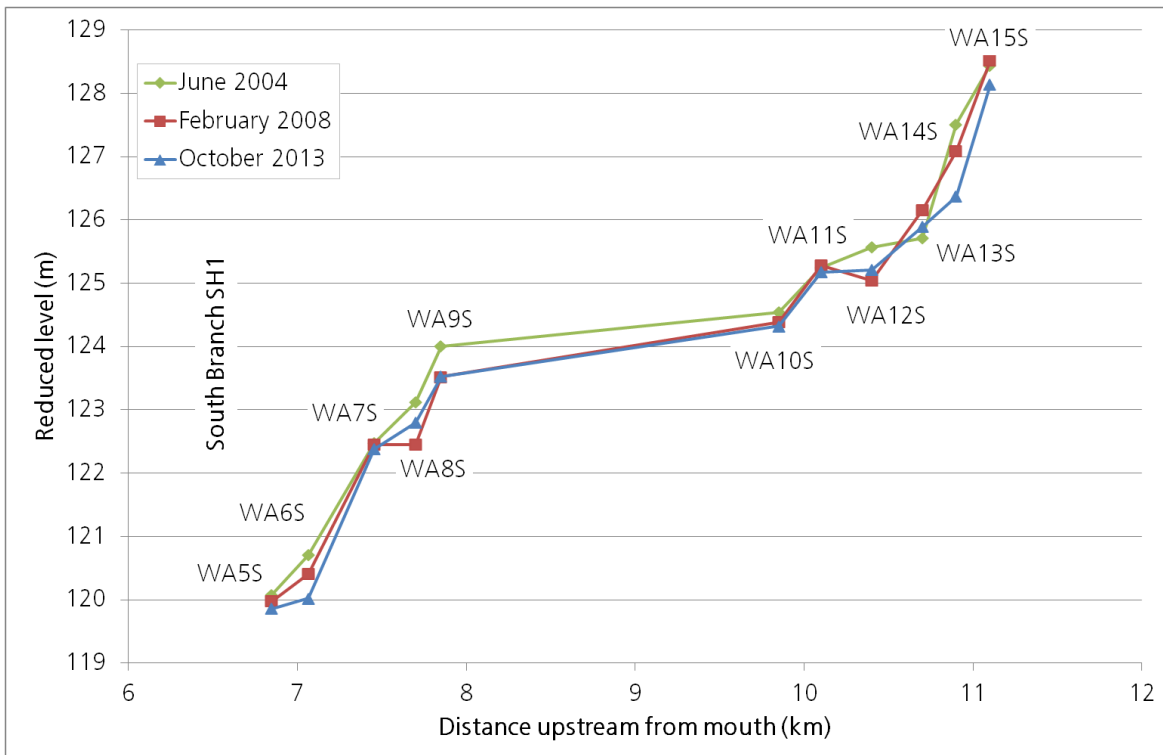
Figure 15-Longitudinal profile showing the thalweg level at cross-section in the South Branch of the Waianakuru River

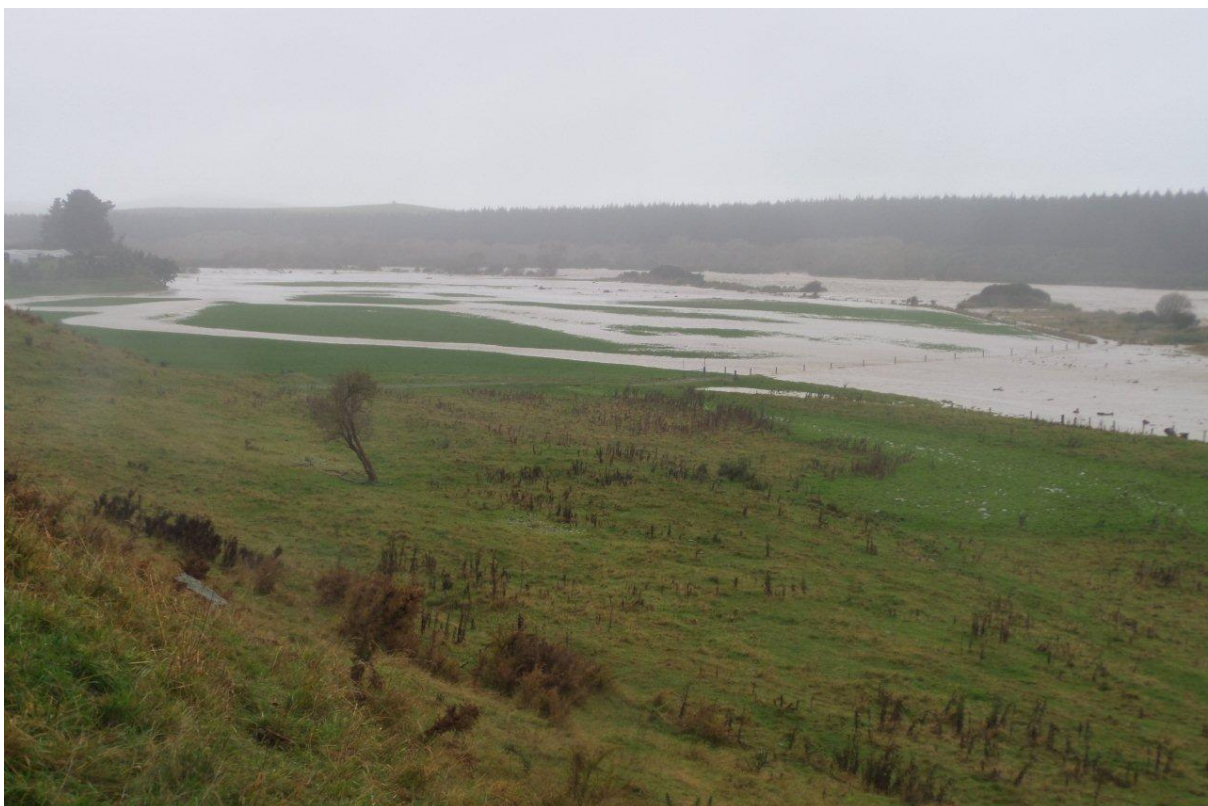
A large flood occurred in April 2014 (after the latest set of cross-section data was collected) which peaked at XXXX (flow to be inserted – Regional Services to provide next day or so) at Brown's Hydrological site (Figure 19). Additional cross-section survey data would be required to describe any changes in channel morphology which may have resulted from this event.

Figure 19- Flooding of farmland on the true left bank of the Waianakarua River, below the confluence of the North and South Branches (Photo taken in the morning of 19 April 2014)
