Document Id: A801392

Report Number: 2015/1008
Prepared For: Technical Committee
Prepared By: Michael Goldsmith, Manager Natural Hazards
Jean-Luc Payan, Senior Investigations Engineer
Rebecca Morris, Groundwater Scientist
Chris Valentine, Manager Engineering
Scott MacLean, Manager Operations
Lu Xiaofeng, Resource Scientist Hydrology
Nineva Vaitupu, Senior Environmental Data Officer
Ben Mackey, Natural Hazards Analyst

Date: 8 July 2015

Subject: **Coastal Otago Flood event 3 June 2015**

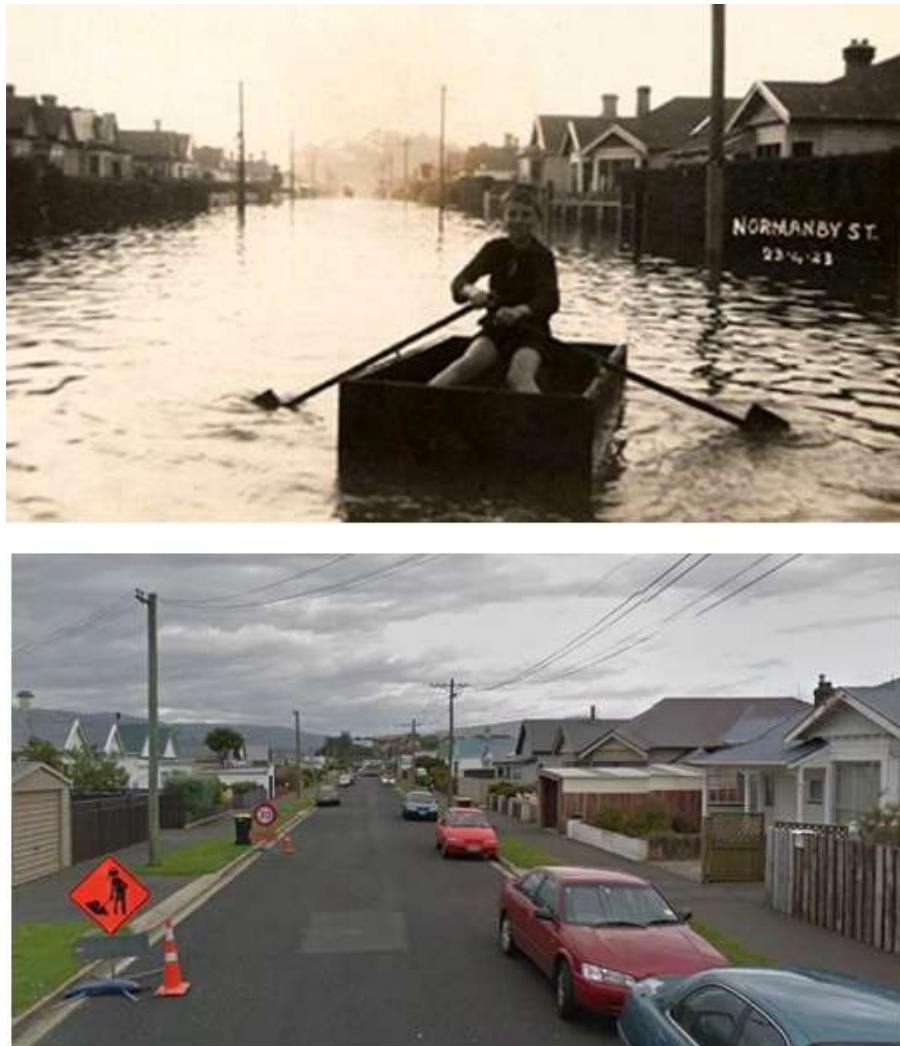
Figure 13. Ponding of surface water at the southern end of Normanby Street, April 1923, and the same view during normal conditions today (Google StreetView). This location is shown on Figure 14.

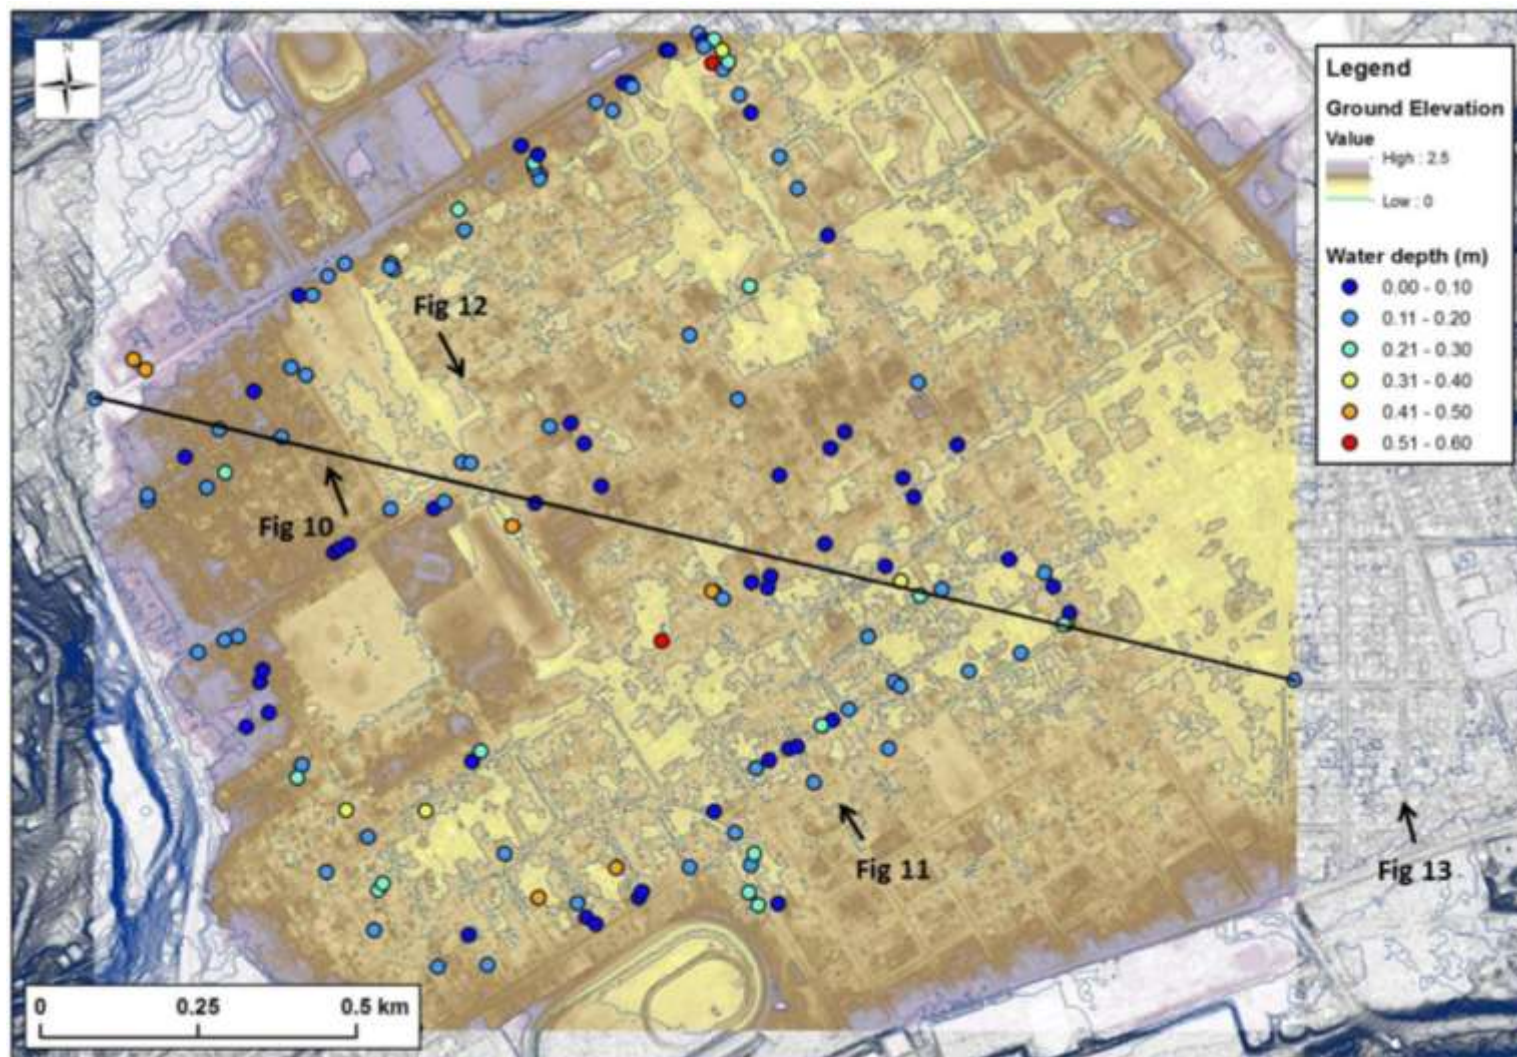
The locations of the 150 surveyed flood debris marks are shown in Figure 14, colour-coded to represent the depth of inundation at each location. It is noted that these are typically located on roads. Depths were calculated by determining the difference between the elevation of the debris mark and the underlying ground level at that location (extracted from LiDAR flown in September 2009). Figure 14 does not show any clear spatial pattern in terms of flood depths across South Dunedin, confirming the initial observation of ORC staff that localised variations in topography were probably the main driver of flood depth. The pale yellow areas mapped on Figure 14 have elevation less than 1m (relative to current mean sea level), and are usually associated with the deeper flood waters. It is noted that the area to the east of the map is also low-lying, but the absence of debris marks suggests it did not experience significant inundation.

Figure 14. Map of South Dunedin with elevation colour scale showing topography between 0 and 2.5m above mean sea level. Contour interval is 1m. Profile line as shown in Figure 15 and Figure 16. Elevation is relative to mean sea level.

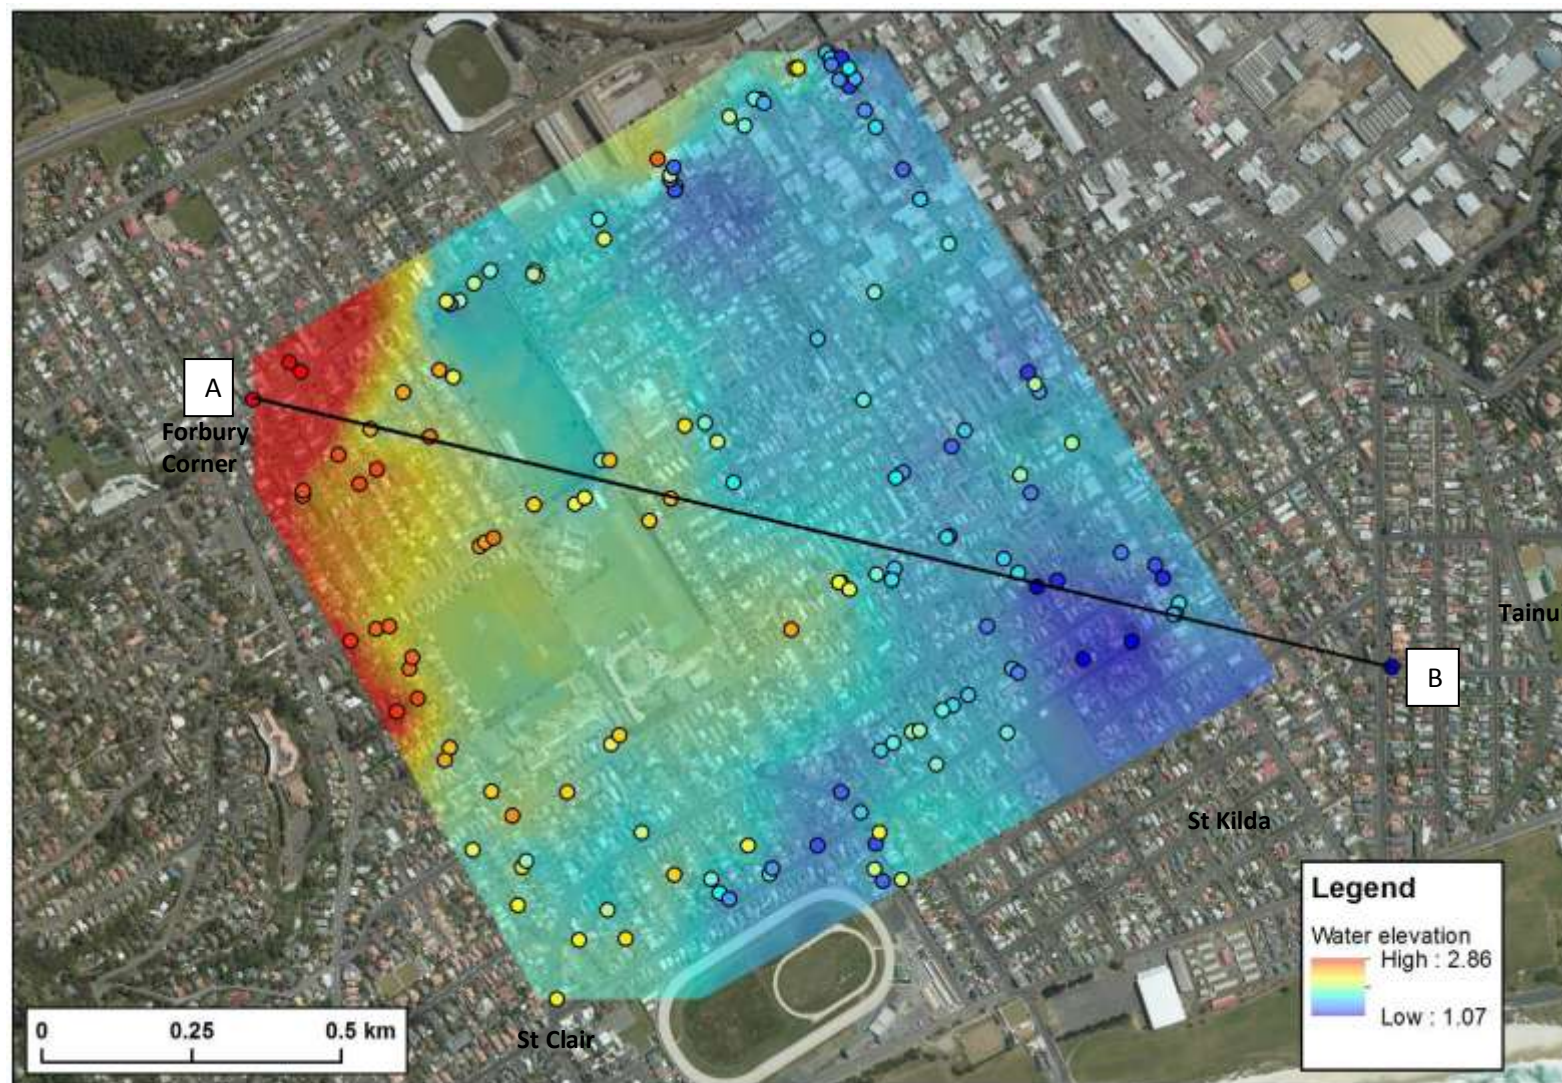
The survey data does show a clear pattern in terms of water elevation relative to mean sea level, as shown in Figure 15. Water level was highest towards the northwest (Forbury Corner) and gradually slopes towards the south and east – i.e. the water level contours generally follow the topography of the gently south-east sloping plain which comprises the South Dunedin area.

Figure 15. Surveyed flood water elevations (dots), and interpolated water surface elevation across South Dunedin. Profile Line A-B as shown in Figure 14 and Figure 16.

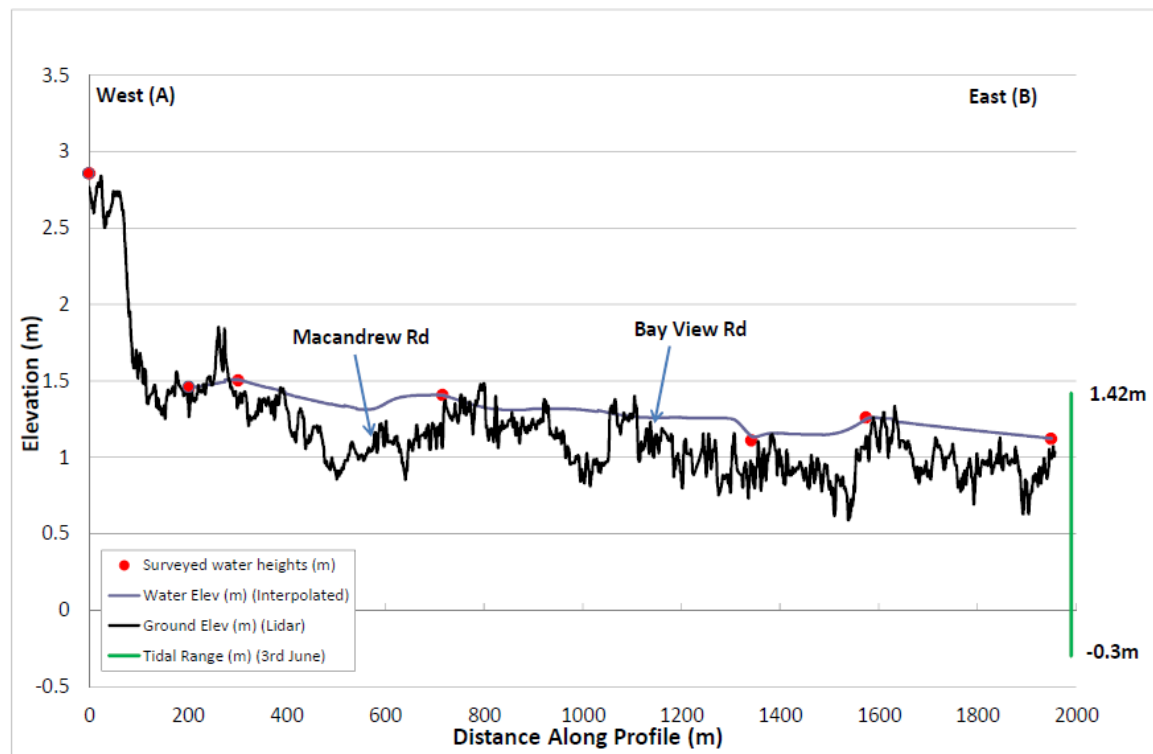
Figure 16. Elevation transect shown on Figure 15. The black line is ground elevation and the blue line is the interpolated maximum flood elevation from Figure 15. The red dots are actual observations of water level in close proximity to the transect line. Water surface has a gradual slope from west to east. The green line shows the range between the highest and lowest sea levels observed at the Green Island sea level recorder on 3 June. Elevations are relative to current mean sea level.

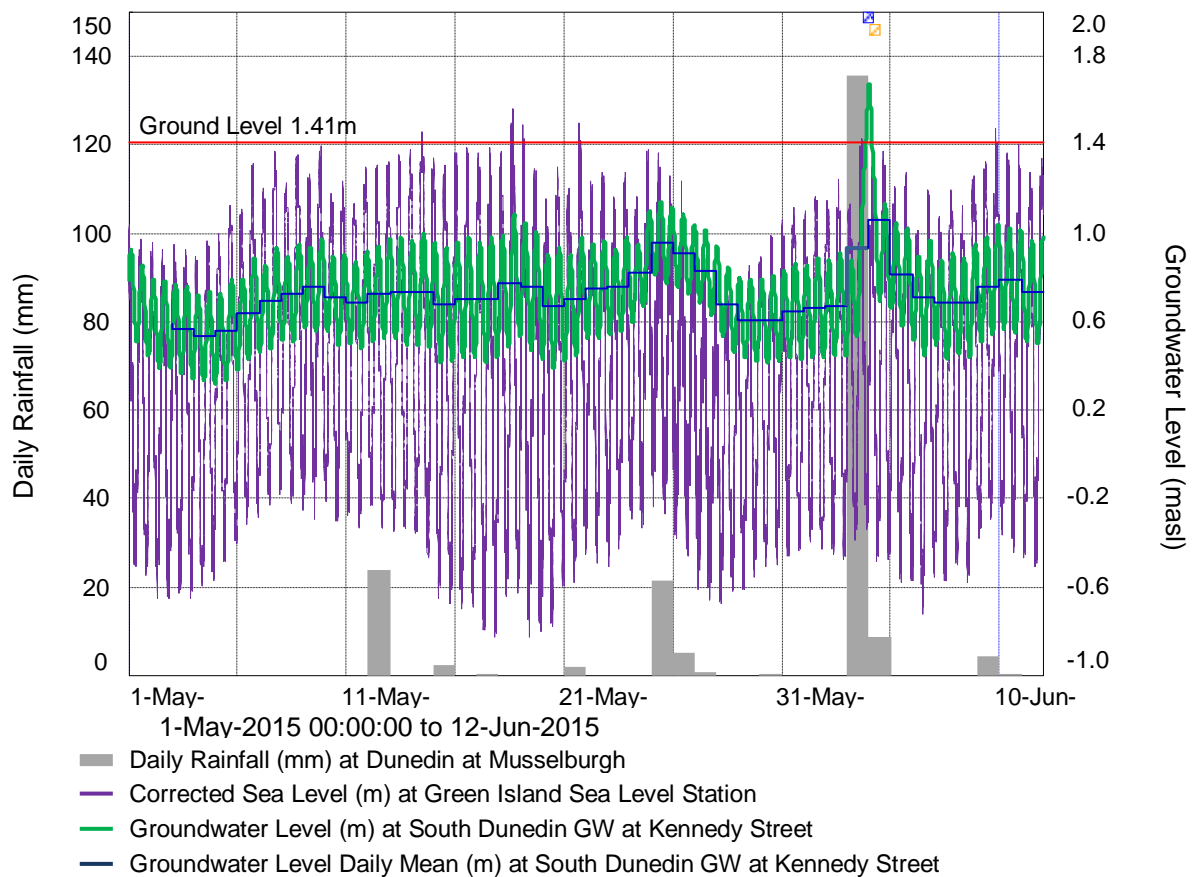
Kennedy Street groundwater bore¹⁶

The Kennedy Street bore is located closest to the coast, and groundwater levels display a cyclic pattern, suggesting that there is tidal influence on water levels at this location. As mentioned in section 6, the tide was at a natural cyclical peak due to a full moon and low barometric pressure. Therefore, groundwater levels at Kennedy Street were also at a cyclical peak. Due to the tidal influence, the groundwater levels prior to the flood have been taken from the average daily groundwater level as shown in blue in Figure 19. Average daily groundwater levels prior to the flood were above average level for this monitoring bore (Average daily groundwater level (gwl): 0.603 metres above sea level (masl); 2 June average daily gwl: 0.674 masl). It is likely that the rain events that occurred on 12 and 26 May 2015 also contributed to a higher groundwater level than average. Groundwater levels rose 0.997 m above the average daily groundwater level for 2 June during the rain event on 3 June 2015 to a maximum level of 1.671 masl, which is 0.261m above the surveyed ground level at this bore (1.41 masl).

Figure 19: Kennedy Street continuous and daily average groundwater record, Green Island Tidal data and daily rainfall from 1 May - 12 June 2015. Ground level is 1.41 masl.

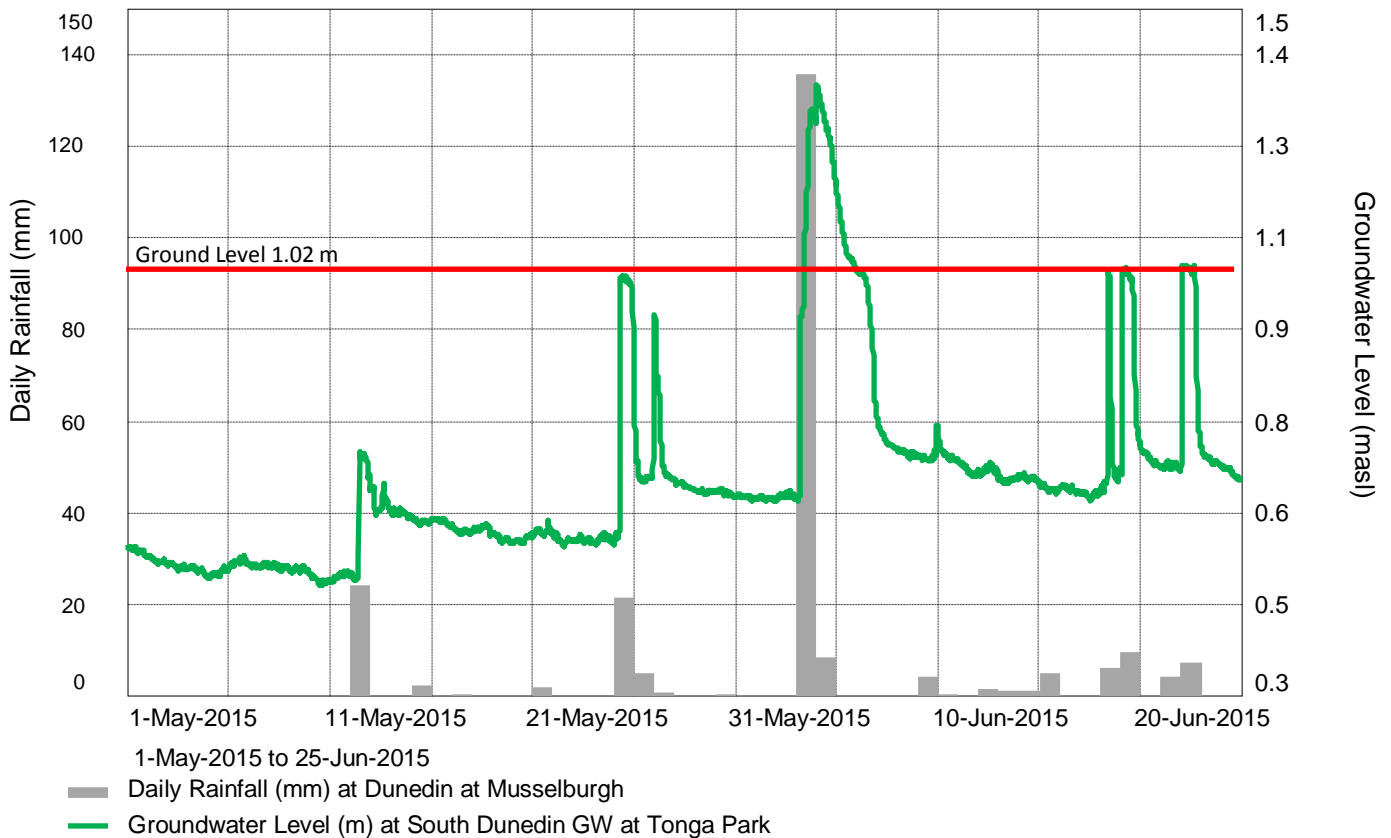
Tonga Park groundwater bore

Groundwater levels prior to the flood were at average level for this monitoring bore (average gwl: 0.557 metres above sea level (masl); 2 June at 11:45 pm: 0.644 masl), though an increasing trend in groundwater level is seen likely due to rain events that occurred on 12 and 26 May 2015. Groundwater levels rose 0.722 m during the rain event on 3 June 2015 to a maximum level of 1.366 masl, which is 0.346 m *above* the surveyed ground level at this bore (1.02 masl). It is noted that the interpolated water surface elevation (Figure 15) at Tonga Park is approximately 1.4 masl, similar to that recorded at the bore, and indicating that this site was likely measuring floodwater as a result of the 3 June event.

Figure 20: Tonga Park continuous groundwater record from 1 May - 25 June 2015. Ground level is 1.02 masl.

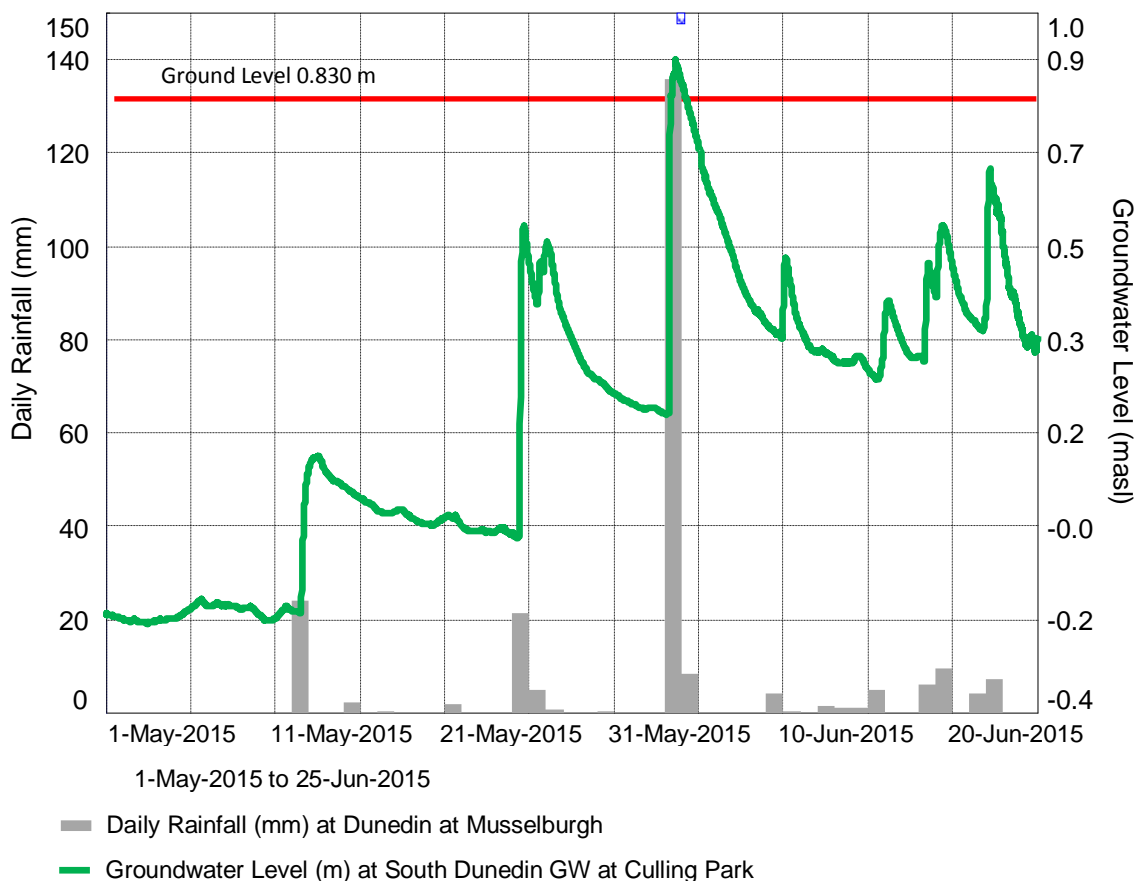
Culling Park groundwater bore

The groundwater monitoring bore at Culling Park has a shorter monitoring record than the other 3 sites, as this bore was installed in May 2014. Groundwater levels prior to the flood were above average level at this location (average gwl: 0.075 masl; 2 June at 11:45 pm: 0.198 masl). This may be as a result of the shorter groundwater record decreasing the average water level, never the less it is likely that the rain events that occurred on 12 and 26 May 2015 contributed to a slightly higher groundwater level than average. Groundwater levels rose 0.707m during the rain event on 3 June 2015 to a maximum level of 0.905 masl, which is 0.075m *above* the surveyed ground level at this bore (0.830 masl).

Figure 21: Culling Park continuous groundwater record from 1 May - 25 June 2015. Ground level is 0.830 masl.

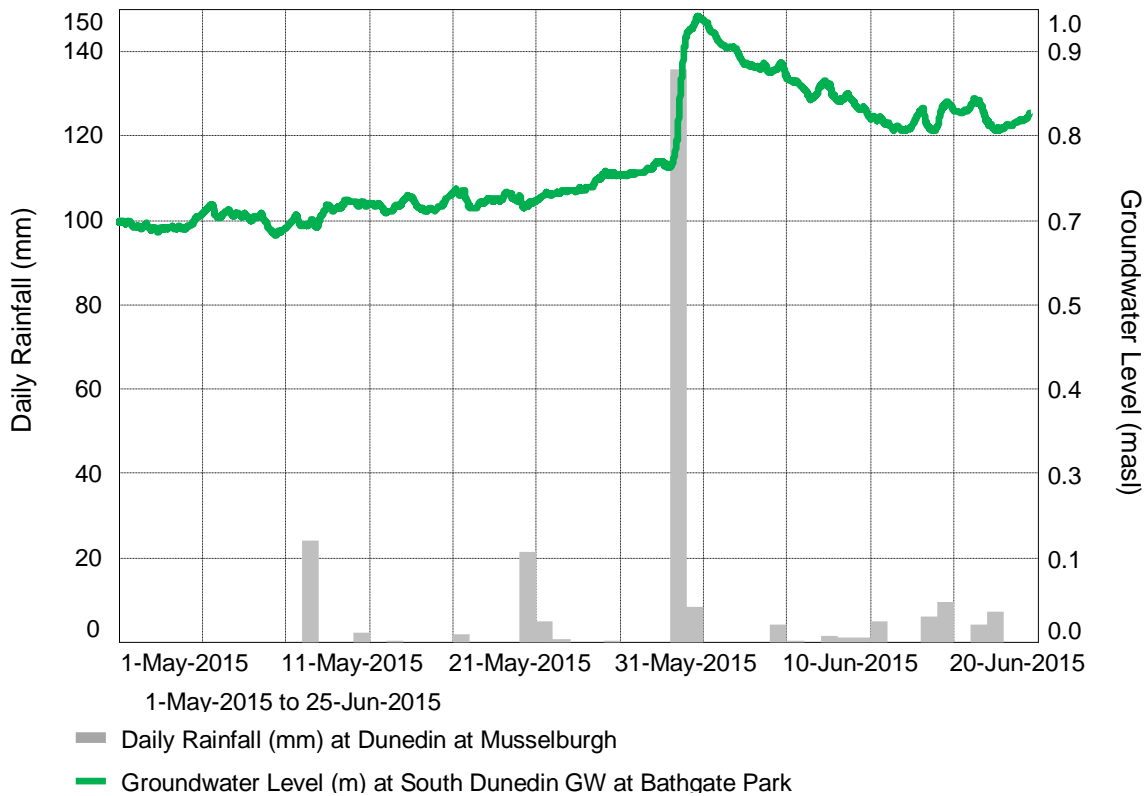
Bathgate Park groundwater bore

Groundwater levels prior to the flood were slightly above average level for this monitoring bore (Average gwl: 0.689 masl; 2 June at 11:45 pm: 0.751 masl), most likely as a result of rain events that occurred on 12 and 26 May 2015. Groundwater levels rose 0.238 m during the rain event on 3 June 2015 to a maximum level of 0.988 masl, which is 0.532 m *below* the surveyed ground level at this bore (1.52 masl).

Figure 22: Bathgate Park continuous groundwater record from 1 May - 12 June 2015. Ground level is 1.52 masl.

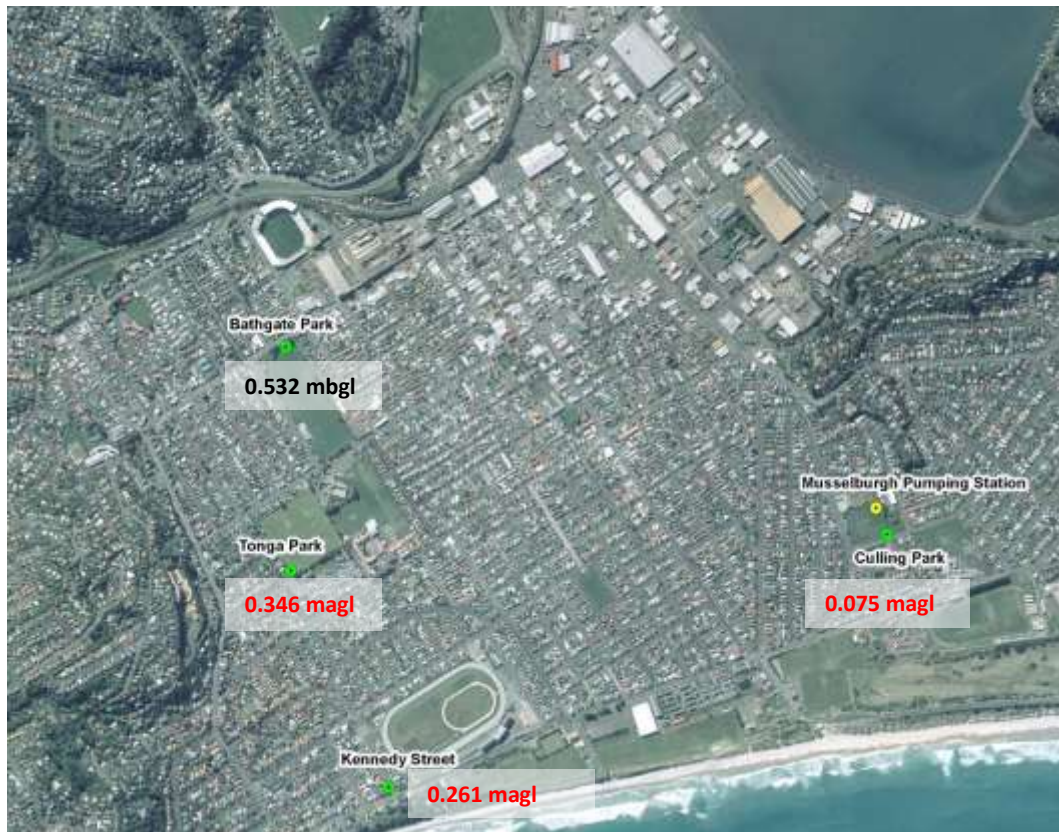
Groundwater levels from three bores (Kennedy Street, Tonga and Culling Park) rose above ground level as a result of the rain event that occurred on 3 June 2015 (Figure 23). Groundwater levels at Bathgate Park were 0.53m below ground level. Groundwater may have contributed to the surface flooding in the low lying areas of South Dunedin. However, elevated groundwater levels close to ground level may have prevented surface water from infiltrating into the ground and dispersing into the aquifer below.

Figure 23: Location of groundwater above and below ground level in South Dunedin. Red – metres above ground level. Black – metres below ground level.

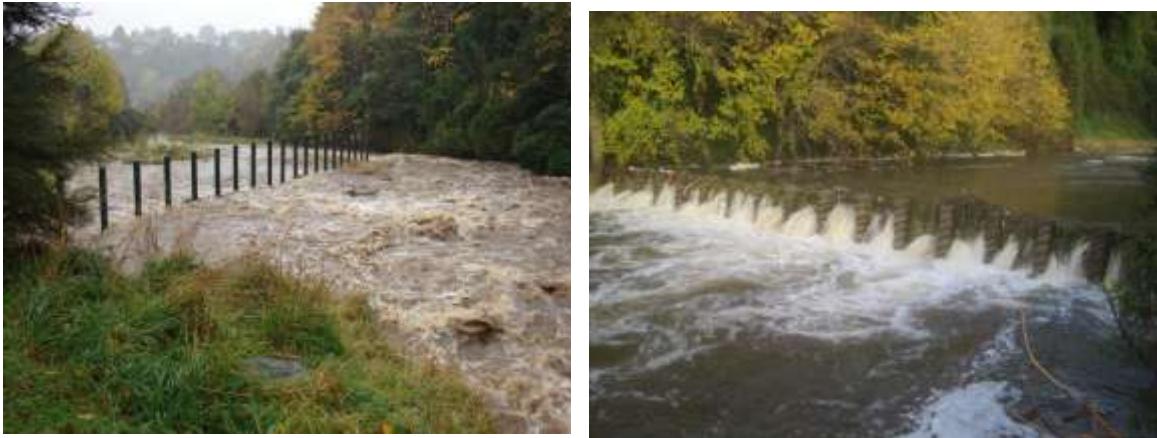
The Water of Leith debris traps performed as intended. The Woodhaugh Street boulder trap collected the bulk of the Leith debris (Figure 26) with the Malvern Street debris trap further upstream collecting a lesser amount of material. As soon as flood waters receded, contractors were engaged to clear the traps. A landslide occurred at the northern end of Malvern Street which partially blocked the channel but did not negatively affect channel capacity during the event. This landslide debris was cleared in the days following the flood.

Figure 26. Water of Leith debris trap at Malvern Street (left) and Woodhaugh Street boulder trap (right) during the event, 3 June 2015

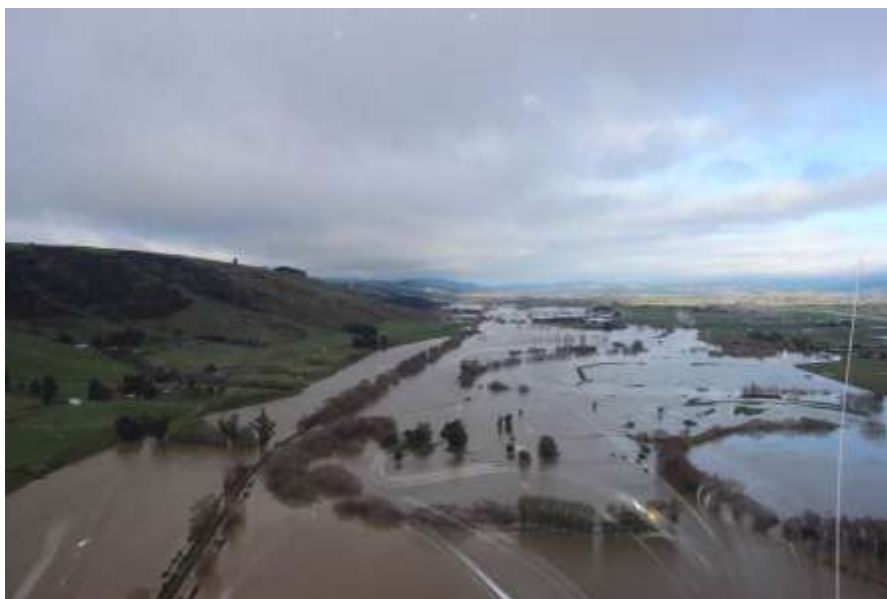
As expected during high flows in the Taieri River, water overtopped the river banks and extensively flooded the berm areas and the Taieri River floodway (Figure 35) but no overtopping of the main floodbanks was recorded. The Henley spillway downstream of Otokia operated between approximately 10am on 4 June and 2am on 5 June (Figure 36) resulting in extensive ponding in the Henley floodway as expected in a rainfall event of this type. Much of the land surrounding the settlement of Henley was flooded, particularly at the southern end of the township (Figure 37). The flooding resulted from runoff from the coastal hills not being able to be discharged into the Taieri River due to high water levels and accumulating on low lying areas.

Figure 35. Taieri River berms and floodway looking southwest, downstream of Allanton – 4 June 2015

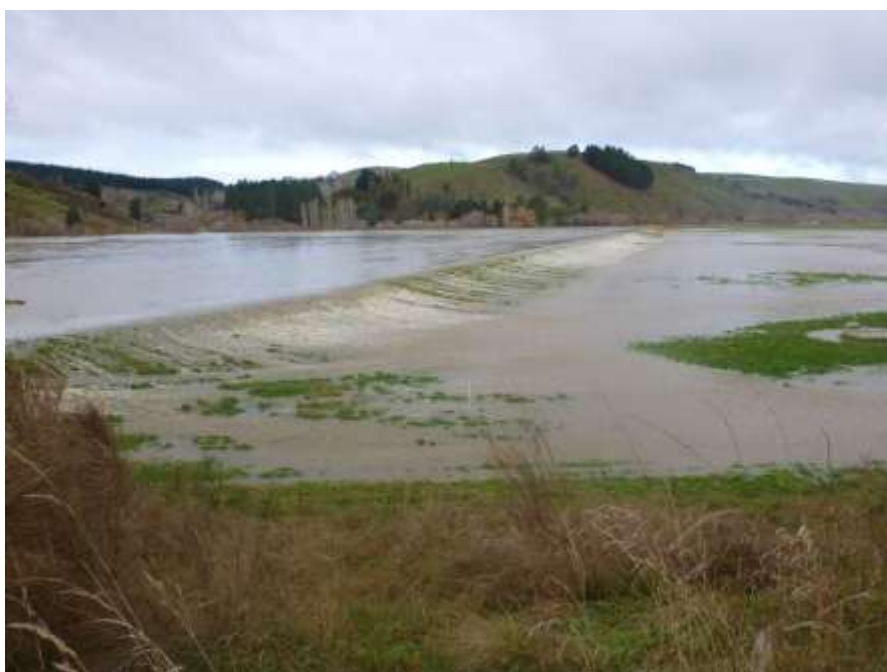
Figure 36. Henley Spillway (downstream of Otokia) operating – 4 June 2015 11.45am

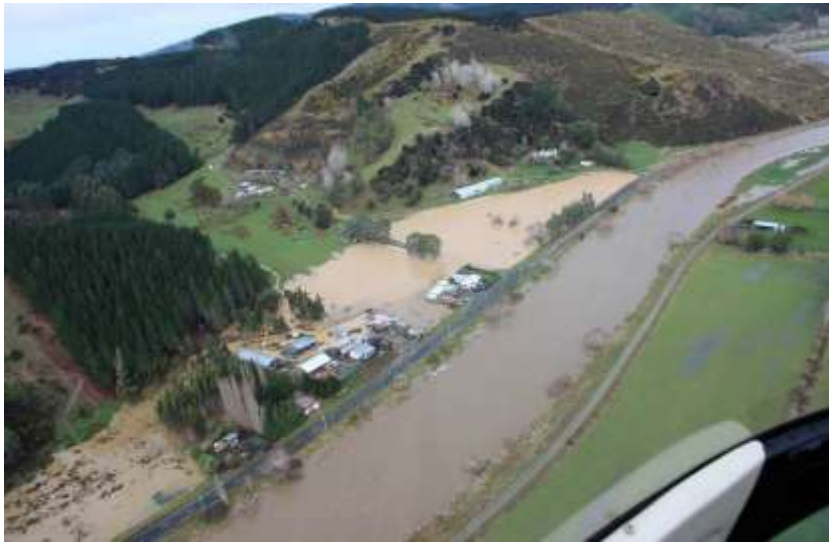
Figure 37. Aerial view towards the south of floodwater at Henley – 4 June 2015

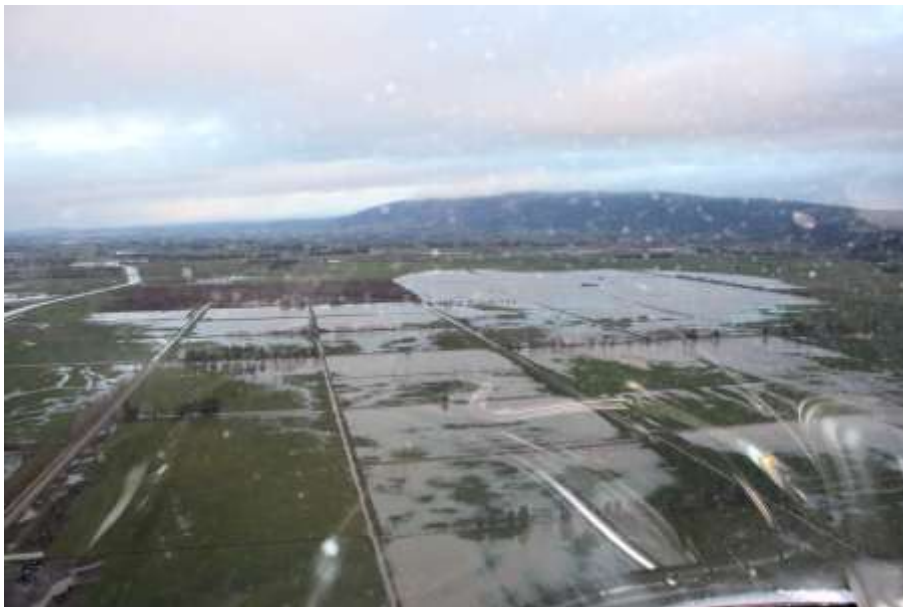
The threshold of operation of the Riverside Spillway was not reached and no water from the Taieri River spilled into the Upper Pond (Figure 38). However, water from other sources resulted in a maximum water depth of approximately 1.2m in the Upper Pond, with a total stored volume of 1.5 million cubic meters (4% of the Upper Pond total capacity). Sources of floodwater included the northern hill catchments (including Mill Creek), internal runoff and the Silver Stream (after it overtopped at the Gordon Road Spillway).

Figure 38. Ponding in the Upper Pond, view is towards the southwest – 4 June 2015

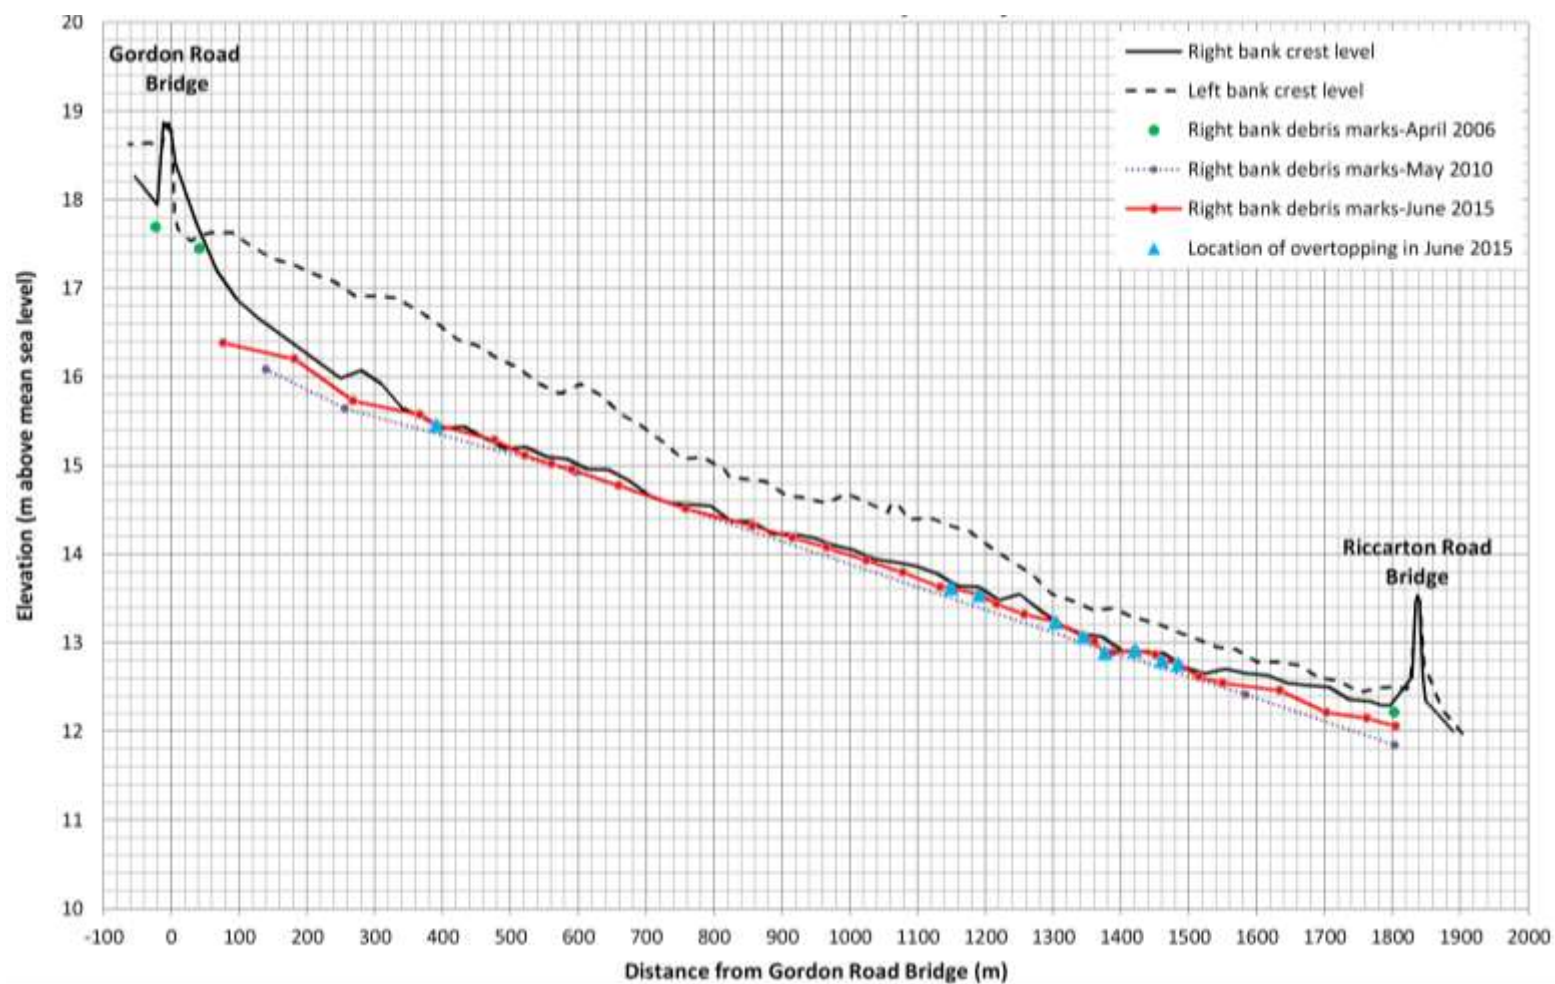
The Silver Stream overtopped at the Gordon Road Spillway, between approximately 4pm and 10pm on 3 June. Figure 39 shows the overtopping locations were mainly at the downstream end of the spillway, and that overtopping was of a considerably smaller scale than during the April 2006 event. The spillway is part of the Lower Taieri Flood Protection Scheme and overtopping is expected during high flows in the Silver Stream. Spilled water from the Silver Stream made its way downslope towards the Upper Pond, and combined with other sources of floodwater, contributed to flooding and ponding in a number of areas.

Figure 39. June 2015 maximum water level in the Silver Stream in relation to the top of the left and right floodbanks, between Gordon and Riccarton roads. Flood debris marks collected after the April 2006 flood event are also plotted.

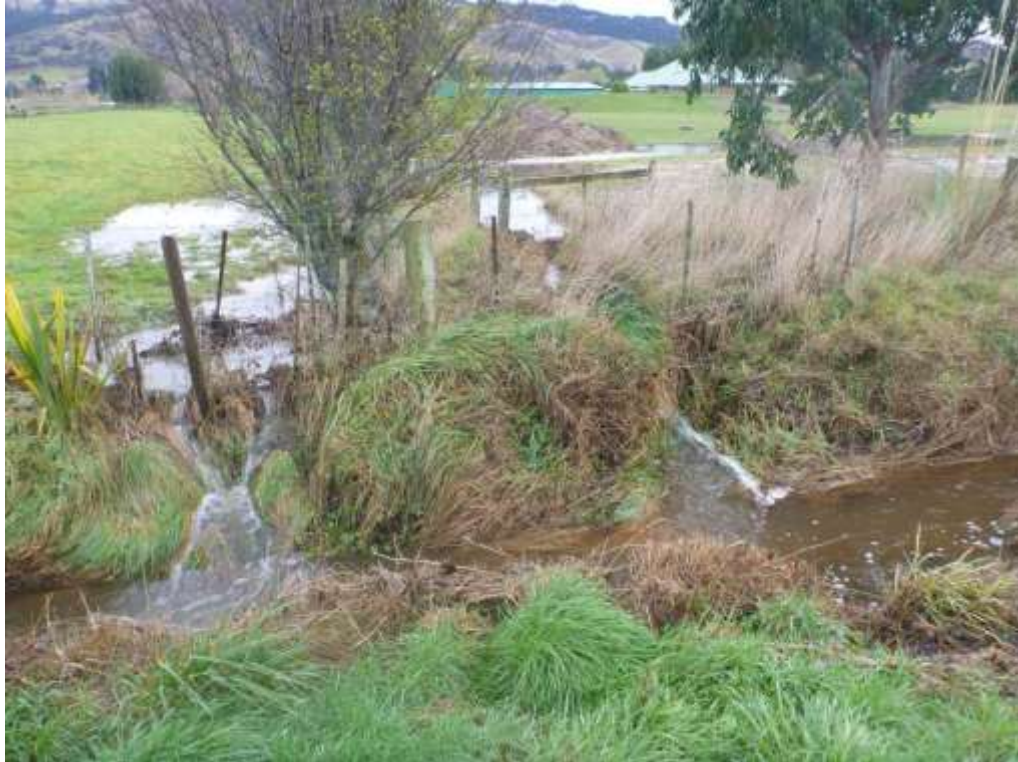
Observations made by ORC staff during and after the event confirmed the criticality of the swales and overland flow paths in conveying runoff from the hill catchments and complementing the ORC rural drainage network (e.g. Figure 42).

Figure 42. Example of overland flow path conveying runoff from the hill catchments to an ORC drain between Riccarton Road and Gordon Road – 4 June 2015

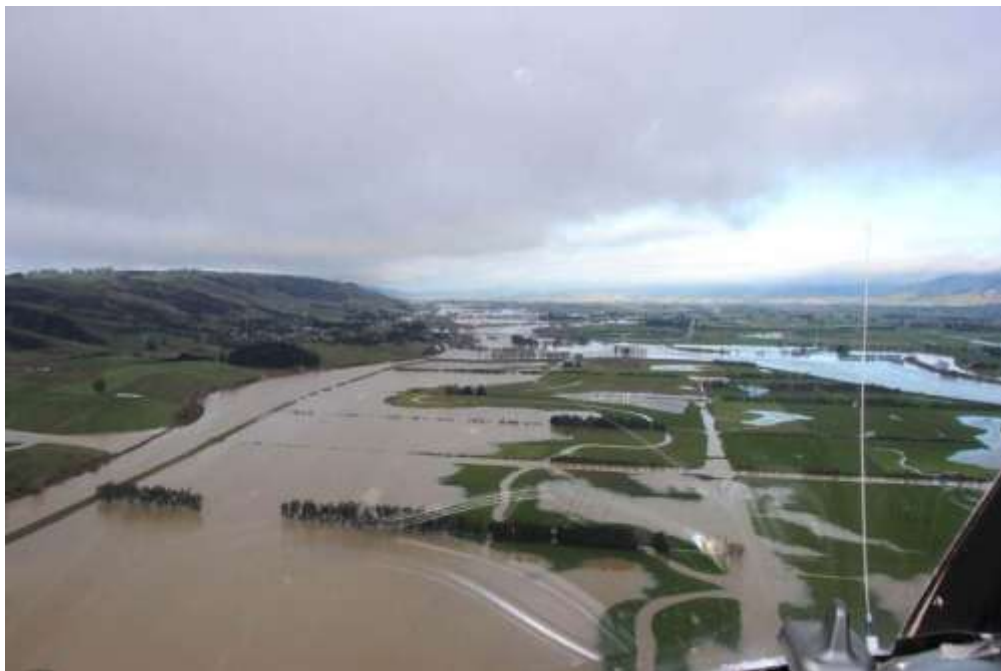
Extensive ponding was also recorded in the Lower Pond (Figure 43 and Figure 44) due to water overtopping the Owhiro Stream right bank, runoff from the southern hill catchments and rainfall accumulation. Extensive flooding occurred on the flanks of the coastal hills south of the Lower Pond mainly due to runoff from the southern hill catchments and the Owhiro Stream (Figure 44).

Figure 43. Ponding in the Lower Pond, view is towards the southwest – 4 June 2015

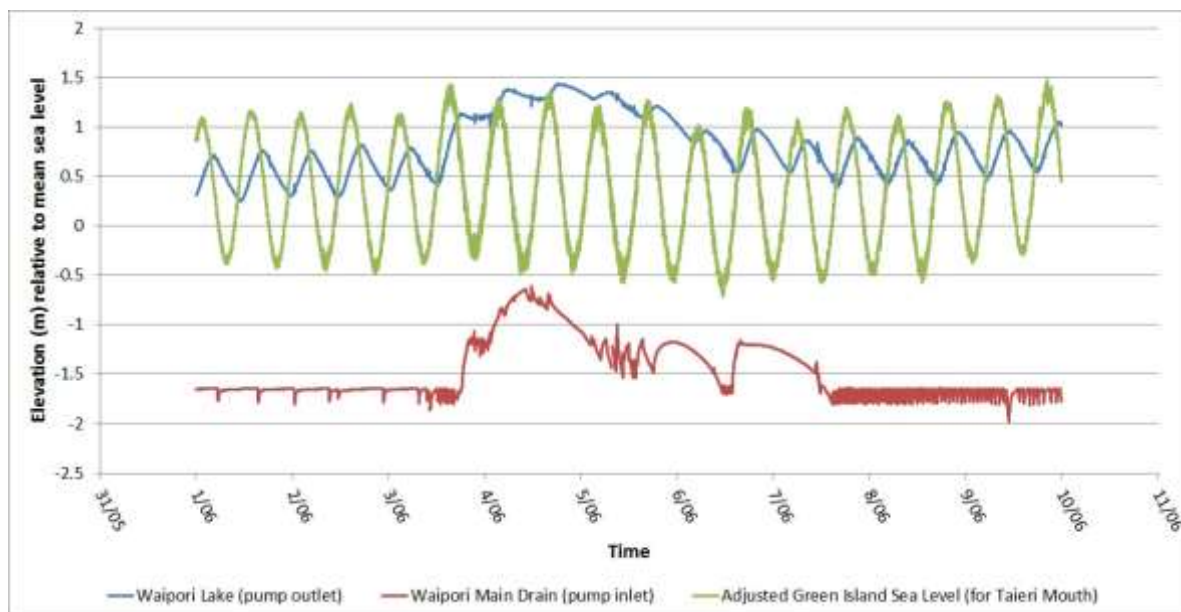
The *Waipori pump station* achieved the necessary pumping capacity to maintain drain levels and convey floodwater (Figure 46).

Figure 46. Main drain level at Waipori pump station, level of Lake Waipori and sea level, 1 to 9 June 2015

Landholders indicated their satisfaction that the event had been contained. The flood conditions provided valuable learnings, and an opportunity to refine the control system. It had not been previously possible to commission the pump station with all pumps running simultaneously with a high discharge head. Low voltages were noted in the pump house, tripping all pumps several times, each time requiring a manual reset. As a result of this, the pump station was manned by operations staff and then contractors for the first 24 hours of the event to ensure that the system operated as required. The reasons why the pumps were tripping was diagnosed and corrected by adjustments to the motor control parameters over the two days succeeding the event. The learning from this event will be applied to other pump stations in the future.

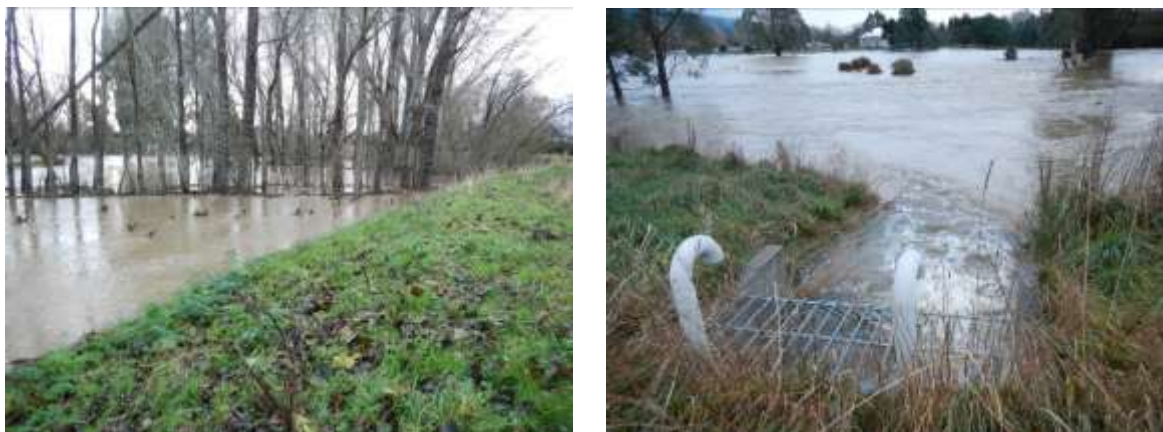
The Clutha District Council (CDC) floodbank downstream of SH1 prevented the Tokomairiro River from affecting low-lying properties in the Mill Street area, with some freeboard (Figure 47), and the CDC pump appeared to be assisting in the removal of surface runoff from Milton.

Figure 47. The floodbank (left) and pump station outlet (right) at Milton, downstream of SH1, 3 June 2015

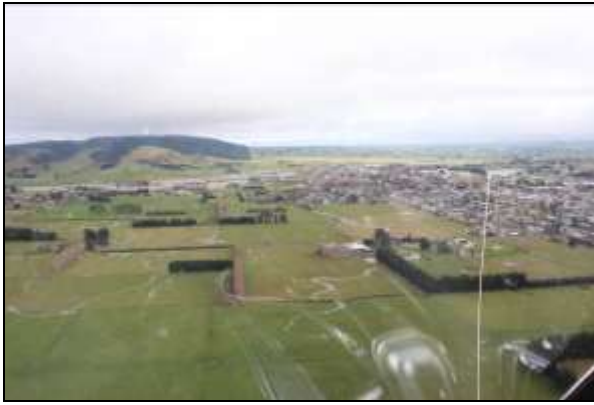
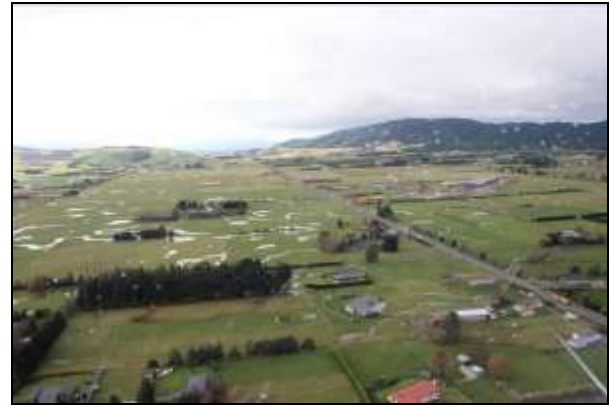
Figure 48. Residual floodwater in swale features, 4 June 2015. The left image shows the area to the east of Milton (looking southwest) and the right image shows the area to the north of Milton (looking northeast), with SH1 visible.

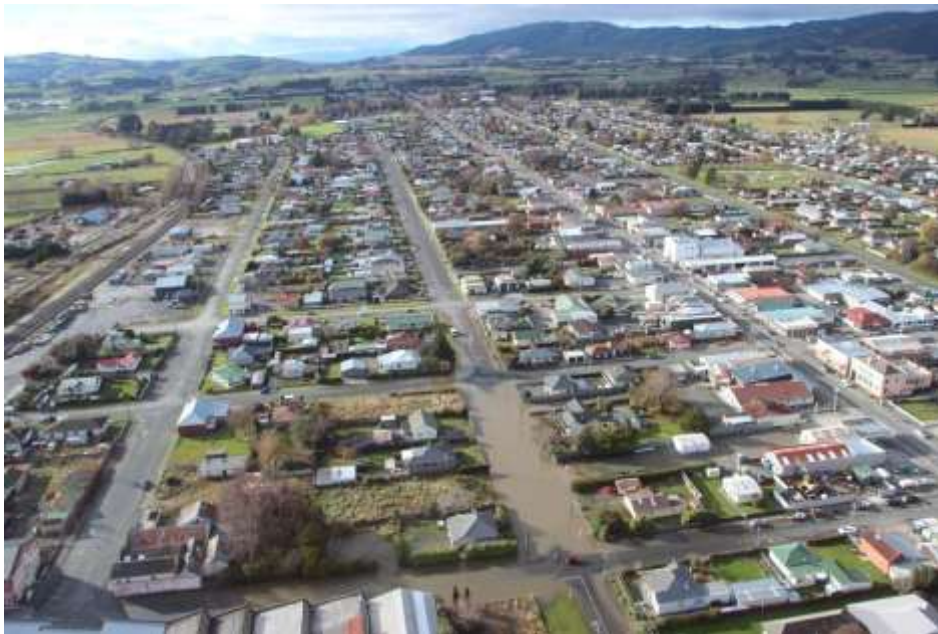
Floodwater affected properties in Milton, as well as a number of roads in the area. Floodwaters again ponded in the naturally low-lying area at the southern end of Ajax Street (Figure 49), and one property in Ajax Street was evacuated, along with one each in Chaucer, Lowery and Johnson streets. All four properties were also evacuated in July 2007. Other residents reported significant amounts of water on their properties, but did not evacuate.

Figure 49. Aerial view of floodwater on Ajax Street (centre) Milton, with Union Street (SH1) to the right, 4 June 2015

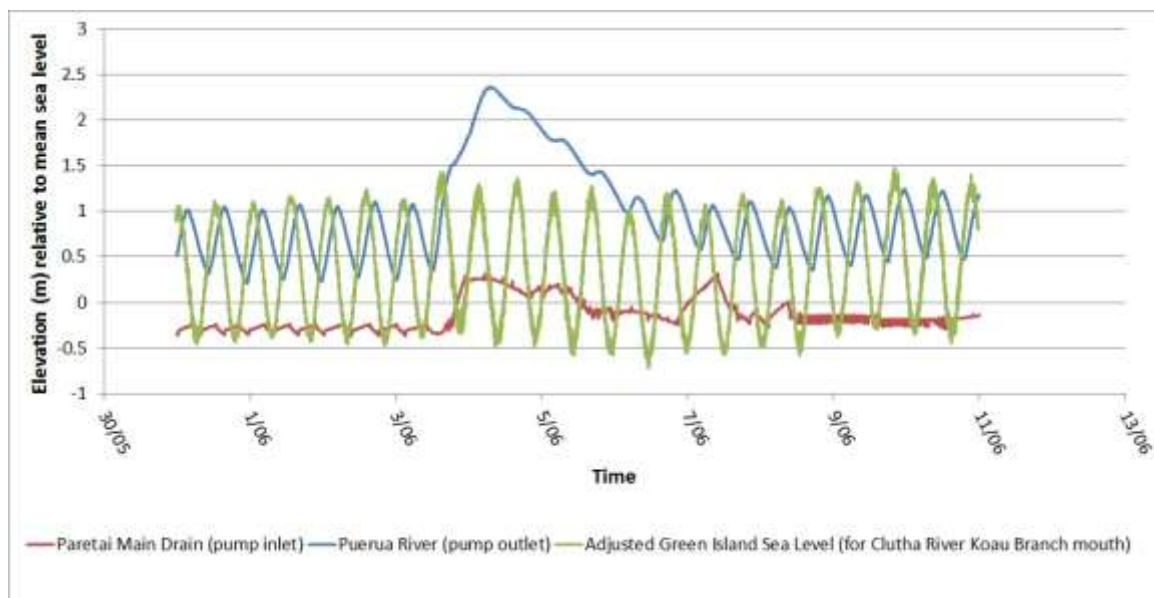
The *Paretai pump station* performed well, the heavy rainfall provided an opportunity to study the new control systems performance while operating under high head and flow conditions (Figure 50). This exercise has resulted in a refinement of the control philosophy. These changes will provide benefits in the future, both for optimising the effectiveness and improving the reliability of the pump station assets.

Figure 50. Paretai Pump Station inlet water level, outlet water level (Puerua River) and sea level, 1 to 10 June 2015
