Document Id: A801392

Report Number: 2015/1008
Prepared For: Technical Committee
Prepared By: Michael Goldsmith, Manager Natural Hazards
Jean-Luc Payan, Senior Investigations Engineer
Rebecca Morris, Groundwater Scientist
Chris Valentine, Manager Engineering
Scott MacLean, Manager Operations
Lu Xiaofeng, Resource Scientist Hydrology
Nineva Vaitupu, Senior Environmental Data Officer
Ben Mackey, Natural Hazards Analyst

Date: 8 July 2015

Subject: **Coastal Otago Flood event 3 June 2015**

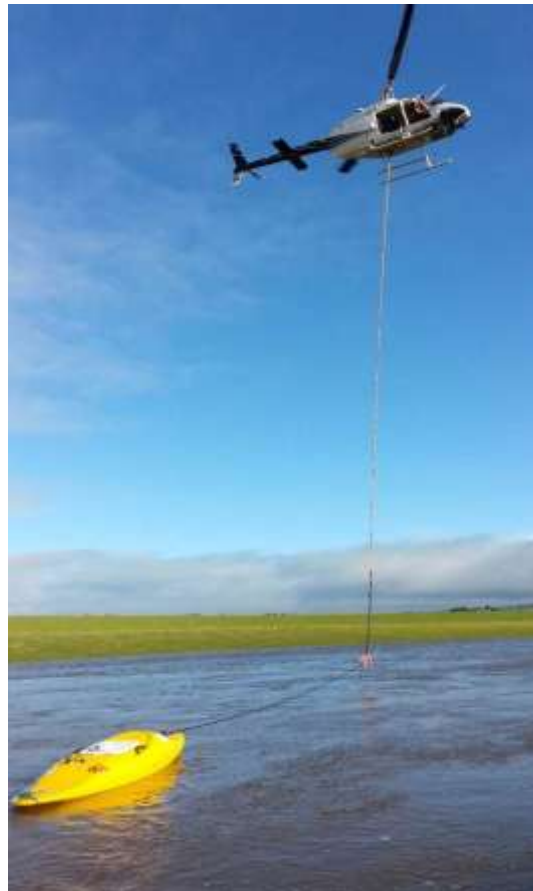
A traditional current meter gauging from the SH87 Bridge at Outram was obtained, and this has helped to corroborate recent flood gaugings using Heli-gauging techniques developed by ORC, using more modern flow measuring technology (as shown in Figure 53).

Figure 53. Heli-gauging underway on the Tokomairiro River using a kayak-mounted Acoustic Doppler Current Profiler (ADCP) flow measuring device
