Cardrona River Channel Morphology

May 2016

Otago Regional Council

Technical summary

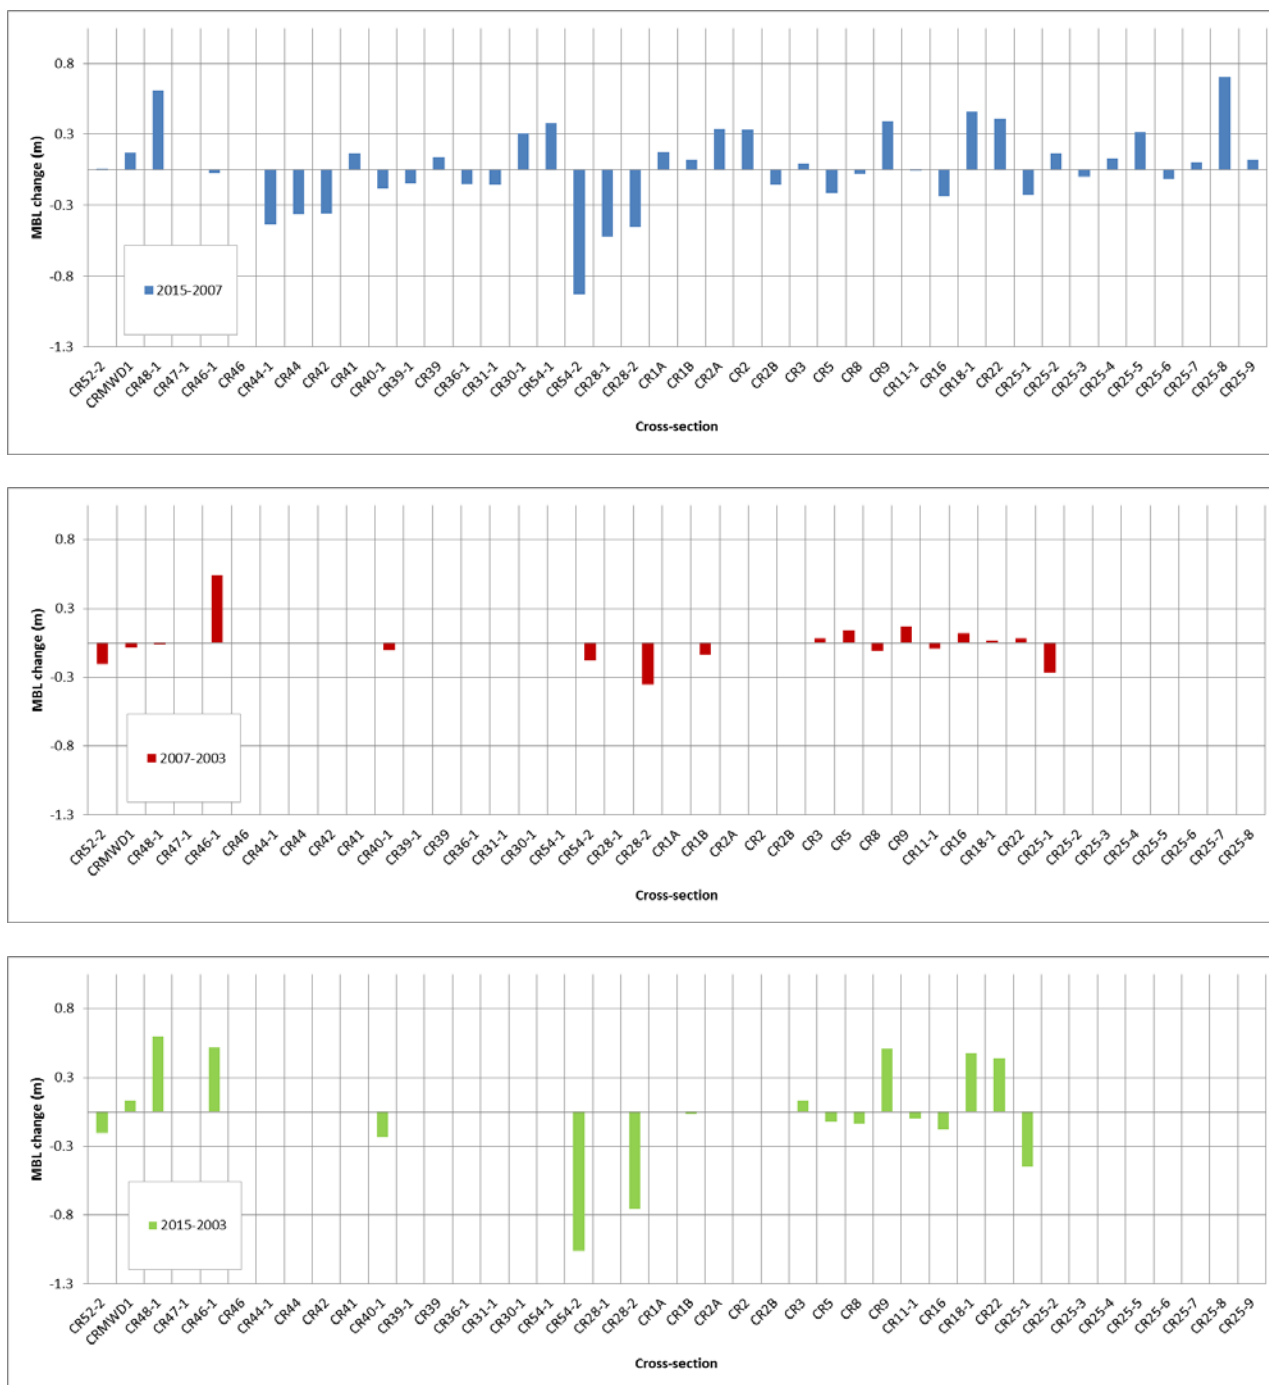
Changes in mean bed level (MBL) at each cross-section between 2007 to 2015 and 2003 to 2007, and the net change over the entire period⁴ are shown in Figure 3. Cross-section locations, the magnitude of MBL change between 2007 and 2015, and areas of bank erosion are shown in Figure 4 to Figure 8. Individual cross-sections are shown in Appendix 3. The variability in MBL change between cross-section locations and survey years is shown in Figure 3. The top graph in Figure 3 (2015 to 2007) shows that there was aggradation in the lowest reaches (as shown in Figure 4 and Figure 5) with large variation in the mid reaches (as shown in Figure 6 and Figure 7) and minimal degradation or aggradation in the upper reaches (as shown in Figure 8). The middle graph in Figure 3 (2007 to 2003) shows less variation in MBL with greatest change being at cross-section CR46-1 (Figure 115) which experienced an increase in MBL of 0.49 m. The bottom graph in Figure 3 shows the net change in MBL over the period 2015 to 2003 which also highlights the variability in MBL.

Figure 3. Changes in MBL at cross-sections on the Cardrona River between 2007 and 2015, 2003 and 2007 and the net change over the entire period. The location of each cross-section is shown in Figure 4 to Figure 8 (MBL could not be calculated at all locations as not all cross-sections were surveyed each year (Appendix 1)).

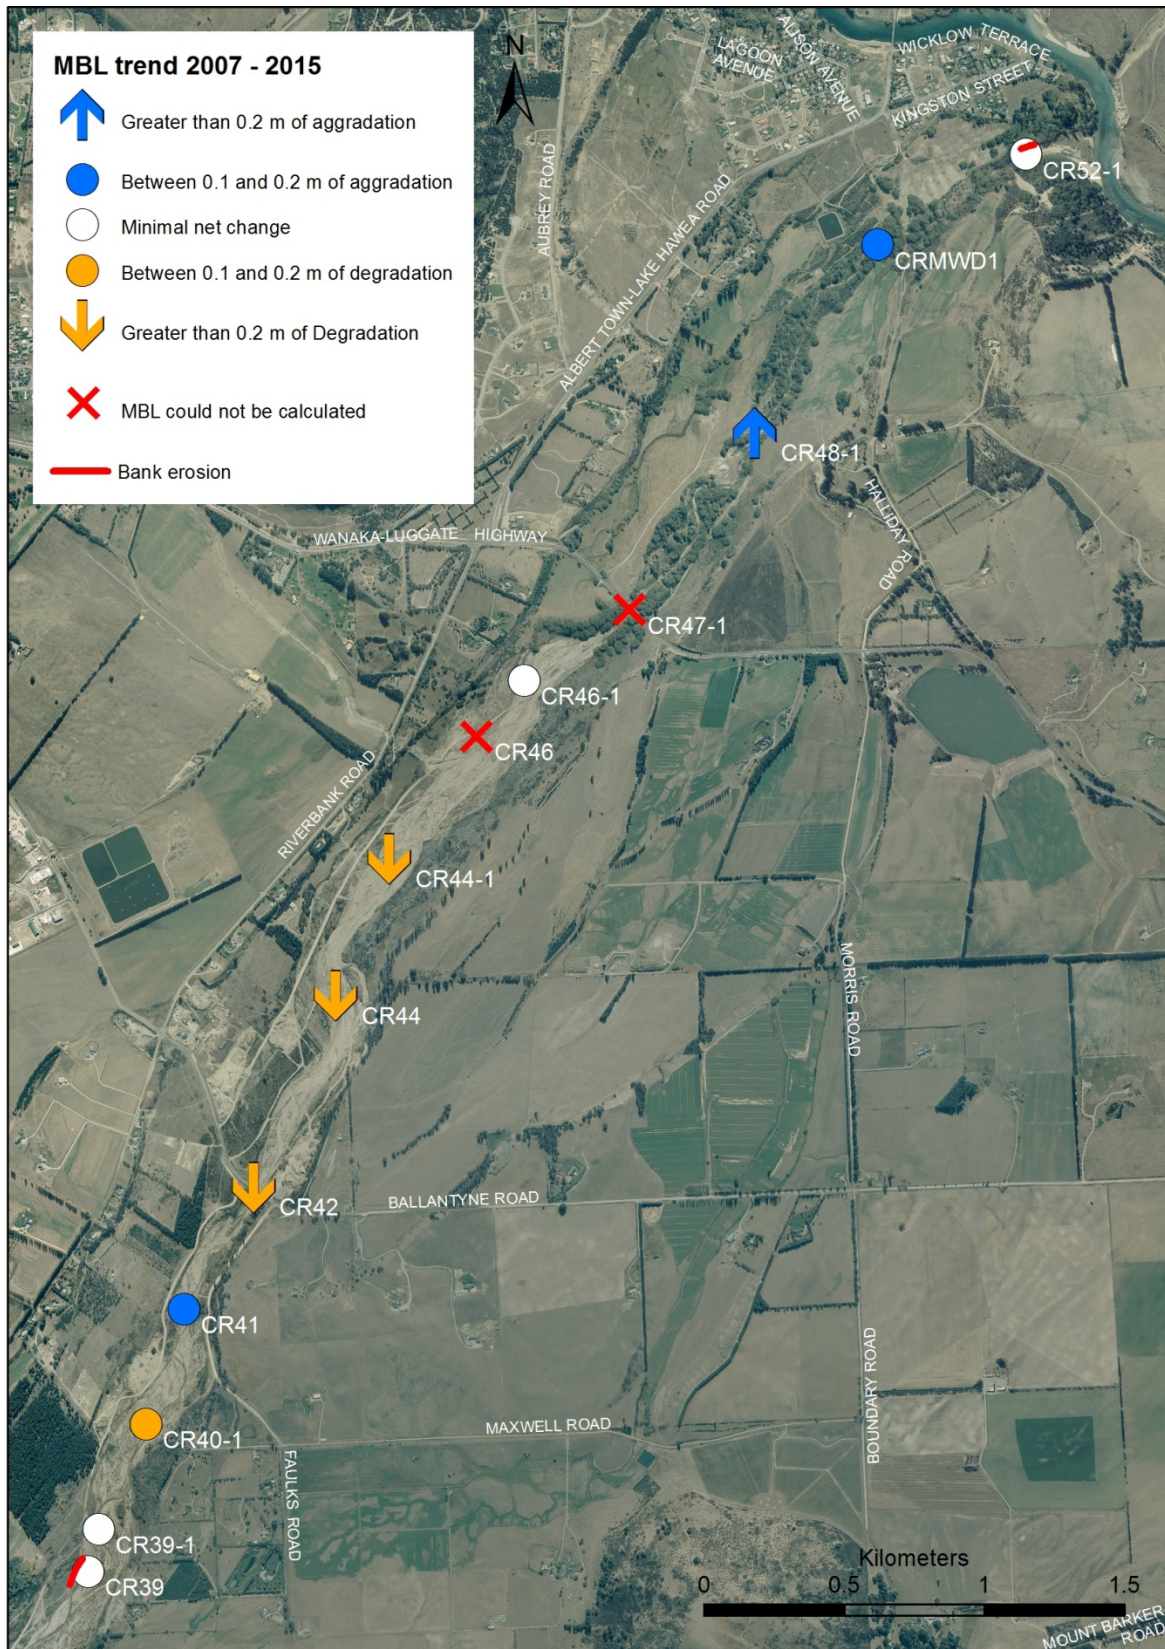
For the most recent survey period (2007 to 2015) the lower reaches of the surveyed reach of the Cardrona River (cross-section CR39 to CR52-1) (Figure 4) experienced areas of aggradation, degradation, and areas of minimal change. MBL changes could not be calculated for two cross-sections in the lowest reach (CR47-1 and CR46).

Figure 4. Location of Cardrona River cross-sections. The white, orange, and blue symbols show the magnitude of MBL change at each cross-section between 2007 and 2015. Locations where significant bank erosion has been observed are shown as red lines, a red cross indicates a cross-section where MBL could not be calculated. Individual cross-sections are shown in Appendix 3.

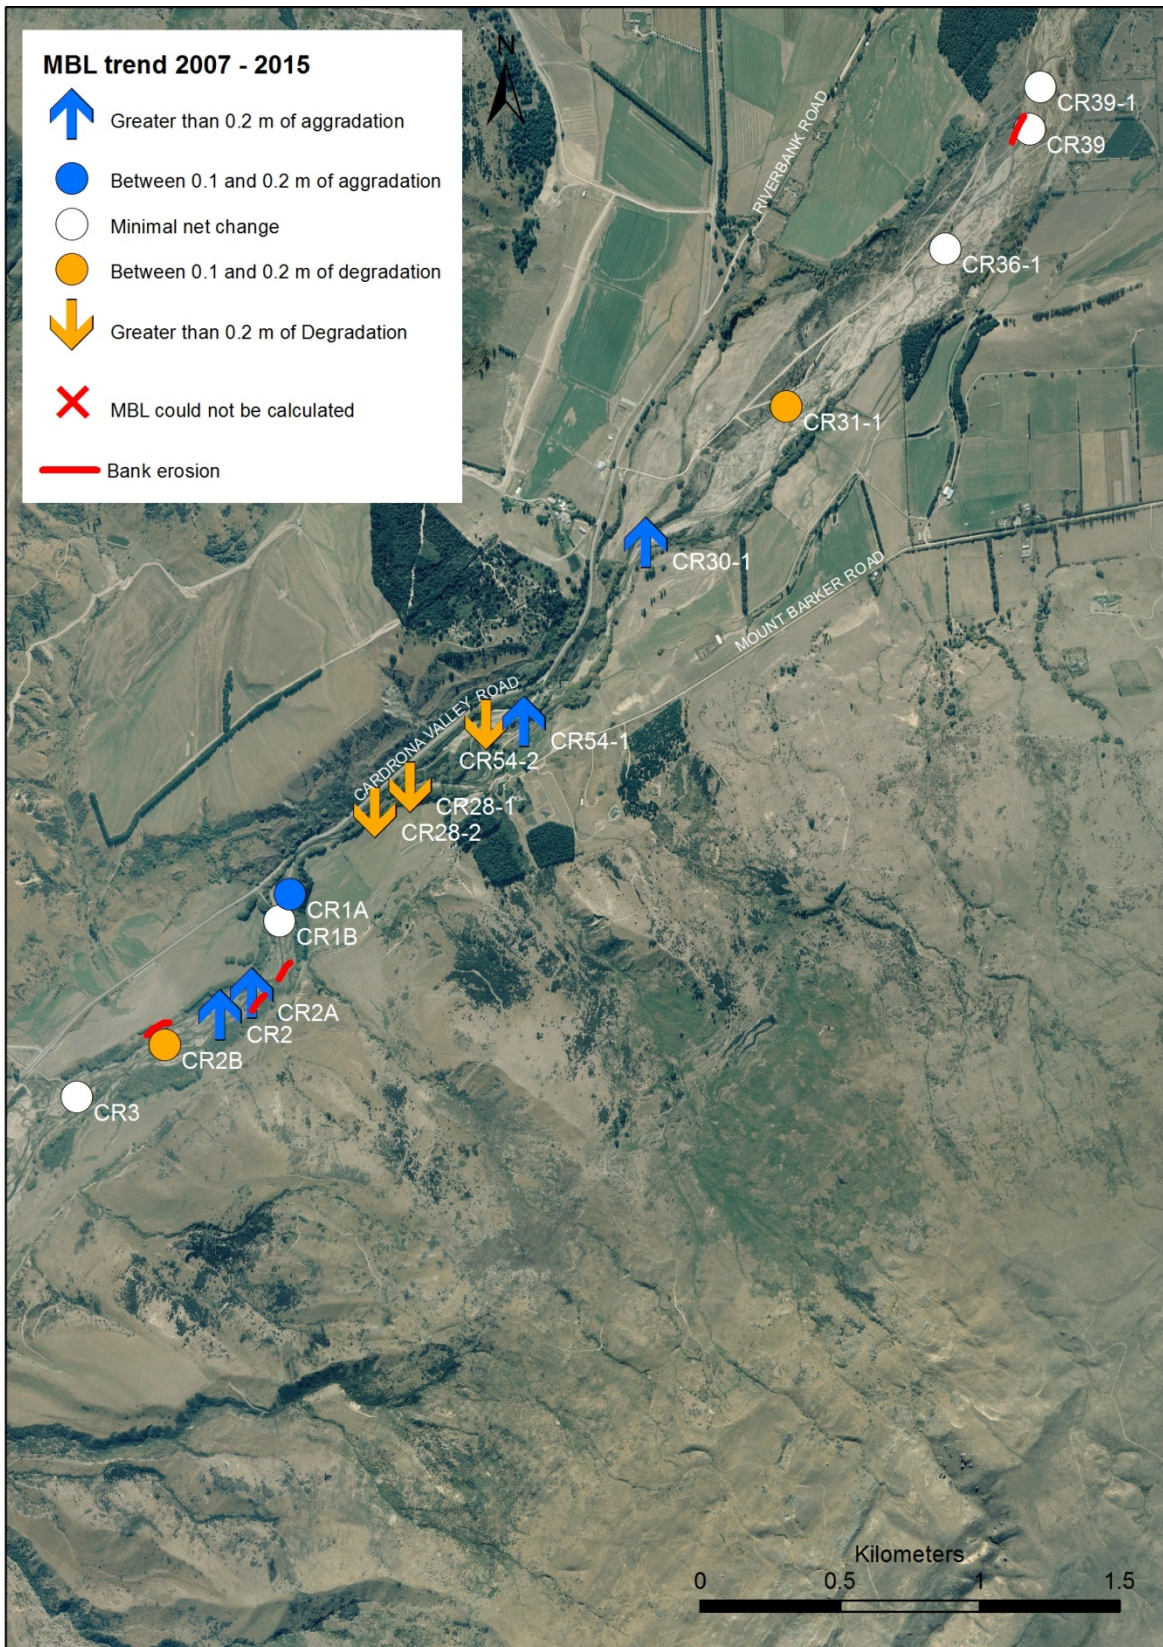
The reach of the Cardrona River between cross-section CR3 and CR39 (Figure 5) experienced areas of aggradation, degradation, and minimal change between 2007 and 2015, areas of degradation were at the downstream end of the reach while areas of aggradation were located at the upstream end (Figure 5).

Figure 5 Location of Cardrona River cross-sections. The white, orange, and blue symbols show the magnitude of MBL change at each cross-section between 2007 and 2015. Locations where significant bank erosion has been observed are shown as red lines, a red cross indicates a cross-section where MBL could not be calculated. Individual cross-sections are shown in Appendix 3.

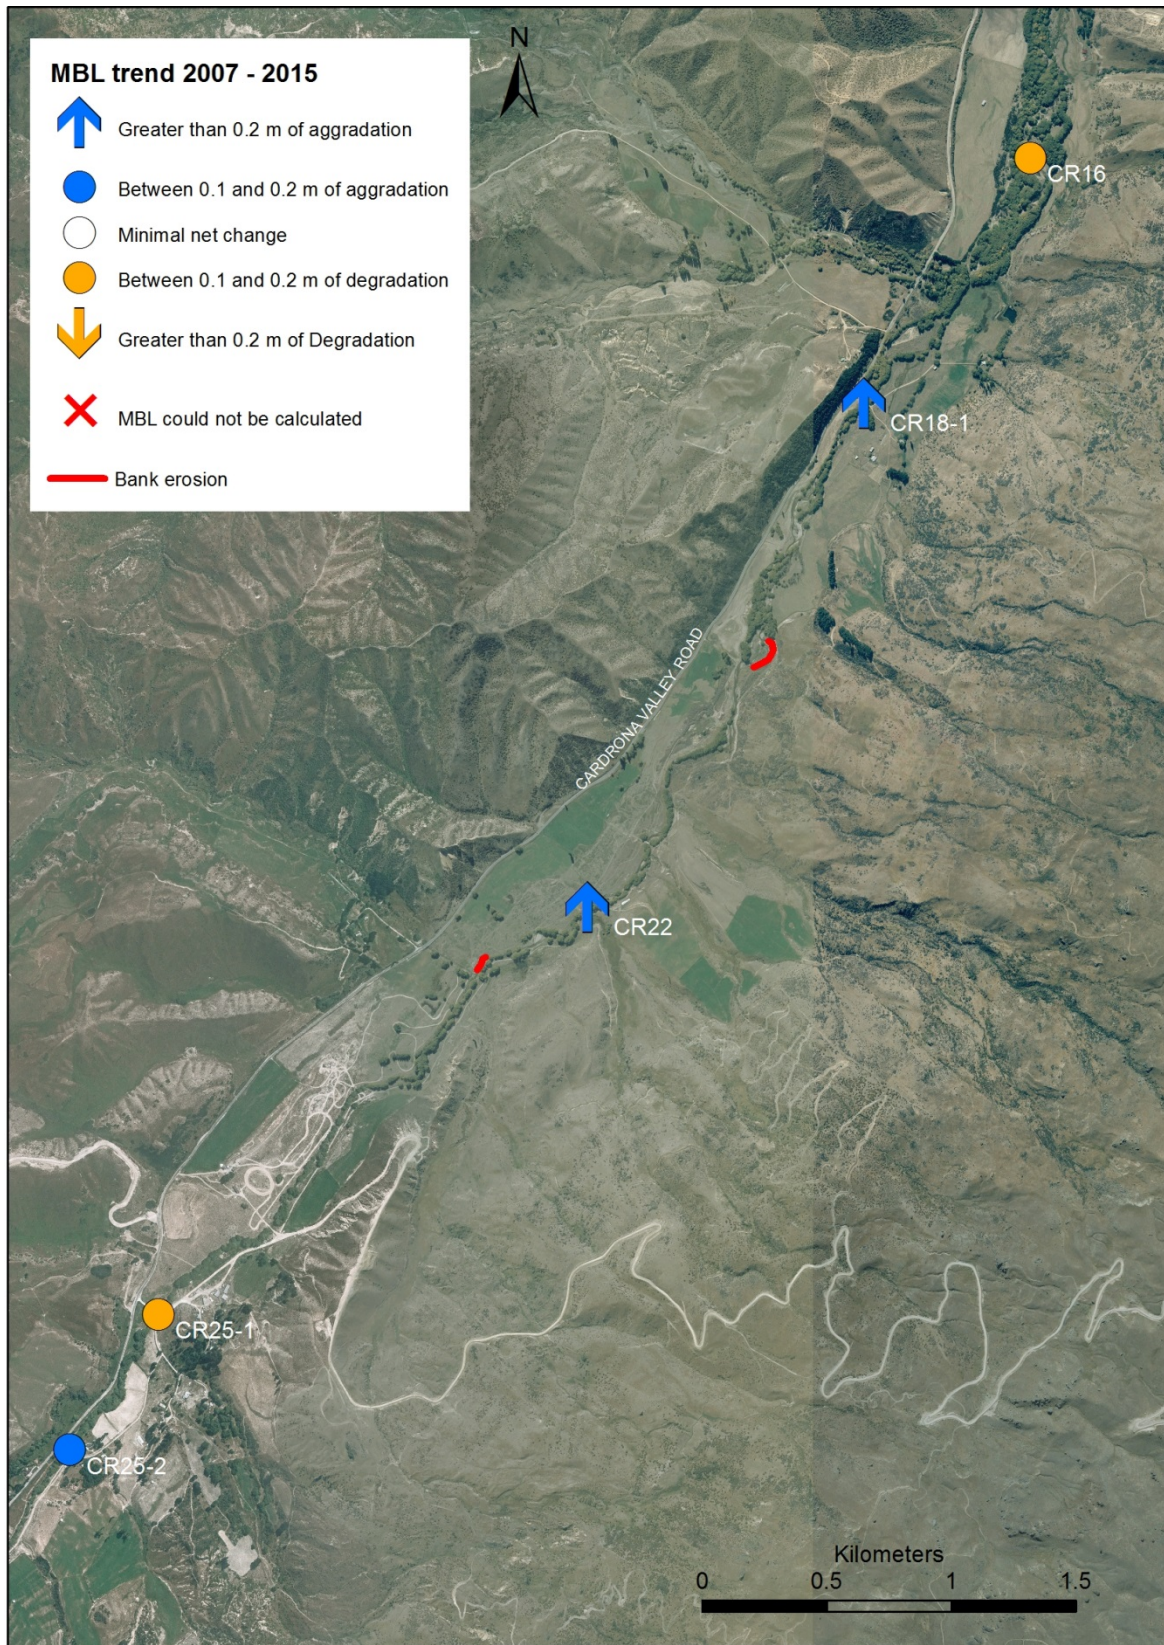
Between 2007 and 2015 the reach of the Cardrona River between cross-section CR25-2 and CR16 (Figure 7) experienced greater than 0.2 m of aggradation at two of the five cross-sections with two sections experiencing degradation (CR25-1, CR16).

Figure 7. Location of Cardrona River cross-sections. The white, orange, and blue symbols show the magnitude of MBL change at each cross-section between 2007 and 2015. Locations where significant bank erosion has been observed are shown as red lines, a red cross indicates a cross-section where MBL could not be calculated. Individual cross-sections are shown in Appendix 3.

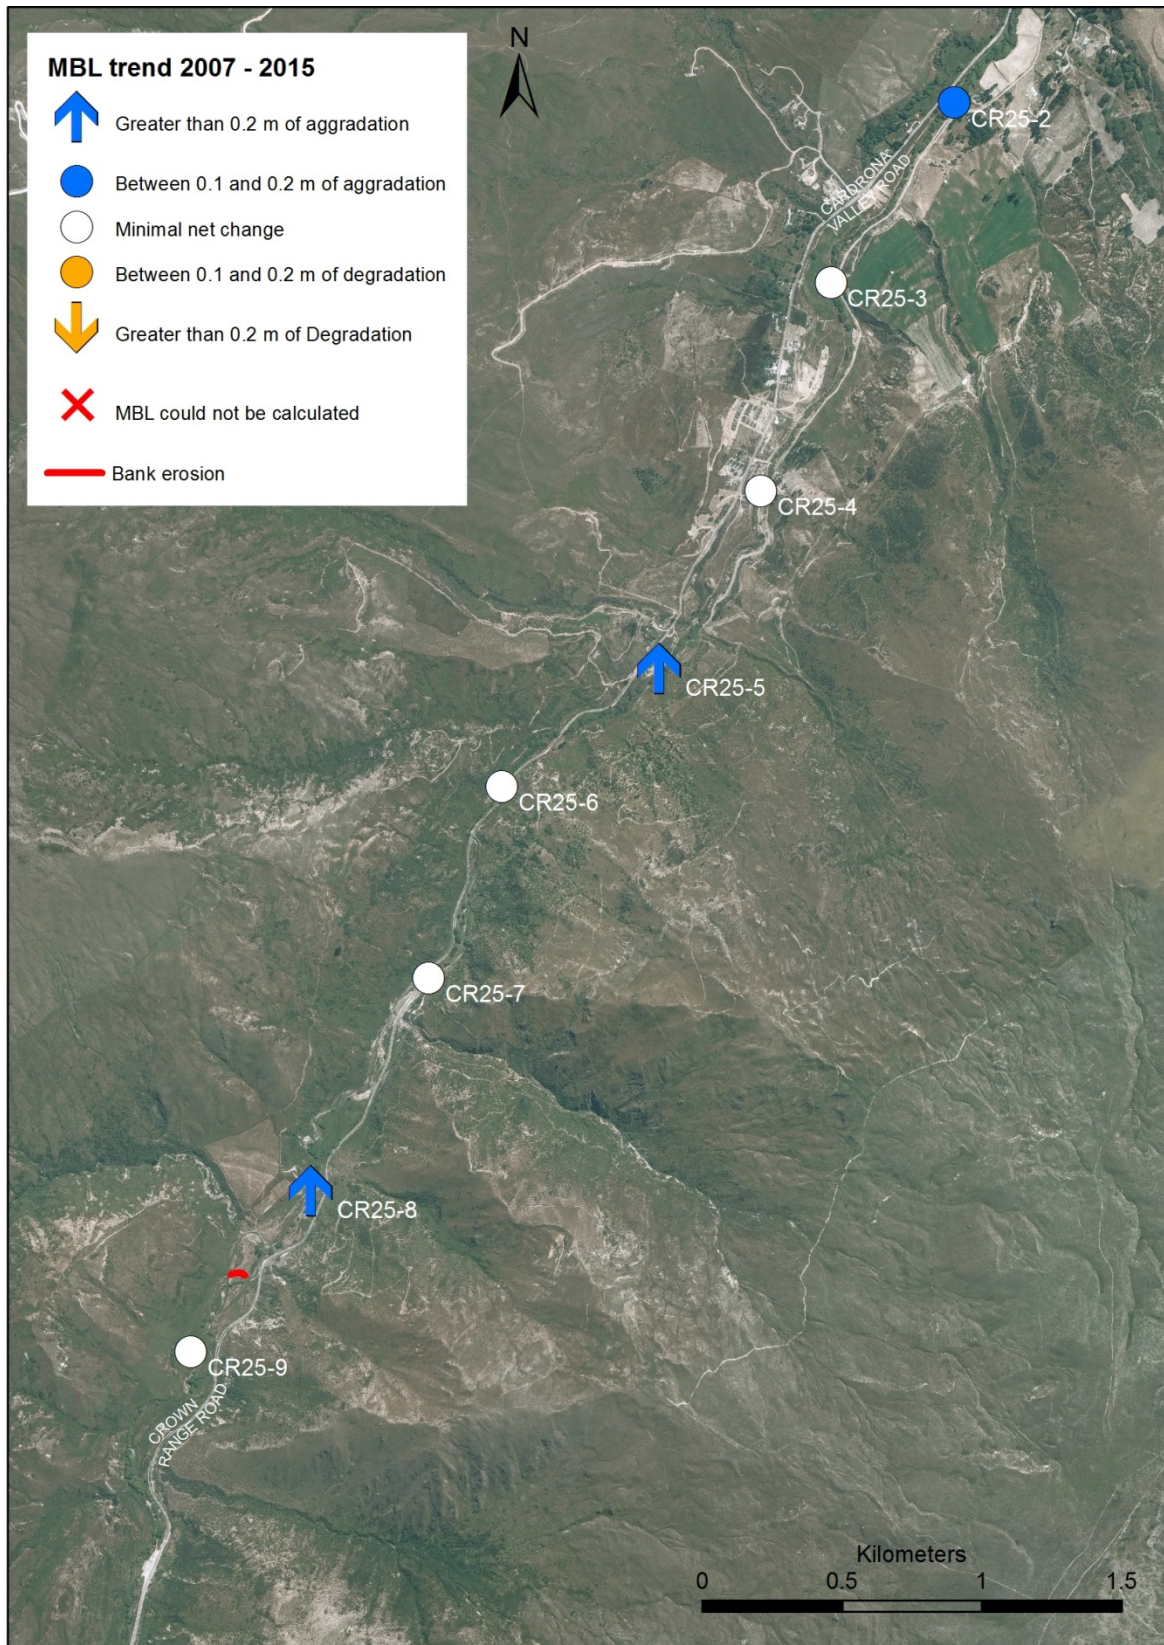
Cross-sections in the upper reaches of the Cardrona River (cross-section CR25-9 to CR25-3) (Figure 8) experienced minimal change in MBL or aggradation at all seven of the surveyed cross-section locations.

Figure 8. Location of Cardrona River cross-sections. The white, orange, and blue symbols show the magnitude of MBL change at each cross-section between 2007 and 2015. Locations where significant bank erosion has been observed are shown as red lines, a red cross indicates a cross-section where MBL could not be calculated. Individual cross-sections are shown in Appendix 3.

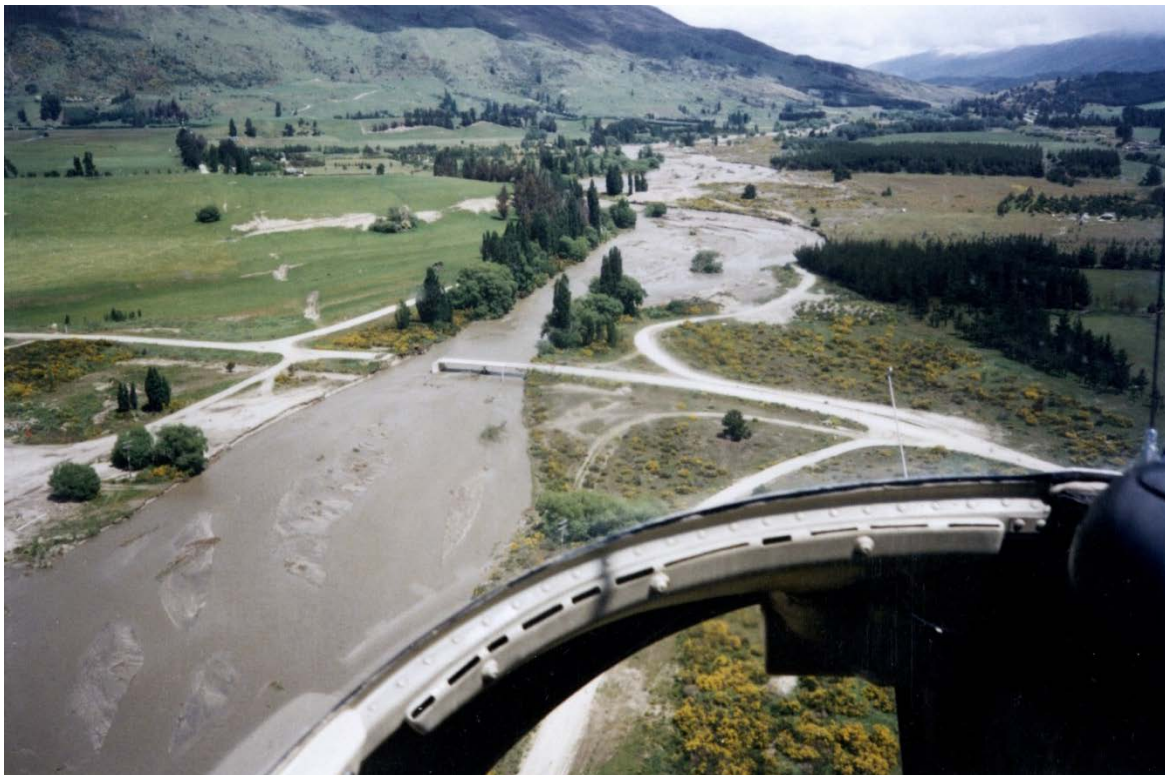
experienced big flood events in the past with the November 1999 event being the largest on record at the Albert Town flow recorder (Figure 11). The November 1999 event caused significant damage to the bed and banks of the Cardrona River as well as destroying the Ballantyne Road bridge (Figure 12). The mapped flood hazard area for the Cardrona River can be seen in the ORC report '*Natural Hazards in the Cardrona Valley*' (2010).

Figure 12. Ballantyne Road bridge (Cardrona River), looking upstream (photography taken after the peak of the flood, November 1999)

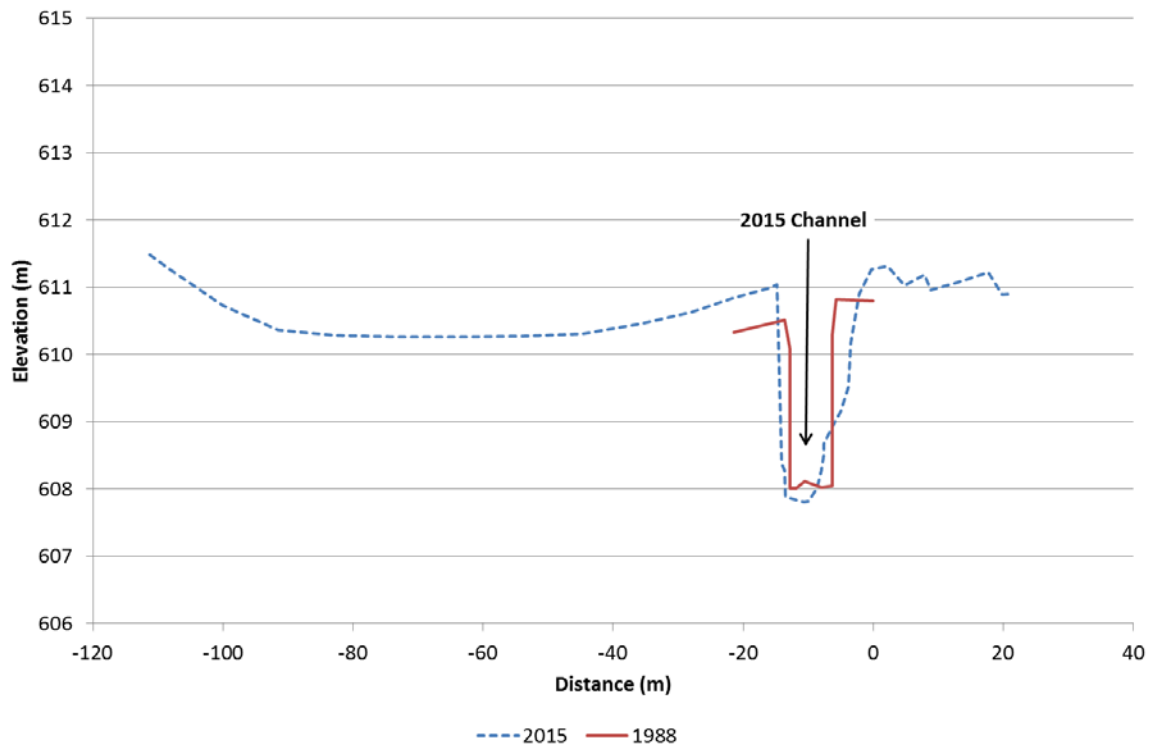
Figure 14. Cardrona River cross-section CR25-1, looking downstream, refer to Figure 7 for location.

Cross-section CR25-1 is located 26.5 km upstream of the confluence with the Clutha River/Mata-Au. Between 2003 and 2015 the main channel has experienced degradation. Aggradation has occurred on the true left channel bank between 2003 and 2015 with degradation occurring on the wider true left and right bank floodplain between 2007 and 2015.

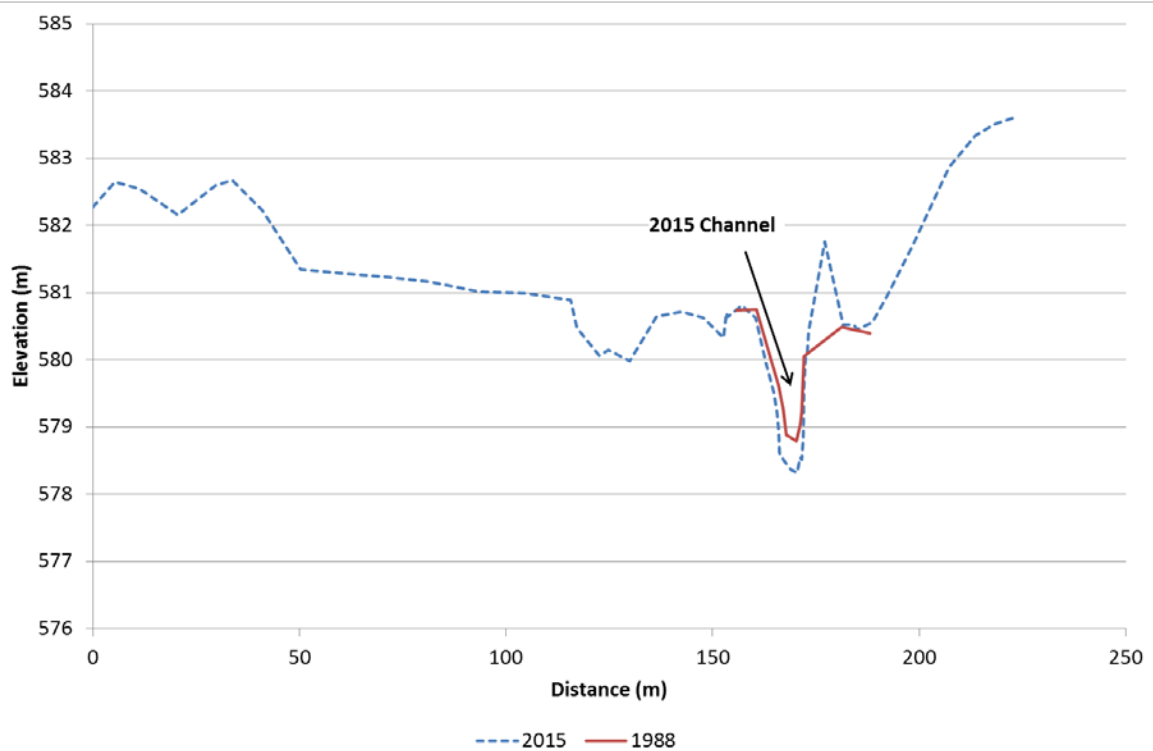
Figure 15. Cardrona River cross-section CR22, looking downstream, refer to Figure 7 for location.

Cross-section CR22 is located 24.1 km upstream of the confluence with the Clutha River/Mata-Au. The main channel has degraded between 2003 and 2015 with the creation of a feature at the point labelled A. Bank erosion occurred on the true right bank between 2003 and 2015.

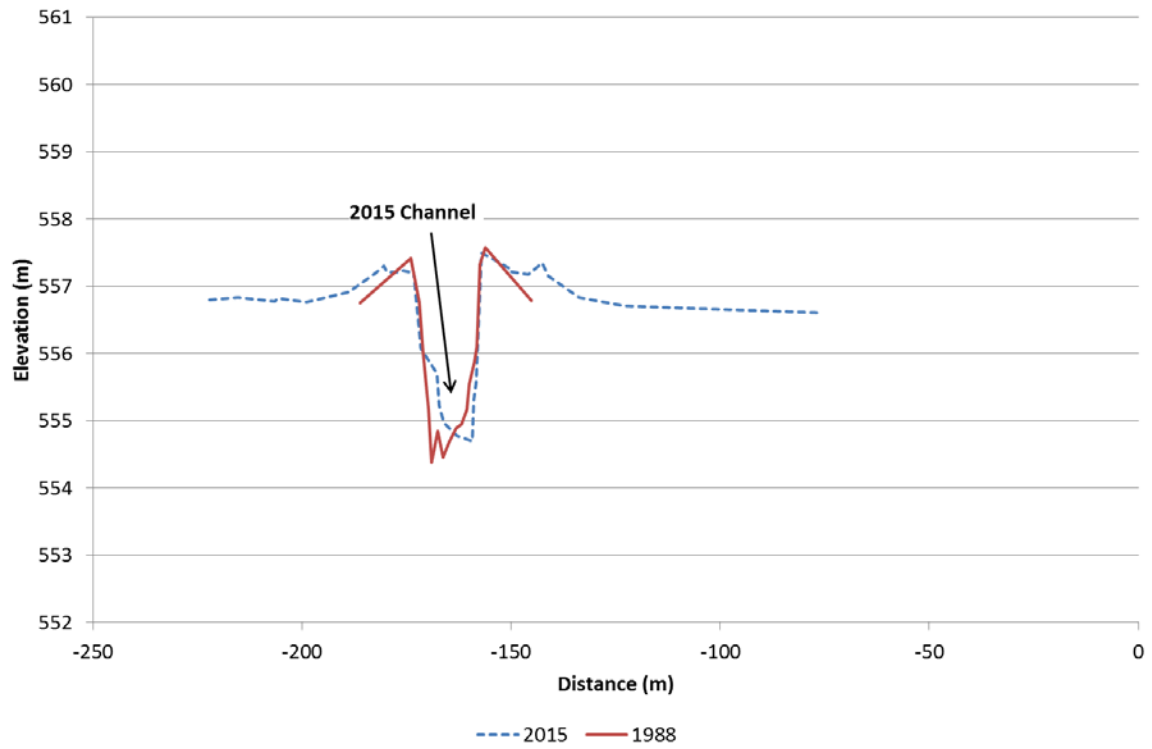
Figure 16. Cardrona River cross-section CR18-1, looking downstream, refer to Figure 7 for location.

Cross-section CR18-1 is located 21.74 km upstream of the confluence with the Clutha River/Mata-Au. The channel has aggraded between 2003 and 2015 but has remained in a similar position between 2007 and 2015. The true right floodplain has aggraded between 2003 and 2015. The true left floodplain has degraded between 2003 and 2015 but has remained in a similar position between 2007 and 2015.

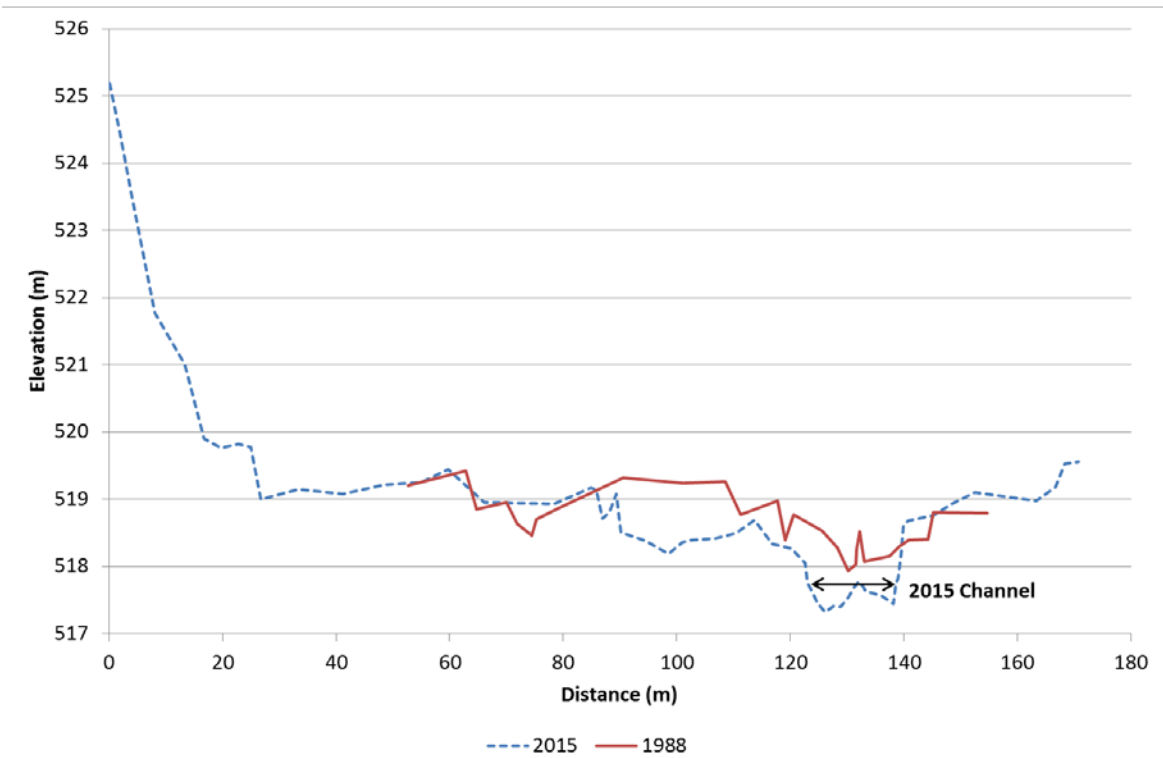
Figure 18. Cardrona River cross-section CR11-1, looking downstream, refer to Figure 6 for location.

Cross-section CR11-1 is located 17.5 km upstream of the confluence with the Clutha River/Mata-Au. Between 2003 and 2015 the main channel has degraded and become more confined. The true left floodplain has aggraded between 2007 and 2015.

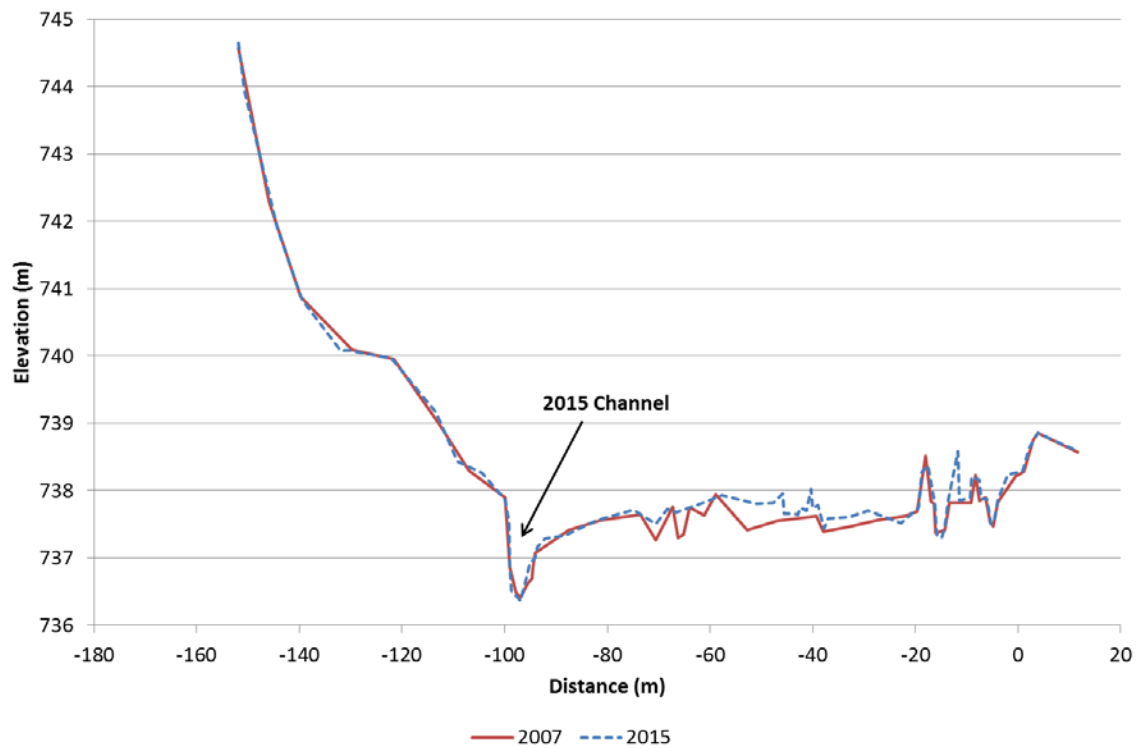
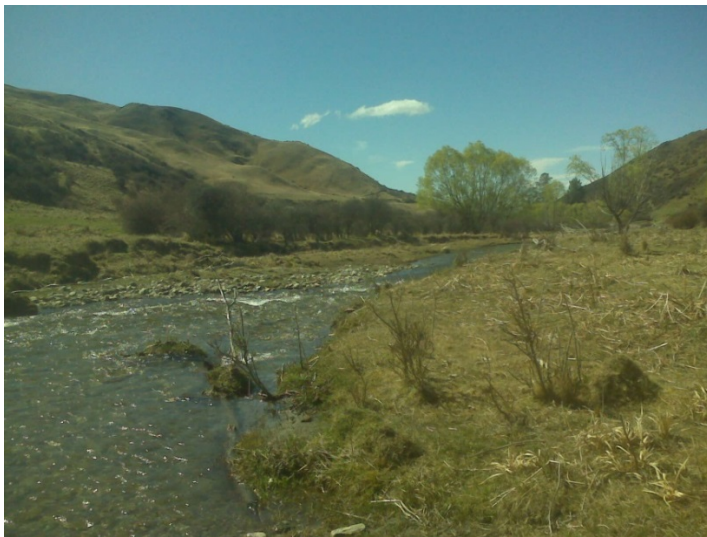
Cardrona River cross-section CR25-9

Figure 42. Cardrona River cross-section CR25-9, looking downstream refer to Figure 8 for location

Figure 43. Cardrona River cross-section CR25-9, looking downstream, November 2015

Cross-section CR25-9 is located 32.8 km upstream of the confluence with the Clutha River/Mata-Au and is the most upstream survey location. The channel has remained in the same position between 2007 and 2015. The true right floodplain has aggraded between 2007 and 2015.

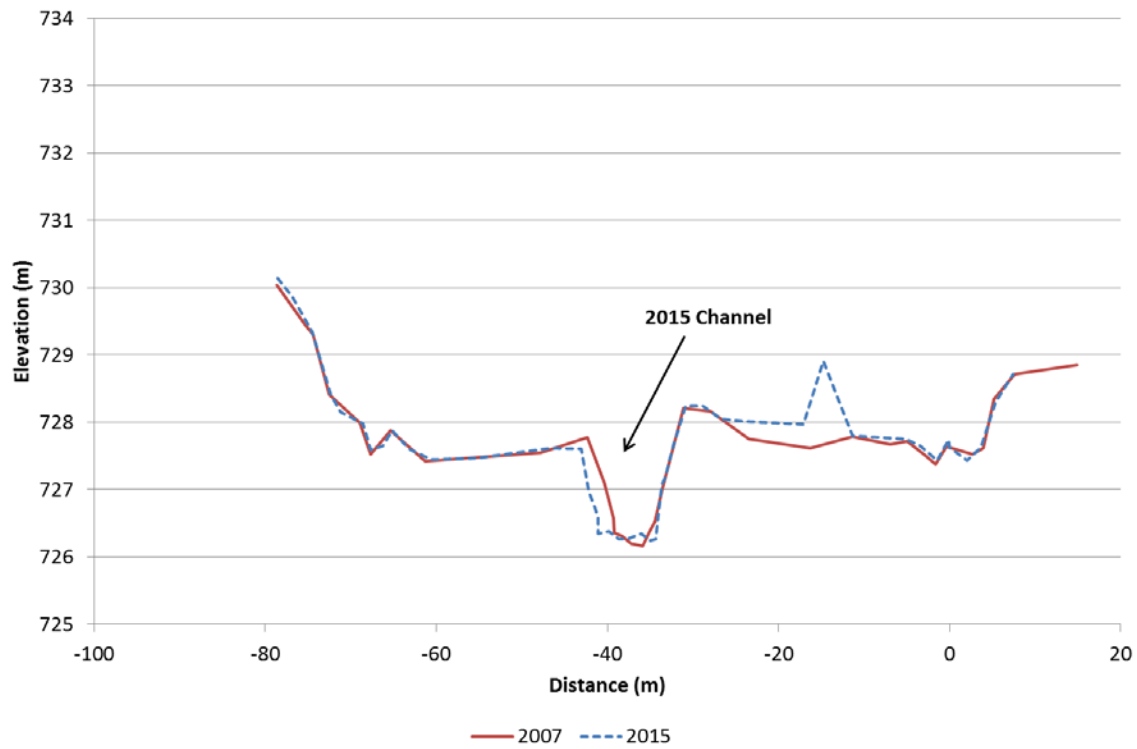
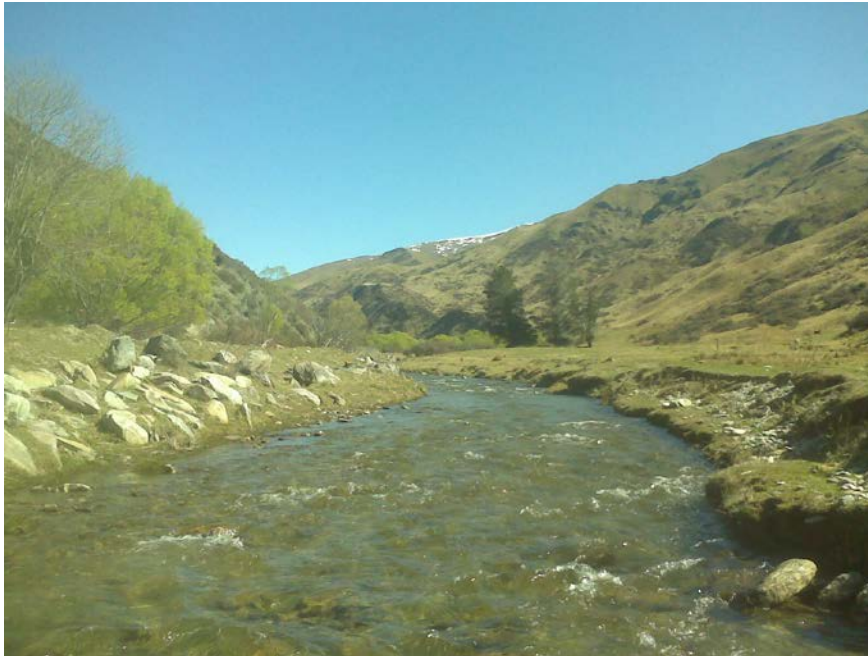
Cardrona River cross-section CR25-8

Figure 44. Cardrona River cross-section CR25-8, looking downstream refer to Figure 8 for location

Figure 45. Cardrona River cross-section CR25-8, looking upstream, November 2015

Cross-section CR25-8 is located 32.1 km upstream of the confluence with the Clutha River/Mata-Au. There has been erosion of the true left bank and some aggradation of the true right floodplain.

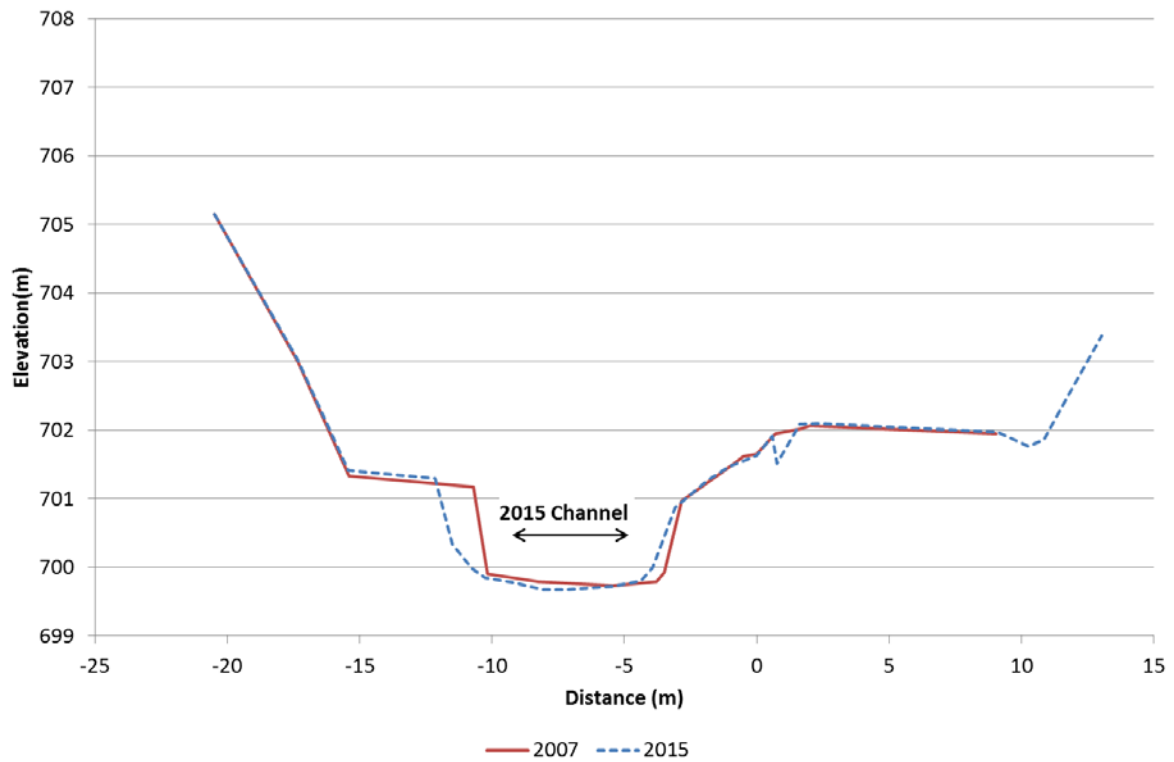
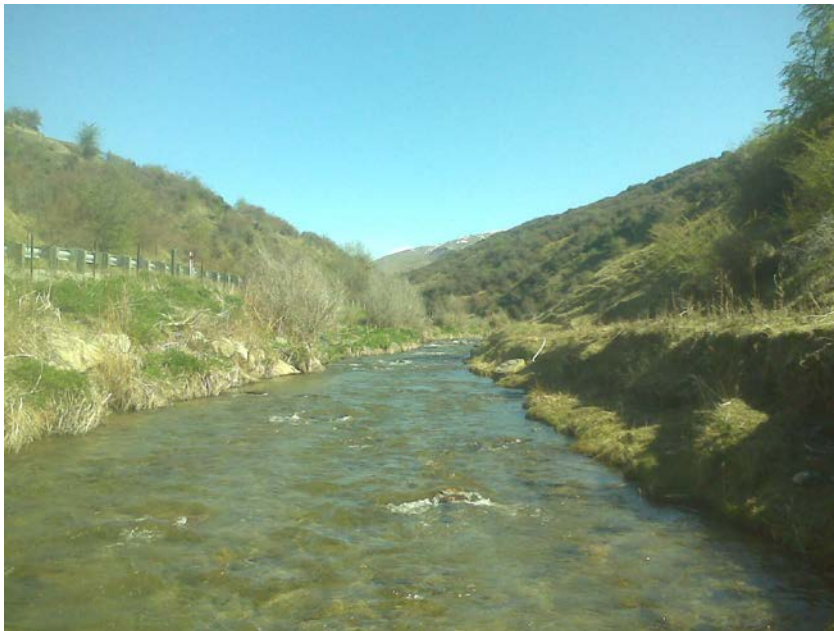
Cardrona River cross-section CR25-6

Figure 47. Cardrona River cross-section CR25-6, looking downstream refer to Figure 8 for location

Figure 48. Cardrona River cross-section CR25-6, looking upstream, November 2015

Cross-section CR25-6 is located 30.2 km upstream of the confluence with the Clutha River/Mata-Au. The true left bank eroded and the true right bank aggraded between 2007 and 2015 with minimal change occurring across the wider floodplain.

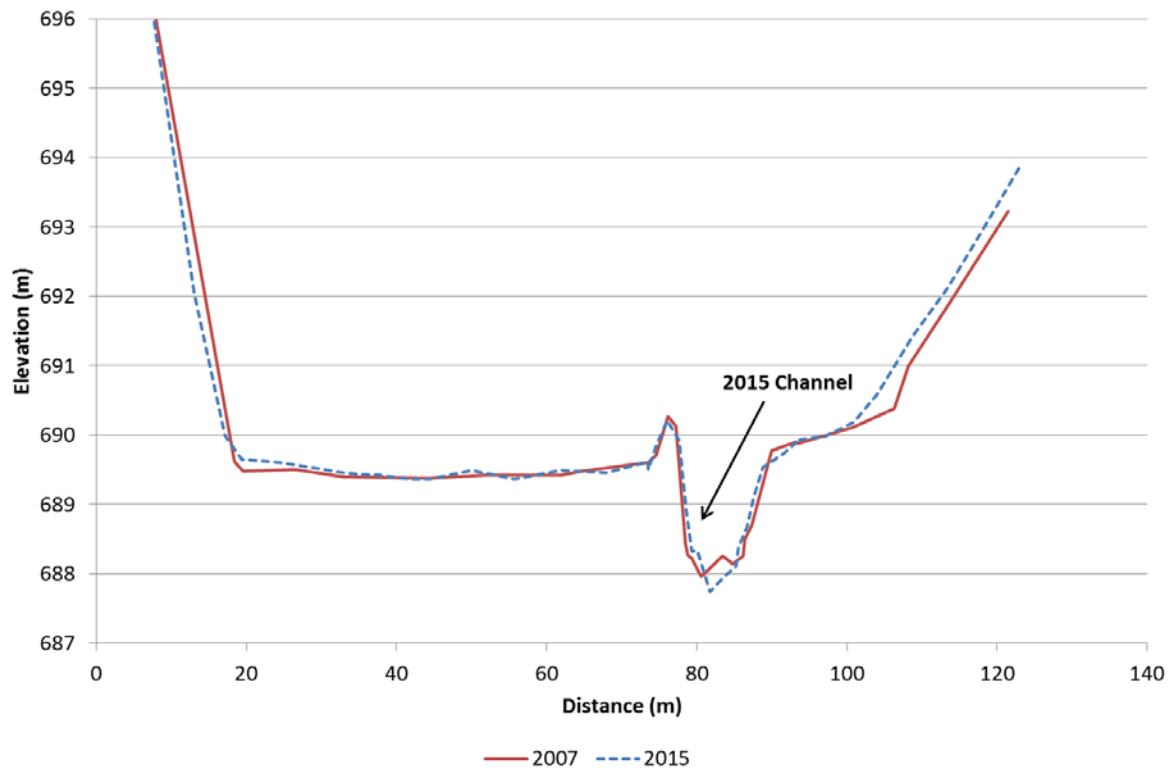
Cardrona River cross-section CR25-5

Figure 49. Cardrona River cross-section CR25-5, looking downstream refer to Figure 8 for location

Cross-section CR25-5 is located 29.5 km upstream of the confluence with the Clutha River/Mata-Au. The channel has degraded between 2007 and 2015 with aggradation occurring on the true right bank.

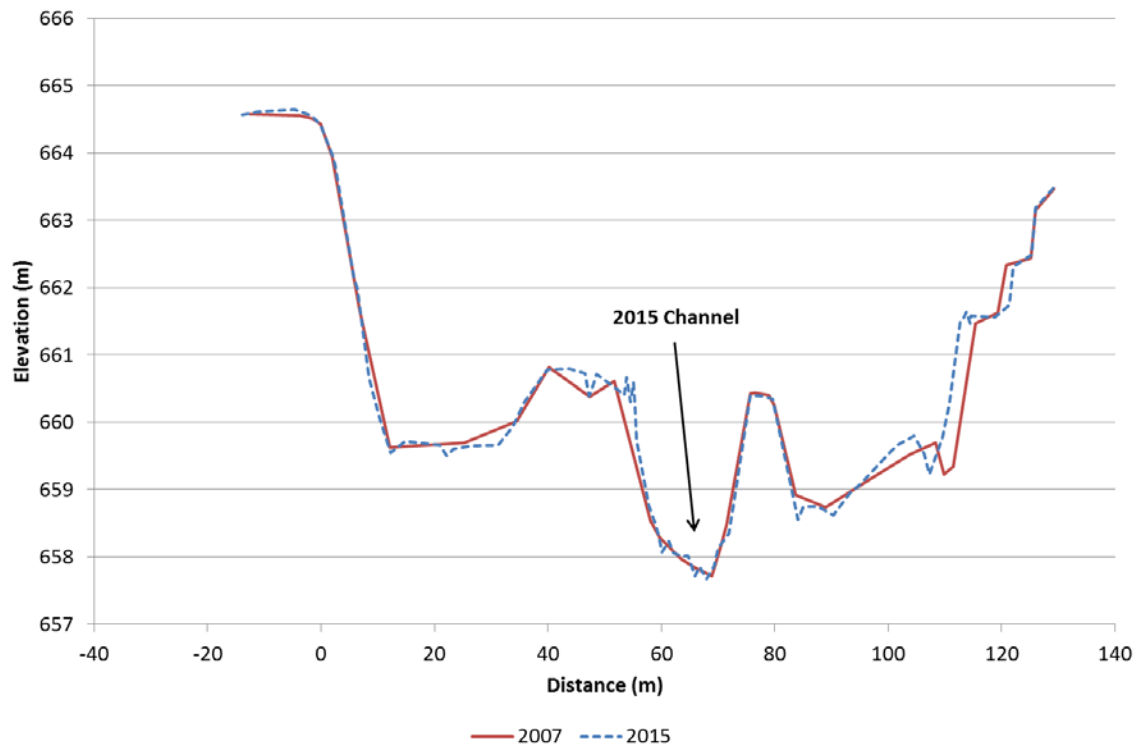
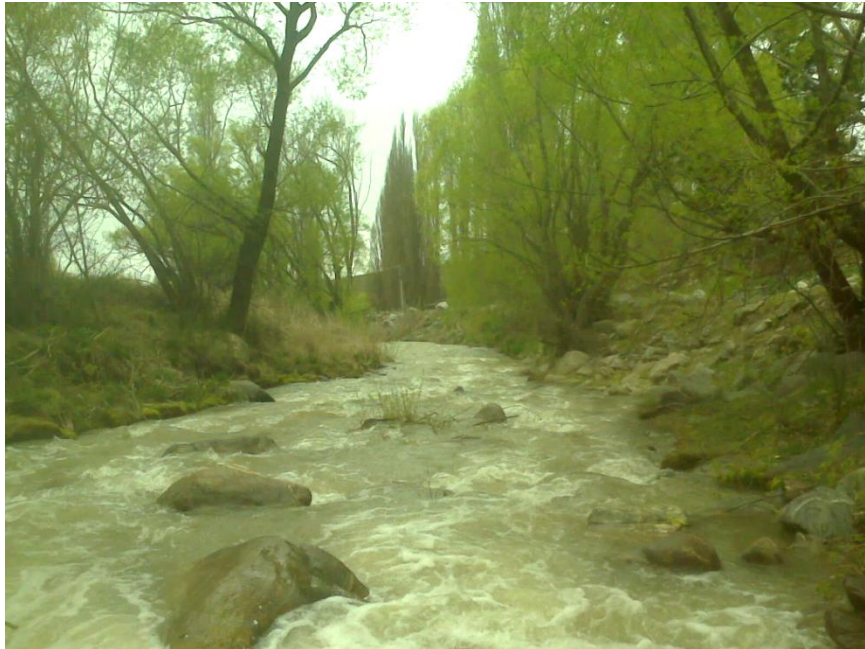
Cardrona River cross-section CR25-4

Figure 51. Cardrona River cross-section CR25-4, looking downstream refer to Figure 8 for location

Figure 52. Cardrona River cross-section CR25-4, looking downstream, November 2015

Cross-section CR25-4 is located 28.8 km upstream of the confluence with the Clutha River/Mata-Au. There has been little change in the main channel between 2007 and 2015, the true right floodplain bank and the true left channel bank aggraded during this period.
