Cardrona River Channel Morphology

May 2016

Otago Regional Council

Technical summary

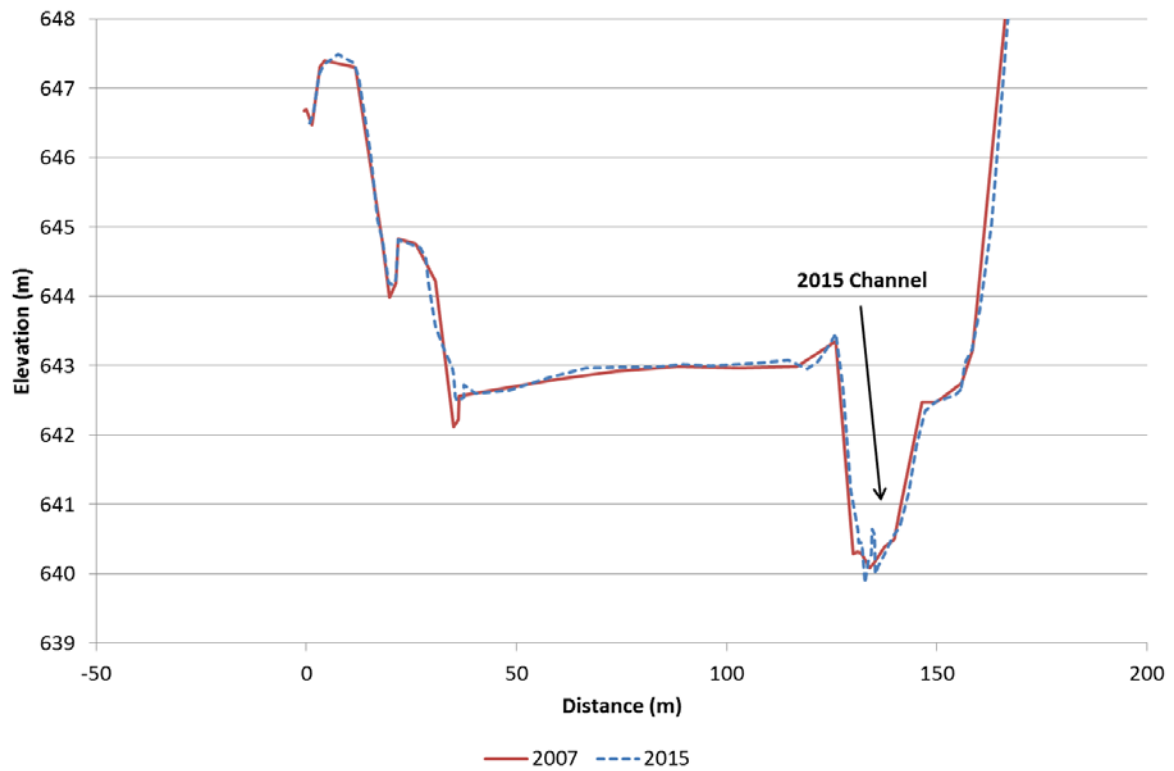
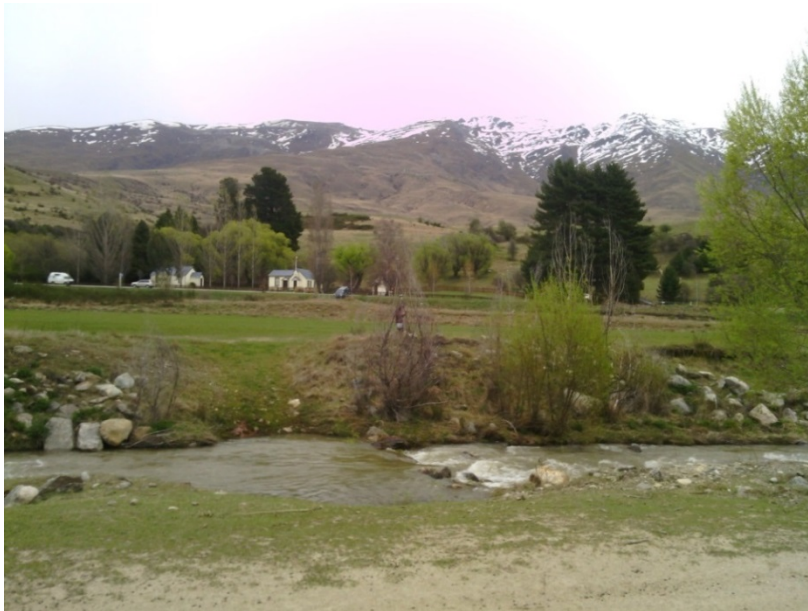
Cardrona River cross-section CR25-3

Figure 53. Cardrona River cross-section CR25-3, looking downstream refer to Figure 8 for location

Figure 54. Cardrona River cross-section CR25-3, looking from true right to true left bank, November 2015

Cross-section CR25-3 is located 27.9 km upstream of the confluence with the Clutha River/Mata-Au. Minimal change in the main channel and wider floodplain occurred between 2007 and 2015.

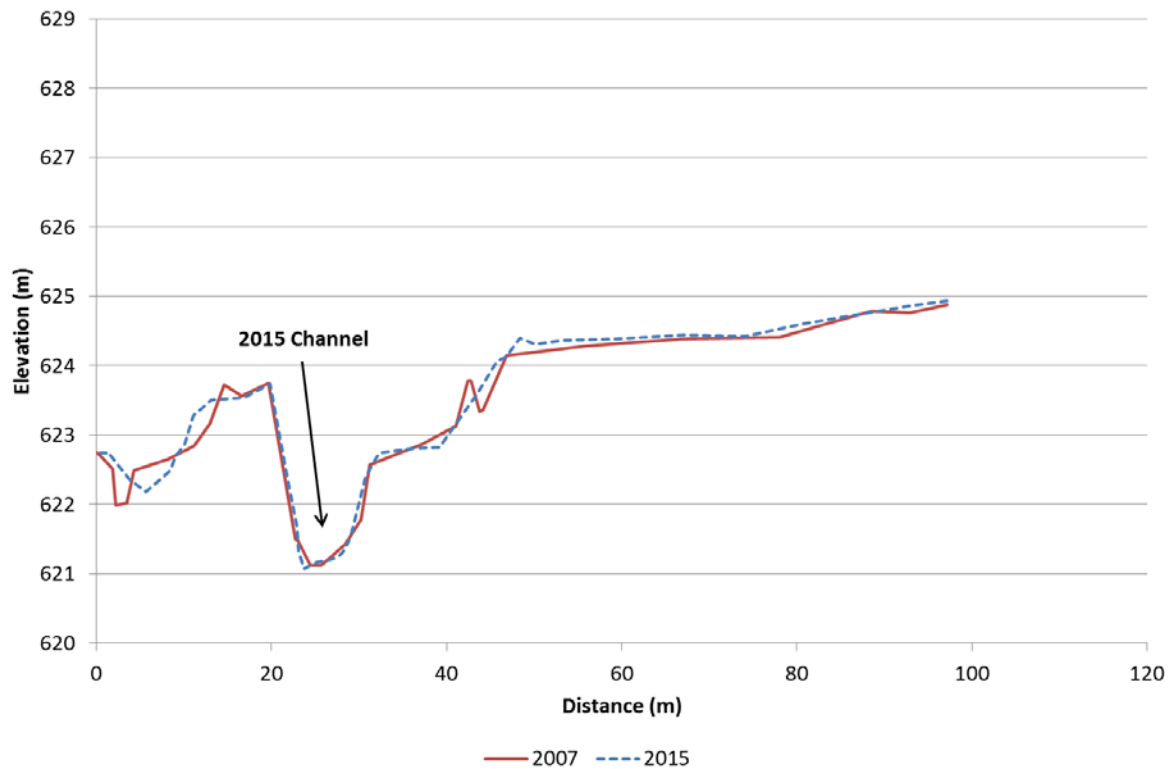
Cardrona River cross-section CR25-2

Figure 55. Cardrona River cross-section CR25-2, looking downstream refer to Figure 7 for location

Cross-section CR25-2 is located 27.1 km upstream of the confluence with the Clutha River/Mata-Au. The main channel has remained in a similar position between 2007 and 2015. The true left floodplain has both aggraded and degraded between 2007 and 2015.

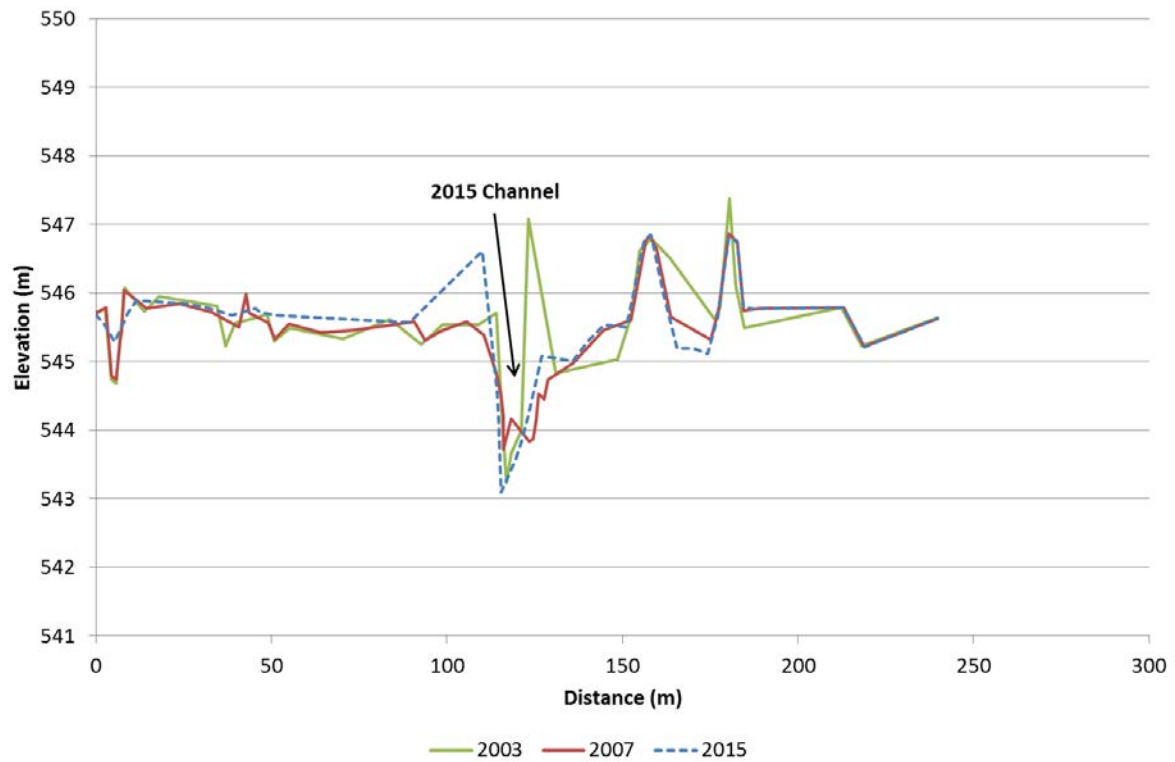
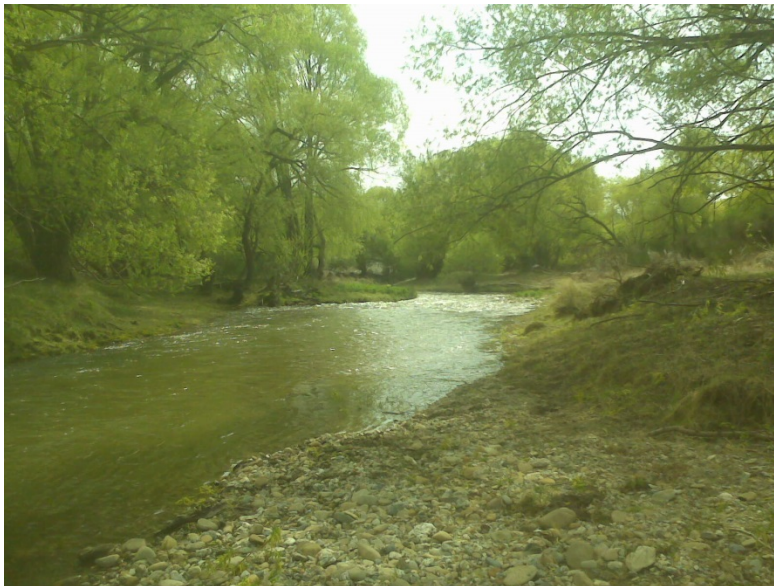
Cardrona River cross-section CR16

Figure 63. Cardrona River cross-section CR16, looking downstream refer to Figure 7 for location

Figure 64. Cardrona River cross-section CR16, looking downstream, November 2015

Cross-section CR16 is located 20.5 km upstream of the confluence with the Clutha River/Mata-Au. The main channel has become more confined between 2007 and 2015 with aggradation occurring on the true right bank. The top of the true left berm has aggraded between 2003 and 2015.

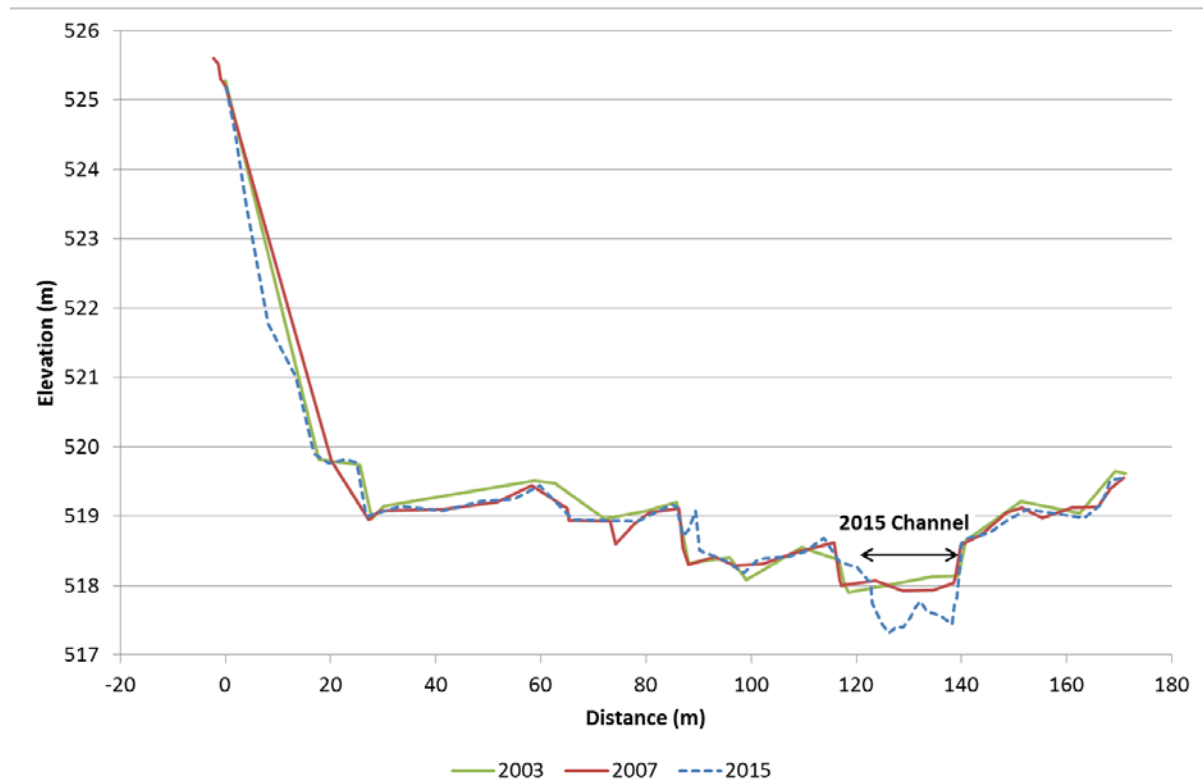
Cardrona River cross-section CR11-1

Figure 65. Cardrona River cross-section CR11-1, looking downstream refer to Figure 6 for location

Cross-section CR11-1 is located 17.5 km upstream of the confluence with the Clutha River/Mata-Au. Between 2003 and 2015 the main channel has degraded and become more confined. The true left floodplain has aggraded between 2007 and 2015.

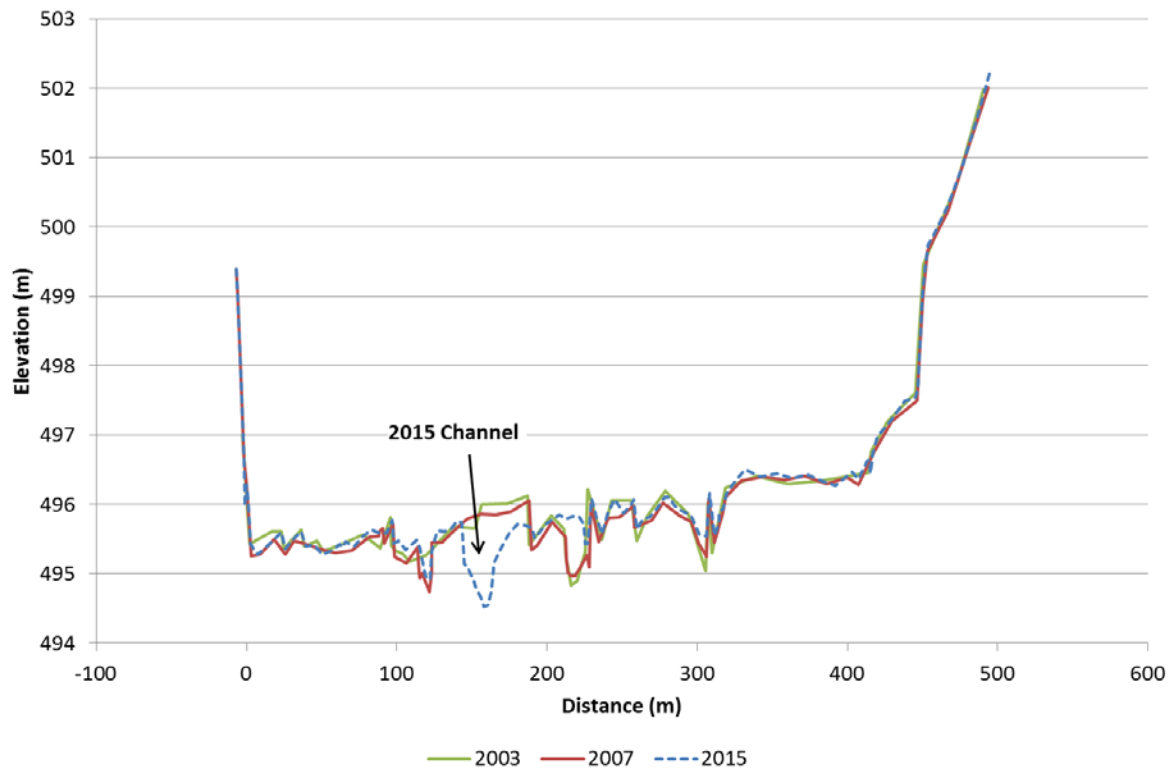
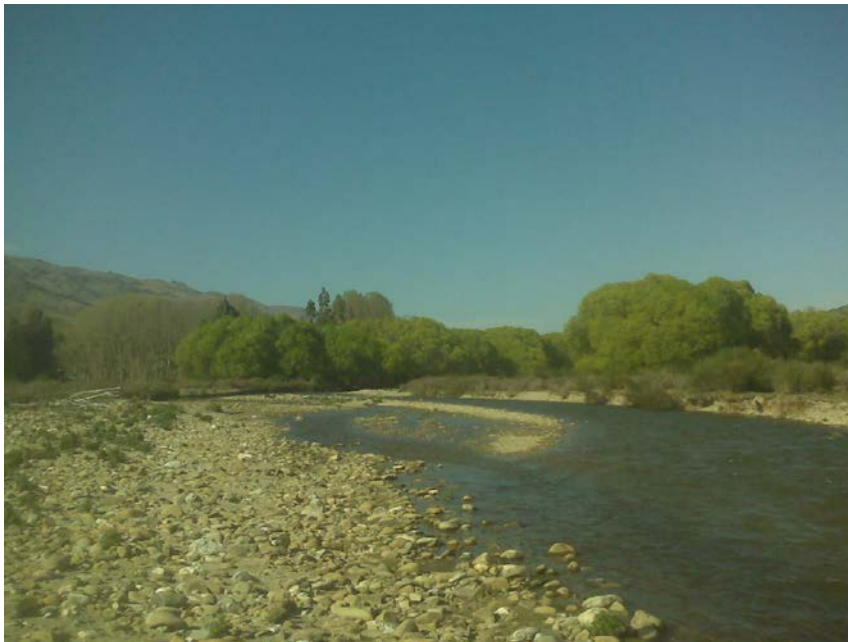
Cardrona River cross-section CR8

Figure 69. Cardrona River cross-section CR8, looking downstream refer to Figure 6 for location

Figure 70. Cardrona River cross-section CR8, looking upstream, November 2015

Cross-section CR8 is located 14.8 km upstream of the confluence with the Clutha River/Mata-Au. Between 2007 and 2015 there has been some infilling of previous channel with the main channel now occupying the centre of the active fairway.

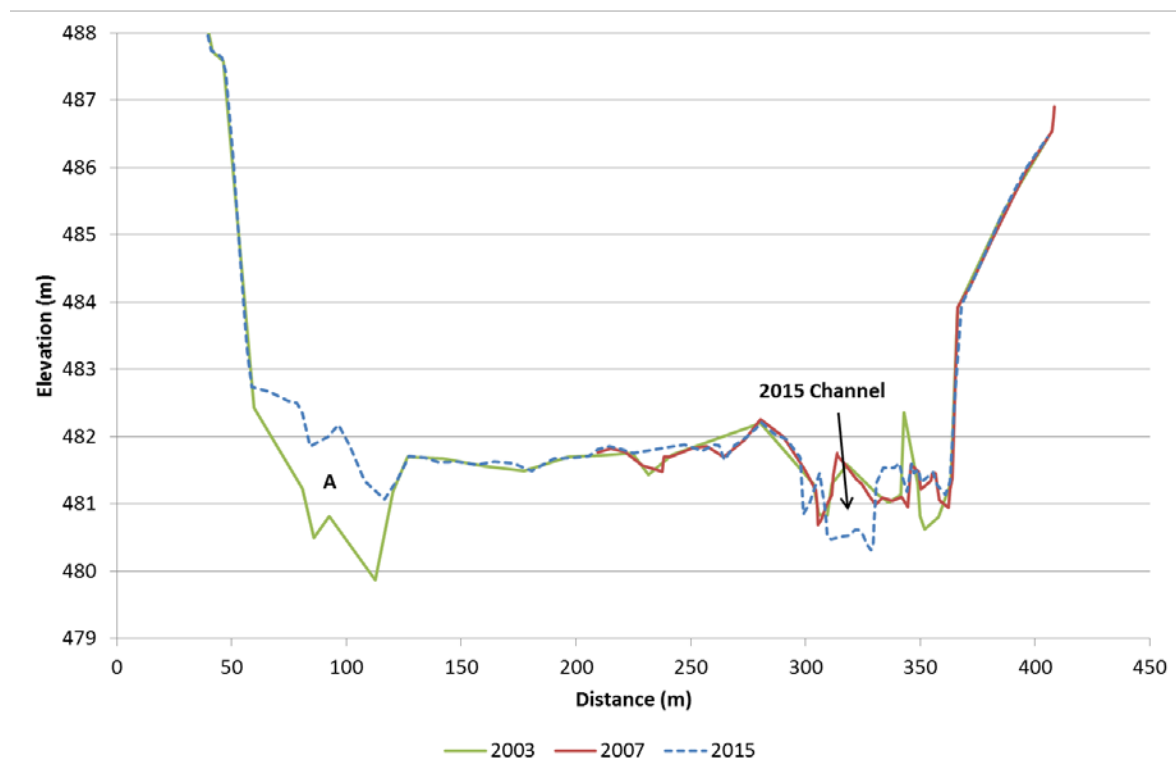
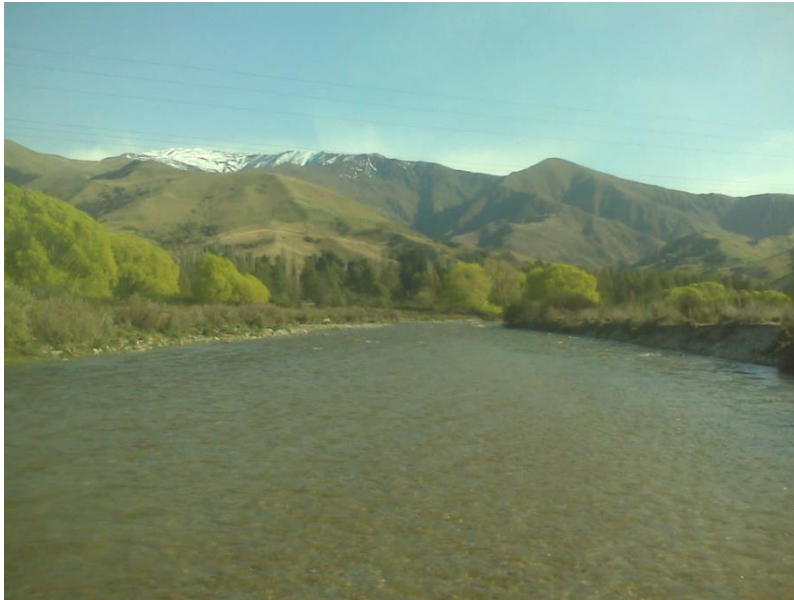
Cardrona River cross-section CR5

Figure 71. Cardrona River cross-section CR5, looking downstream refer to Figure 6 for location

Figure 72. Cardrona River cross-section CR5, looking downstream, November 2015

Cross-section CR5 is located 13 km upstream of the confluence with the Clutha River/Mata-Au. The main channel has become more defined between 2007 and 2015 with aggradation occurring in the 2003 and 2007 secondary channels. Aggradation of the true left bank floodplain at the point labelled A occurred between 2003 and 2015.

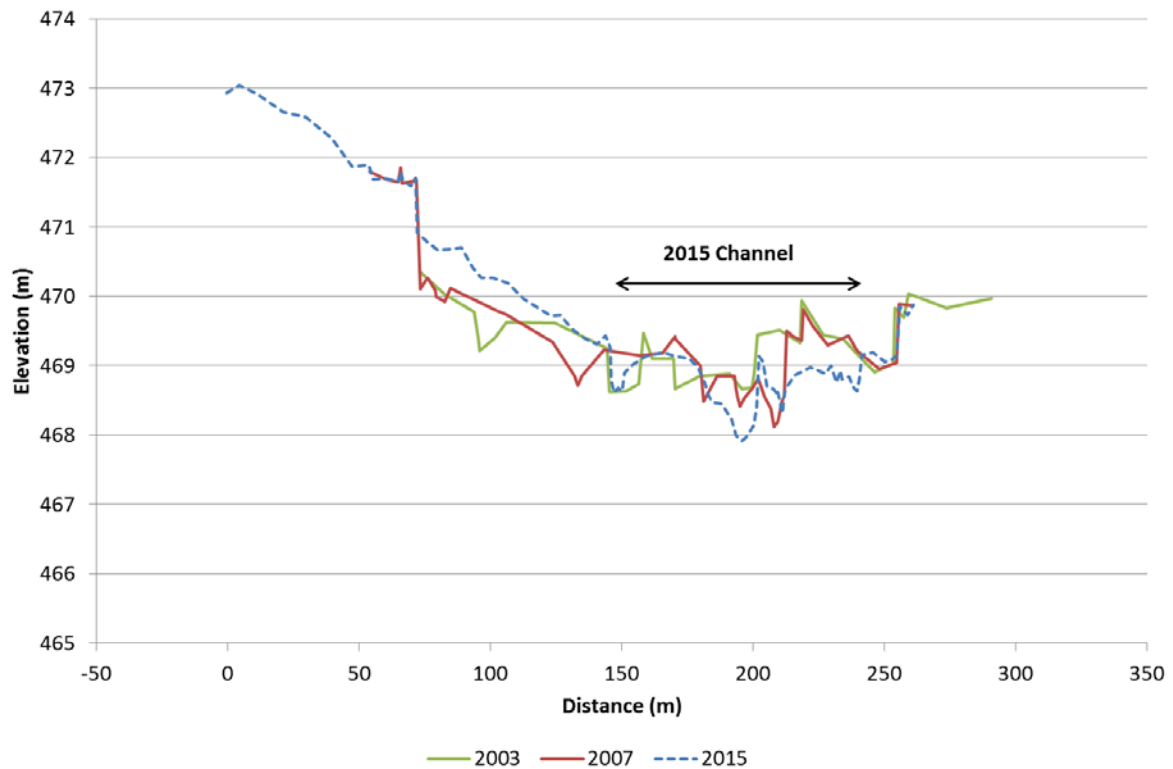
Cardrona River cross-section CR3

Figure 73. Cardrona River cross-section CR3, looking downstream refer to Figure 5 for location

Cross-section CR3 is located 11.7 km upstream of the confluence with the Clutha River/Mata-Au. The channel at this location is braided with one main channel in the centre of the active fairway and several low flow channels. These channels have both aggraded and degraded between 2003 and 2007. Aggradation of the true left bank terrace has occurred between 2007 and 2015.

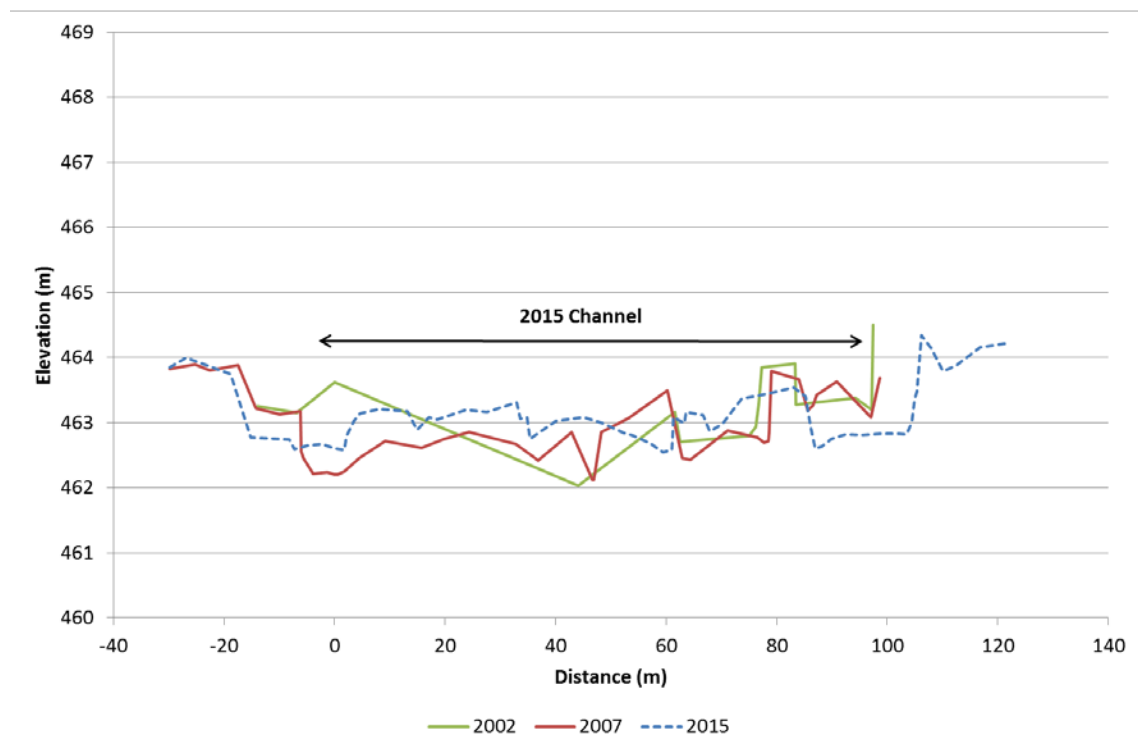
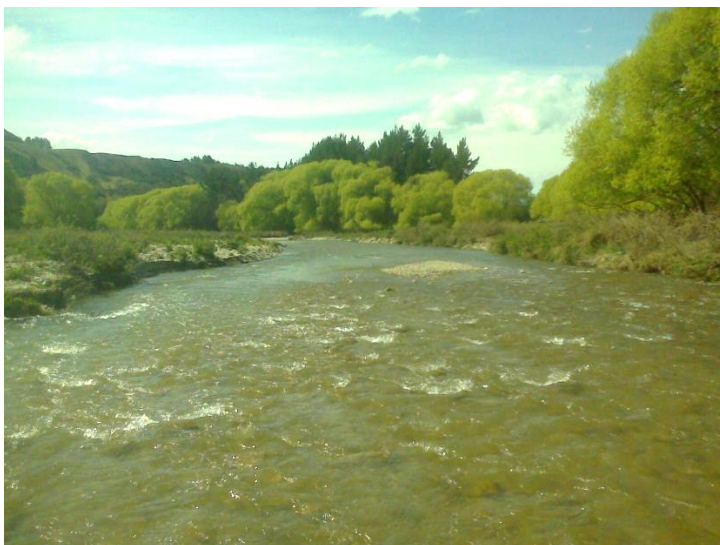
Cardrona River cross-section CR2A

Figure 79. Cardrona River cross-section CR2A, looking downstream refer to Figure 5 for location

Figure 80. Cardrona River cross-section CR2A, looking downstream, November 2015

Cross-section CR2A is located 11 km upstream of the confluence with the Clutha River/Mata-Au. The true left bank has eroded between 2007 and 2015, with aggradation of the true left side of the braid network occurring. Bank erosion occurred on the true right bank (between 2007 and 2015 with the creation of a new secondary channel).⁷

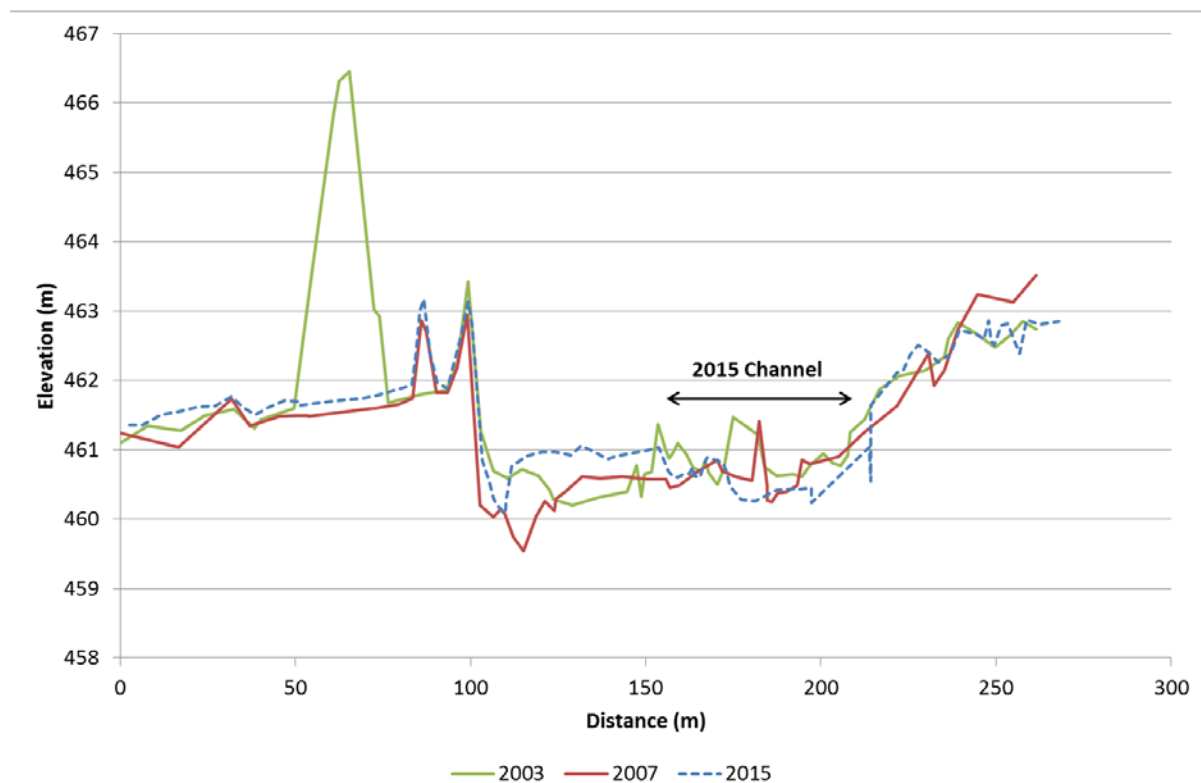
Cardrona River cross-section CR1B

Figure 81. Cardrona River cross-section CR1B, looking downstream refer to refer to Figure 5 for location

Cross-section CR1B is located 10.7 km upstream of the confluence with the Clutha River/Mata-Au. Aggradation has occurred on the true left of the fairway with degradation occurring on the true right between 2007 and 2015. The main channel has switched from the true left of the fairway in 2007 to the true right side of the fairway in 2015. Aggradation has occurred on the true right bank between 2007 and 2015.

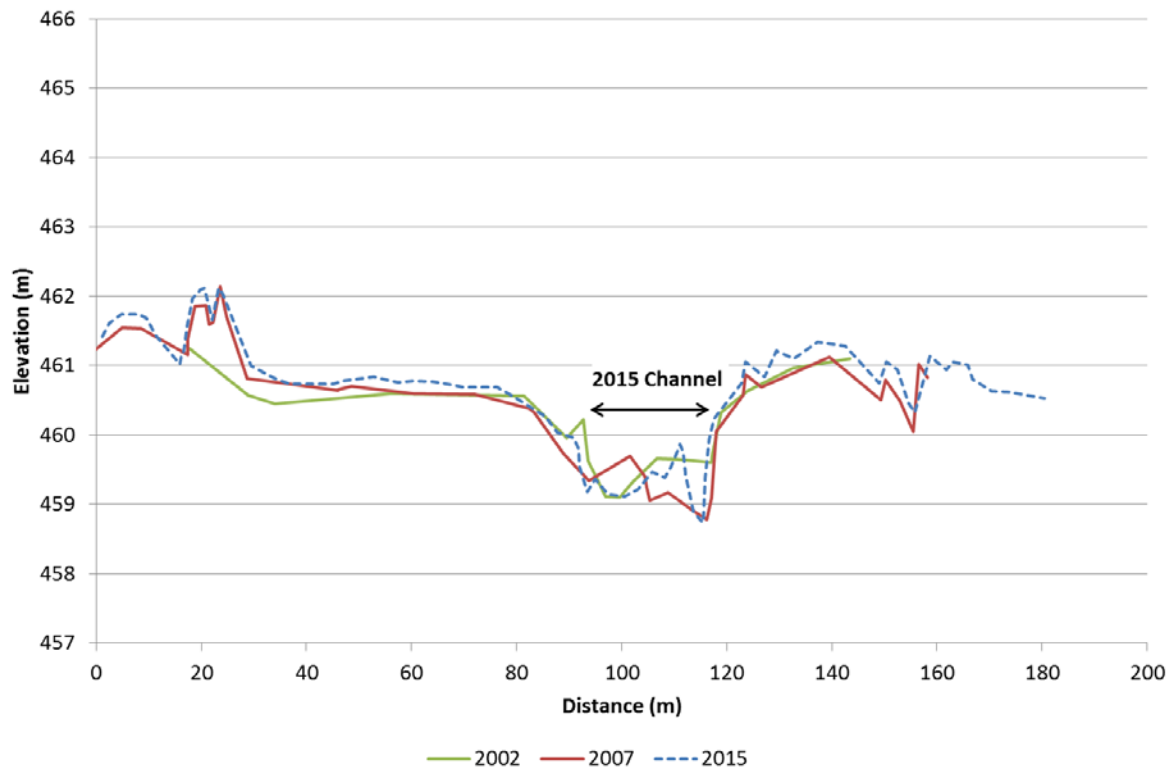
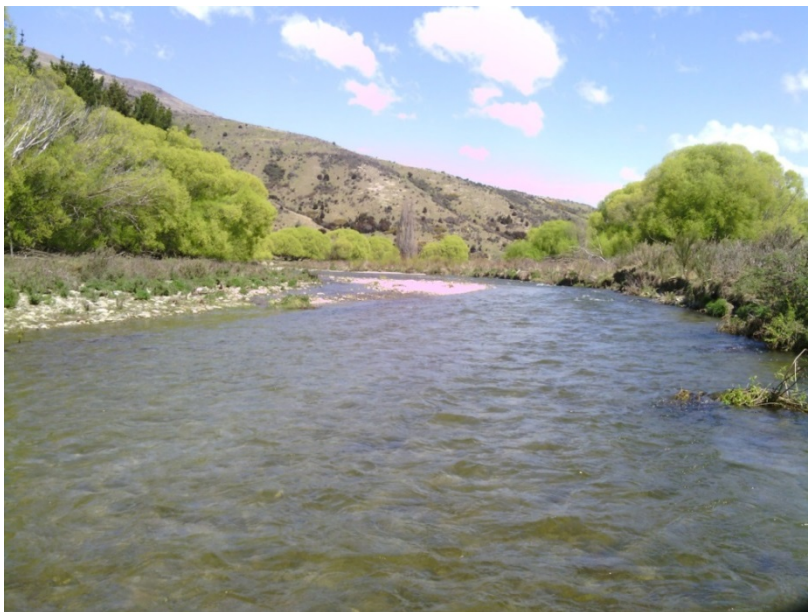
Cardrona River cross-section CR1A

Figure 83. Cardrona River cross-section CR1A, looking downstream refer to Figure 5 for location

Figure 84. Cardrona River cross-section CR1A, looking upstream, November 2015

Cross-section CR1A is located 10.6 km upstream of the confluence with the Clutha River/Mata-Au. Aggradation has occurred across the wider floodplain between 2003 and 2007. A mid channel bar has formed in the main channel between 2007 and 2015.

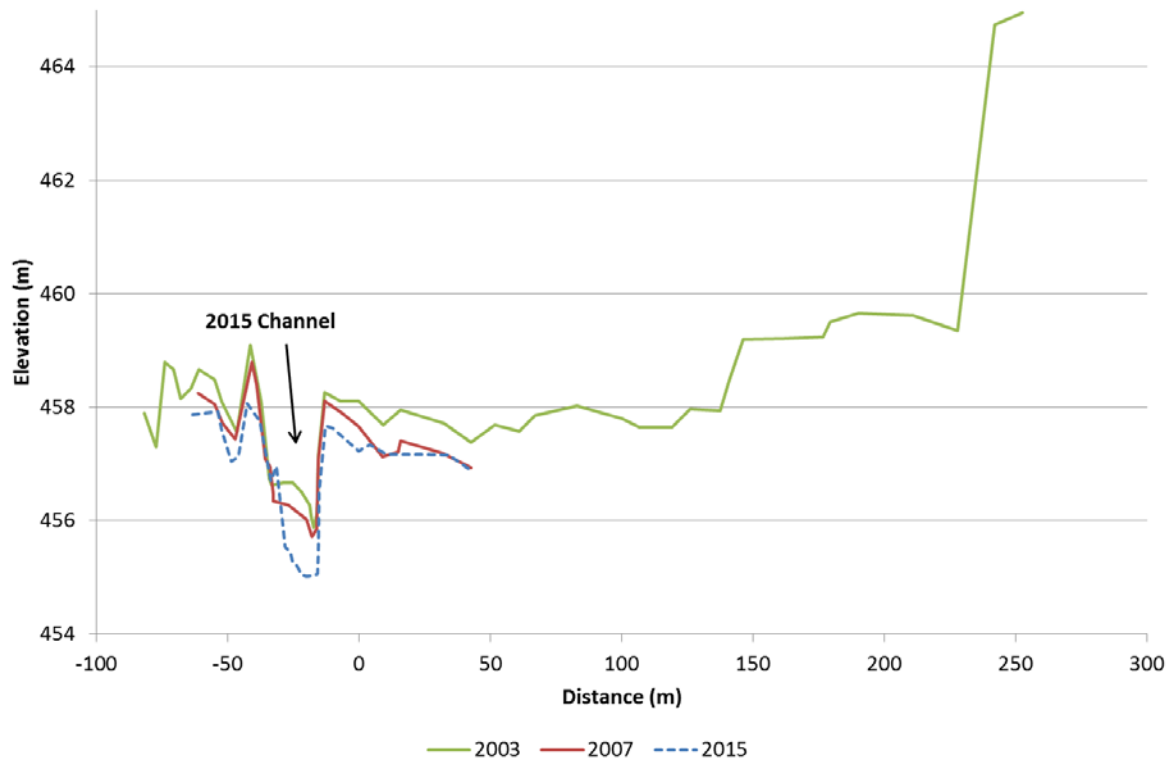
Cardrona River cross-section CR28-2

Figure 85. Cardrona River cross-section CR28-2, looking downstream refer to Figure 5 for location

Cross-section CR28-2 is located 10.18 km upstream of the confluence with the Clutha River/Mata-Au. The main channel has degraded between 2007 and 2015 with degradation occurring on the true left and right bank floodplain.

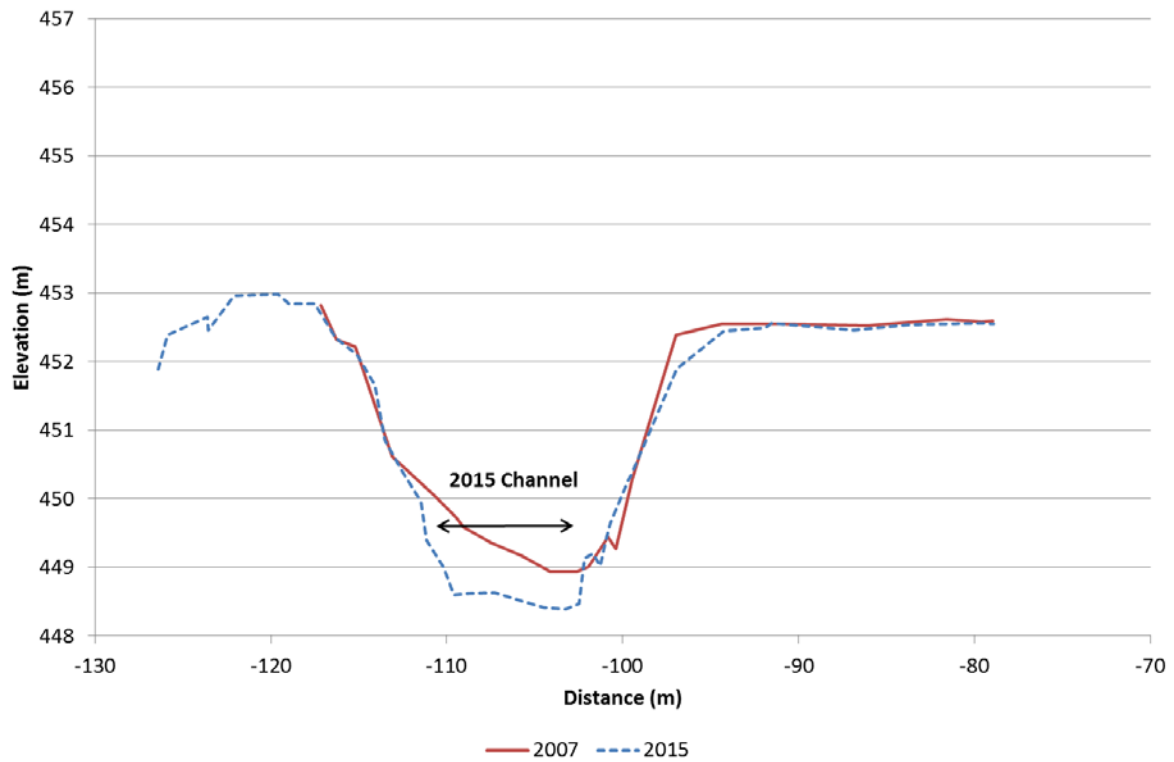
Cardrona River cross-section CR54-1

Figure 91. Cardrona River cross-section CR54-1, looking downstream refer to Figure 5 for location

Cross-section CR54-1 is located 9.4 km upstream of the confluence with the Clutha River/Mata-Au. The main channel has degraded between 2007 and 2015 with some degradation occurring on the true right bank floodplain.

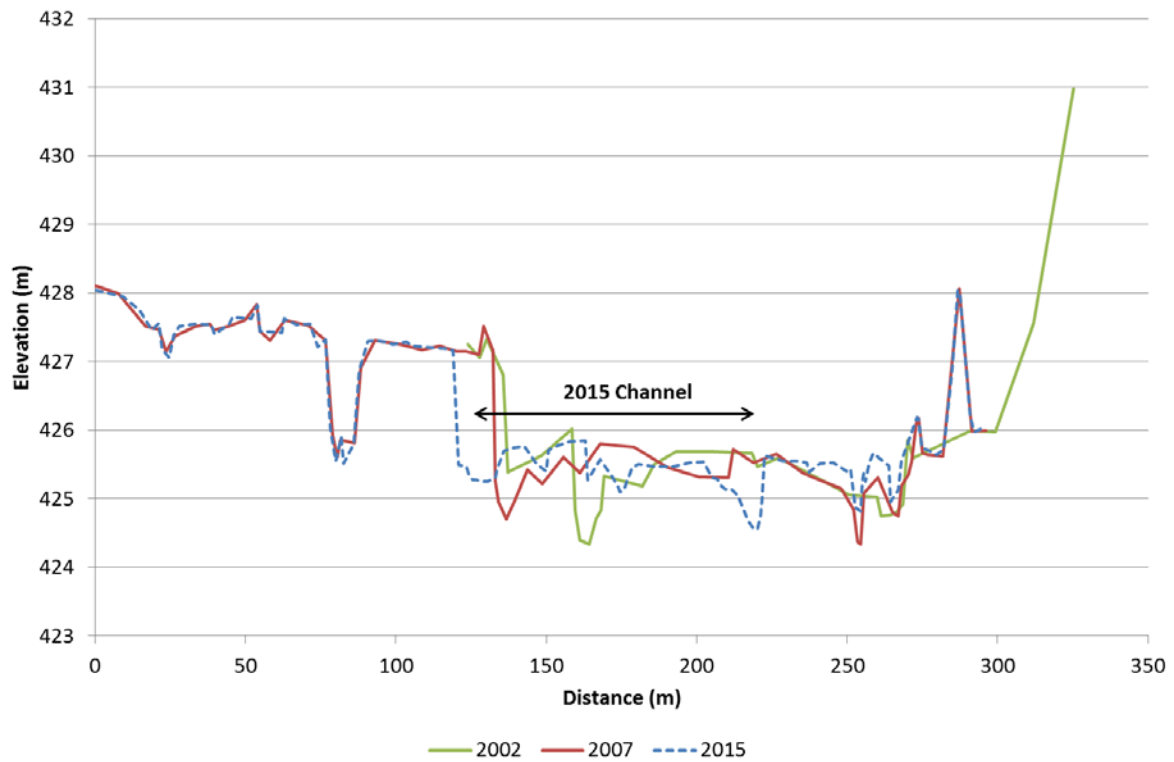
Cardrona River cross-section CR39

Figure 99. Cardrona River cross-section CR39, looking downstream refer to Figure 5 for location

Cross-section CR39 is located 6.6 km upstream of the confluence with the Clutha River/Mata-Au. The true left bank of the active fairway has eroded between 2007 and 2015. The active fairway has both aggraded and degraded between 2007 and 2015 as the river braids migrate across the river fairway.

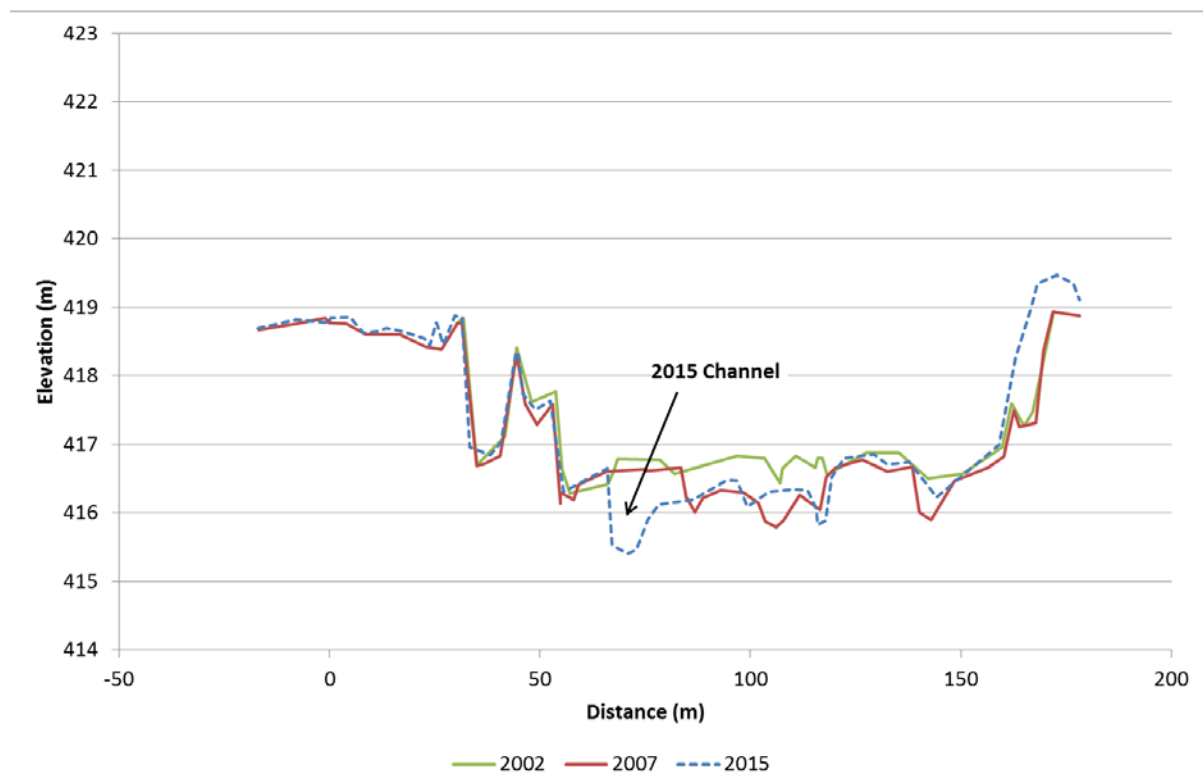
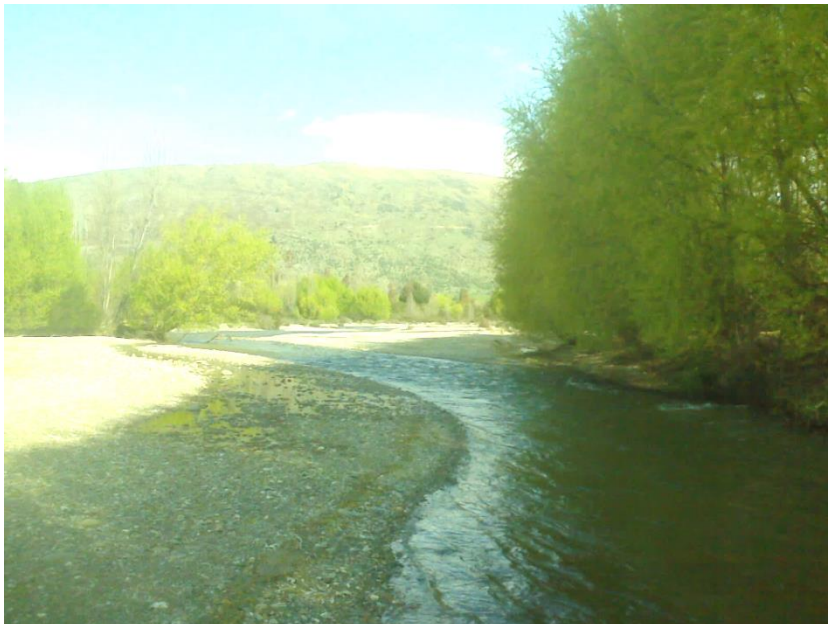
Cardrona River cross-section CR41

Figure 105. Cardrona River cross-section CR41, looking downstream refer to Figure 4 for location

Figure 106. Cardrona River cross-section CR41, looking upstream, November 2015

Cross-section CR41 is located 5.6 km upstream of the confluence with the Clutha River/Mata-Au. The main channel has switched from the centre of the active fairway in 2007 to the true left side in 2015. The true right bank has experienced aggradation between 2007 and 2015.

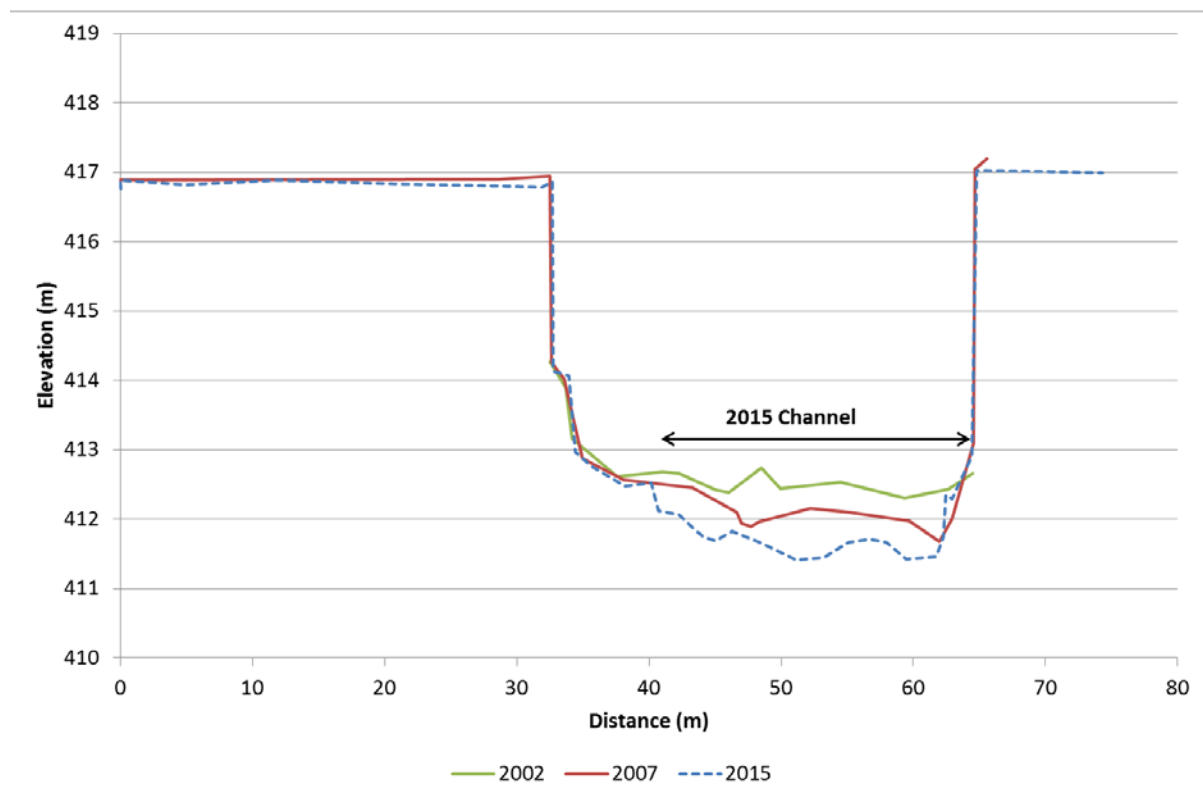
Cardrona River cross-section CR42

Figure 107. Cardrona River cross-section CR42, looking downstream refer to Figure 4 for location

Cross-section CR42 is located 5.1 km upstream of the confluence with the Clutha River/Mata-Au at the Ballantyne Road bridge. The active channel at this location is confined by the presence of the bridge and has continued to degrade between 2002 and 2015.

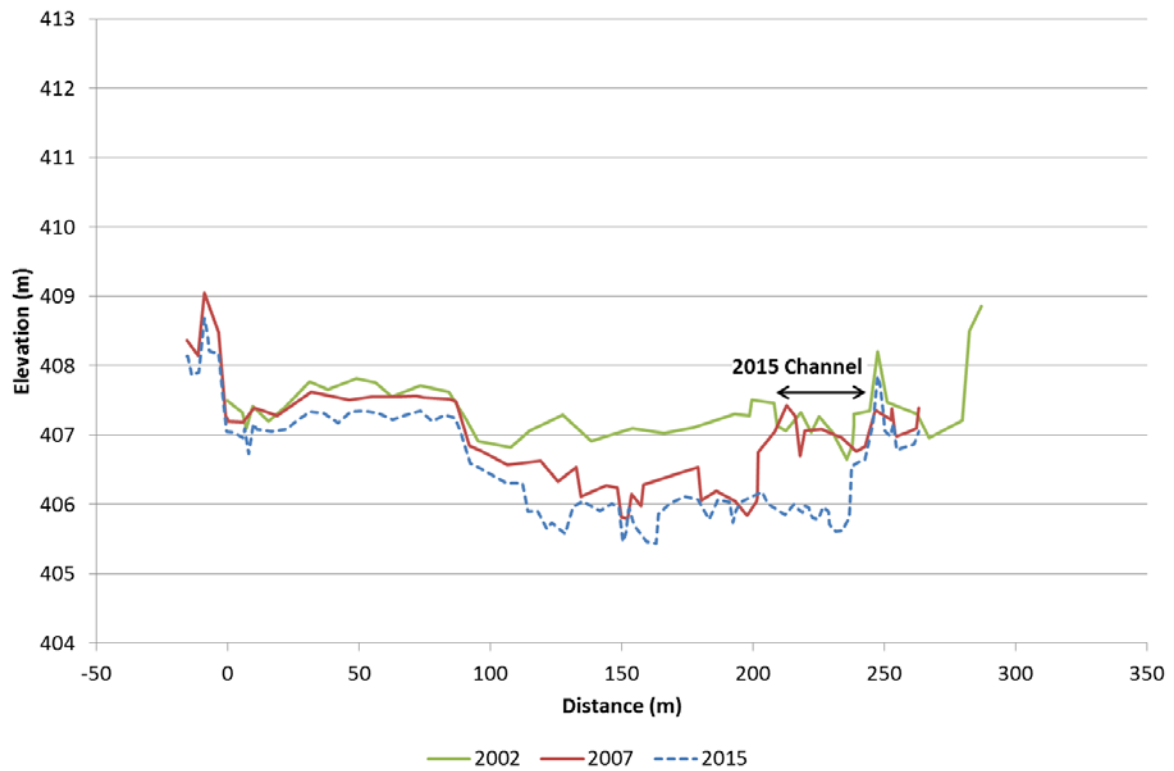
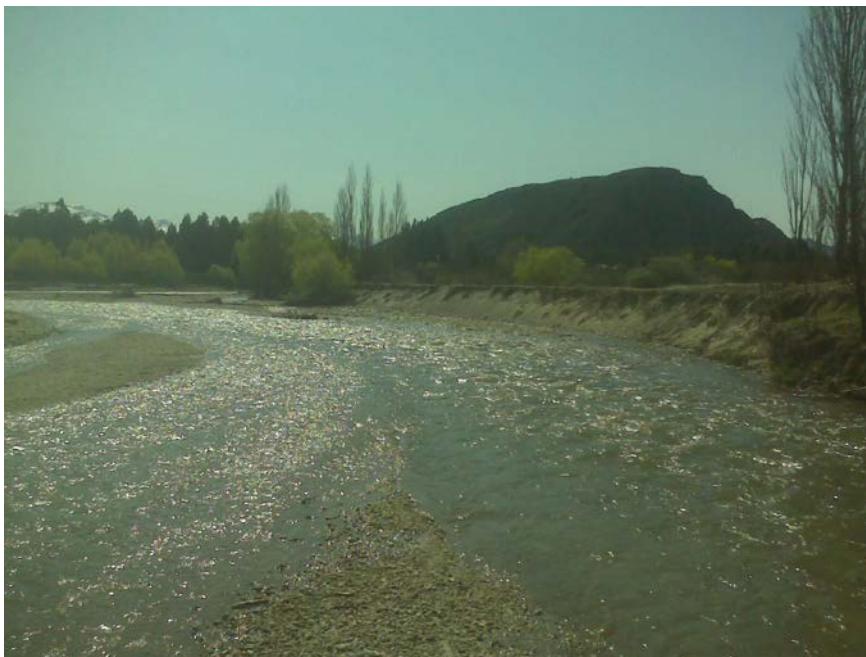
Cardrona River cross-section CR44

Figure 109. Cardrona River cross-section CR44, looking downstream refer to Figure 4 for location

Figure 110. Cardrona River cross-section CR44, looking downstream, November 2015

Cross-section CR44 is located 4.3 km upstream of the confluence with the Clutha River/Mata-Au. The active fairway has degraded between 2002 and 2015. Degradation of the true left bank floodplain has occurred between 2002 and 2015.

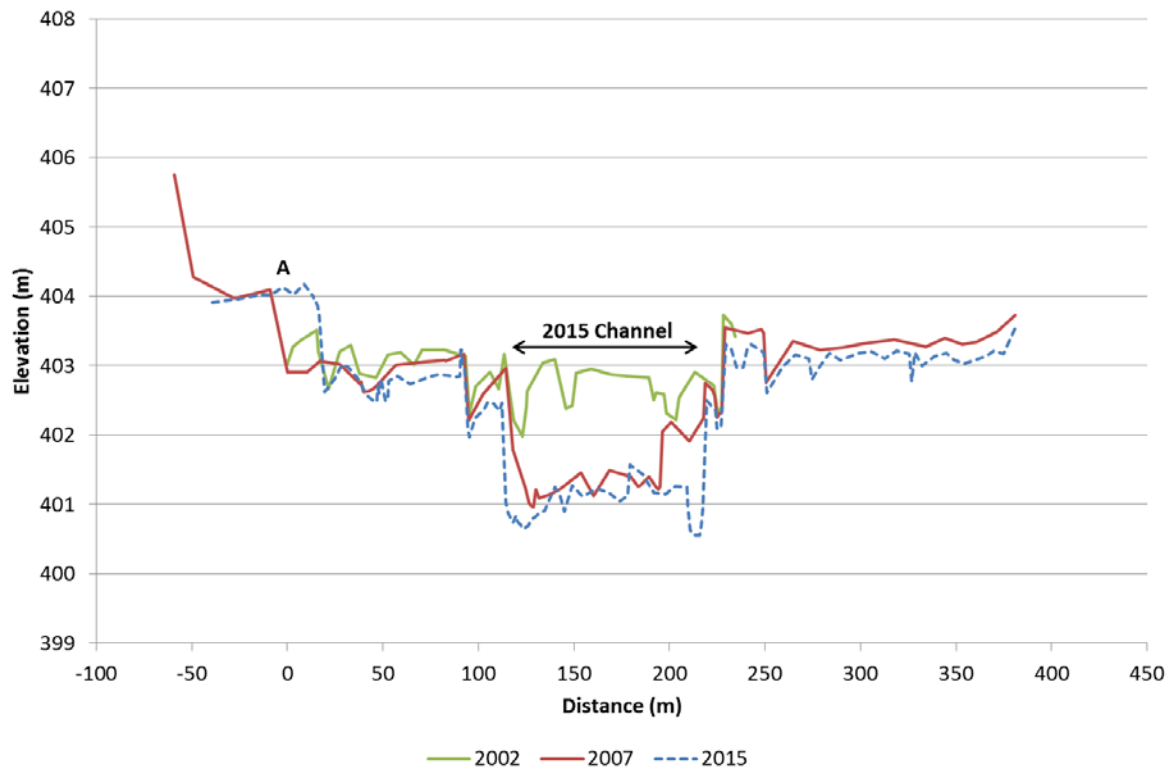
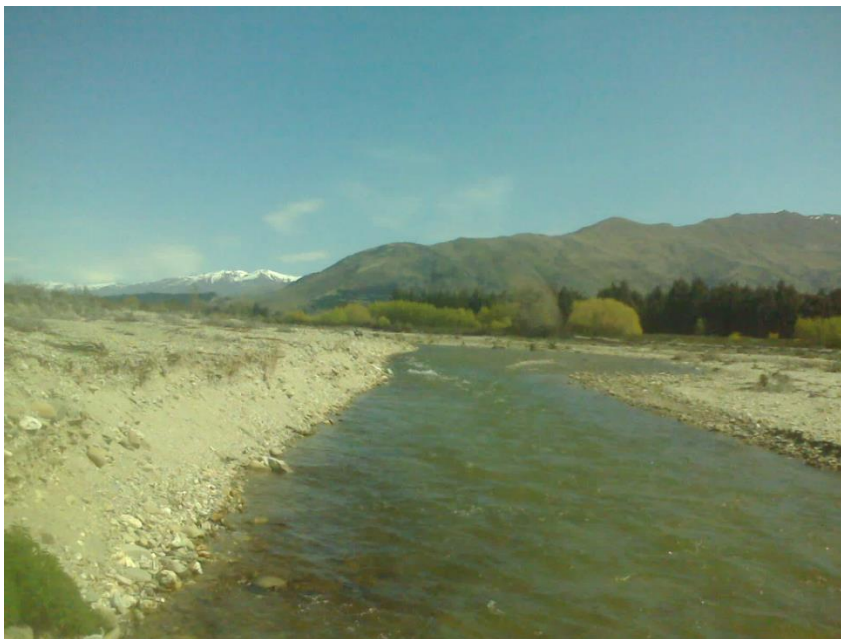
Cardrona River cross-section CR44-1

Figure 111. Cardrona River cross-section CR44-1, looking downstream refer to Figure 4 for location

Figure 112. Cardrona River cross-section CR44-1, looking downstream, November 2015

Cross-section CR44-1 is located 3.8 km upstream of the confluence with the Clutha River/Mata-Au. The active fairway and the true left and right bank floodplain have degraded between 2007 and 2015. The true left bank terrace has aggraded (at the point labelled A).
