Cardrona River Channel Morphology

May 2016

Otago Regional Council

Technical summary

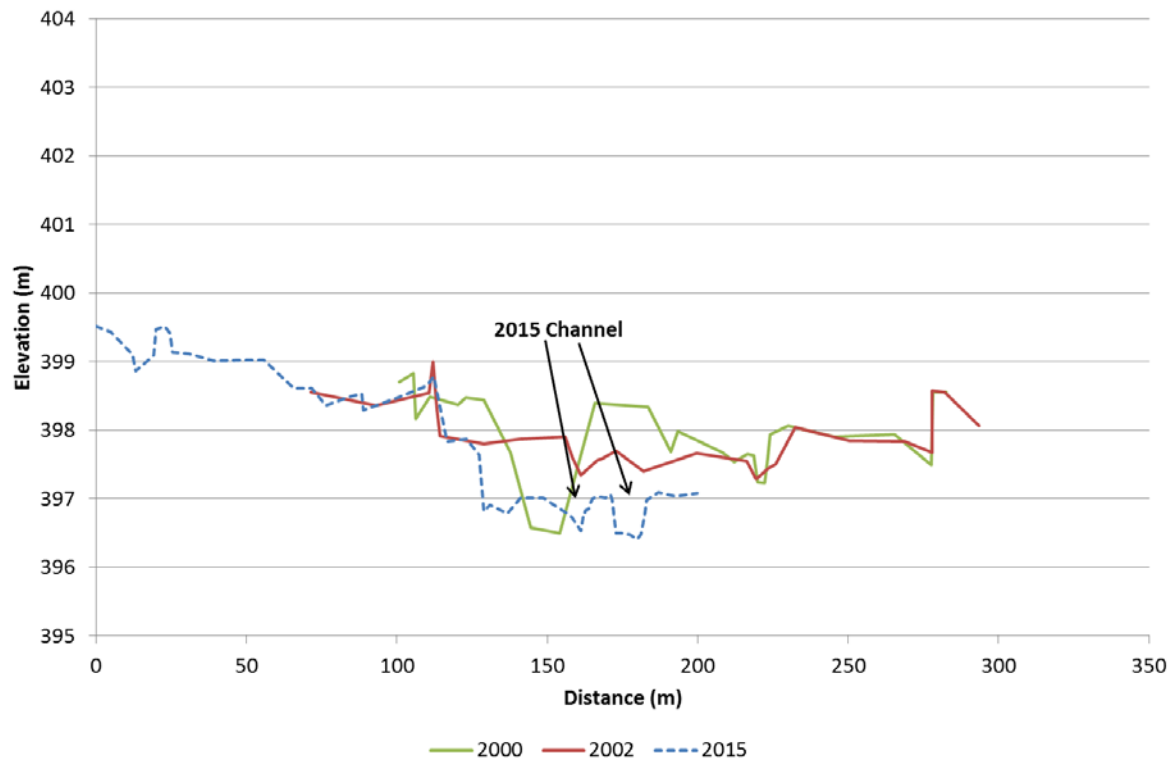
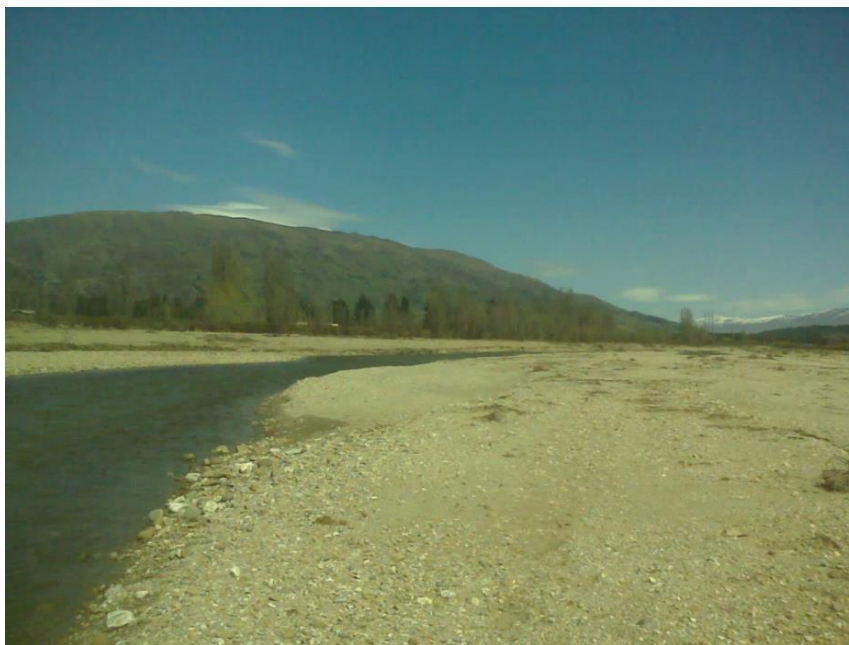
Cardrona River cross-section CR46

Figure 113. Cardrona River cross-section CR46, looking downstream refer to Figure 4 for location

Figure 114. Cardrona River cross-section CR46, looking upstream, November 2015

Cross-section CR46 is located 3.3 km upstream of the confluence with the Clutha River/Mata-Au. The active fairway has degraded between 2002 and 2015. The 2015 survey does not extend sufficiently onto the true right floodplain to allow a comparison to be made.

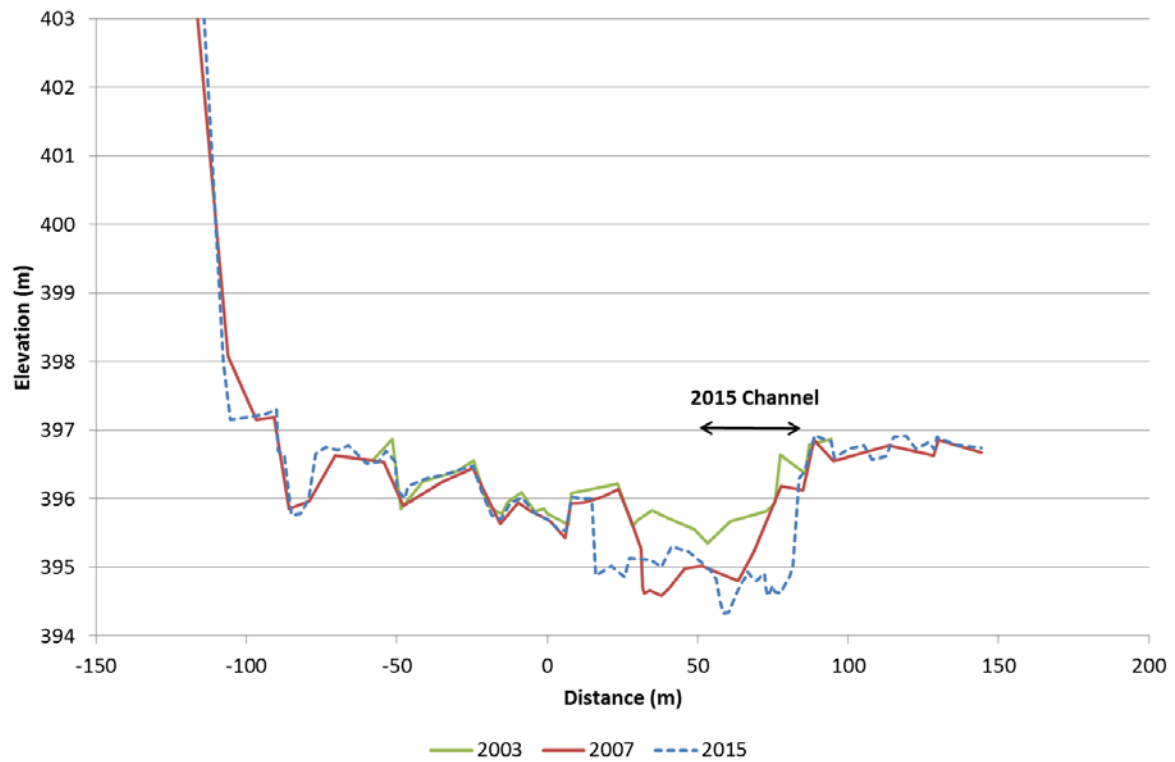
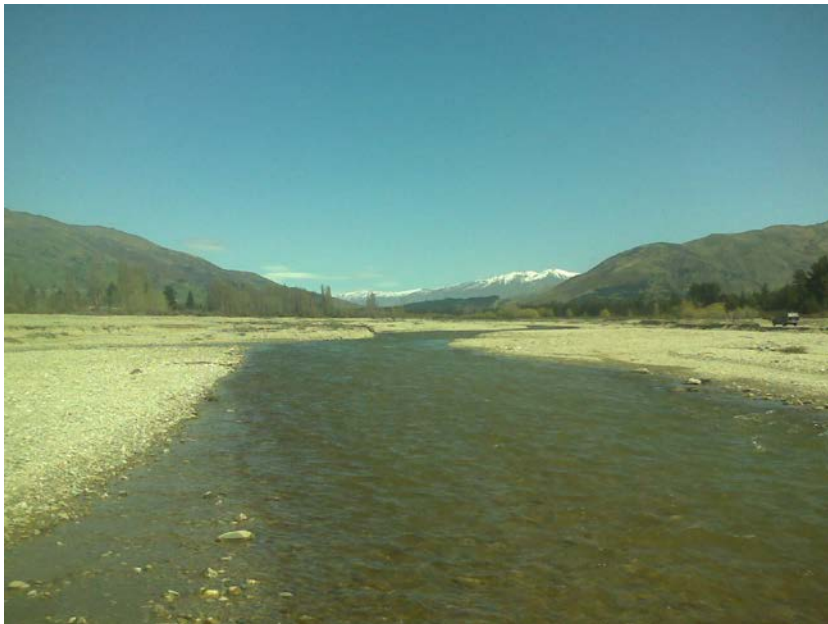
Cardrona River cross-section CR46-1

Figure 115. Cardrona River cross-section CR46-1, looking downstream refer to Figure 4 for location

Figure 116. Cardrona River cross-section CR46-1, looking upstream, November 2015

Cross-section CR46-1 is located 3 km upstream of the confluence with the Clutha River/Mata-Au. Between 2007 and 2015 the active fairway has both aggraded and degraded with erosion occurring on the true left and right banks. The wider floodplain has remained similar between 2007 and 2015.

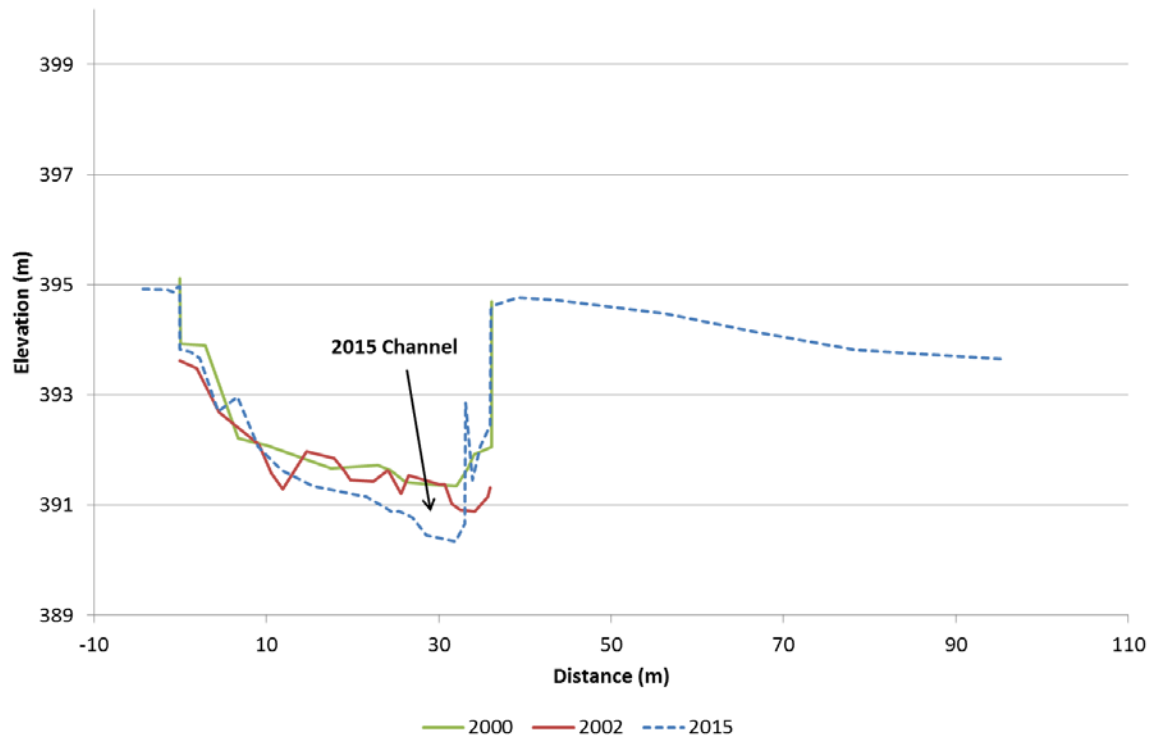
Cardrona River cross-section CR47-1

Figure 117. Cardrona River cross-section CR47-1, looking downstream refer to Figure 4 for location

Cross-section CR47-1 is located 2.5 km upstream of the confluence with the Clutha River/Mata-Au at the SH6 bridge. This cross-section was not surveyed in 2007. Between 2000 and 2015 the main channel has degraded creating a more confined river channel.

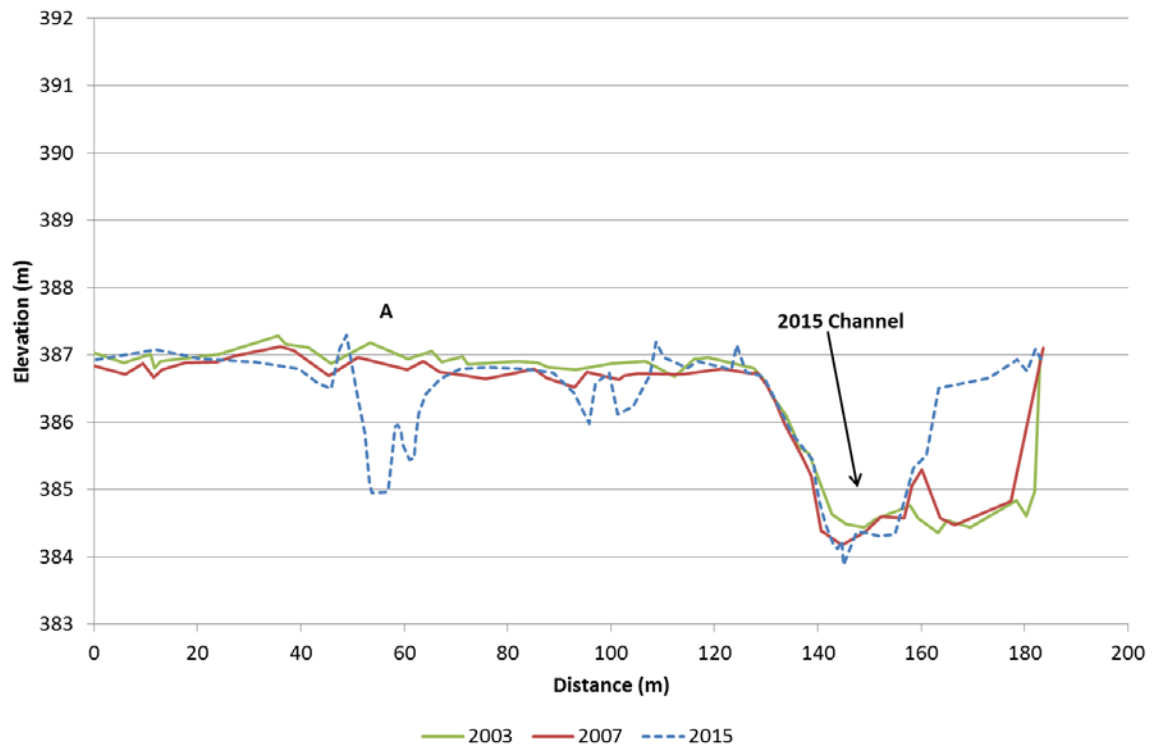
Figure 119. Cardrona River cross-section CR48-1, looking downstream refer to Figure 4 for location

Cross-section CR48-1 is located 1.7 km upstream of the confluence with the Clutha River/Mata-Au. The main channel in 2015 has remained in a similar position to 2007; there has been a large quantity of aggradation of the true right bank between 2007 and 2015. A new channel that has formed on the true left floodplain (at the point labelled A) is associated with a new industrial development.

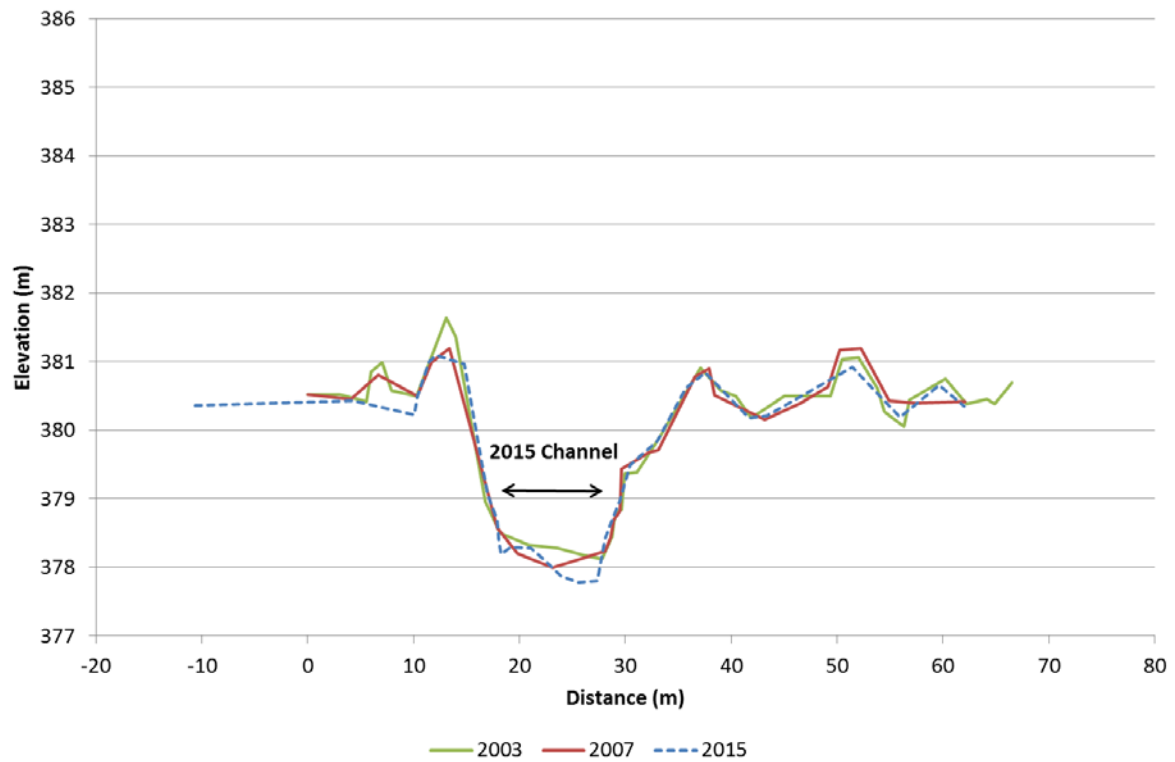
Figure 121. Cardrona River cross-section CRMWD1, looking downstream refer to Figure 4 for location

Cross-section CRMWD1 is located 0.9 km upstream of the confluence with the Clutha River/Mata-Au. Between 2007 and 2015 the main channel has degraded while the wider floodplain has remained similar.

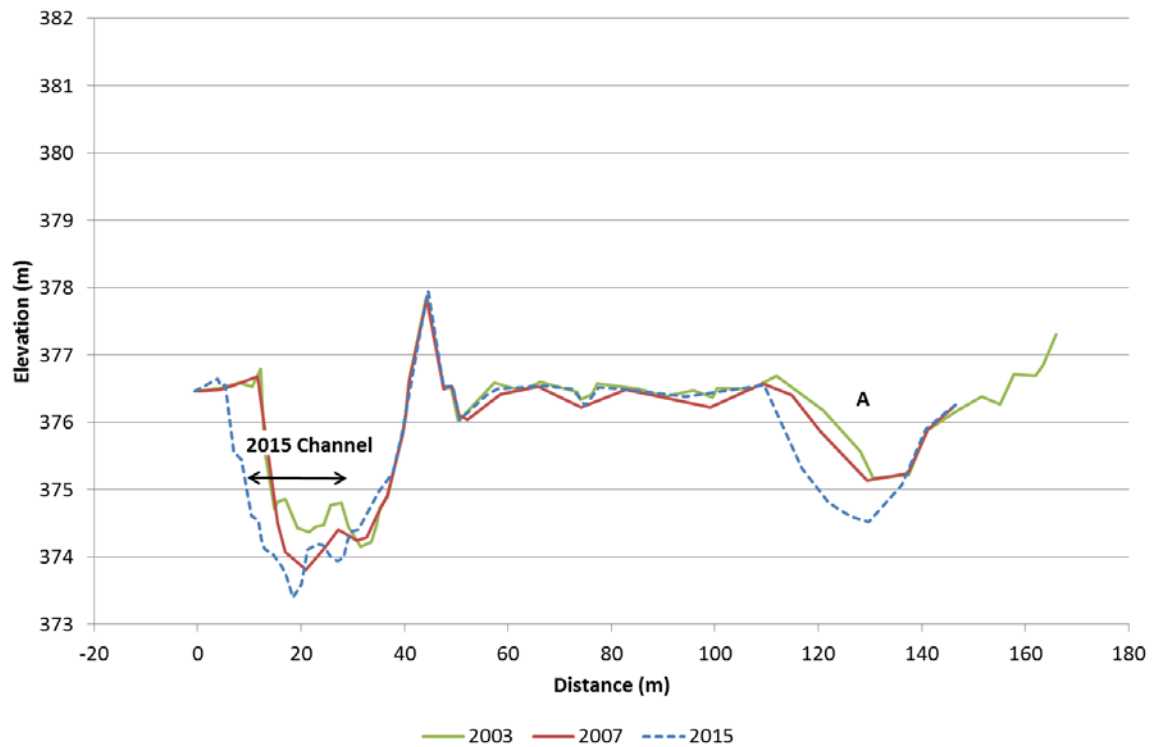
Figure 122. Cardrona River cross-section CR52-1, looking downstream refer to Figure 4 for location

Cross-section CR52-1 is located 0.2 km upstream of the confluence with the Clutha River/Mata-Au. Between 2007 and 2015 the true left bank eroded with degradation occurring in the main channel. A secondary channel (at the point labelled A) degraded between 2007 and 2015.
