Coastal Otago flood event
3 June 2015

Published October 2015

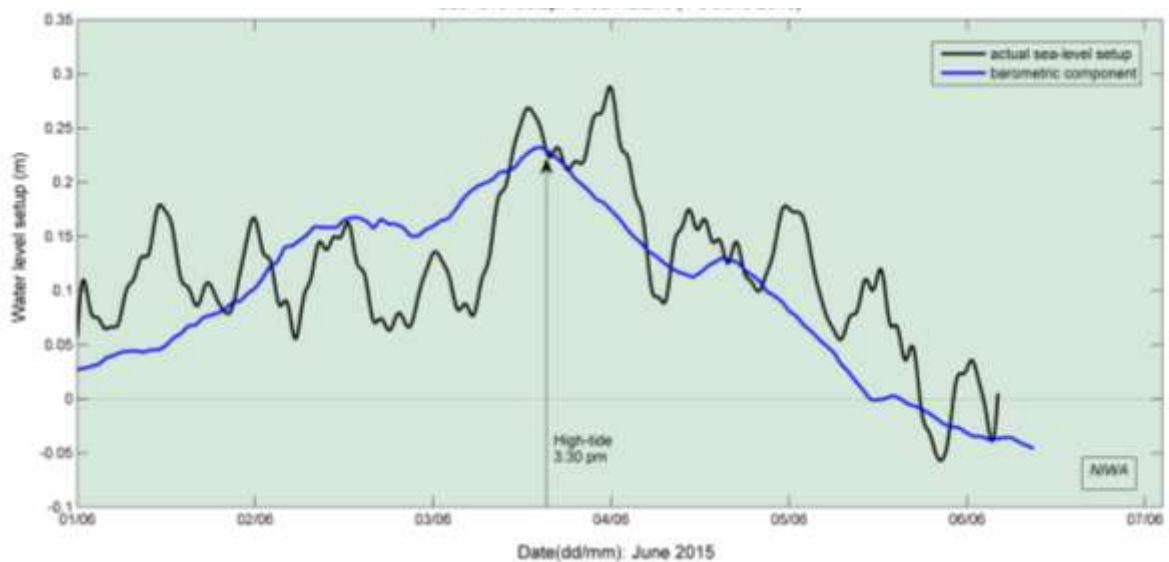
Figure 9 shows that the actual storm-tide level (black line) at the Green Island gauge on 3 June was up to 0.25m higher than the predicted high tide, due mainly to the setup (blue line) from the low-pressure system that crossed the region (down to 989 hPa).

Figure 9. Sea-level setup at Green Island (1-6 June 2015)

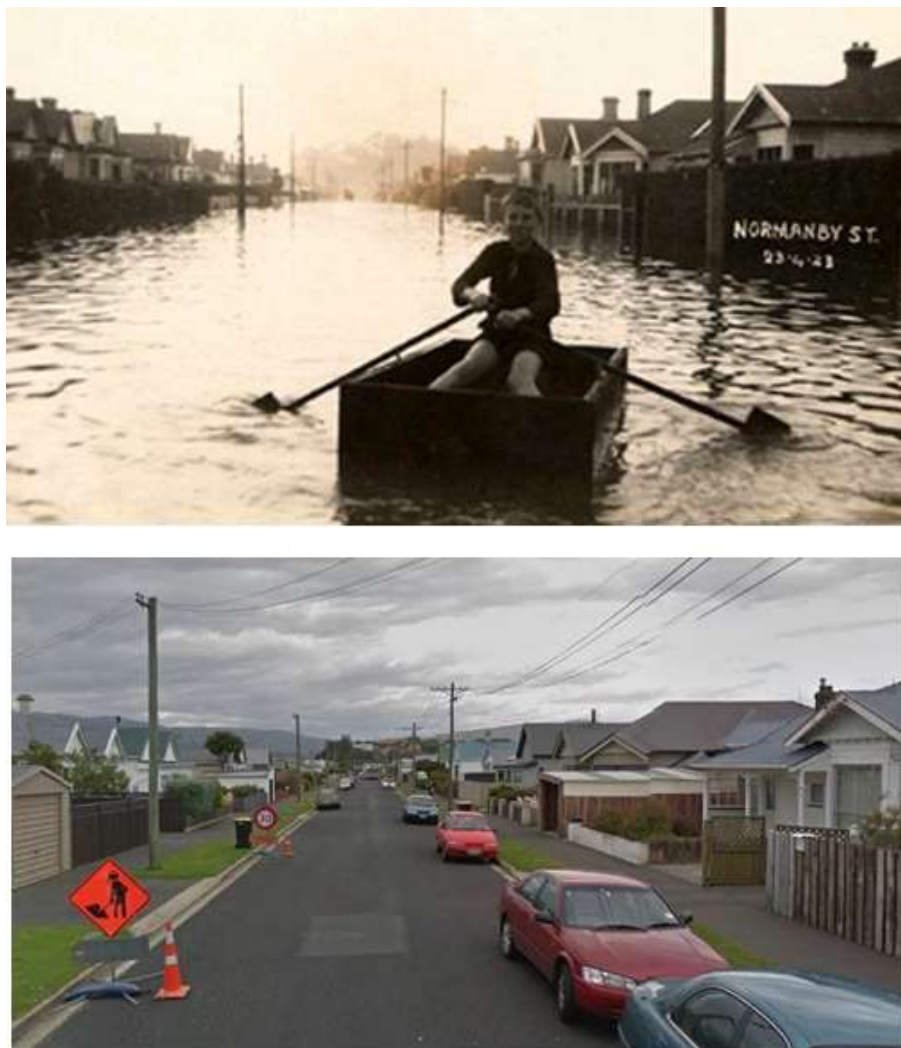
Figure 15. Ponding of surface water at the southern end of Normanby Street, April 1923, and the same view during normal conditions today (Google StreetView). This location is shown on Figure 16.

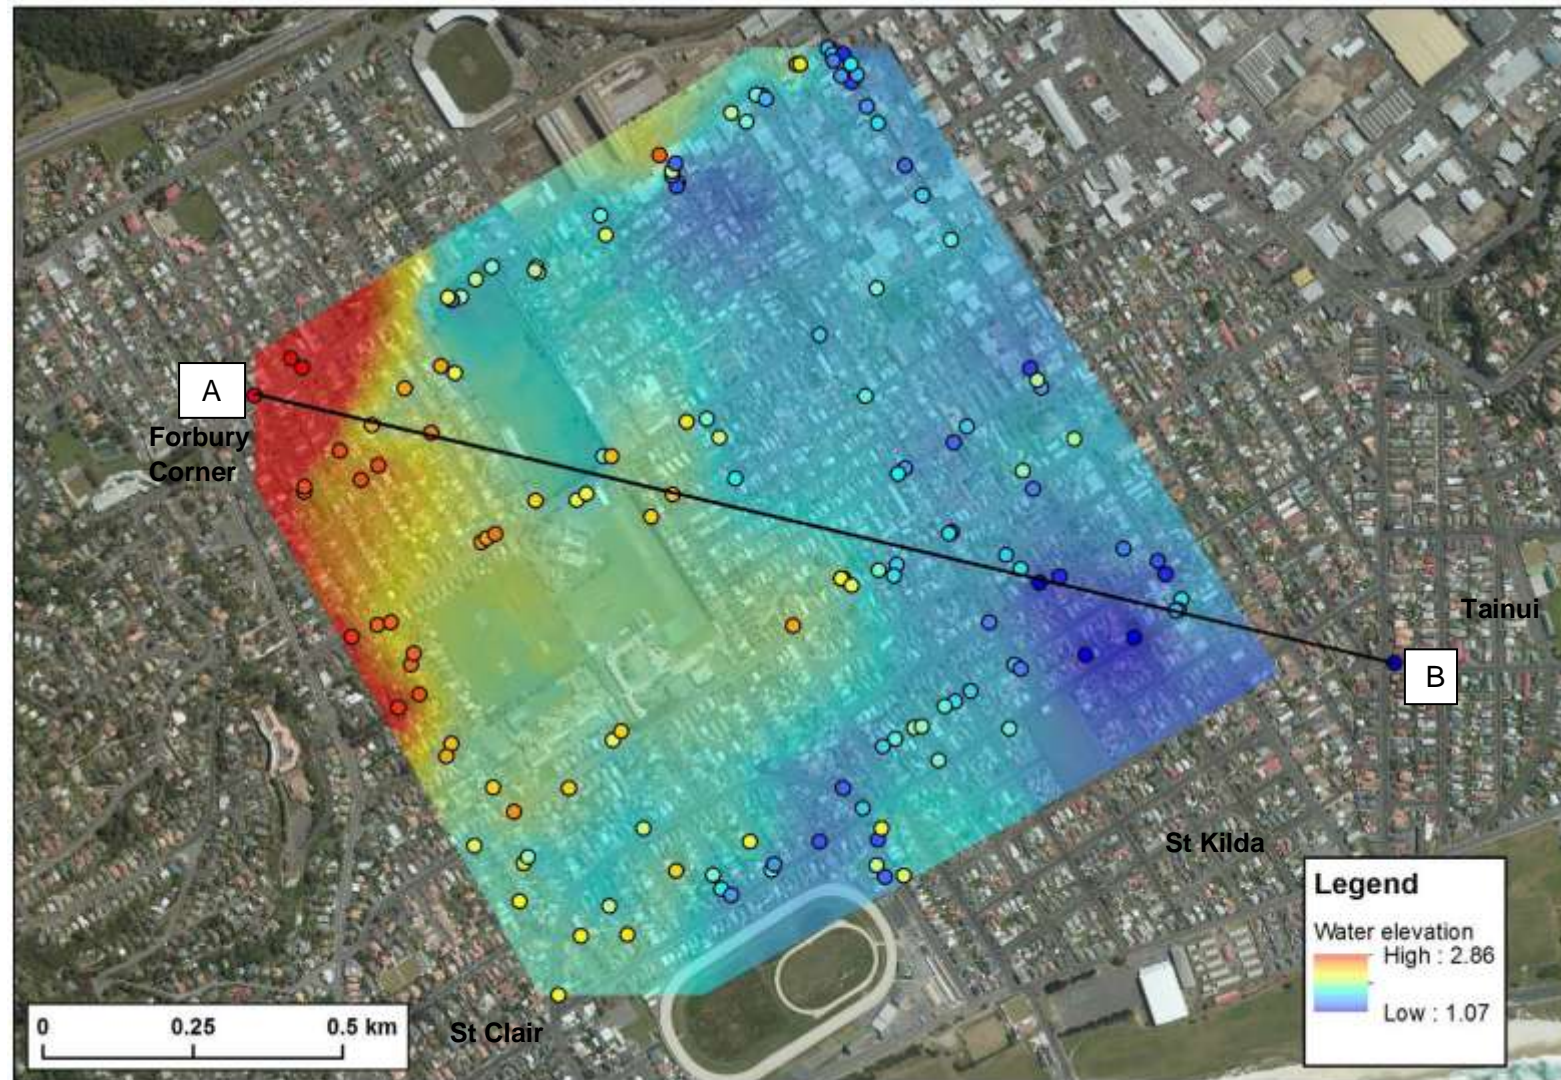
The survey data does show a clear pattern in terms of water elevation relative to mean sea level, as shown in Figure 17. Water level was highest towards the northwest (Forbury Corner) and gradually slopes towards the south and east (i.e. the water-level contours generally follow the topography of the gently southeast sloping plain that comprises the South Dunedin area).

Figure 17. Surveyed flood-water elevations (dots), and interpolated water-surface elevation across South Dunedin. Profile Line A-B as shown in Figure 16 and Figure 18.

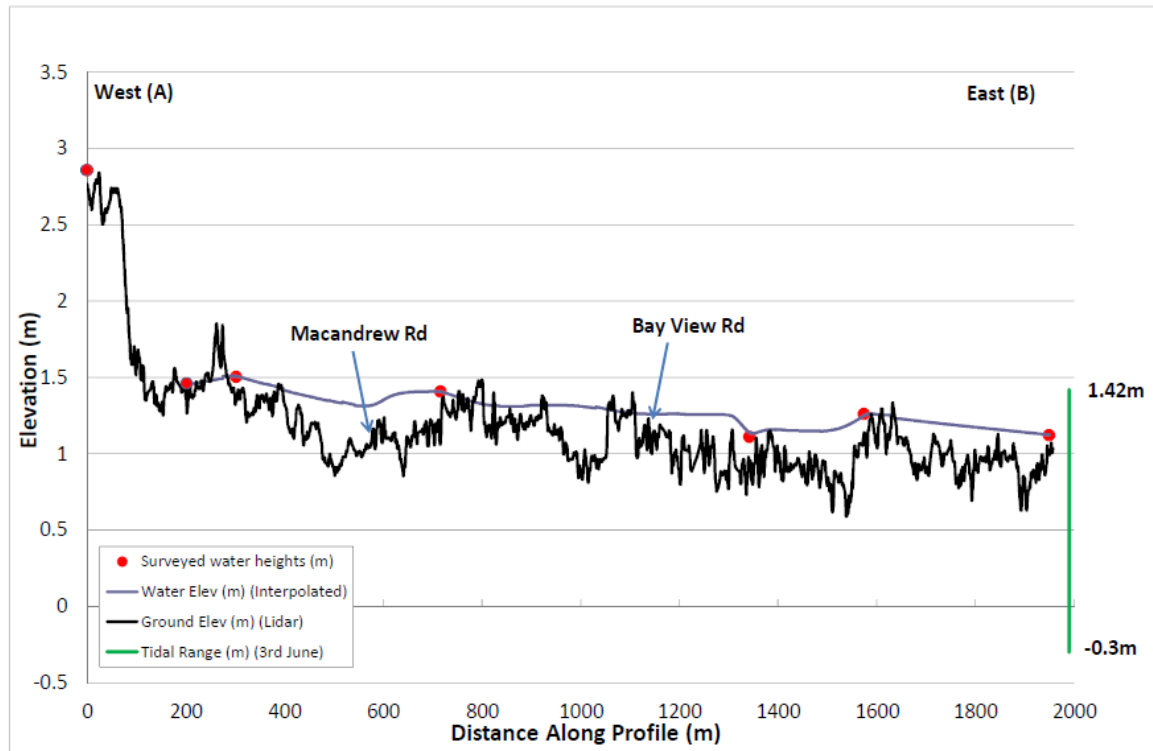
Figure 18. Elevation transect shown on Figure 17. The black line is ground elevation, and the blue line is the interpolated maximum flood elevation from Figure 17. The red dots are actual observations of water level in close proximity to the transect line. Water surface has a gradual slope from west to east. The green line shows the range between the highest and lowest sea levels observed at the Green Island sea-level recorder on 3 June. Elevations are relative to current mean sea level.

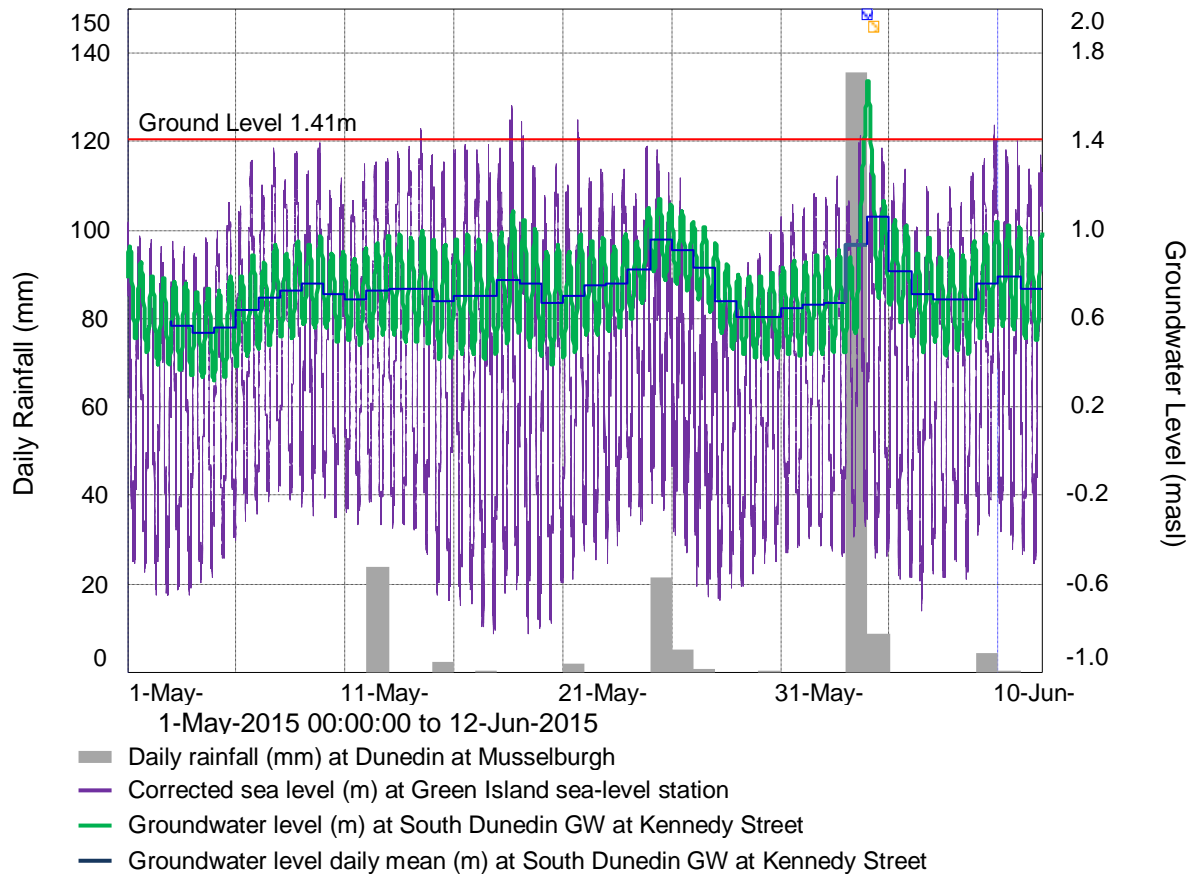
The Kennedy Street bore is located closest to the coast, and groundwater levels display a cyclic pattern, suggesting that there is tidal influence on water levels at this location. As mentioned in Section 5, the tide was at a natural cyclical peak due to a full moon and low barometric pressure. Therefore, groundwater levels at Kennedy Street were also at a cyclical peak. Due to the tidal influence, the groundwater levels before the flood have been taken from the average-daily groundwater level, as shown in blue in Figure 21. Average-daily groundwater levels before the flood were above average for this monitoring

bore (average-daily groundwater level (gwl): 0.603 metres above sea level (masl); 2 June average-daily gwl: 0.674 masl). It is likely that the rain events that occurred on 12 and 26 May 2015 also contributed to a higher-groundwater level than average. Groundwater levels rose 0.997 m above the average-daily groundwater level for 2 June during the rain event on 3 June 2015 to a maximum level of 1.671 masl, which is 0.261m above the surveyed-ground level at this bore (1.41 masl).

Figure 21. Kennedy Street continuous and average-daily groundwater record, Green Island tidal data and daily rainfall from 1 May - 12 June 2015. Ground level is 1.41 masl.

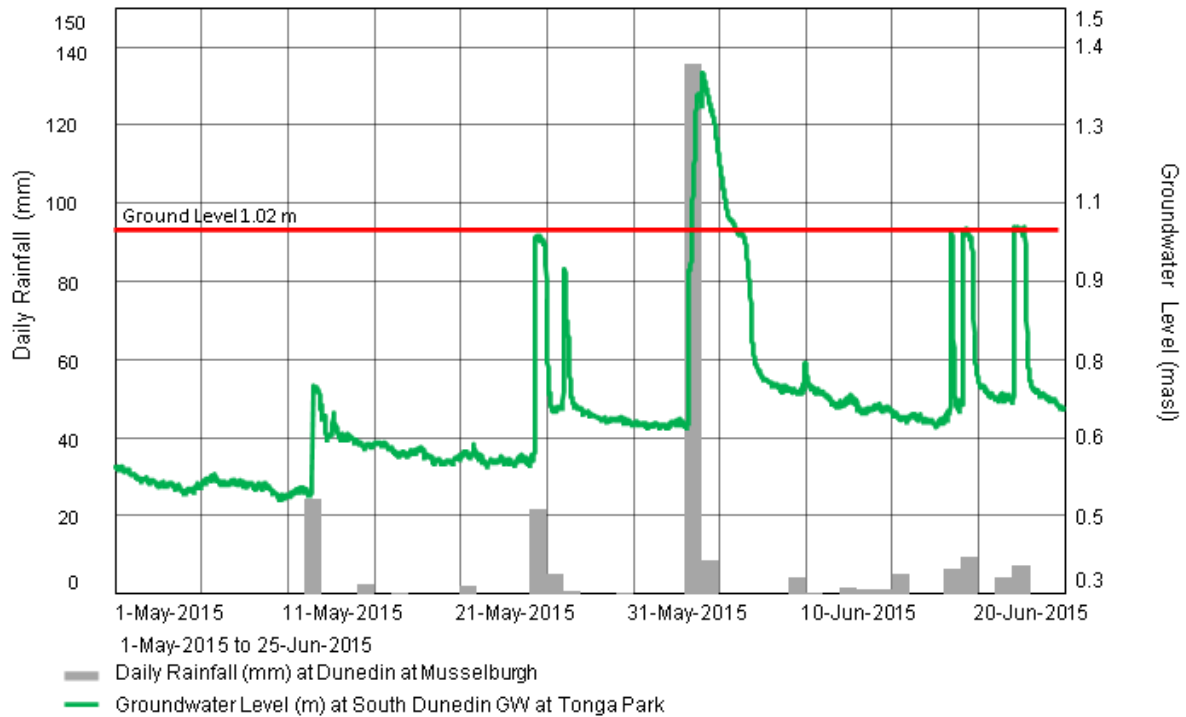
Groundwater levels before the flood were at average level for this monitoring bore (average gwl: 0.557 metres above sea level (masl); 2 June at 11:45 pm: 0.644 masl), although there is an increasing trend in groundwater level, possibly due to rain events that occurred on 12 and 26 May 2015. Groundwater levels rose 0.722 m during the rain event on 3 June 2015 to a maximum level of 1.366 masl, which is 0.346 m above the surveyed-ground level at this bore (1.02 masl). It is noted that the interpolated water-surface elevation (Figure 17) at Tonga Park is about 1.4 masl, similar to that recorded at the bore, and indicating that this site was possibly measuring floodwater as a result of the 3 June event.

Figure 22. Tonga Park continuous groundwater record from 1 May - 25 June 2015. Ground level is 1.02 masl.

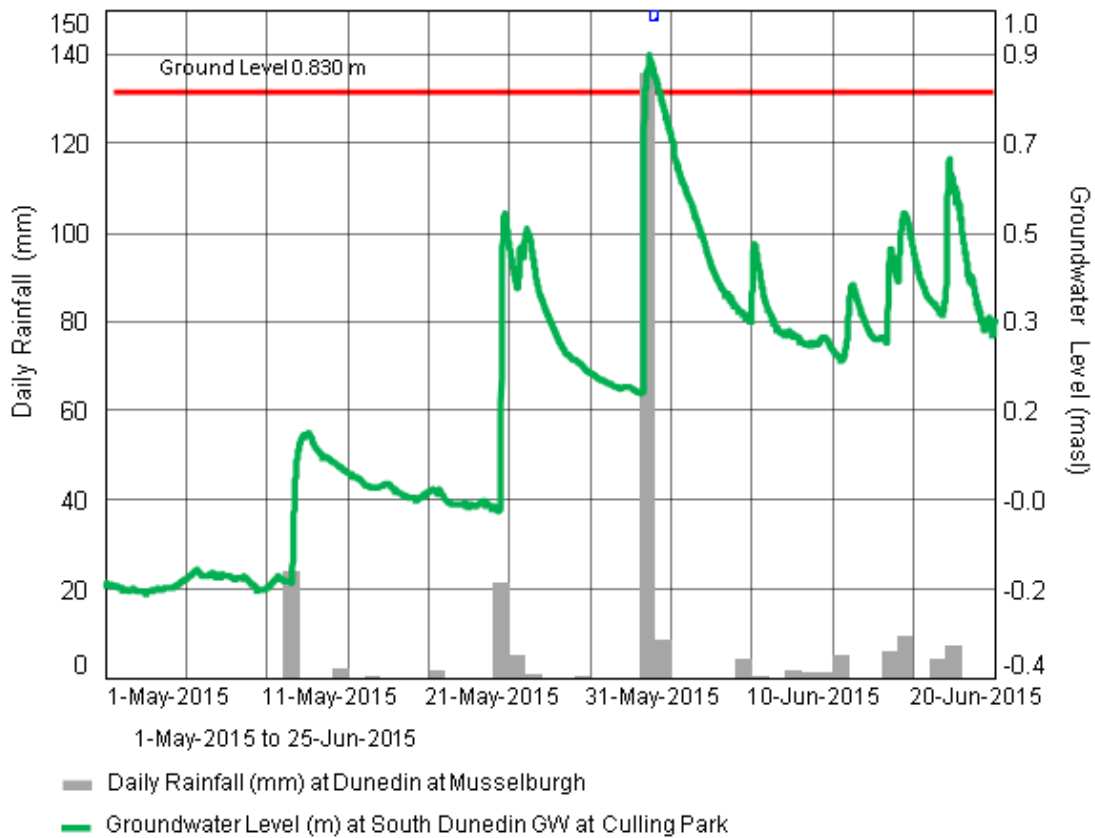
The groundwater-monitoring bore at Culling Park has a shorter monitoring record than the other three sites, as this bore was installed in May 2014. Groundwater levels before the flood were above average at this location (average gwl: 0.075 masl; 2 June at 11:45 pm: 0.198 masl). This may be as a result of the shorter groundwater record decreasing the average water level. Nevertheless, it is possible that the rain events that occurred on 12 and 26 May 2015 contributed to a slightly higher groundwater level than average. Groundwater levels rose 0.707m during the rain event on 3 June 2015 to a maximum level of 0.905 masl, which is 0.075m *above* the surveyed-ground level at this bore (0.830 masl).

Figure 23. Culling Park continuous groundwater record from 1 May - 25 June 2015. Ground level is 0.830 masl.

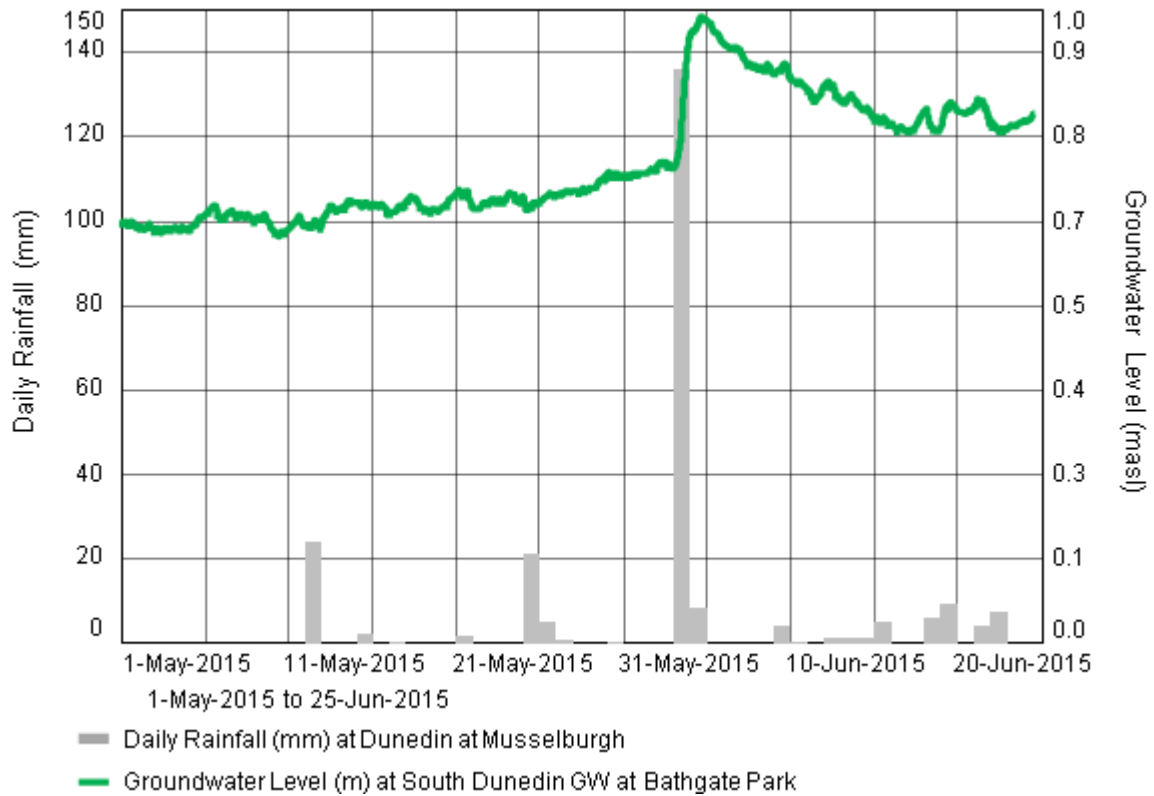
Groundwater levels before the flood were slightly above average for this monitoring bore (average gw: 0.689 masl; 2 June at 11:45 pm: 0.751 masl), probably as a result of rain events that occurred on 12 and 26 May 2015. Groundwater levels rose 0.238 m during the rain event on 3 June 2015 to a maximum level of 0.988 masl, which is 0.532 m *below* the surveyed-ground level at this bore (1.52 masl).

Figure 24. Bathgate Park continuous groundwater record from 1 May - 12 June 2015. Ground level is 1.52 masl.

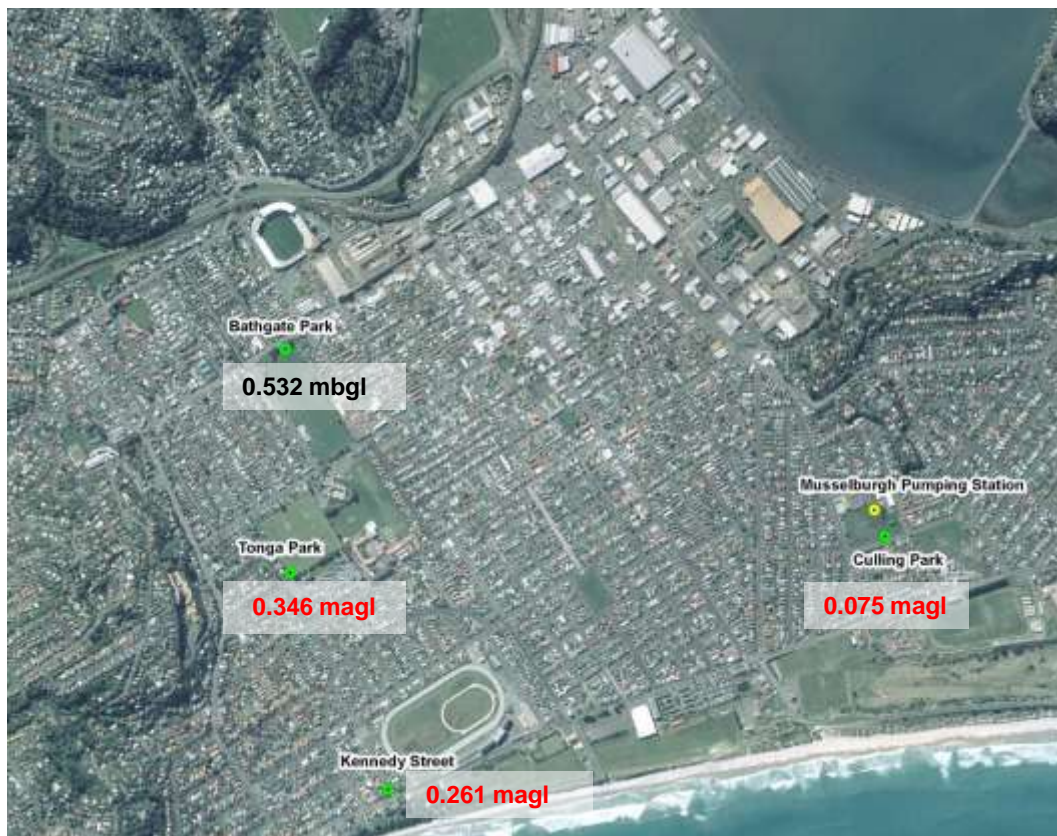
Groundwater levels from three bores (Kennedy Street, Tonga and Culling parks) rose above ground level as a result of the rain event that occurred on 3 June 2015 (Figure 25). Groundwater levels at Bathgate Park were 0.53 m below ground level. Groundwater may have contributed to the surface flooding in the low-lying areas of South Dunedin. However, elevated groundwater levels close to ground level may have prevented surface water from infiltrating into the ground and dispersing into the aquifer below.

Figure 25. Location of groundwater above and below ground level in South Dunedin. Red – metres above ground level; black – metres below ground level

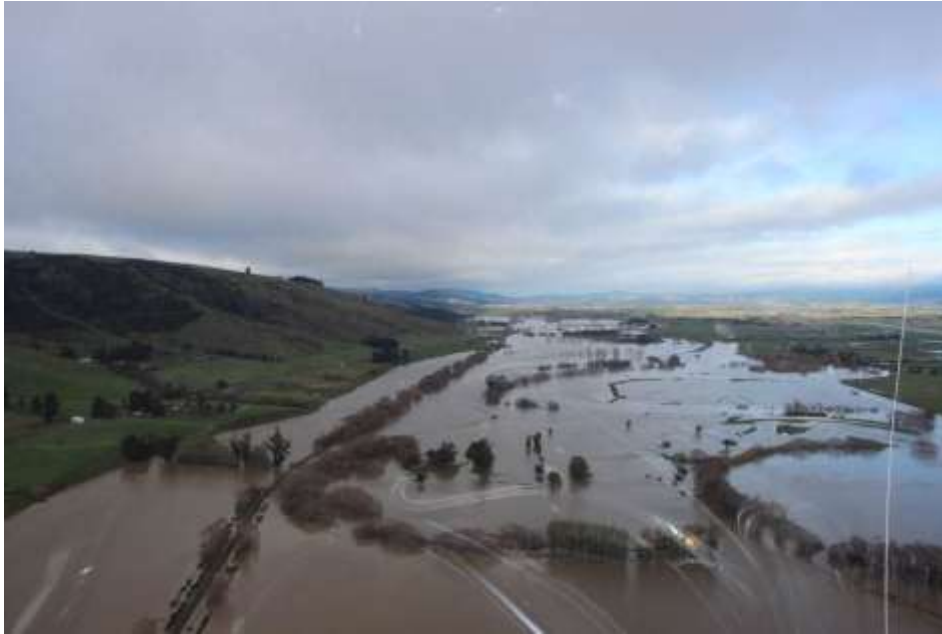
As expected, during high flows in the Taieri River, water overtopped the river banks and extensively flooded the berm areas and the Taieri River floodway (Figure 37), but no overtopping of the main floodbanks was recorded. The Henley spillway, downstream of Otokia, operated between about 10am on 4 June and 2am on 5 June (Figure 38), resulting in extensive ponding in the Henley floodway, as would be expected in a rainfall event of this type. Much of the land surrounding the settlement of Henley was flooded, particularly at the southern end of the township (Figure 39). The flooding resulted from runoff from the coastal hills not being able to be discharged into the Taieri River due to high-water levels and accumulating on low-lying areas.

Figure 37. Taieri River berms and floodway looking southwest, downstream of Allanton – 4 June 2015

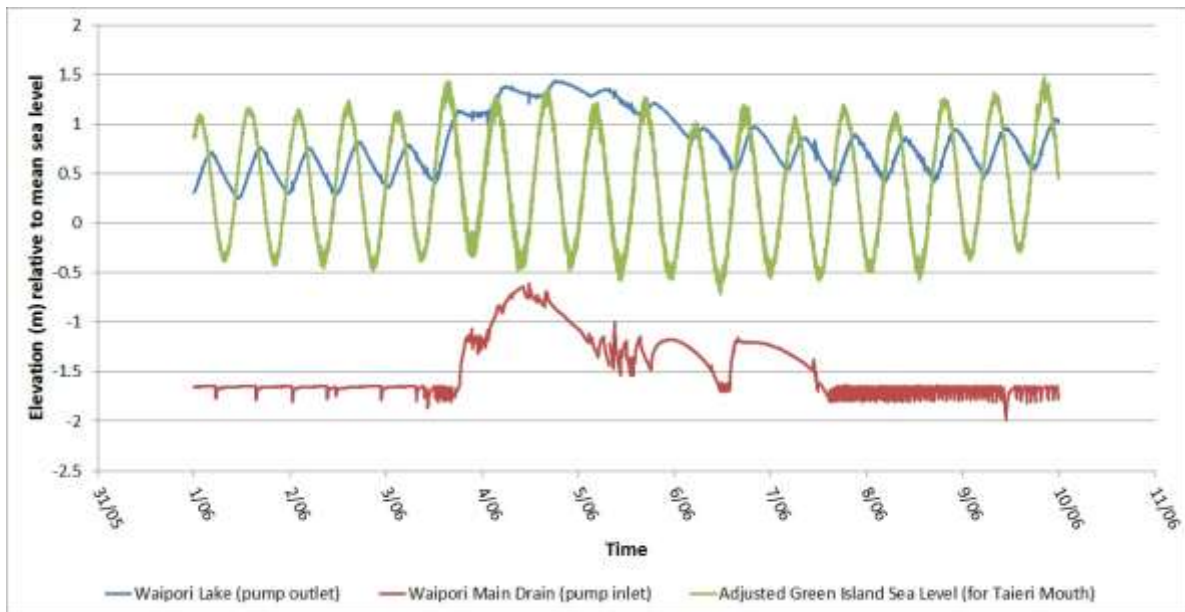
The Waipori pump station achieved the necessary pumping capacity to maintain drain levels and convey floodwater (Figure 48).

Figure 48. Main drain level at Waipori pump station, level of Lake Waipori and sea level, 1 to 9 June 2015

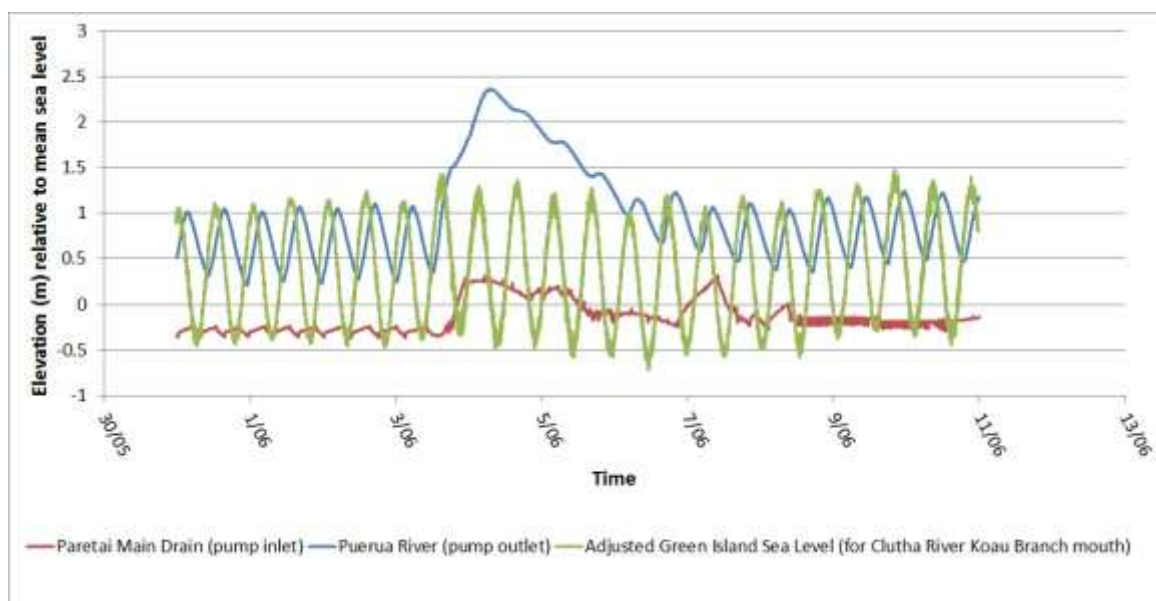
The Paretai pump station performed well. The heavy rainfall provided an opportunity to study the new control-systems performance while operating under high-head and flow conditions (Figure 52). This exercise has resulted in a refinement of the control philosophy. These changes will provide benefits in the future, both for optimising the effectiveness and improving the reliability of the pump station assets.

Figure 52. Paretai pump station inlet water level, outlet water level (Puerua River) and sea level, 1 to 10 June 2015

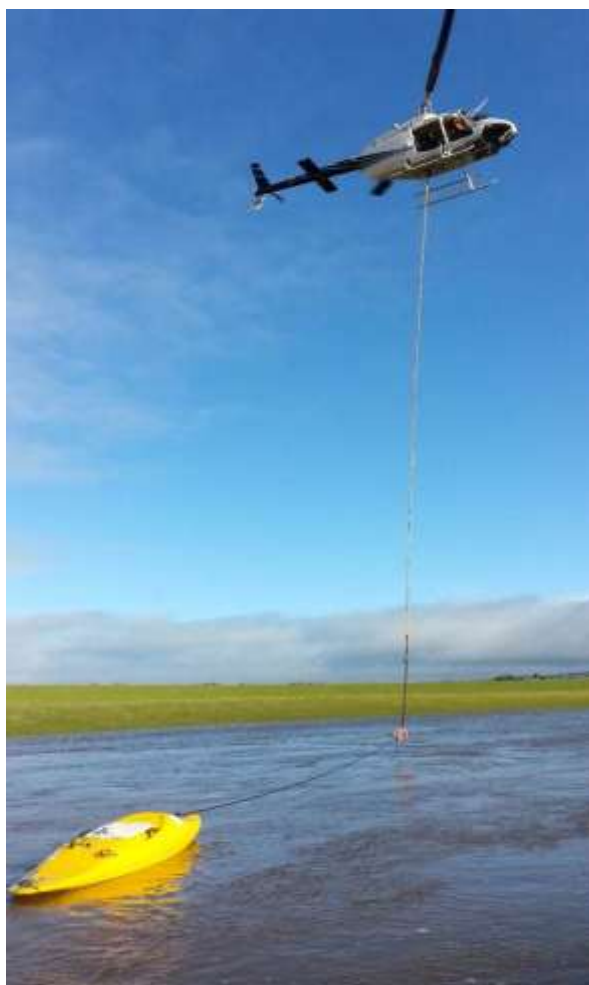
A traditional current metre gauging from the SH87 Bridge at Outram was obtained, and this has helped to corroborate recent flood gaugings using Heli-gauging techniques developed by ORC using more modern flow measuring technology (as shown in Figure 55).

Figure 55. Heli-gauging underway on the Tokomairiro River using a kayak-mounted acoustic Doppler current profiler (ADCP) flow-measuring device
