# **Otago Alluvial Fans: High Hazard Fan Investigation**

**June 2011**

Otago Regional Council

Prepared by Richard Woods, Natural Hazards Analyst, Otago Regional Council

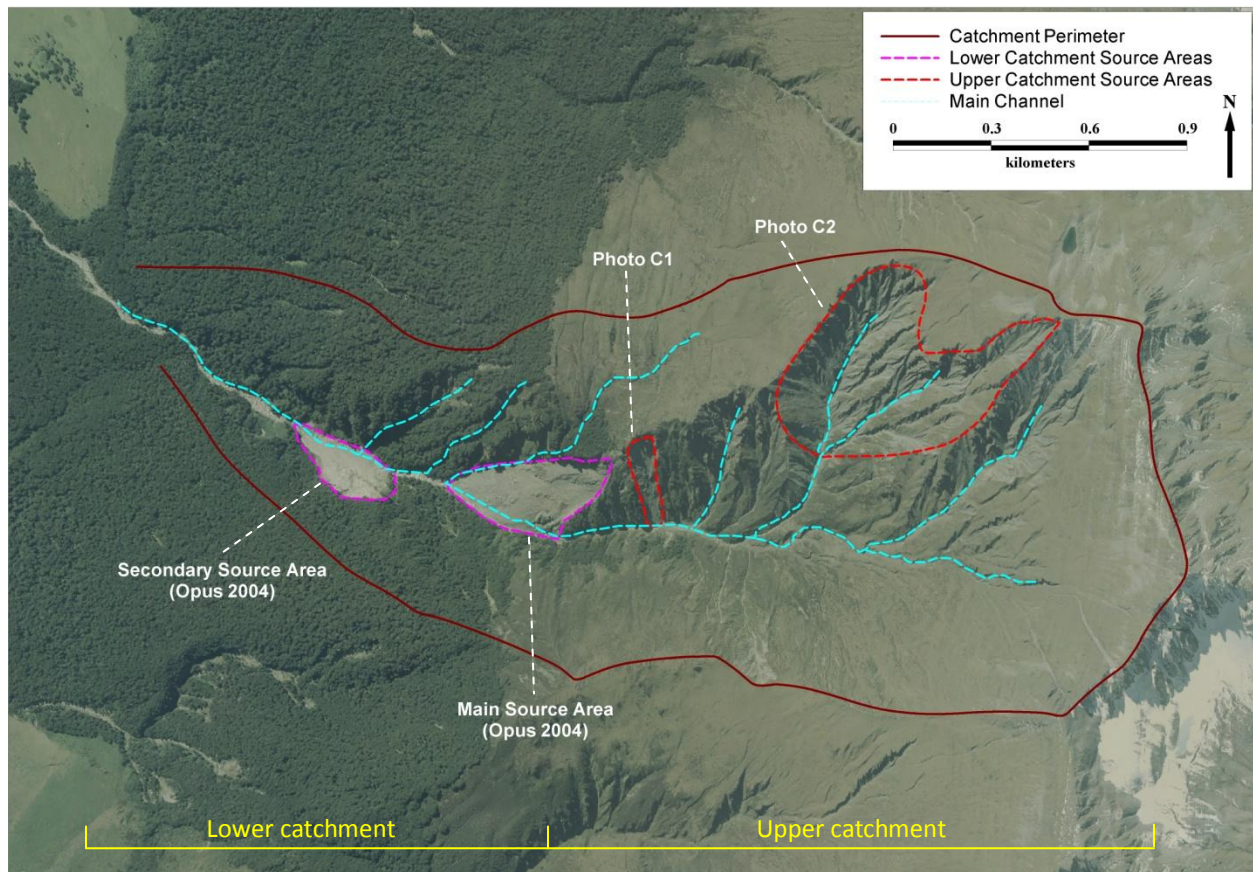
**Figure 2.2** The Pipson Creek catchment, noting sediment-source areas and sites of interest; aerial photo dated March 2006

Field investigations, undertaken by ORC on 7 March 2011, indicate that the scale of upper-catchment mass-movement activity has increased in recent decades, with the pronounced reactivation of slope movements or the development of fresh scarps. Figure 2.3 shows a large area of recent slope movement at the location identified as *Photo C1* in Figure 2.2. Intense-rainfall events, greater than 20mm/hour, in February 2011 and December 2010, are likely to have contributed to the reactivation of this slip, as well

The lower Pipson Creek catchment (Figure 2.2) is typified by steep rock faces, which have a predominant cover of dense bush. The channel at this location is confined and often incised to bedrock; conditions that are favourable for the efficient conveyance of debris flow. Two sediment-source areas (Figure 2.4), described in Opus (2004), contribute significant volumes of sediment and debris to the main channel during periods of high, intense rainfall. These sediment-source areas have formed as a result of channel incision by Pipson Creek over-steepening adjacent slopes. Historic aerial photography indicates that these rock-fall features have formed and developed within the last 50 years. Opus (2004) note that these locations are the primary source areas which have contributed to debris flows on the fan surface. Observations in March 2011 indicate that these rock-fall features are still being actively eroded and continue to provide large volumes of material to Pipson Creek.

Field observations indicate that the majority of the Pipson Creek catchment is dominated by mass-movement processes. An increased level of instability has been observed in the catchment over the last 50 years, a phenomenon that continues today.

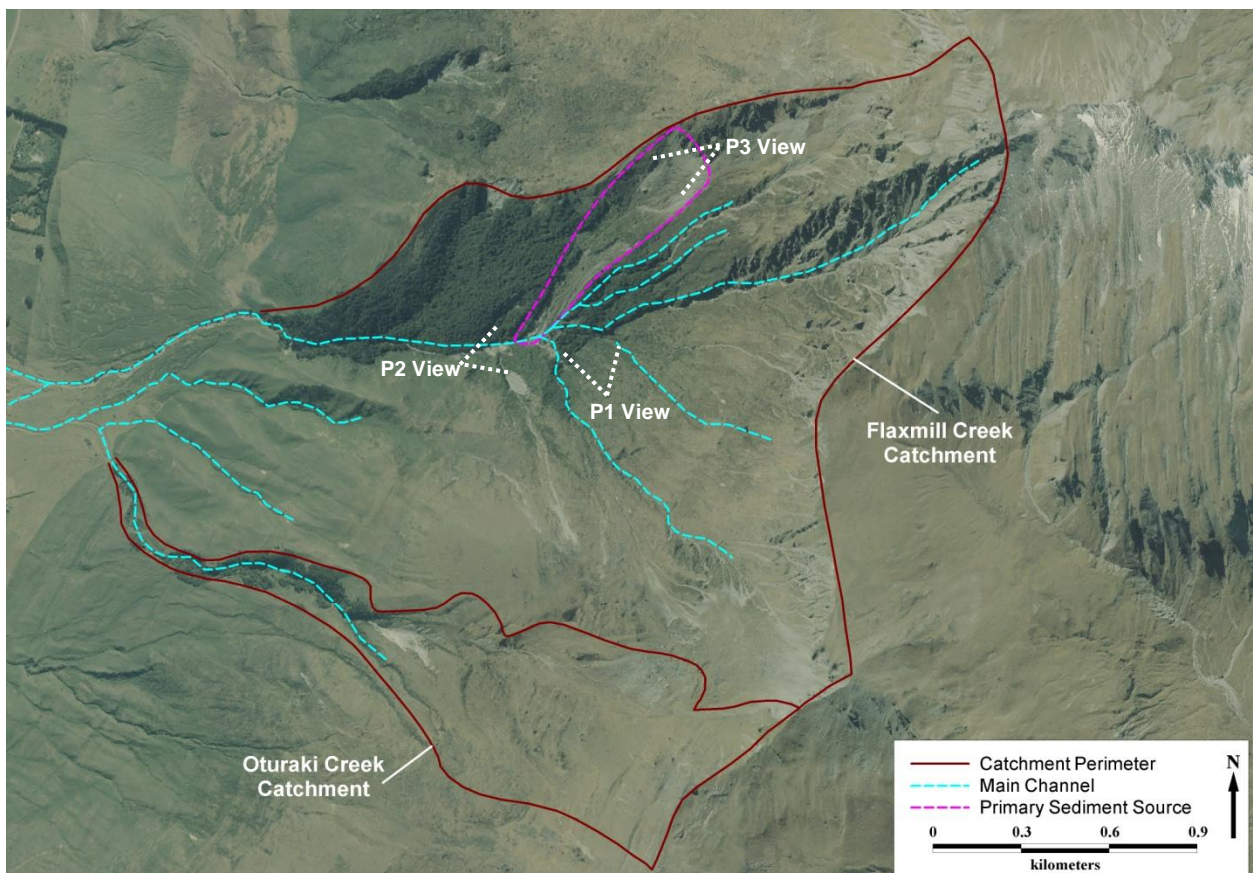
**Figure 3.2** The Flaxmill and Oturaki creek catchments; aerial photo dated March 2006

Field investigations, undertaken by ORC on 7 March 2011, indicate that a primary-sediment-source area in Flaxmill Creek (Figure 3.2) is actively providing sediment to the channel (Figure 3.3). The absence of vegetation on this slip area, particularly when compared to 2006 aerial photography (Appendix 1), indicates that it has been active during the period 2006 to 2011. Intense rainfall events, greater than 20mm/hour, in February 2011 and December 2010, have likely contributed to the reactivation of this slip, as well as progressive incision of the toe by Flaxmill Creek.

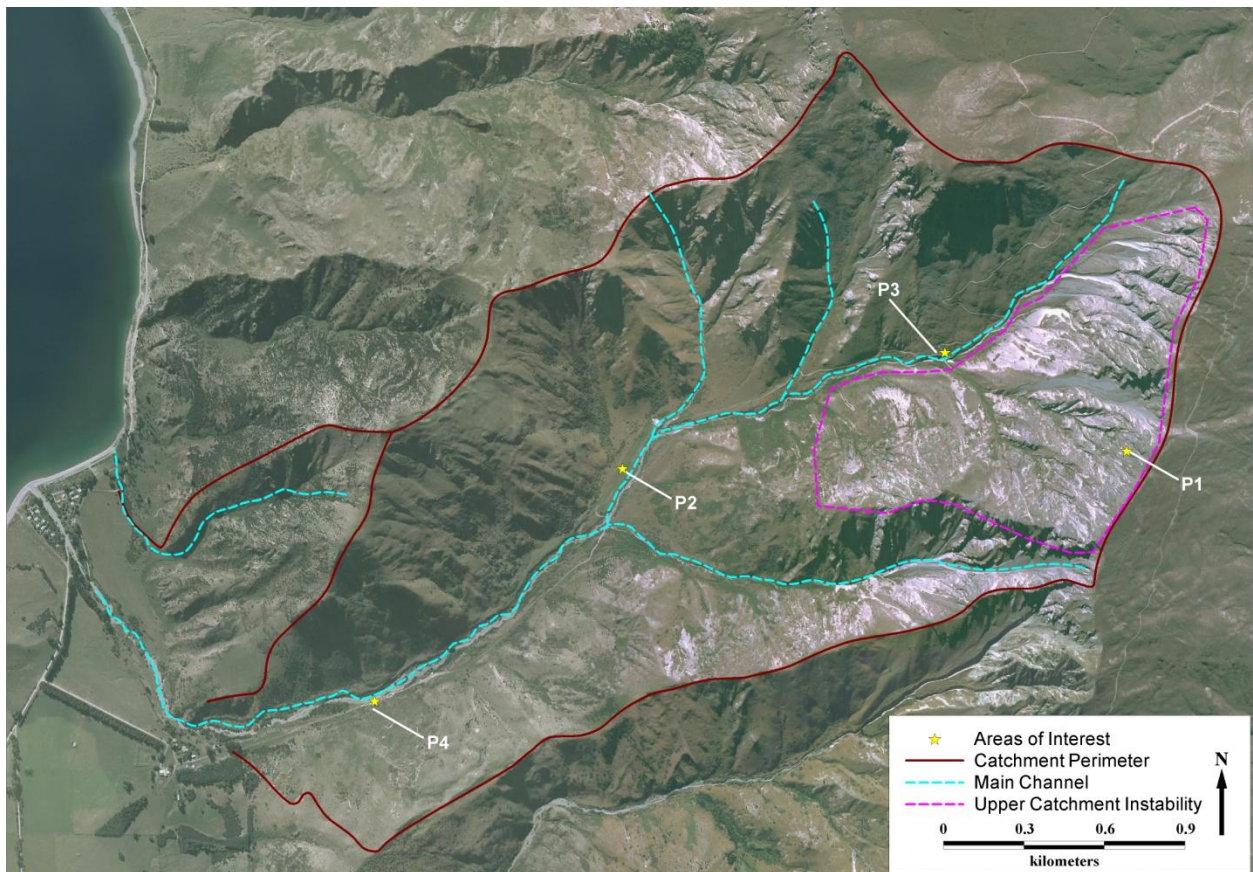
**Figure 4.2** The Johns Creek catchment, noting sites of interest; aerial photo dated April 2005

The valley floor of the Johns Creek catchment is very well incised into basement schist, which is reflected in the relatively shallow 14% grade of the channel between the head of the fan and location P3 (Figure 4.2). These conditions have allowed the deposition of large amounts of sediment within the catchment's active channel, probably on the recession of debris-flow events (Figure 4.3-P4). Subsequent to their deposition, the contemporary channel has incised into these deposits, reworking the sediments downstream. The widespread erosion and instability of slopes, coupled with bed and bank erosion in the Johns Creek catchment, provide large quantities of unconsolidated sediments conducive to the initiation of debris flows.

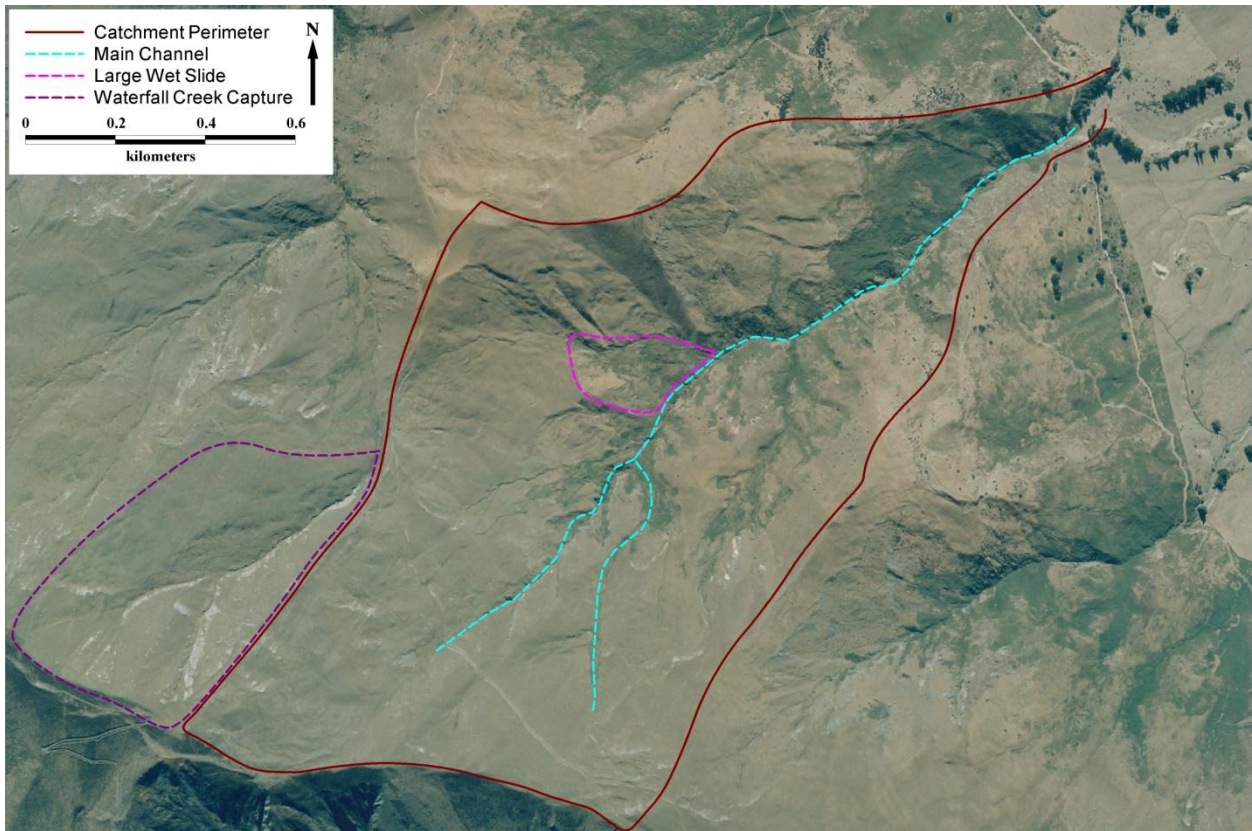
**Figure 5.2** The Stoney Creek catchment, noting areas of interest; aerial photo dated March 2006

The 'large wet slide' (Figure 5.2) on the true-left slopes of the catchment is shown in Figure 5.3. Following a magnitude 6.7 earthquake, 60km west of Milford Sound on 16 October 2007, parts of this slide were subject to surficial-debris flow, initiated by a sudden release of water in a pre-existing headscarp. Observations by ORC in November 2007 identified that this slide area is very active, with high groundwater levels and many surface channels. In addition, the toe of this slide area is being actively eroded by Stoney Creek.

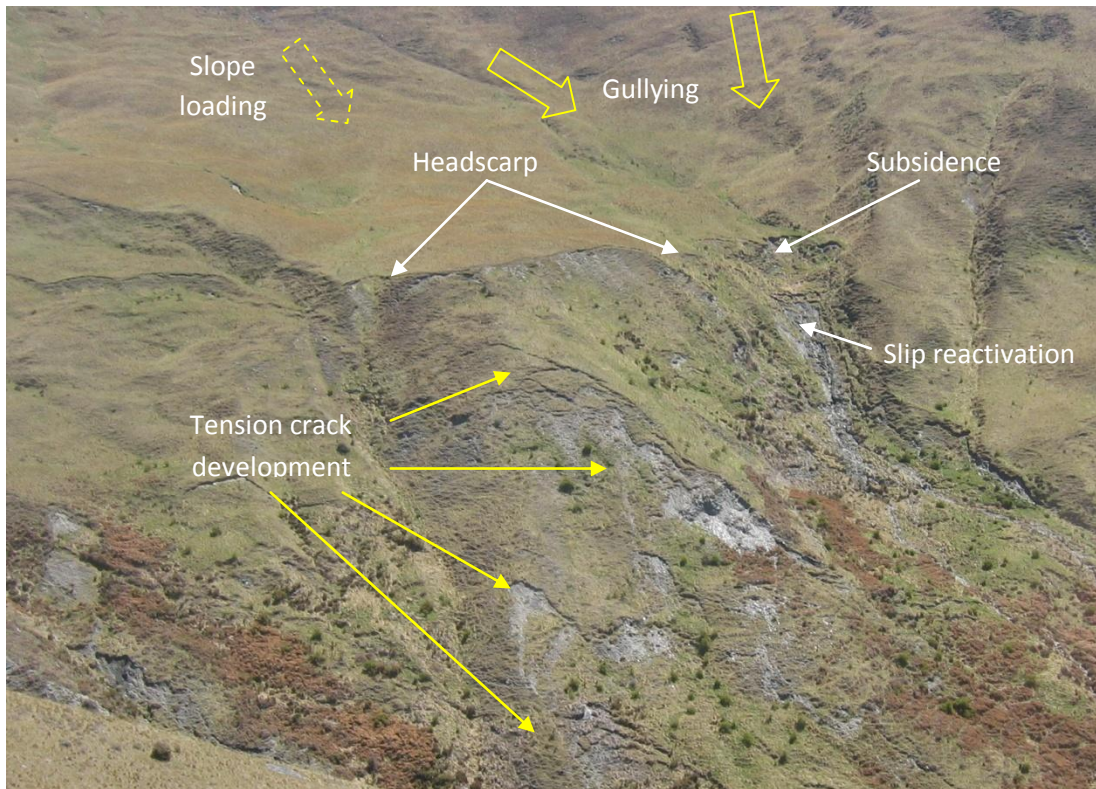
**Figure 5.3** Catchment instability on true left of Stoney Creek, 6 November 2007

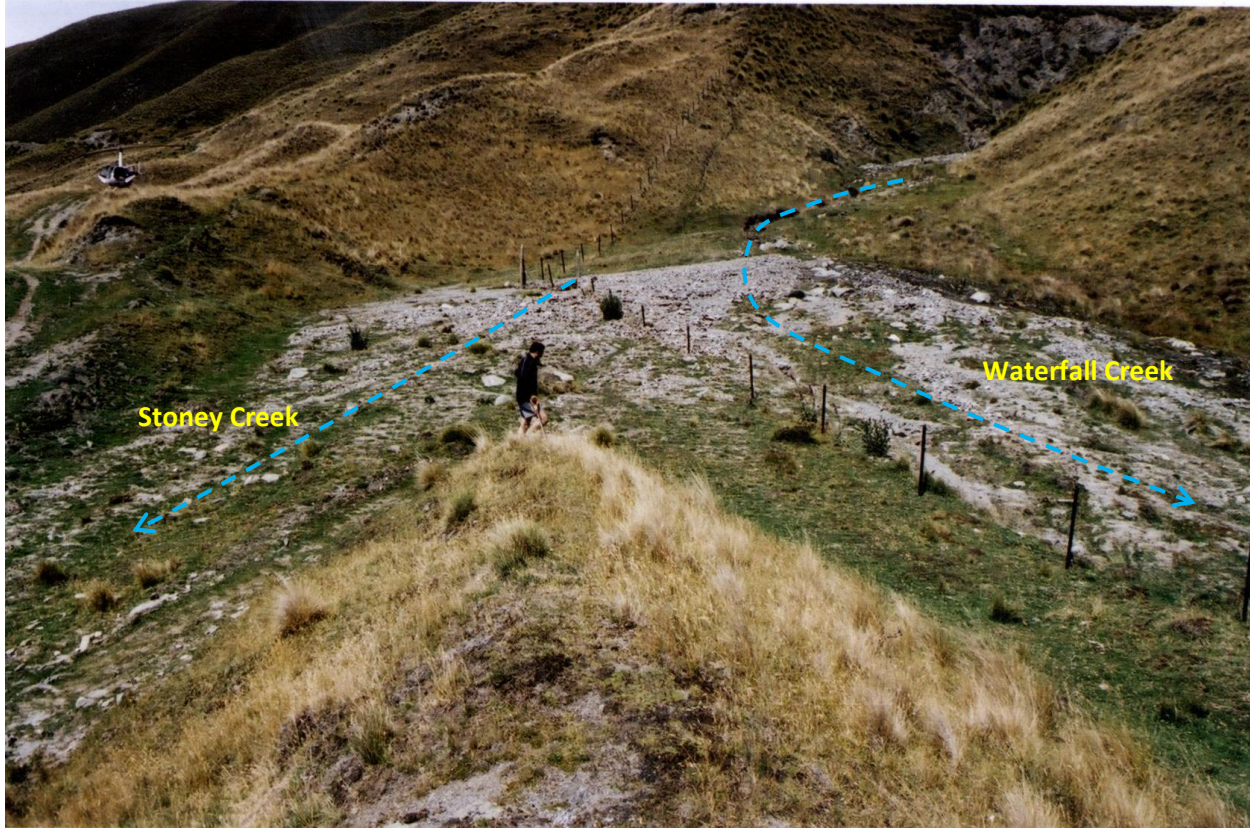
On the evening of 30 January 2004, a storm event, concentrated above the Stoney Creek catchment, caused an upper channel of the Waterfall Creek catchment to aggrade and divert flow across the catchment divide into the Stoney Creek catchment (Figure 5.4). This phenomenon contributed sediment and flow to Stoney Creek exacerbating the alluvial-fan hazards downstream. Following this storm event, ORC undertook earthworks at the catchment divide to train the channel towards Waterfall Creek.

**Figure 5.4** The headwaters of Waterfall Creek, where the creek switches across the catchment divide to enter the Stoney Creek catchment, taken shortly after the storm event of 30 January 2004

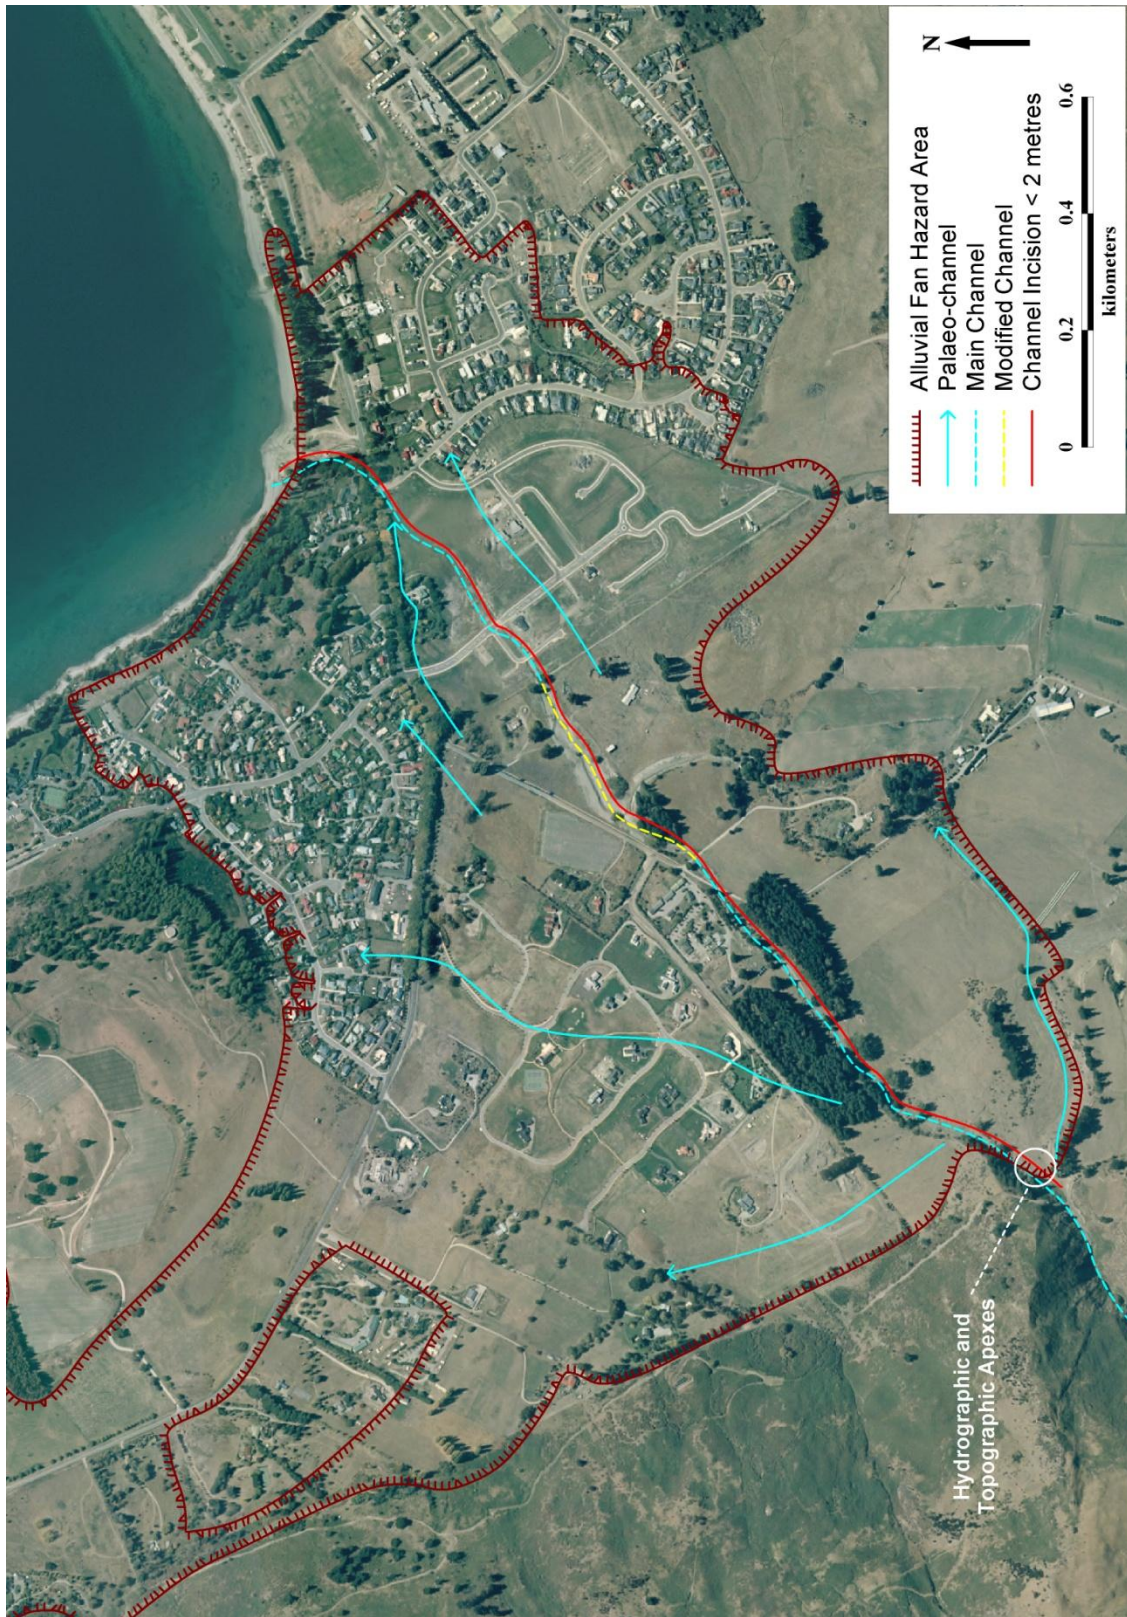
**Figure 5.5** The Stoney Creek alluvial fan, noting the identified hazard area and other key features; aerial photo taken in March 2006

Stoney Creek currently occupies a central position on its alluvial fan (Figure 5.5). The topographic and hydrographic apex locations are at the head of the alluvial fan. Here, the stream is incised by up to 2m, but has migrated laterally from its current position in the past, as indicated by the presence of prominent palaeo-channels to the north and south. Downstream, the channel becomes less incised and has less than one metre incision for much of its length. Historic palaeo-channels, as a result of channel avulsion, are common across the fan surface where flood and/or debris flows have eroded new channels during storm events; a selection of large palaeo-channels is depicted in Figure 5.5.

The Stoney Creek alluvial-fan hazard area (Figure 5.5) has been derived from the active alluvial-fan areas mapped by Barrell *et al.* (2009) and those areas subject to alluvial-fan hazard identified by ORC in 2006. Barrell *et al.* (2009) identified areas that have been subject to sedimentation and debris deposition from past storm events and are still subject to these alluvial-fan processes. The ORC (2006) investigation identifies those locations that have a level of risk from Stoney Creek alluvial-fan hazards and includes areas that may not have been subject to easily identifiable sedimentation or debris deposition in the past. It is noted that the alluvial-fan hazard area depicted to the north merges with the hazard derived from the adjacent Waterfall Creek catchment.

The existing ORC channel works will have no effect on the extent and magnitude of alluvial hazards observed upstream of their current location (i.e. upstream of Studholme Road). This is also true for those parts of the fan that are impacted by debris and/or flood flows occurring as a result of channel avulsion on the upper fan. Future works in this reach of Stoney Creek may reduce the potential for channel avulsion and the extent of observed channel aggradation downstream.

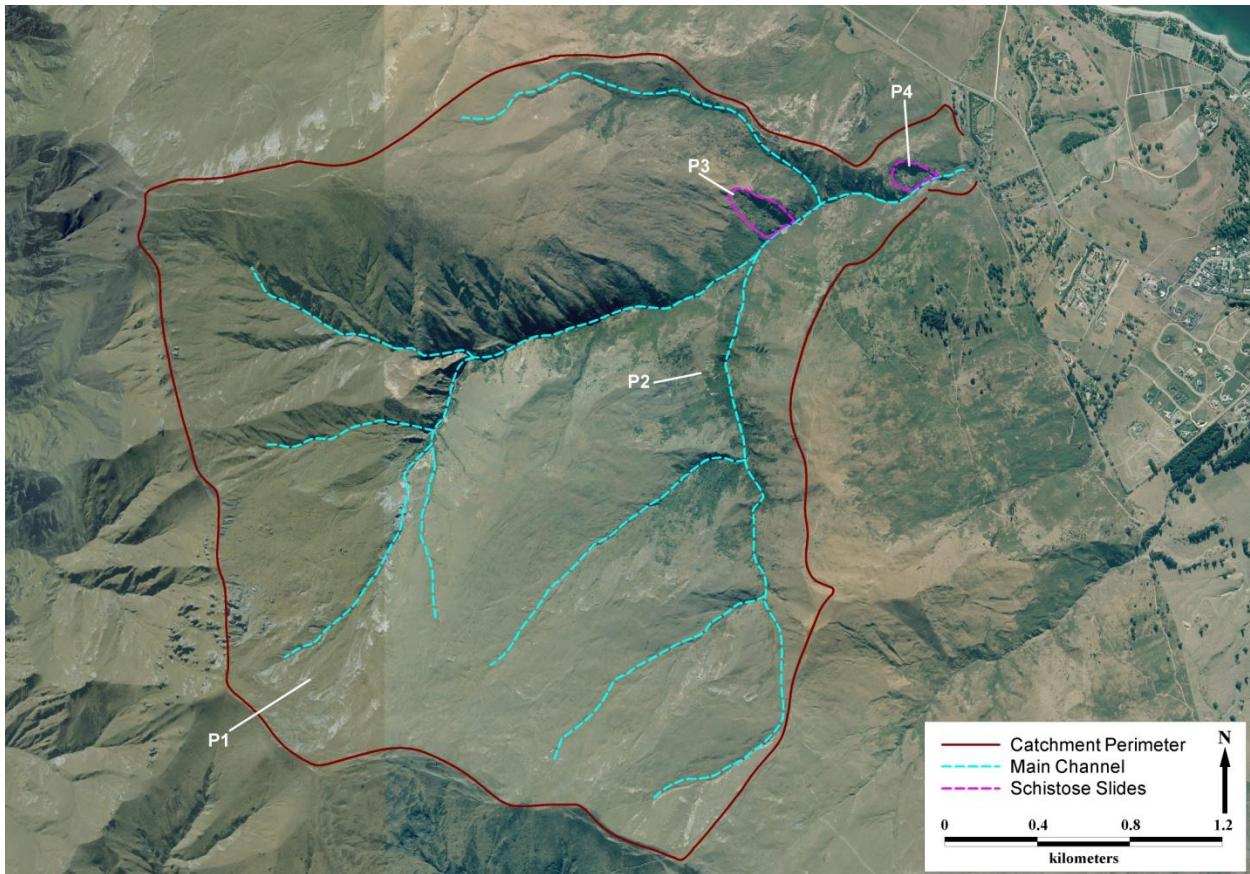
**Figure 6.2** The Waterfall Creek catchment, noting areas of interest; aerial photo dated March 2006

The upper Waterfall Creek catchment is defined by high mountainous terrain, with small bushes and alpine tussock being the dominant vegetation cover (Figure 6.2). Slope processes in this area are dominated by mass movement, with creep, slumping, gullying and fresh scarps, signifying instability (Figure 6.3). Large-scale mass movement is dominant on east to south-east facing slopes, consistent with the dip of the underlying schist foliation; while north to north-east facing slopes exhibit undulating hummocky terrain. These conditions provide mechanisms for the direct transportation of high-sediment loads to the channel. In-channel slumping on steep gradients and an abundance of freshly formed scarps are common in this part of the catchment.

Recent large-scale slope instability and failure is common throughout lower parts of the catchment, particularly on true-left slopes. The channel in this reach is deeply incised into the valley-floor sediments and basement schist further downstream. Toe incision of slide features by Waterfall Creek is a common factor in exacerbating slope instability within these reaches by over-steepening slope material (Figure 6.4).

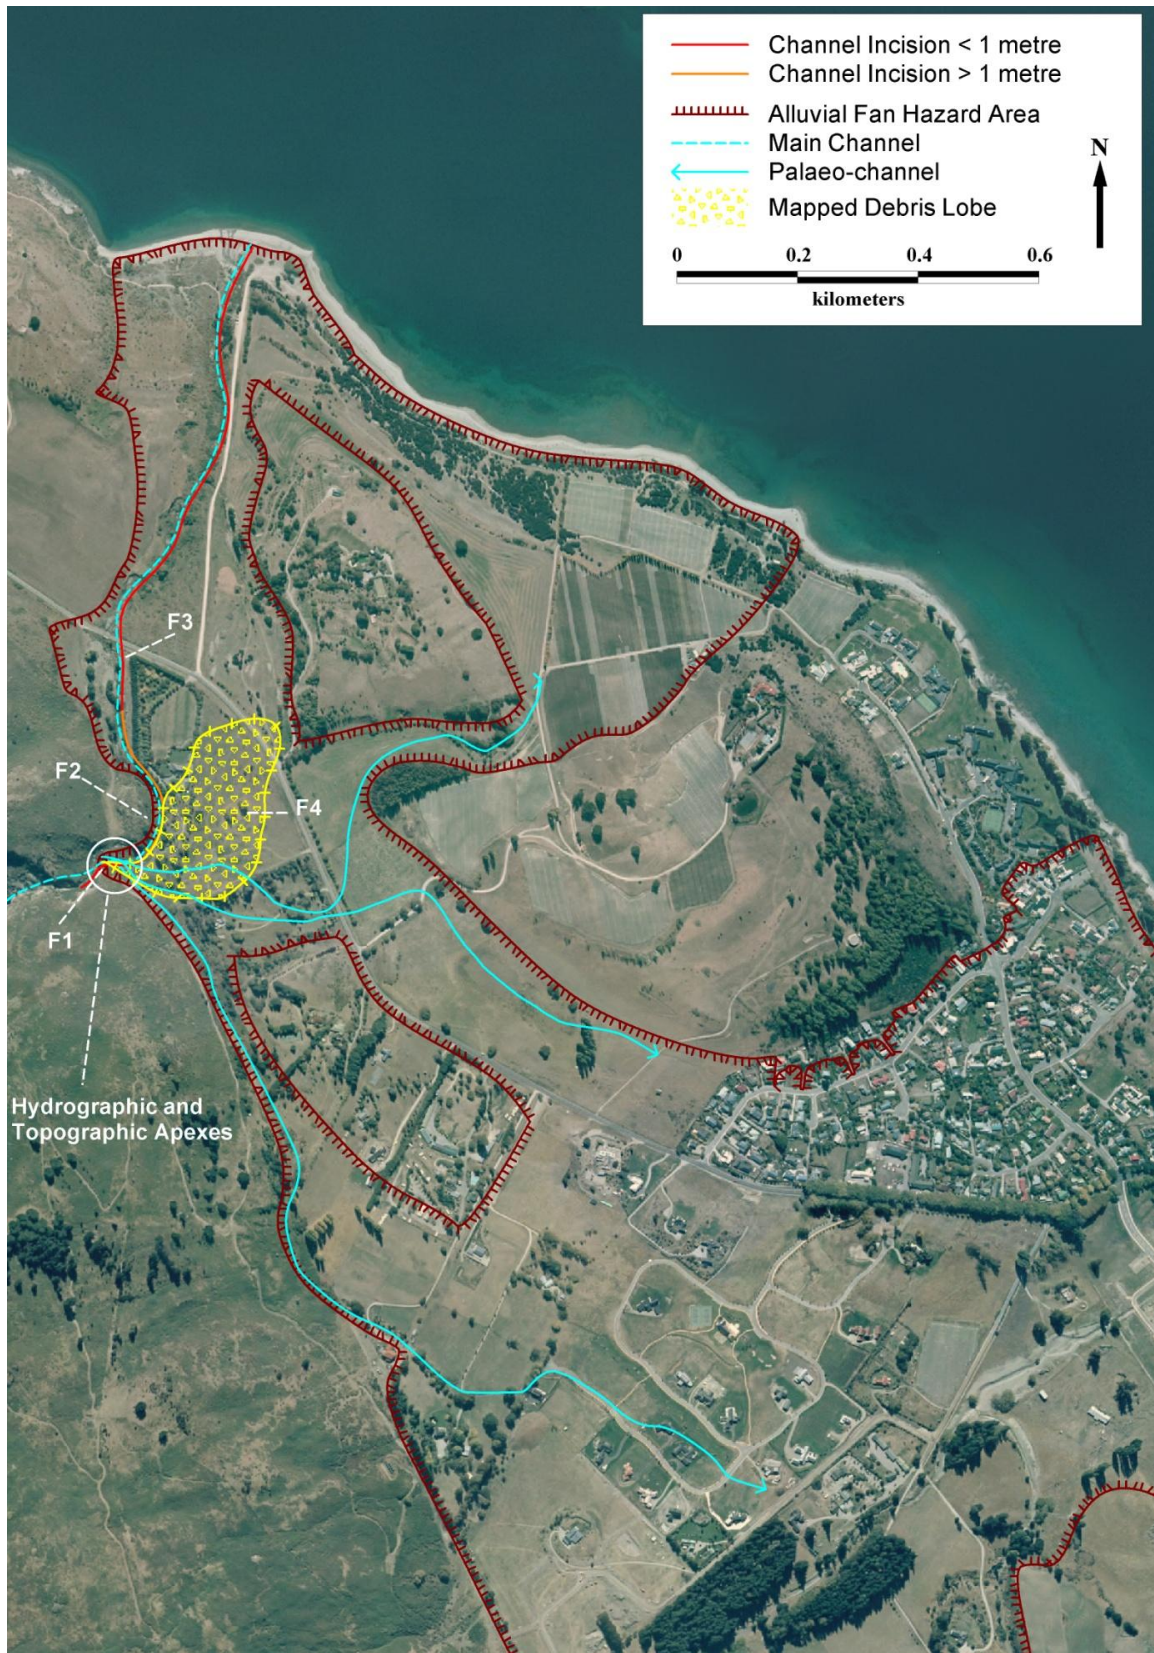
**Figure 6.5** Waterfall Creek alluvial fan, noting some key alluvial-fan features; aerial photo taken in March 2006

Waterfall Creek has formed a semicircular fan that extends from the base of the ranges down to Lake Wanaka (Figure 6.5), and bisects large outcrops of schist bedrock and moraine deposits. Channel incision varies along the length of the fan. As the channel exits the confines of the valley, it is incised down to bedrock and is less than one metre below the surrounding fan surface (Figure 6.6-F1). Downstream, the creek becomes rapidly incised into the alluvial fan, where the erosive power of the creek has removed unconsolidated sediments and incised into the fan surface by more than 10m (Figure 6.6-F2). Just upstream of Wanaka-Mount Aspiring Road, the creek is less incised and prone to lateral migration across a wider channel width (Figure 6.6-F1). Below the road, the creek meanders between a wider channel width, incised into old moraine and post-glacial deposits.

ORC (2004) undertook an investigation that used site-specific survey information to map historic palaeo-channels onto the Waterfall Creek fan surface (Figure 6.5). Three large palaeo-channels were identified extending south-east towards West Wanaka and north-east towards Lake Wanaka.

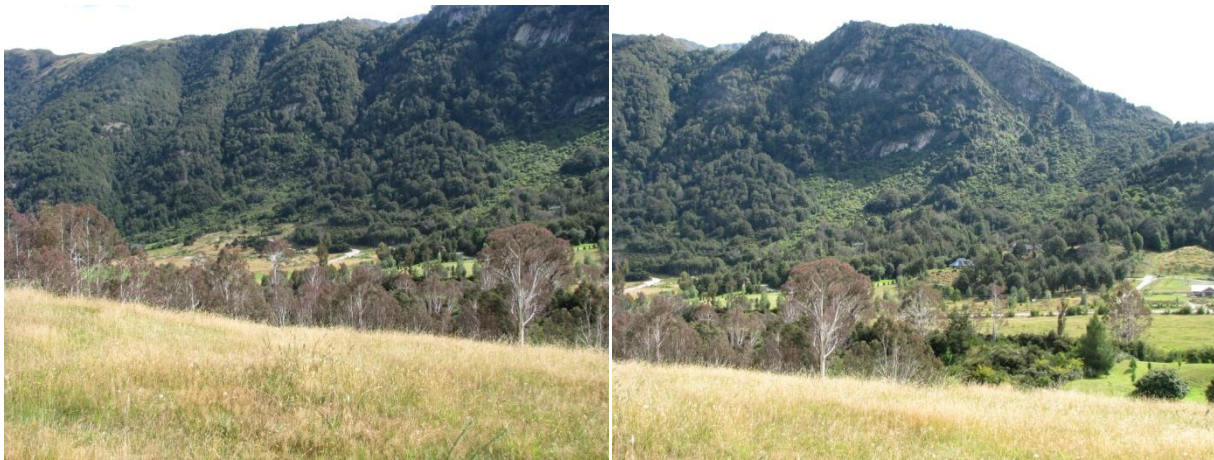
Slope processes generally consist of mass movements in the form of rock falls from over-steepened bluffs and gulying within some of the larger catchments. The stability of slopes in these catchments is facilitated by the dense vegetation cover, where root systems increase the coherency of shallow surface slopes and reduce ground saturation through interception (Figure 7.2).

**Figure 7.2** Steep, heavily vegetated catchments at Bob's Cove

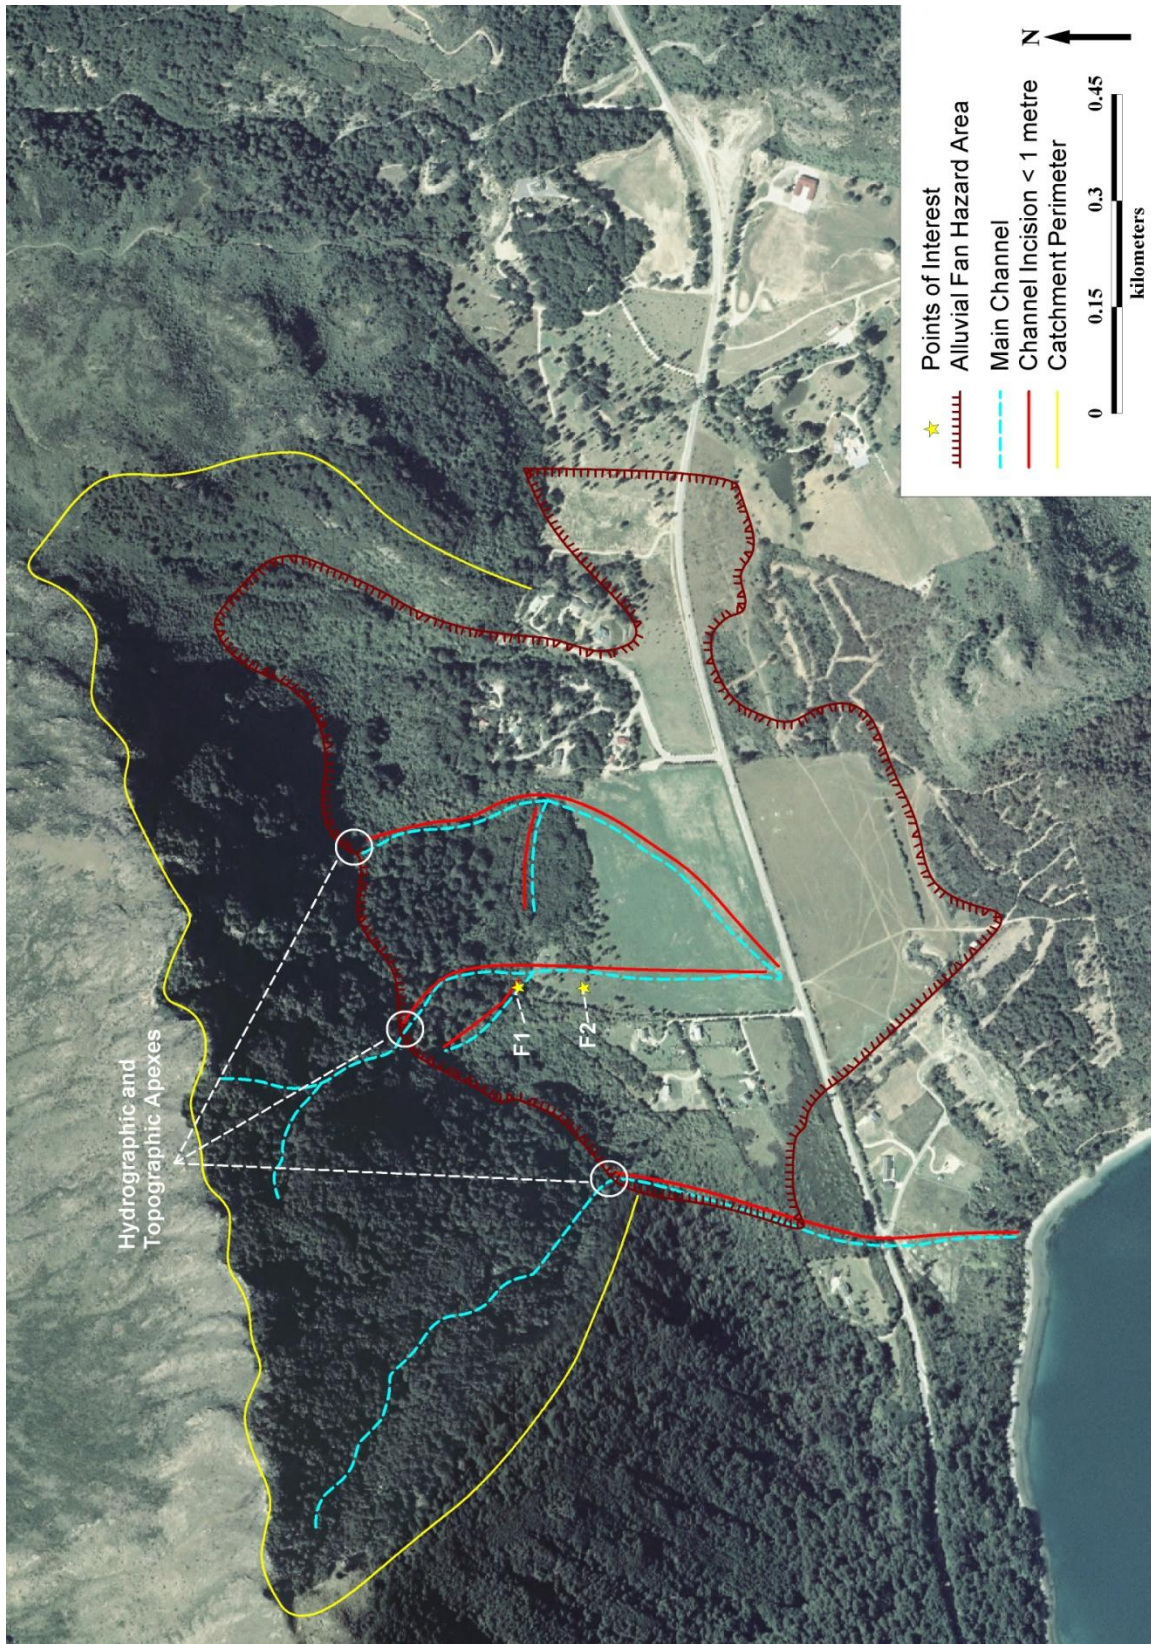
**Figure 7.3** Bob's Cove alluvial fans and catchments, noting some key alluvial fan features; aerial photo taken in February 2006

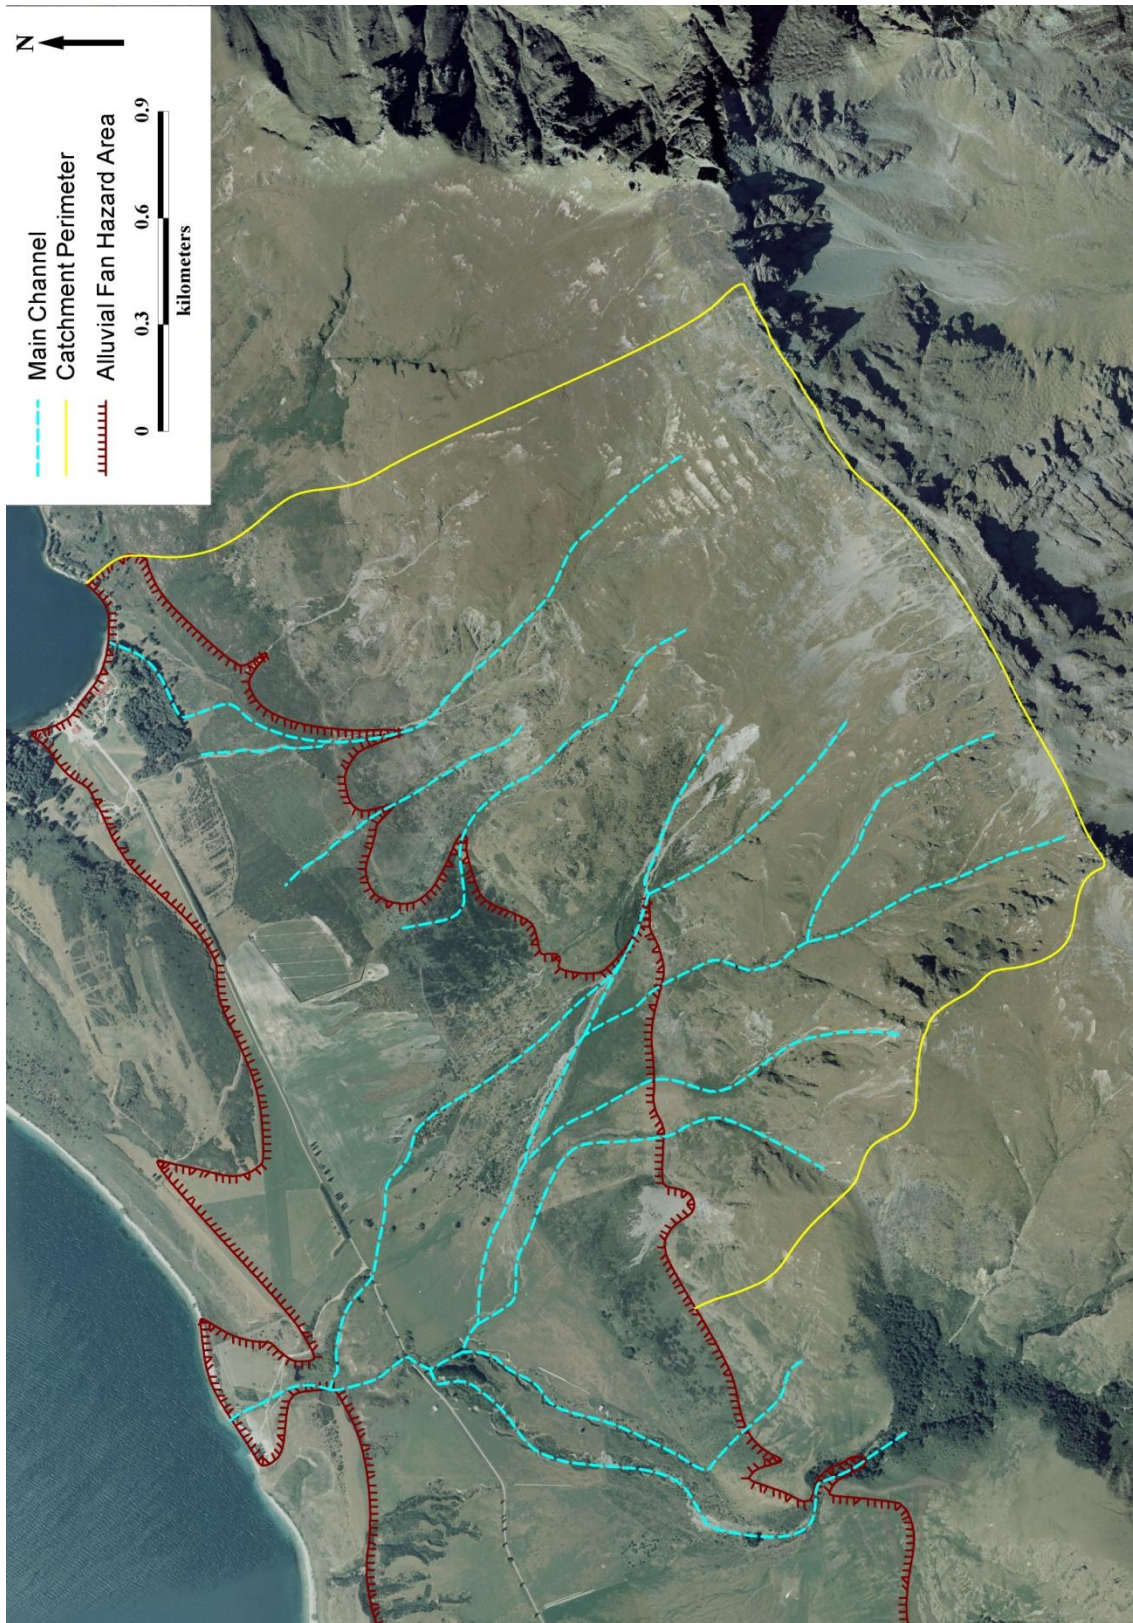
Slopes are generally vegetated by small bushes and alpine tussocks and are subject to widespread slope instability in the form of gullying, slumping and creep, with fresh scarps, signifying instability. Gullying and the over-steepening of slopes have led to further incision of the surficial-slope deposits, which are prone to failure and subsequent debris-flow initiation during high-intensity storm events. The active scarps evident in Figure 8.2 are examples of these processes.

**Figure 8.2** Walter Peak alluvial fans and catchments, noting some key alluvial fan features; aerial photo taken in February 2006

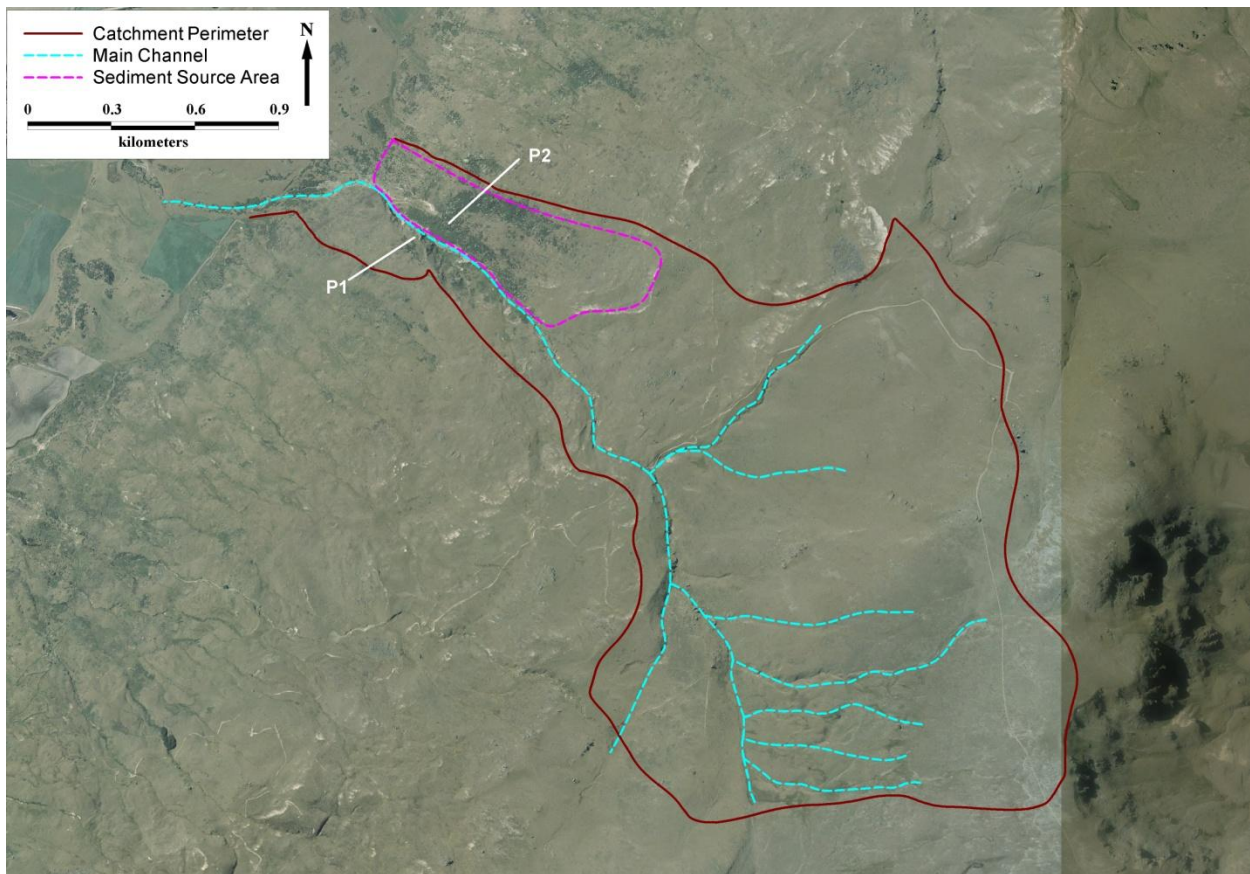
The Kingston Creek catchment is approximately 3.4km<sup>2</sup> in size (Figure 9.2). The upper catchment, from its peak at Flat Rock to around 1100 masl, has a relatively gentle grade of 15% and is dominated by alpine tussocks. Downstream of this elevation, the creek steepens considerably to a grade of 45% down to the topographic apex.

**Figure 9.2** The Kingston Creek catchment, noting areas of interest; aerial photo dated February 2006

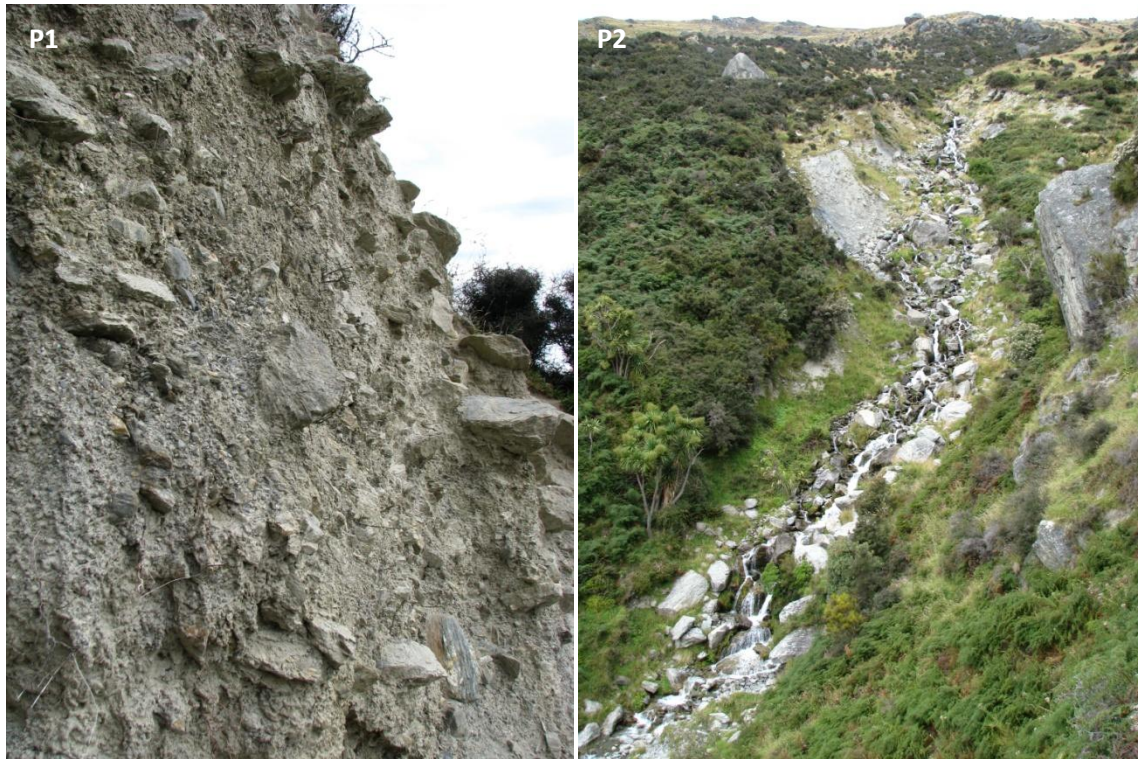
Where the catchment steepens, the creek is eroding into post-glacial landslide deposits that flank the slopes of the Hector Mountains. These deposits were formed following the recession of the buttressing glaciers during the last glacial period. Subsequent to slope relaxation, mechanical-weathering and mass-movement processes have contributed to the widespread development of unconsolidated landslide deposits on these slopes (Figure 9.3-P1). Slope instability is common in this reach of the catchment, with the greatest volume of sediment being derived from the sediment-source area on the true right of the creek (Figure 9.3-P2).

**Figure 9.3** Left: Large landslide deposits flank the slopes of the Kingston Creek catchment on the channel's true left. Right: Kingston Creek, as it descends from the flatter-grade upper catchment; the creek is actively eroding landslide material in this reach of the catchment.

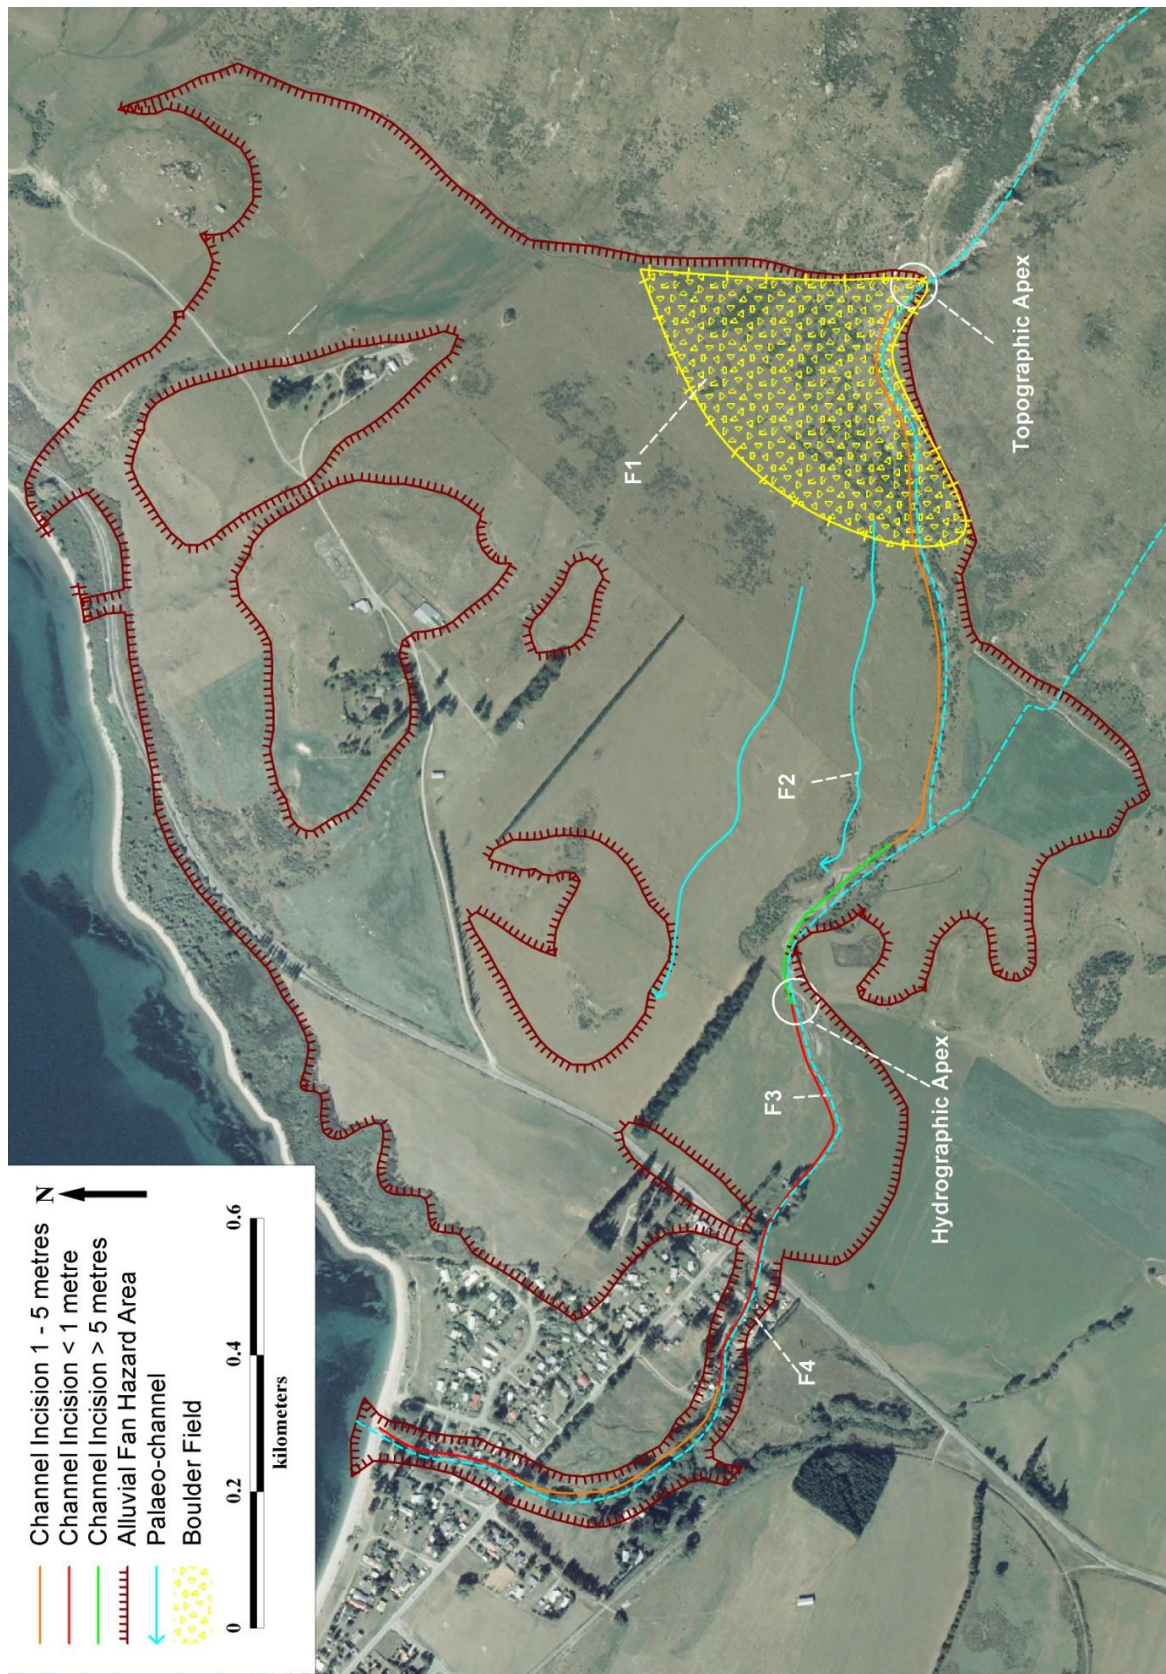
Kingston Creek has formed a symmetrical semicircular fan that extends from the base of the Hector Mountains to Lake Wakatipu (Figure 9.4). The dominant debris-flow processes observed at the head of the alluvial fan are a direct result of the widespread slope instability in the lower catchment (Figure 9.2). These conditions promote debris-flow processes on the upper fan and debris-flood flows further downstream. The large boulder field (Figure 9.5-F1), located just downstream of the topographic apex, has been formed by these debris flows during past events.

**Figure 9.5** Kingston Creek alluvial fan, noting key alluvial fan features; aerial photo dated February 2006
