# **Otago Alluvial Fans: High Hazard Fan Investigation**

**June 2011**

Otago Regional Council

Prepared by Richard Woods, Natural Hazards Analyst, Otago Regional Council

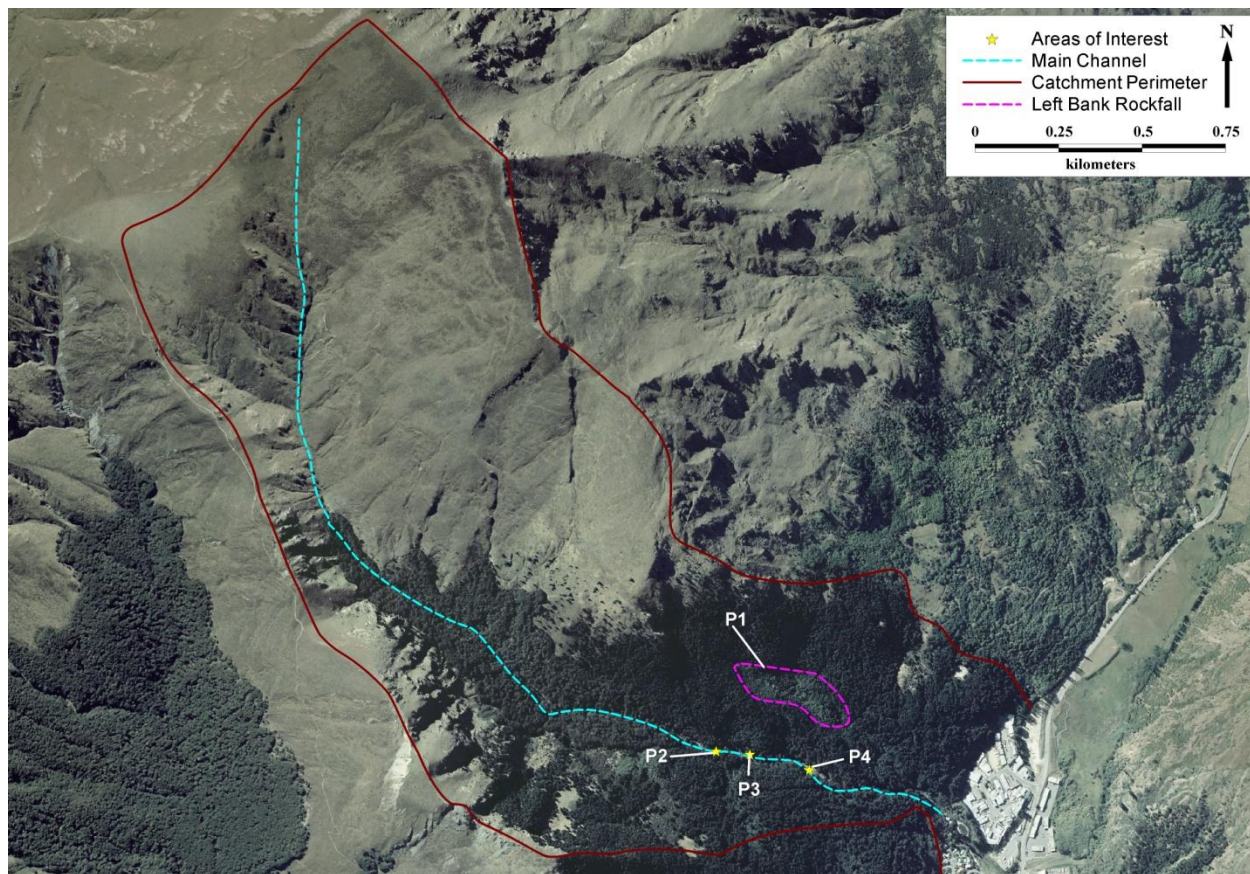
The Brewery Creek catchment is approximately 8.4km<sup>2</sup> in size (Figure 10.2) and is very steep. The upper catchment is dominated by small bushes and alpine tussocks down to around 1000 masl, where both sides of the catchment are covered in dense forest. Large rock falls have occurred in the true-left-bank forested area in the past (Figure 10.3-P1), which is represented by the presence of much younger trees in the 2006 aerial photography (Appendix 1).

**Figure 10.2** The Brewery Creek catchment, noting areas of interest; aerial photo dated February 2006

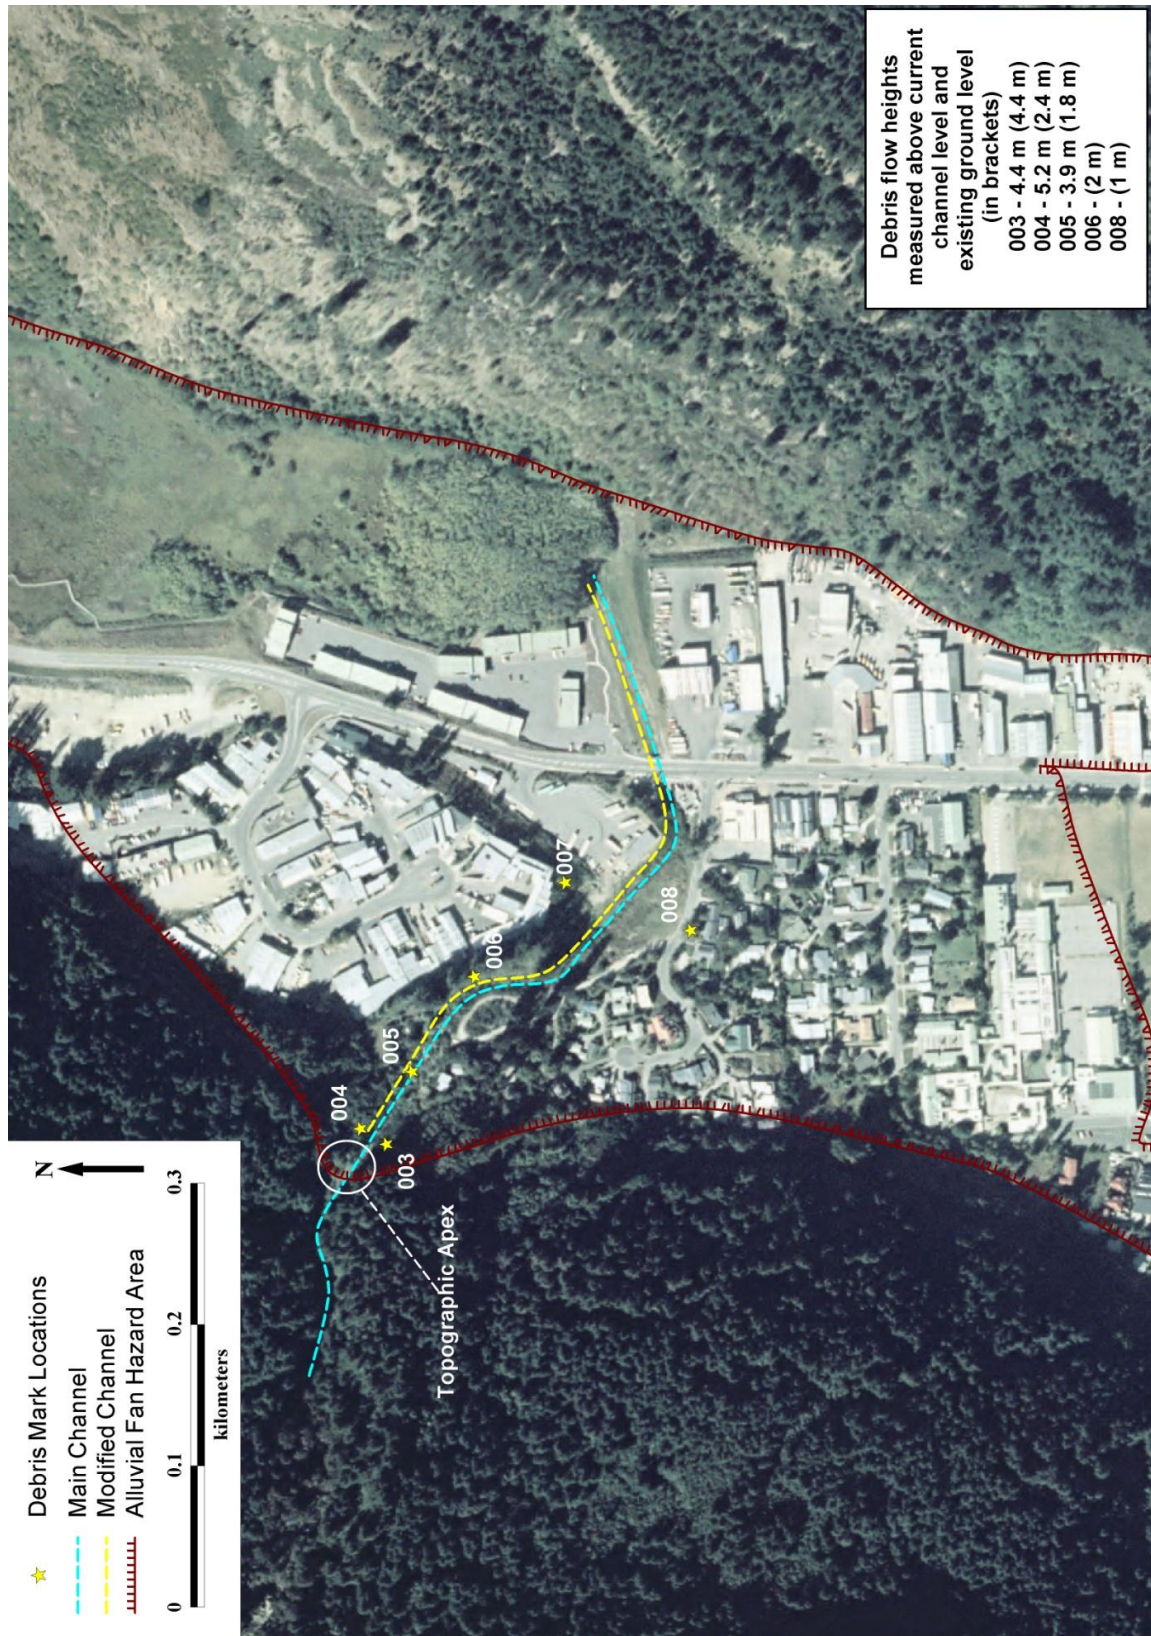
During a debris-flow event, trees on the lateral margins of the flow often have bark and superficial layers removed from the trunk due to the flow’s erosive power. Figure 10.4 shows a number of locations where historic-debris-flow heights have been measured from scars on mature trees with respect to the existing modified-channel invert and respective ground level; examples of these marks are depicted in figures 10.6 and 10.7.

Figure 10.4 Brewery Creek alluvial fan, noting key features; aerial photo dated February 2006

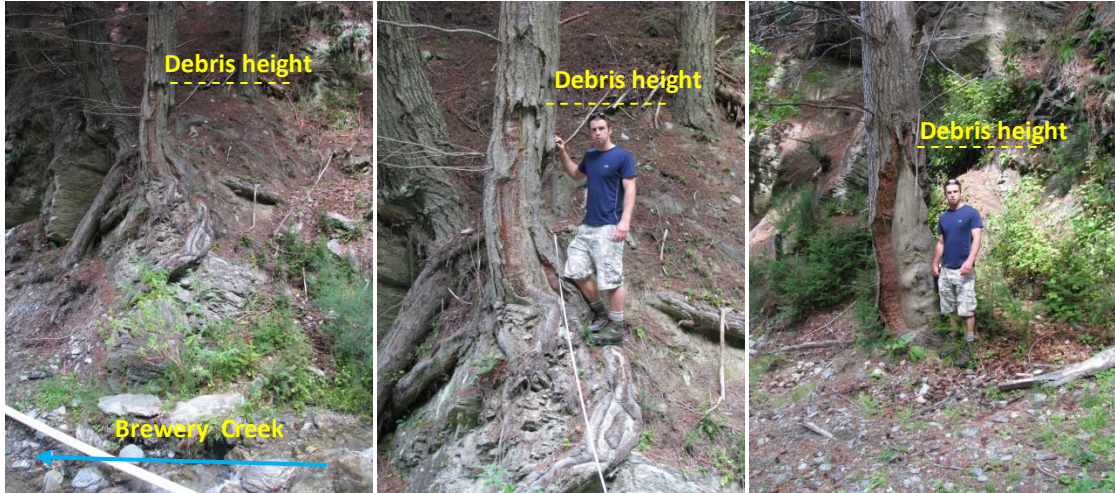
**Figure 10.6** Debris-impact scars on mature trees near Brewery Creek’s topographic apex. Left: Debris mark at 003 (Figure 10.4), showing height with respect to ground level. Centre: Same tree as left image, with figure for scale. Right: Similar tree just downstream of mark 003

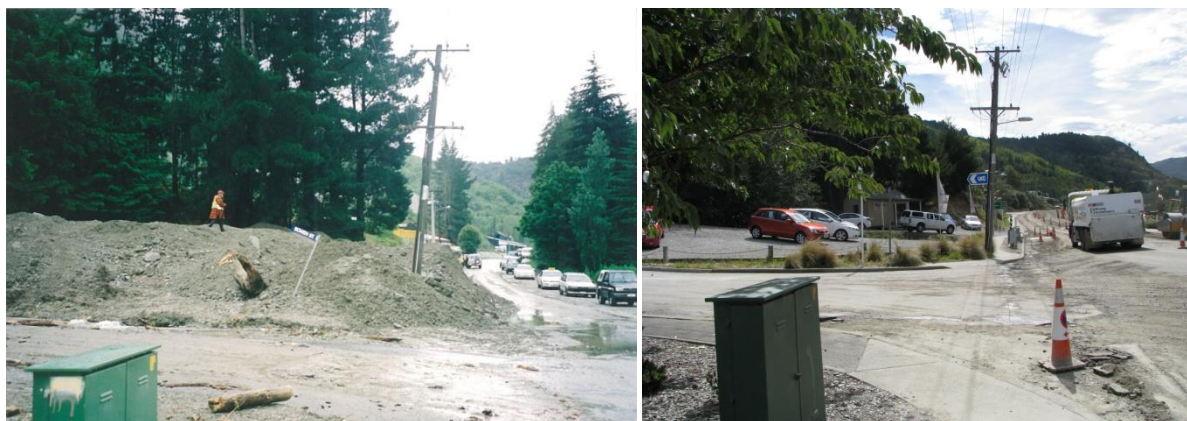
The Brewery Creek alluvial fan has been subject to recurrent debris-flow events in the past (figures 10.8, 10.9 and 10.10). The effects of debris and flood flows on the alluvial-fan surface were exacerbated by the failure of a man-made dam in the catchment in May 1986. In November 1999, large volumes of debris and sediment inundated a large portion of the fan surface. Debris flows cut access on Gorge Road and impacted many buildings and residential properties.

**Figure 10.9** The intersection of Bowen Street and Gorge Road, following the November 1999 flood event (left), compared to the same view March 2011 (right). Brewery Creek flows down the centre of the road in the left image.

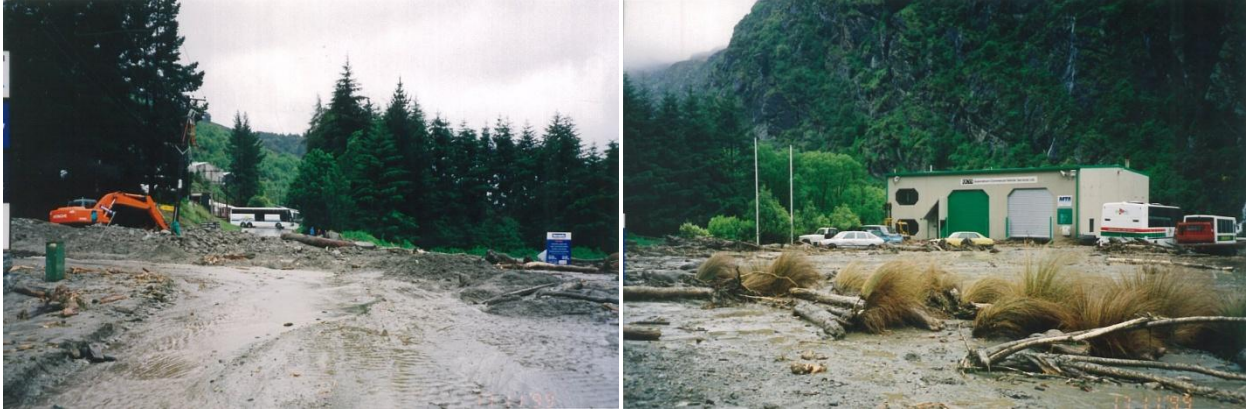
**Figure 10.10** Brewery Creek, following the November 1999 storm event. Left: Looking north up Gorge Road on the corner with Bowen Street. Right: Sediment and tree debris carried by Brewery Creek on the downstream side of Gorge Road, 17 November 1999

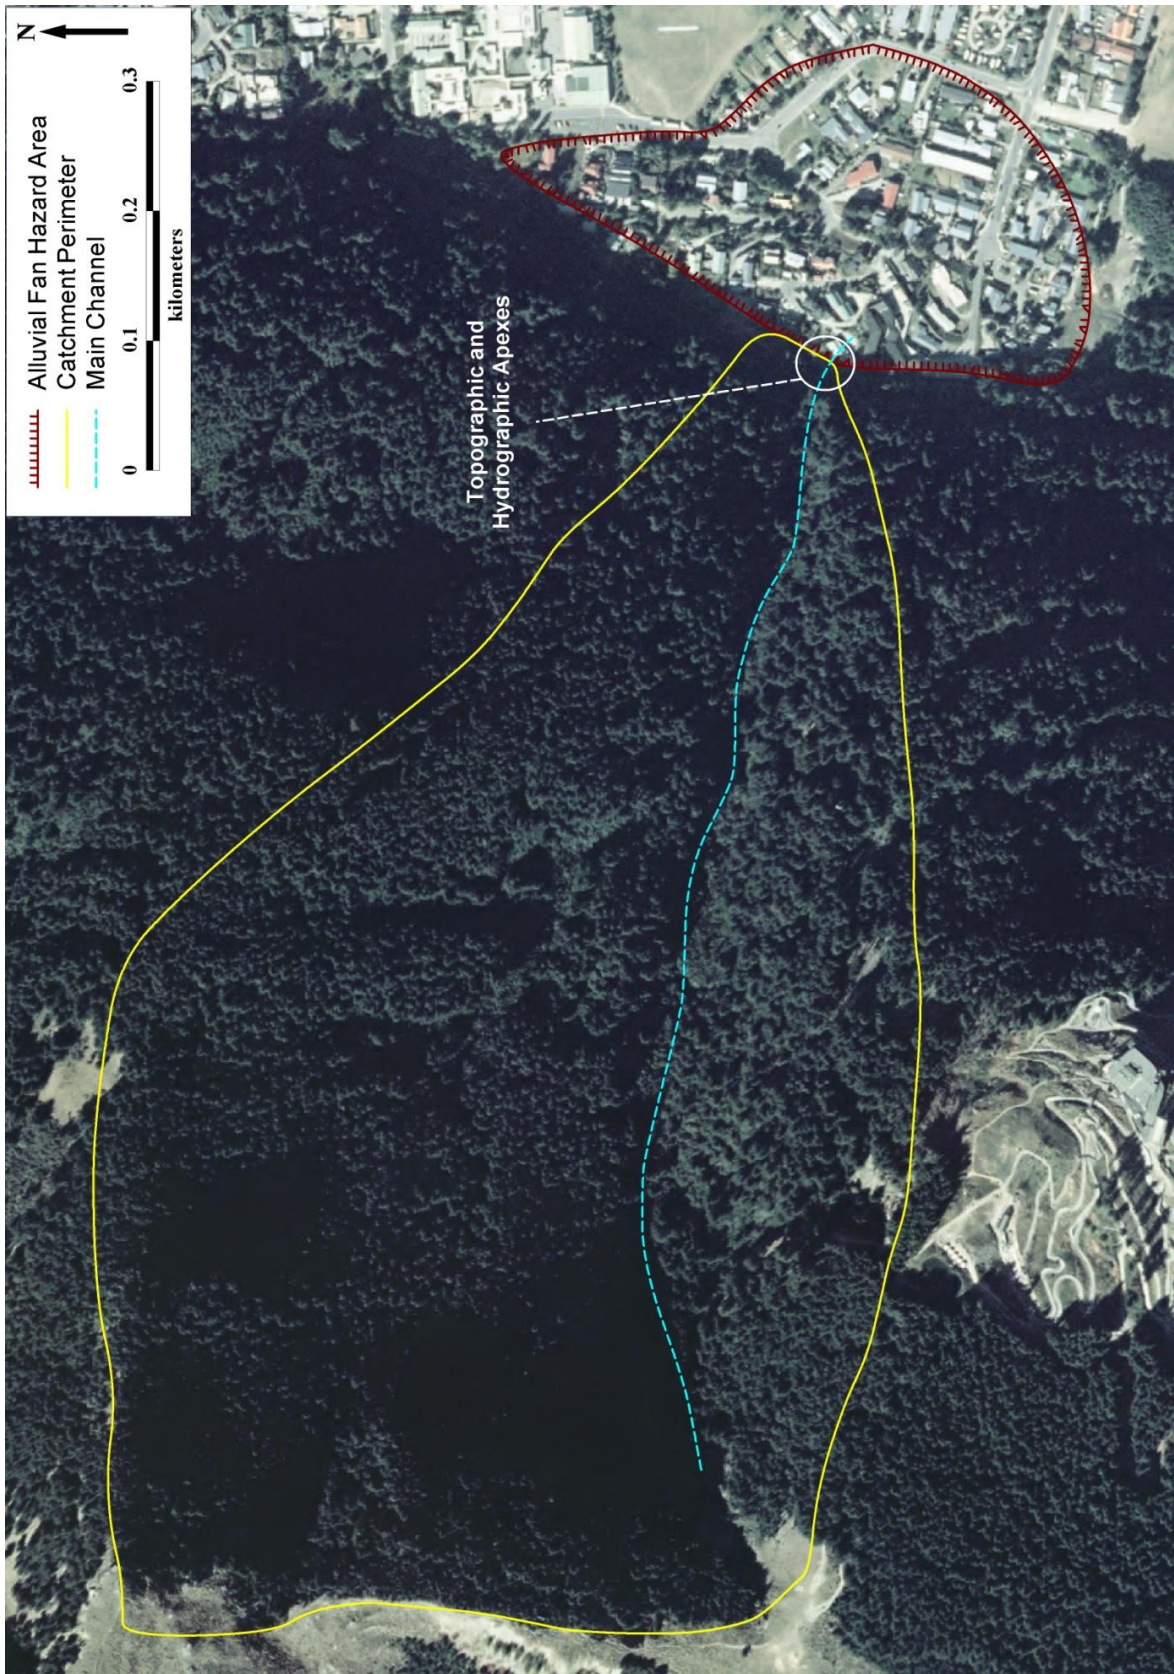
As there is no surface channel across the Reavers Lane alluvial-fan surface, the full appreciation of potential alluvial-fan hazard is not well recognised. At present, a small debris screen and culvert connected to the reticulated stormwater system is relied upon to accommodate water flows derived from this catchment (Figure 11.5). Heavily forested catchments have contributed to the coherency of slopes in these catchments, and decreased slope saturation has resulted in a reduced frequency of mass-movement processes. Debris-flow and rock-fall events have been infrequent in recent decades.

**Figure 11.2** Reavers Lane alluvial fan and catchment; aerial photo taken February 2006

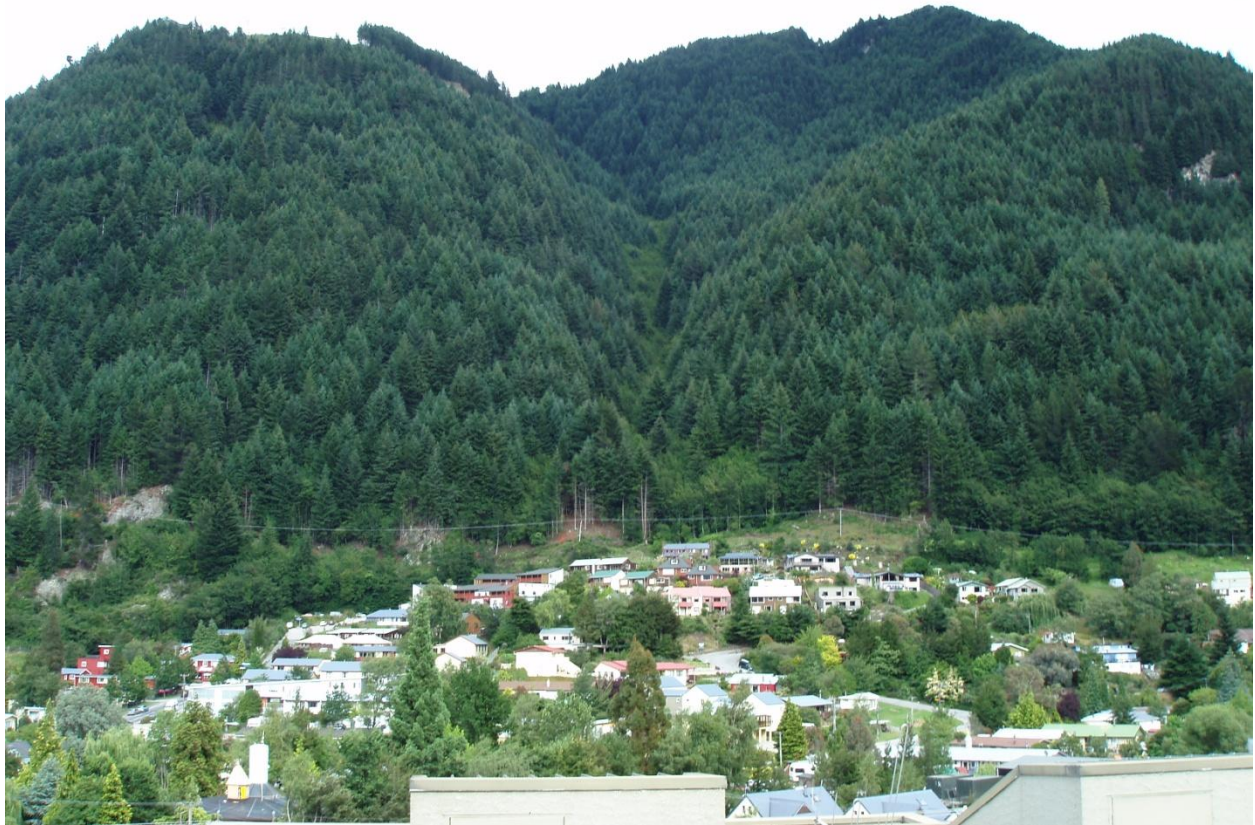
The Reavers Lane alluvial fan reflects the steep and rugged nature of the source catchment from which it is derived (Figure 11.3). The steep slope of the fan surface from the topographic apex indicates that the fan has mainly been formed by debris-flow processes in the past. Much of the past evidence of debris flow has been removed by urban development on the fan surface. Site observations in March 2011 noted large boulders near the head of the alluvial fan, which were believed to have been derived from the fan surface (Figure 11.4).

**Figure 11.3** Reavers Lane catchment and alluvial fan

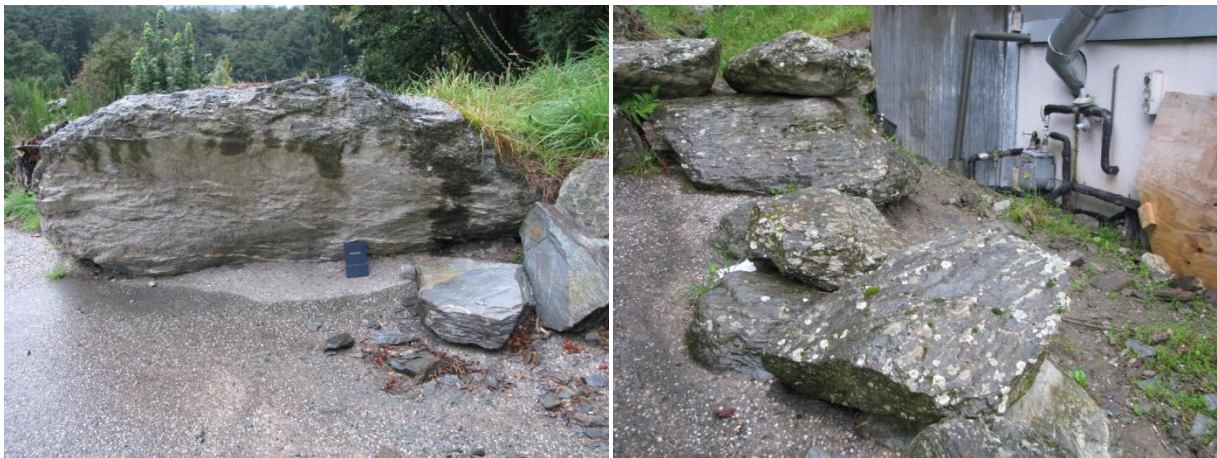
**Figure 11.4** Large boulders and clasts of schist just down slope of the topographic apex of the Reavers Lane alluvial fan. While not *in situ*, it can be inferred that these boulders were derived from the alluvial-fan surface.

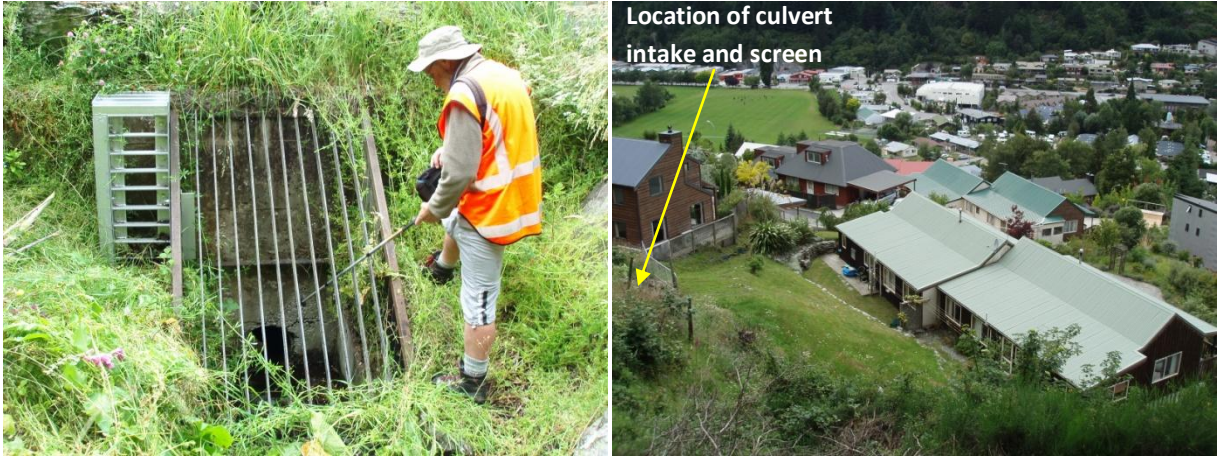
**Figure 11.5** Reavers Lane alluvial-fan stormwater screen and culvert entrance (left). Residential properties at the head of the alluvial fan with respect to location of this structure (right)

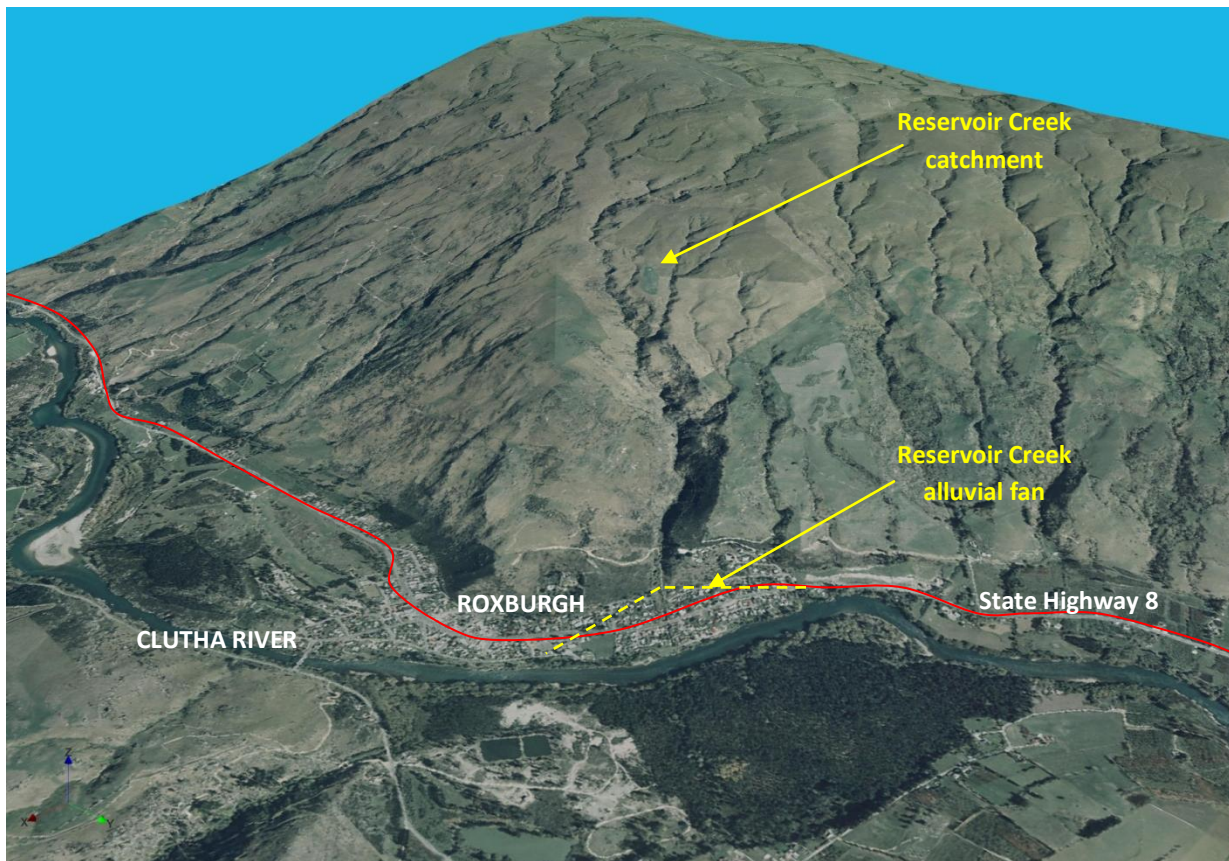
**Figure 12.1** Image showing the Reservoir Creek alluvial fan with respect to the surrounding environment

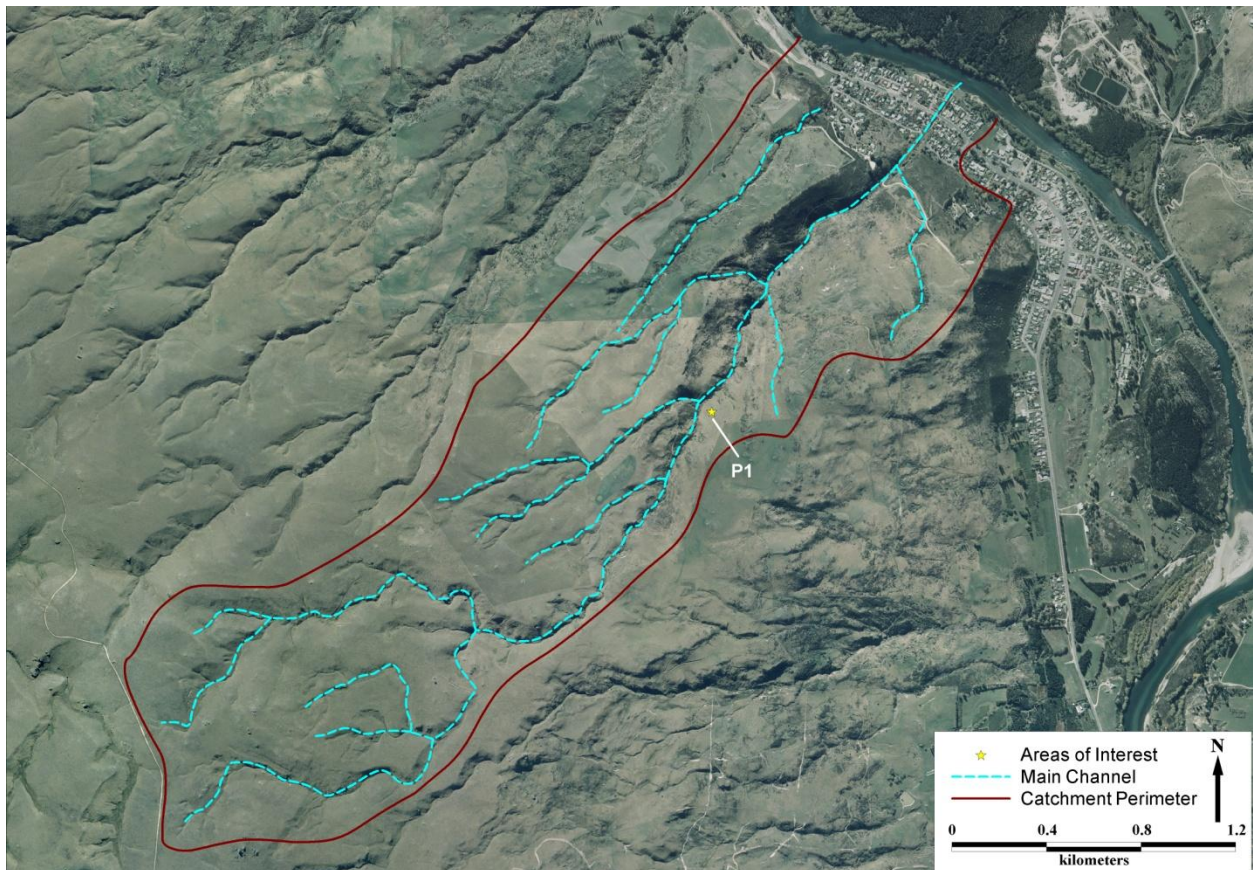
**Figure 12.2** The Reservoir Creek catchment and surrounding environment; aerial photo dated March 2006

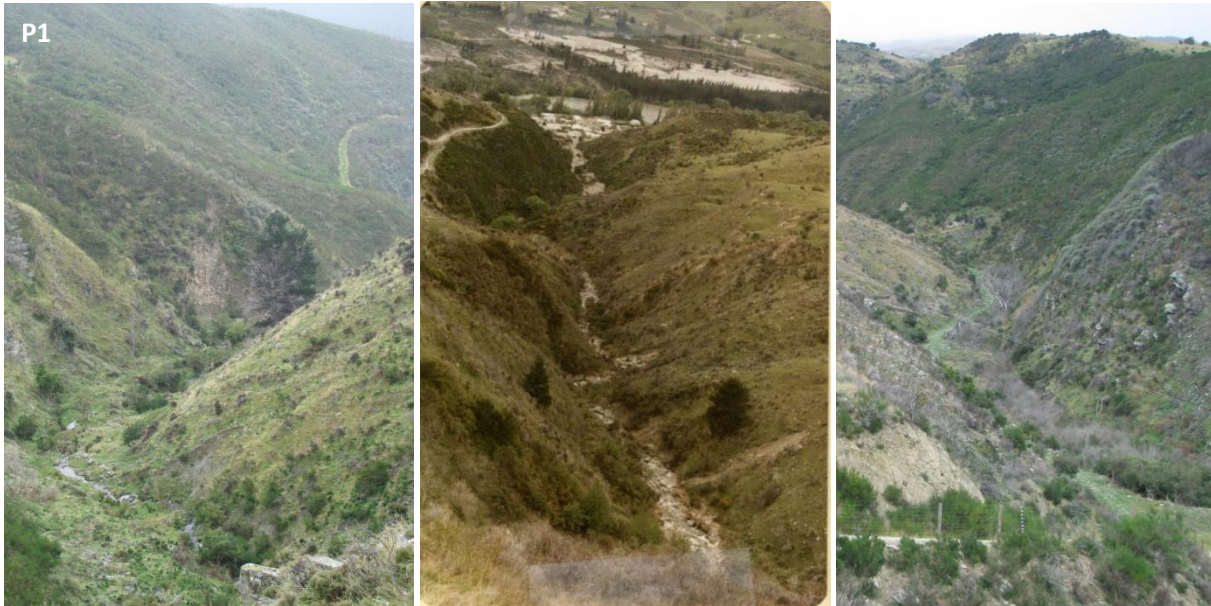
Catchment observations, undertaken by ORC in March 2011, found that Reservoir Creek is well incised into basement schist, having been subject to progressive erosion and valley uplift in the past. Catchment slopes are mantled by large-scale mass-movement features overlain by highly weathered colluvial deposits that are being actively eroded by the creek (Figure 12.3-P1). The bed of the creek is comprised of unconsolidated debris deposits sourced from the adjacent slopes, and deposited during debris-flow events (Figure 12.3). Following the recession of debris-flow events, the channel has incised into these deposits. For much of its length, the catchment channel is well defined and confined between the adjacent slopes. These conditions are favourable for the efficient transfer of debris and flood flows down to the alluvial-fan surface.

**Figure 12.3** The Reservoir Creek catchment. Left: Incision into the base of the adjacent slopes contributes sediment and debris to the channel. Centre: Lower catchment on 17 October 1978, looking downstream; fresh debris deposits are evident along the length of the channel. Right: The same stretch of lower catchment as centre image, taken in March 2011, looking upstream. Debris deposits are now vegetated in this reach and have been subsequently incised by the active channel.

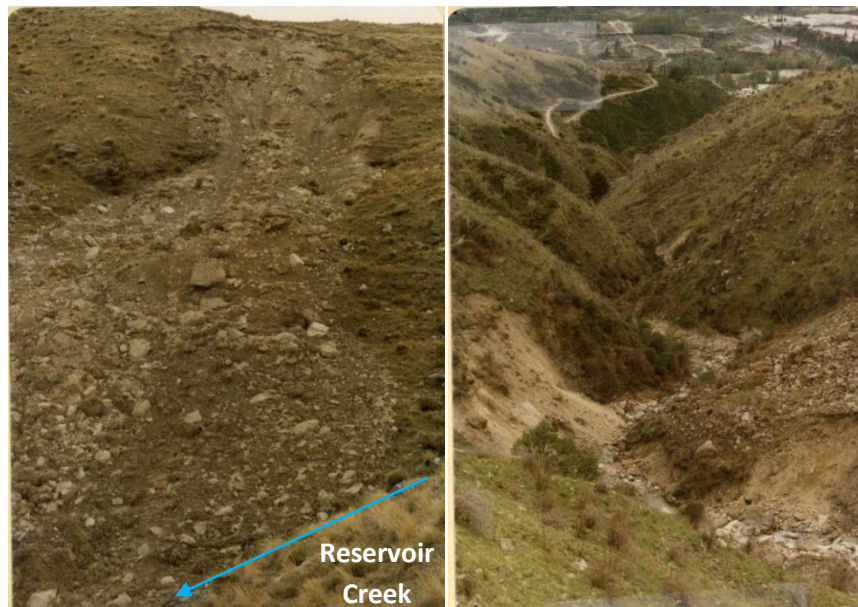
Active slope instability in the catchment is generally the direct result of over-saturation during storm events. Slides and rock falls are common occurrences during high-intensity events, as observed in October 1978 (Figure 12.4).

**Figure 12.4** Left: Upper catchment debris slide almost impounding the Reservoir Creek channel, 17 October 1978. Right: Channel incision and erosion directly supply debris to the channel, 17 October 1978.

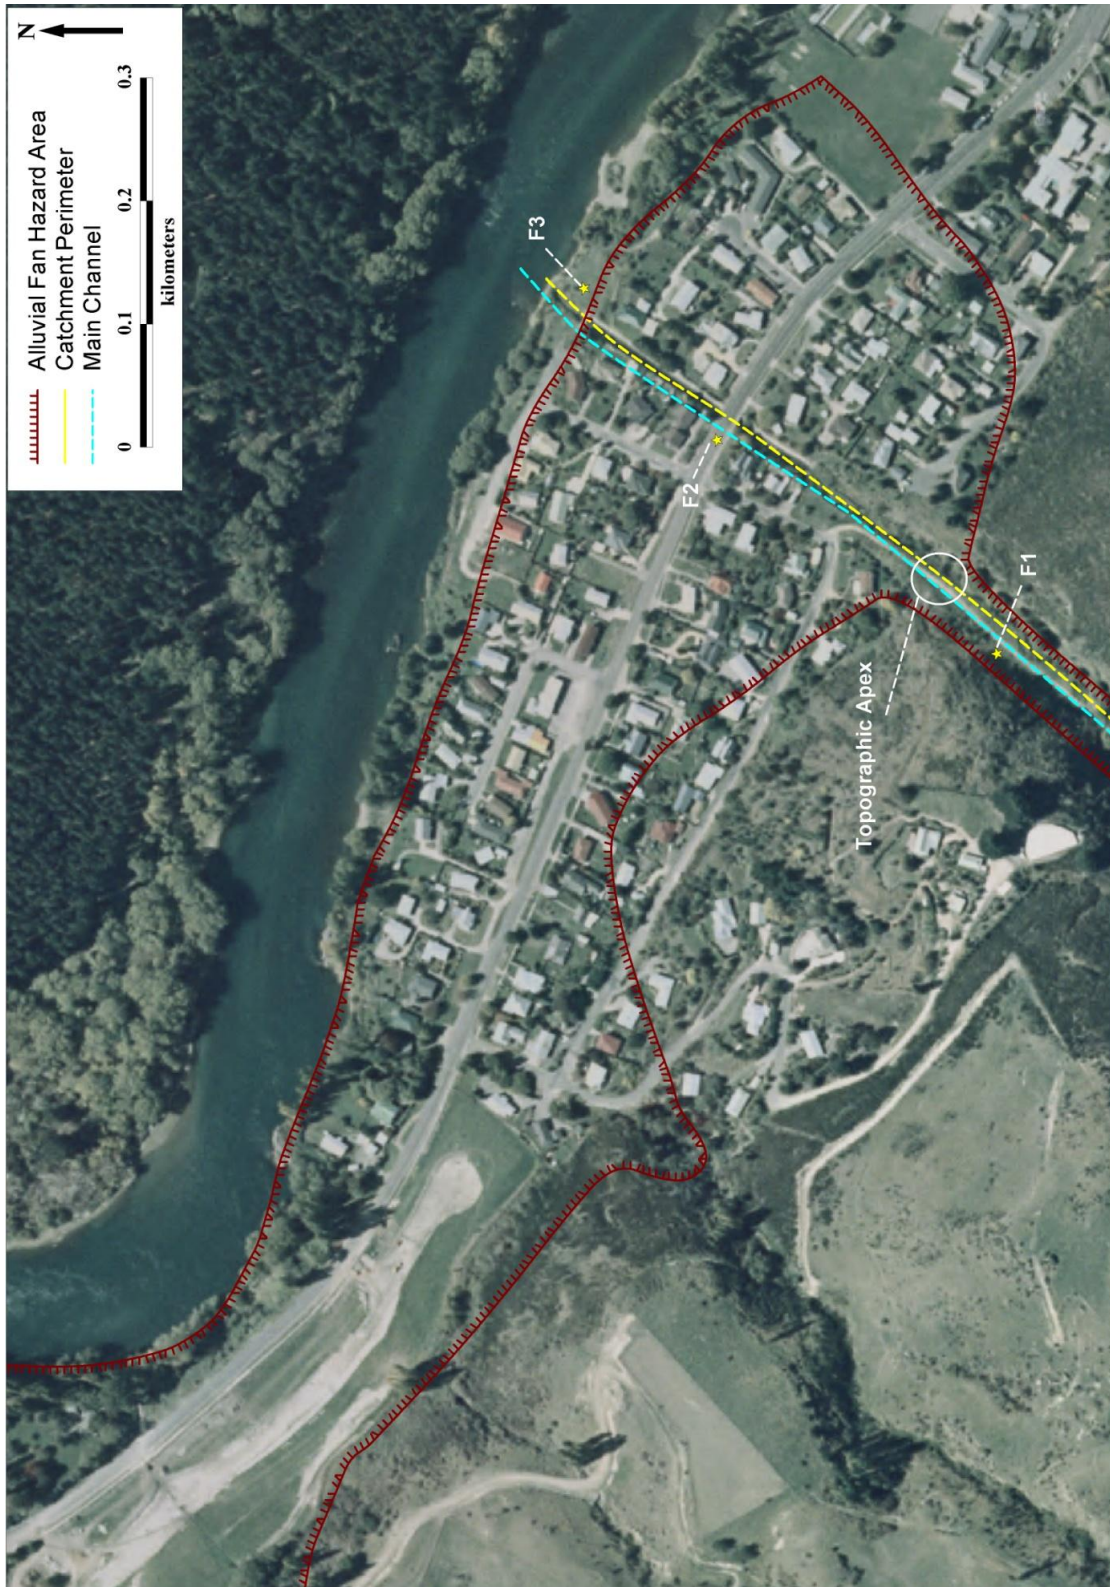
Reservoir Creek has formed a semicircular alluvial fan onto old river terraces, previously deposited by the Clutha River (Figure 12.5). At the toe of the alluvial fan, the Clutha River actively removes sediment and debris. Near the topographic apex of the fan, the channel flows in a U-shaped scoured valley, indicating historic-debris flows have passed through this location. As the channel leaves the confines of the valley, it has been extensively modified by excavation and the construction of concrete-lined channels on the fan surface (Figure 12.6). The intention of this structure is to enable the efficient transfer of debris flows down the fan surface to the Clutha River to prevent flows from spreading into residential areas.

The alluvial-fan hazards associated with Reservoir Creek generally consist of high-velocity-debris and debris-flood flows, channel avulsion, bank erosion and floodwater 'sheet-flow' inundation. Upper parts of the fan are subject to high-velocity debris flow where the channel is currently confined and steep. As the fan and channel gradients change downstream, debris-flood deposits are more common (Figure 12.7), with considerable channel aggradation occurring during and in the immediate recession of the debris-flow event.

Depending on the nature and characteristics of each storm event, any part of the hazard area may be impacted by debris or debris-flood flows or floodwater inundation in the future. It is likely that the fans upper slopes will be impacted by debris flow, as these processes have occurred here in the past, forming the underlying landforms. On the fan's lower margins, it is more likely that debris-flood or floodwater sheet-flows will occur; however, debris flows may impact these areas during high-magnitude events. Catchment conditions indicate that a large volume of unconsolidated debris is stored in the active channel margin that may be transported to the fan surface in future events.

**Figure 12.5** Reservoir Creek alluvial fan noting key features; aerial photo dated March 2006

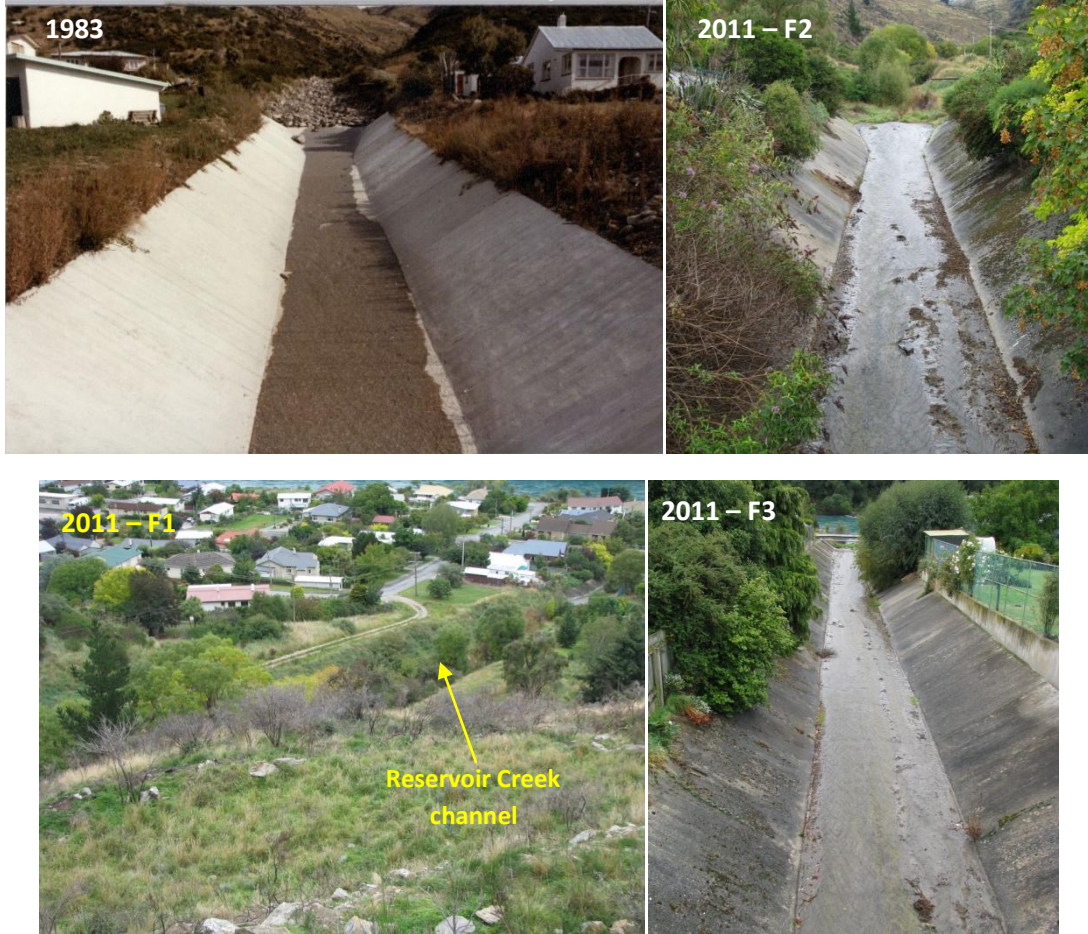
Channel contouring and the construction of the concrete-lined channel were undertaken by the Otago Catchment Board (OCB) in 1980 and 1981 (Figure 12.6). In 1983, a storm event in the Reservoir Creek catchment caused damage to the lined channel, and further improvements were undertaken by the OCB in 1984. Upstream of the concrete-lined channel, large willows and dense vegetation has grown in the channel, following the 1984 works (Figure 12.6).

**Figure 12.6** Reservoir Creek concrete-lined channel, upstream of SH 8 in March 1983 (top left), and in March 2011 (top right), looking upstream. Bottom left: Reservoir Creek channel upstream of concrete-lined channel. Bottom right: Reservoir Creek concrete-lined channel below SH 8

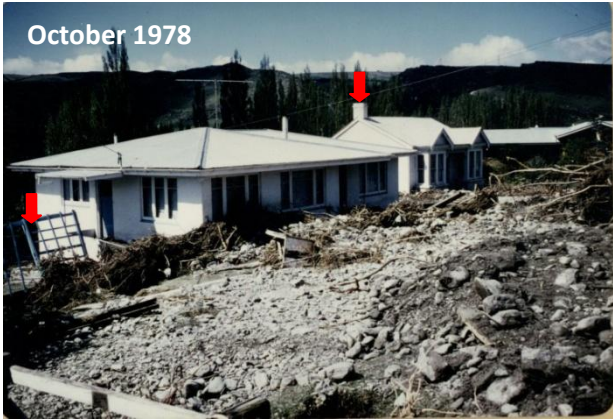
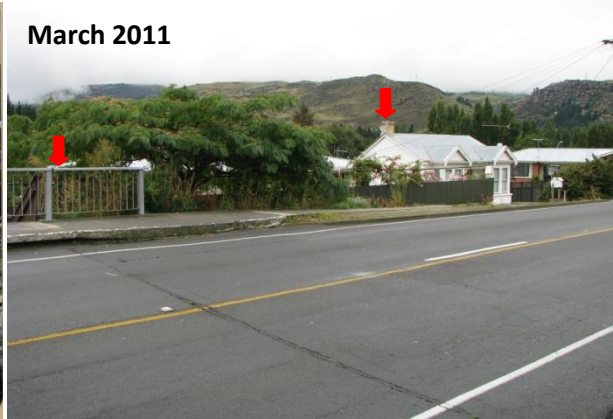
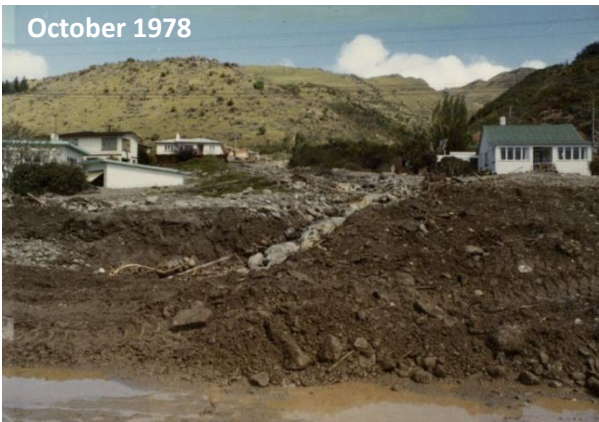
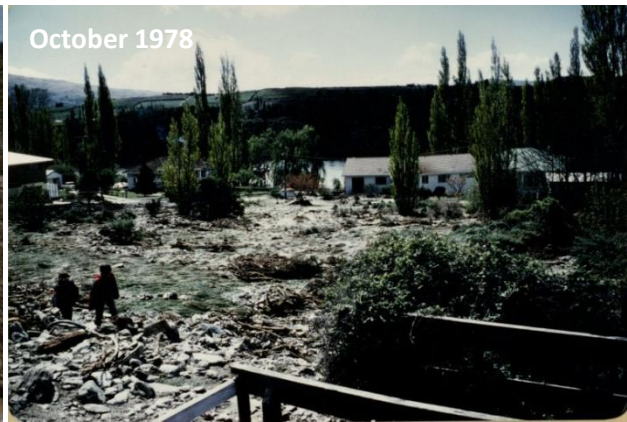
The Reservoir Creek alluvial fan has been subject to recurrent debris-flow events in the past (Figure 12.7). In October 1978, debris flows overwhelmed the channel and impacted residential properties on the fan surface above and below the state highway. In response, authorities excavated the channel and constructed a concrete-lined channel to convey debris flows efficiently to the lower fan. This structure was in place by the early 1980s (Figure 12.6).

**Figure 12.7** Top: Reservoir Creek at SH 8 after the October 1978 storm event, compared to March 2011. Large volumes of debris blocked the state highway in 1978 and impacted residential property. Bottom: Reservoir Creek, looking upstream (left) and downstream (right) of SH 8 in October 1978. Large volumes of debris are evident in both images.
