APPENDIX A

Photographs

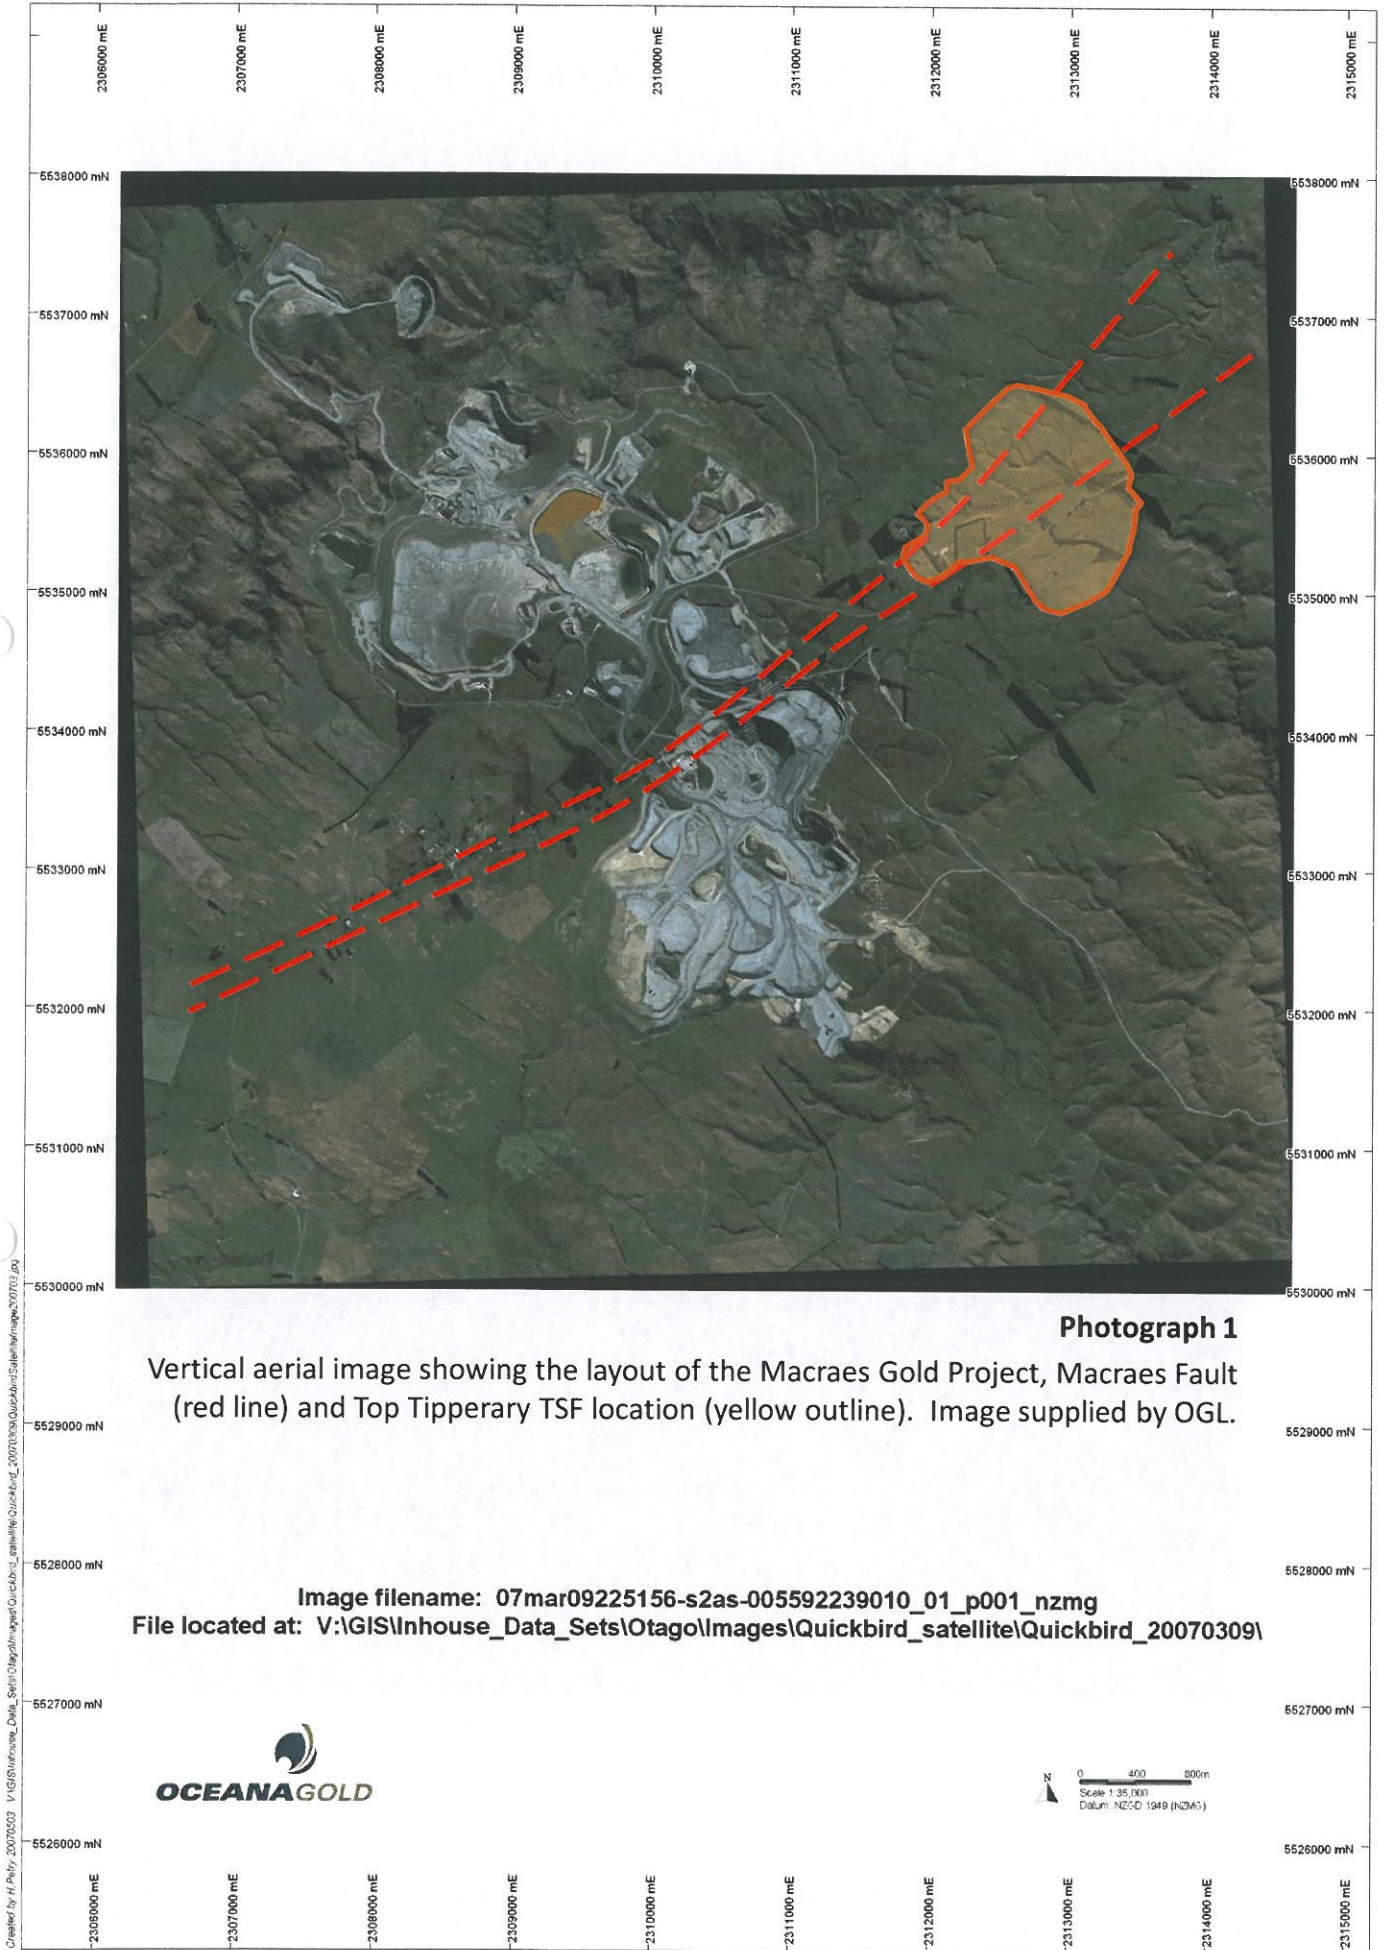
Photograph 1

Vertical aerial image showing the layout of the Macraes Gold Project, Macraes Fault (red line) and Top Tipperary TSF location (yellow outline). Image supplied by OGL.

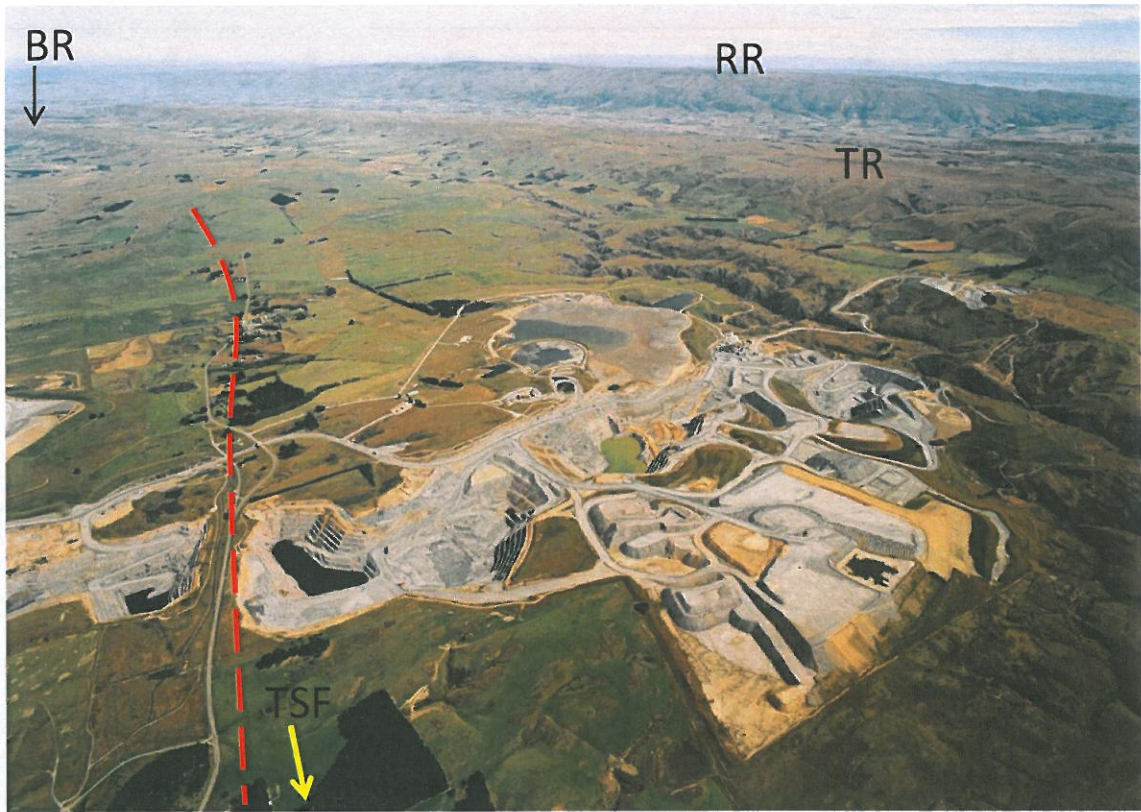
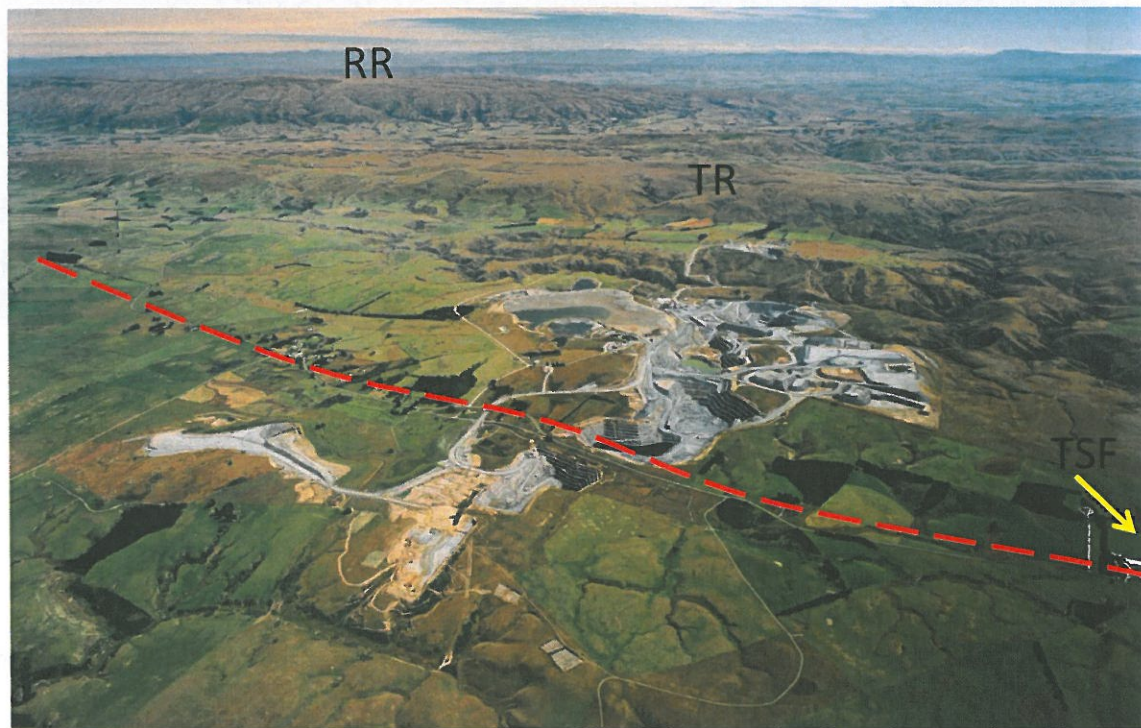
Photograph 2
Oblique aerial photographs of the Macraes Gold Project at Macraes Flat. Labelled structures include RR (Rock and Pillar Range), TR (Taieri Ridge) and BiR (Billy's Ridge). Approximate location of the Macraes Fault is dashed in Red. Top Tipperary TSF site is outside these images (arrowed). Photos supplied by OGL.
