**Channel morphology of the
Waianakarua River, North
Otago**

Report writer: Jacob Williams, Natural Hazards Analyst
Reviewed by: Michael Goldsmith, Manager Natural Hazards

Published December 2014

Technical Summary

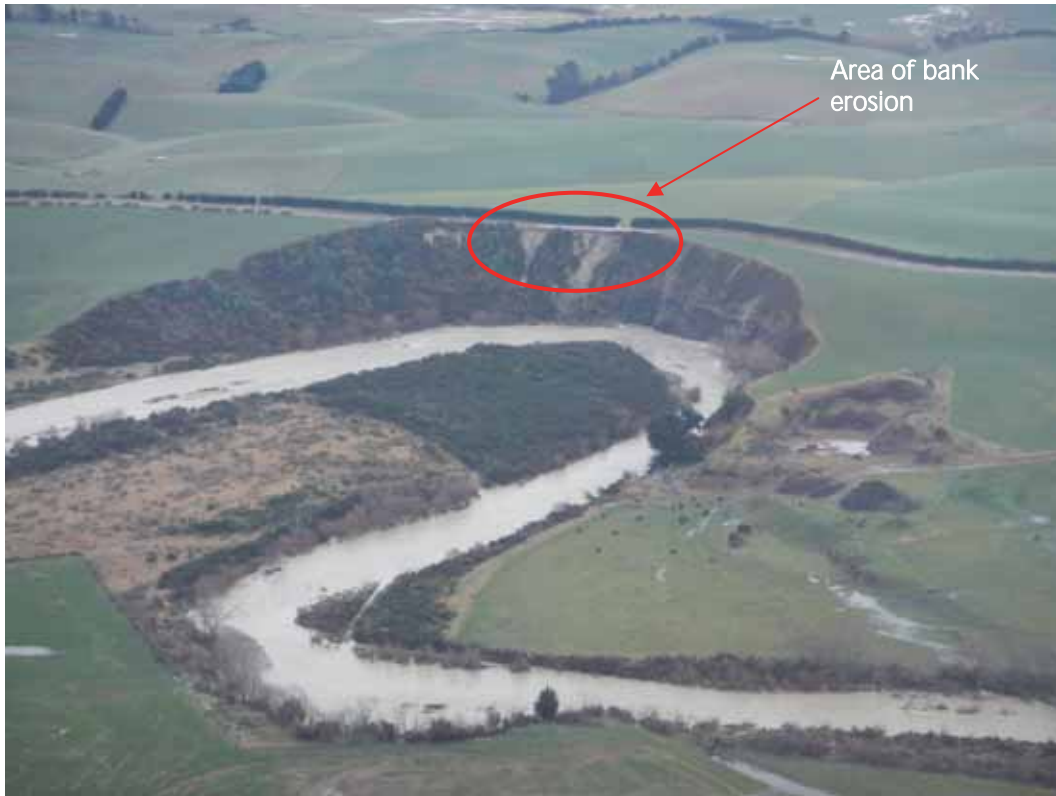
In the main stem of the Waianakarua River the channel switches between areas of braiding and single thread channels. The river is actively eroding the bank below Waianakarua Road, approximately 2km from the river mouth (Figure 6 and Figure 7). Between February 2008 and

Figure 7 Aerial view of the Waianakarua River looking upstream during a period of high flow in August 2012. The location of Figure 6 is circled in red.

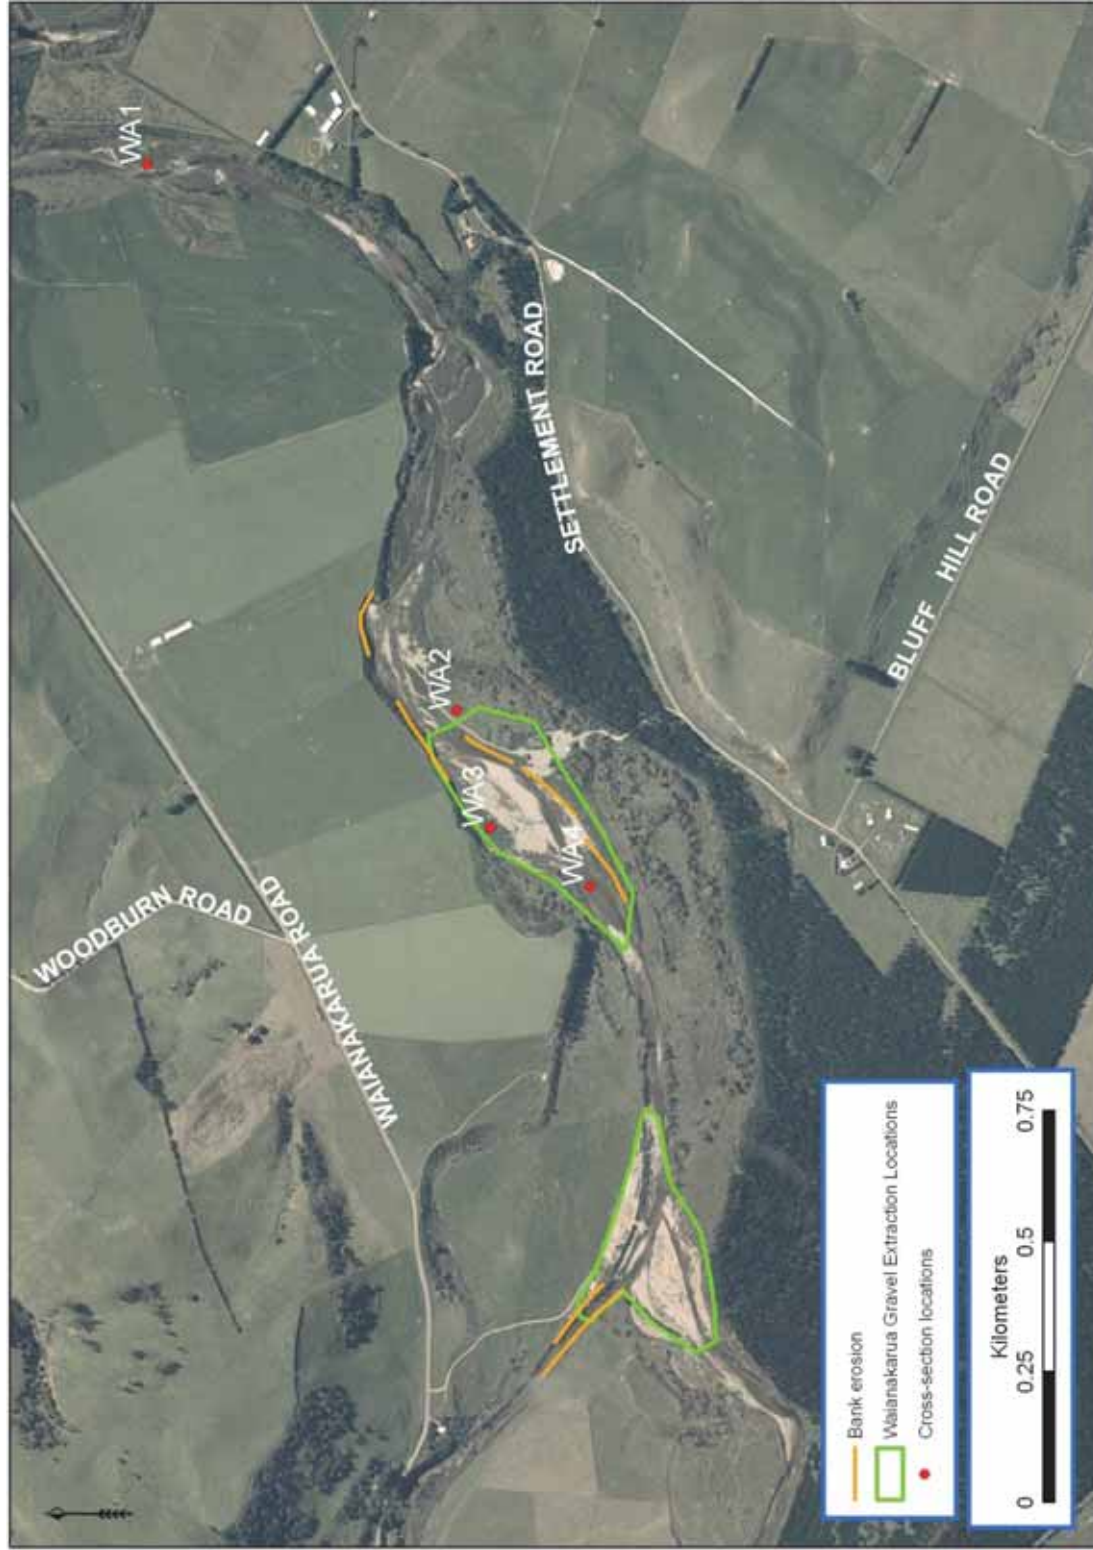
October 2013 survey data show that the main stem of the Waianakarua has shown erosion of both the true left and true right banks (Figure 10). The upstream sites (WA3 - Figure 25, and WA4 - Figure 27) show aggradation of the bed and widening of the main channel (WA3) and the creation of multiple flow channels (WA4) during this period. The main channel became wider and shallower at the most downstream site (WA1, Figure 21) and narrower and deeper at WA2 (Figure 23) between 2008 and 2013. Cross-sections WA3 and WA4 are affected by gravel extraction activities.

Figure 10. Location of surveyed cross-sections on the main stem of the Waianakarua River. Areas where significant bank erosion was observed are shown as orange lines. Locations where gravel extraction has historically taken place are shown as green lines.

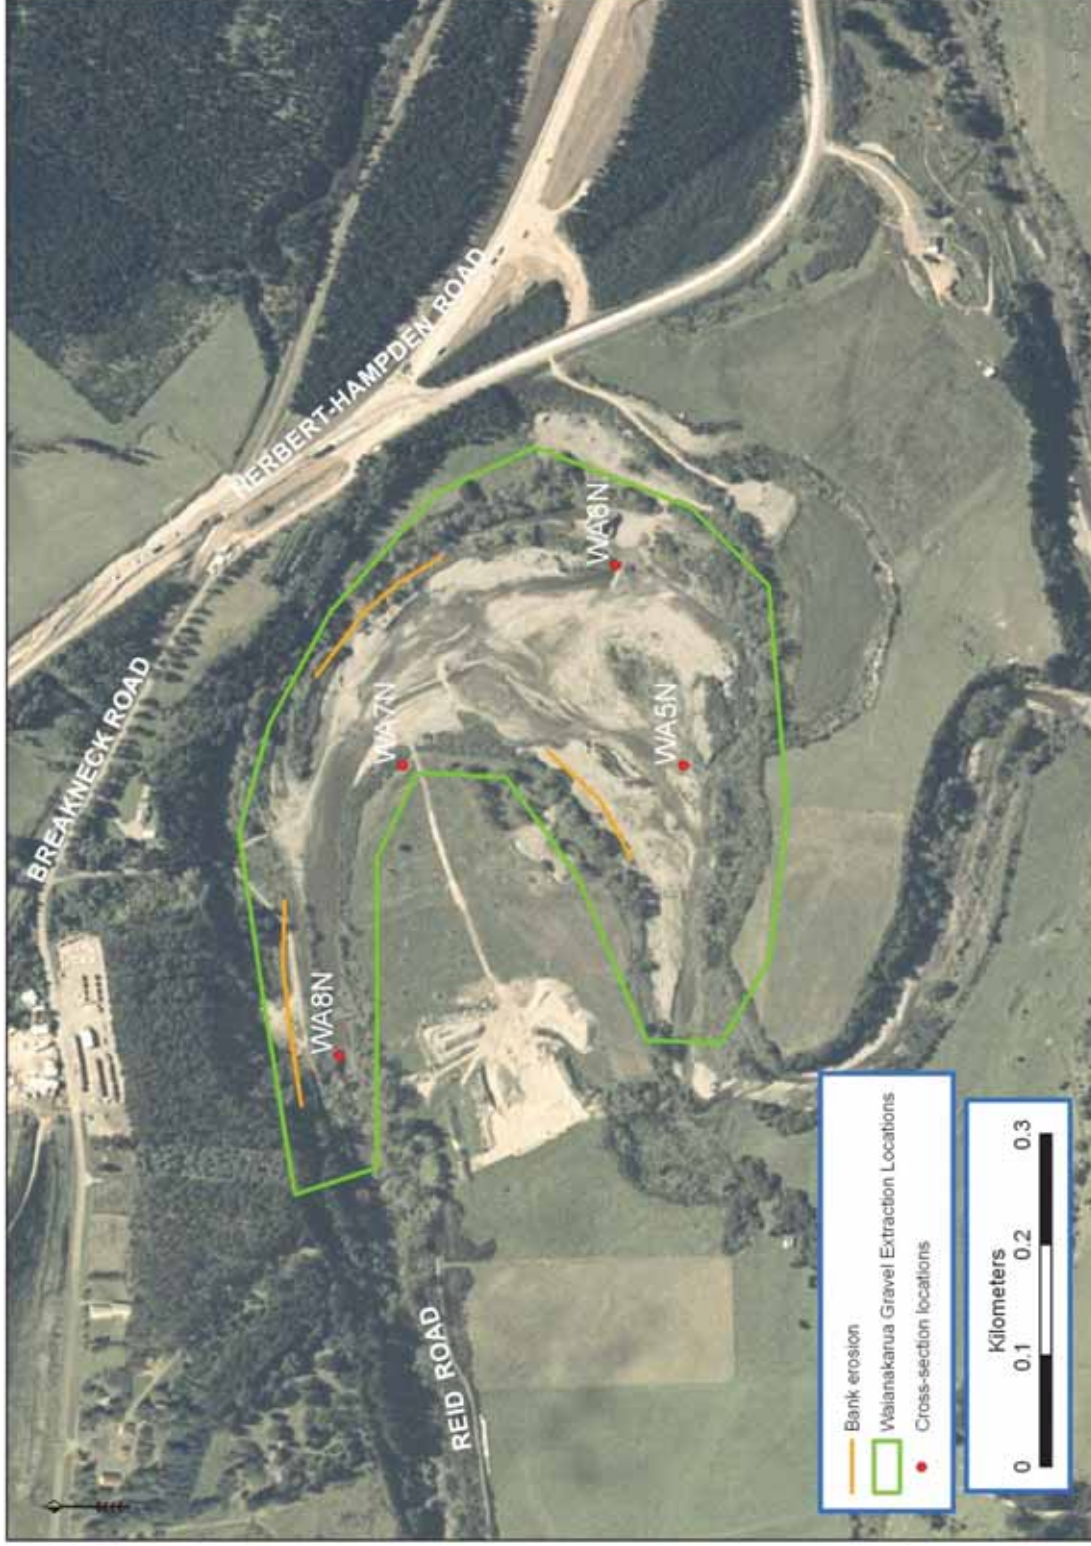
Between February 2008 and October 2013 there was erosion of both the left and right banks of the North Branch of the Waianakarua River (Figure 8, Figure 11). The surveyed reach of the North Branch includes areas of both aggradation and degradation, and an area where multiple channels have developed during the most recent survey period (WA6N, Figure 31). The morphology of the surveyed reach of the North Branch is affected by gravel extraction activities at Sharps Bend (Figure 1).

Figure 11. Location of surveyed cross-sections on the North Branch of the Waianakarua River near Sharps Bend. Areas where significant bank erosion was observed are shown as orange lines. Locations where gravel extraction has historically taken place are shown as green lines.

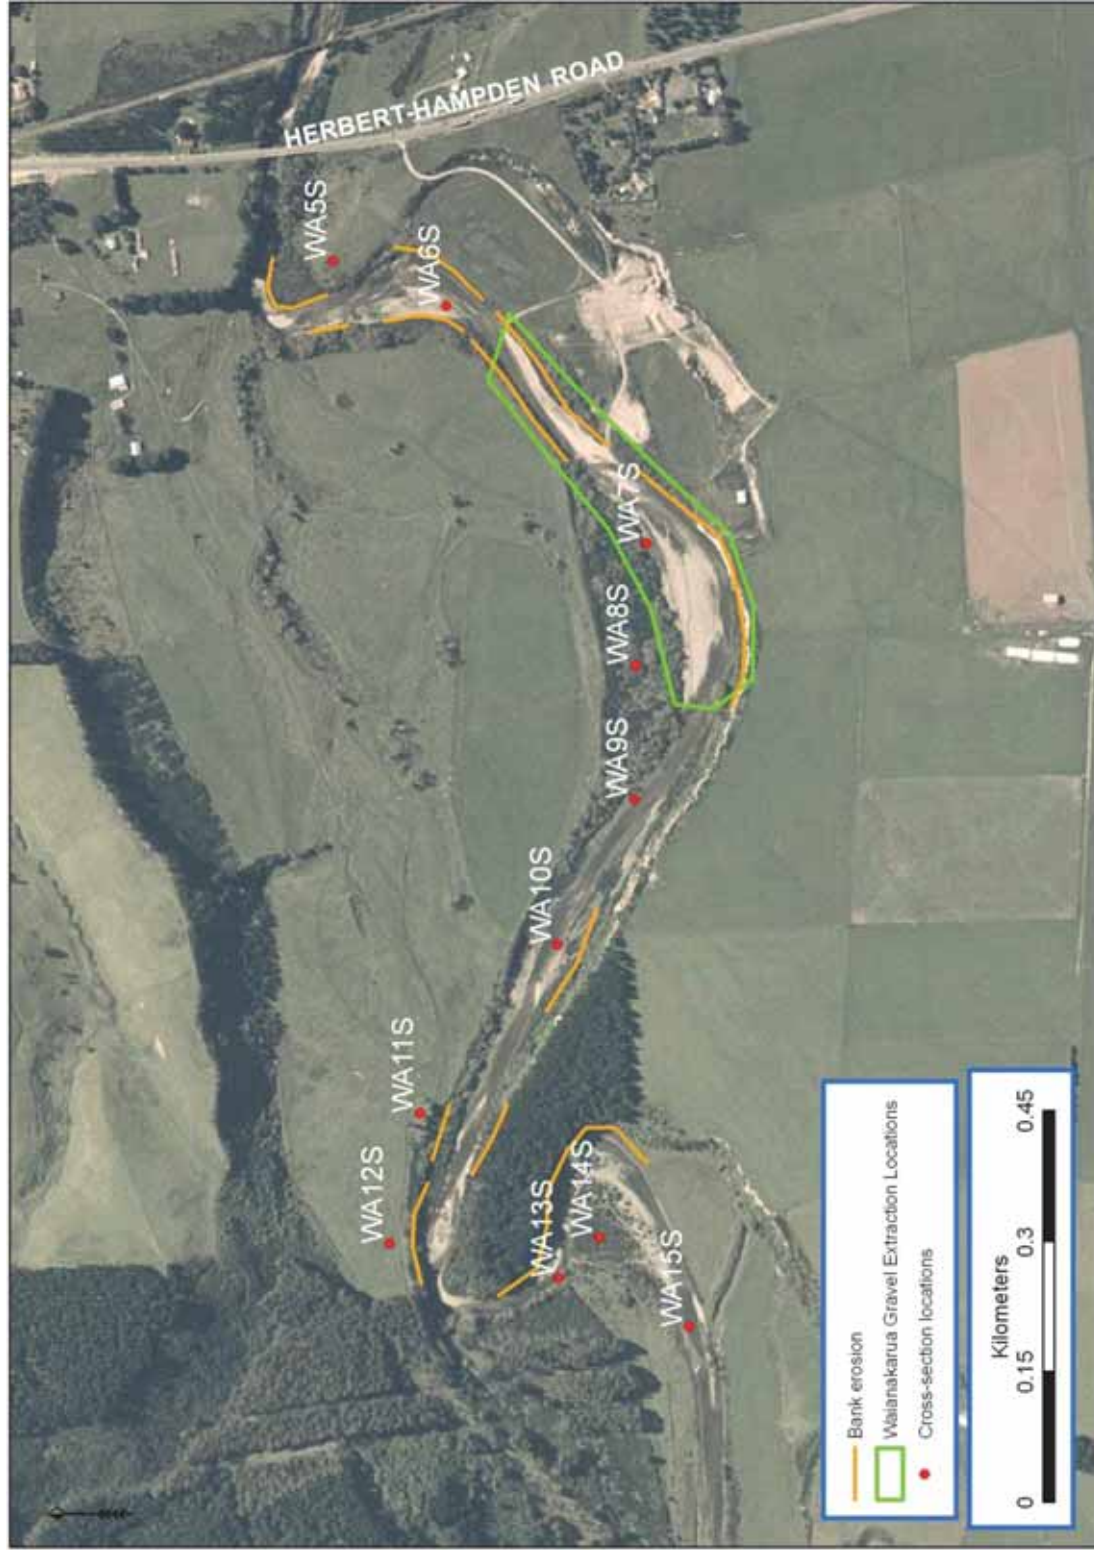
Erosion of both the left and right banks is an ongoing process in the South Branch of the Waianakarua River (Figure 9, Figure 12). Sediment movement (in the form of both erosion and deposition) in the surveyed reach has led to the channel becoming wider in some locations (WA5S - Figure 37, and WA7S - Figure 41) but narrower and deeper in others (WA9S - Figure 45, and WA15S - Figure 57). Cross-sections between WA5S and WA9S are affected by gravel extraction activities.

Figure 12. Location of surveyed cross-sections on the South Branch of the Waianakarua River. Areas where significant bank erosion was observed are shown as orange lines. Locations where gravel extraction has historically taken place are shown as green lines.

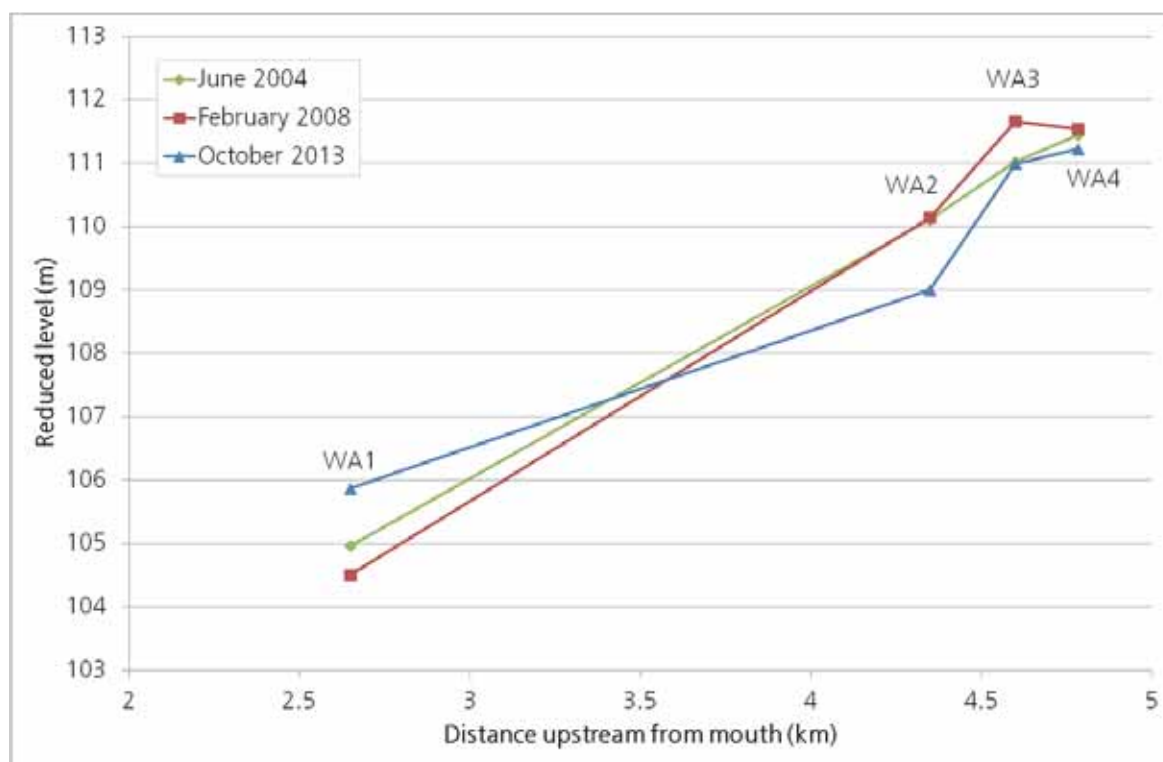
- Cross-section WA2 on the main stem
- Cross-section WA7N on the North Branch

Figure 13. Longitudinal profile showing the thalweg level at cross-section in the main stem of the Waianakarua River

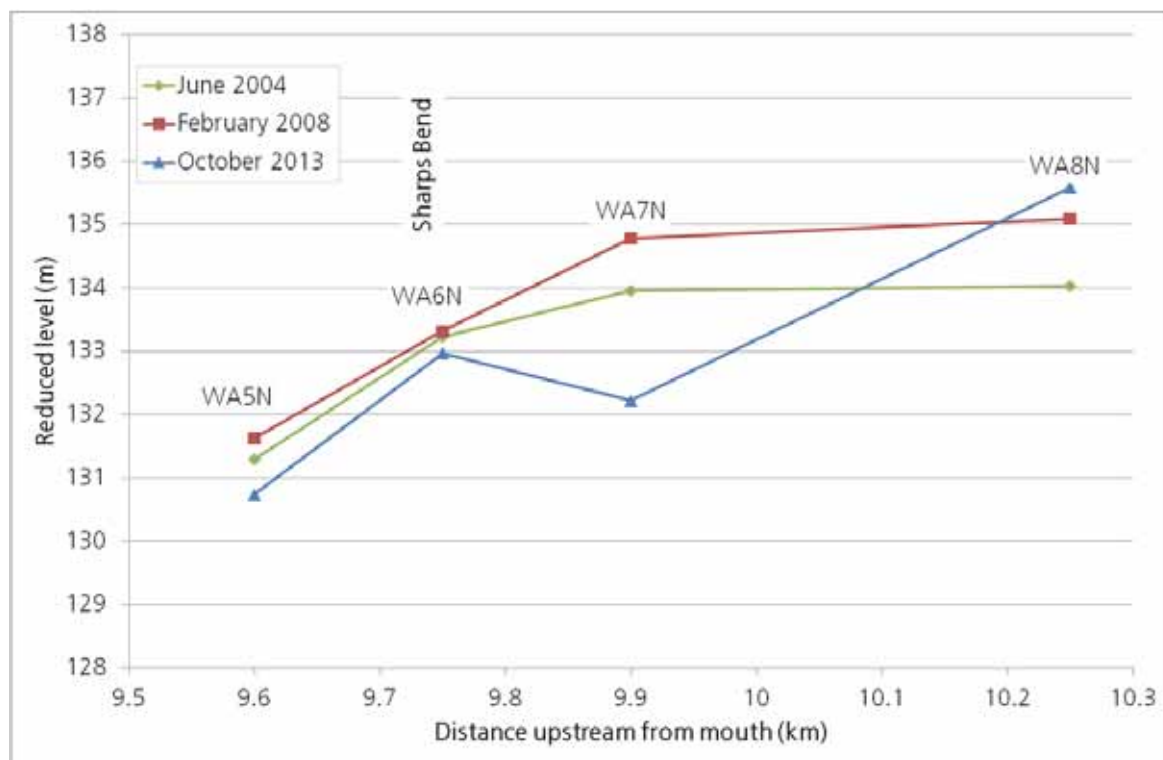
Figure 14. Longitudinal profile showing the thalweg level at cross-section in the North Branch of the Waianakarua River

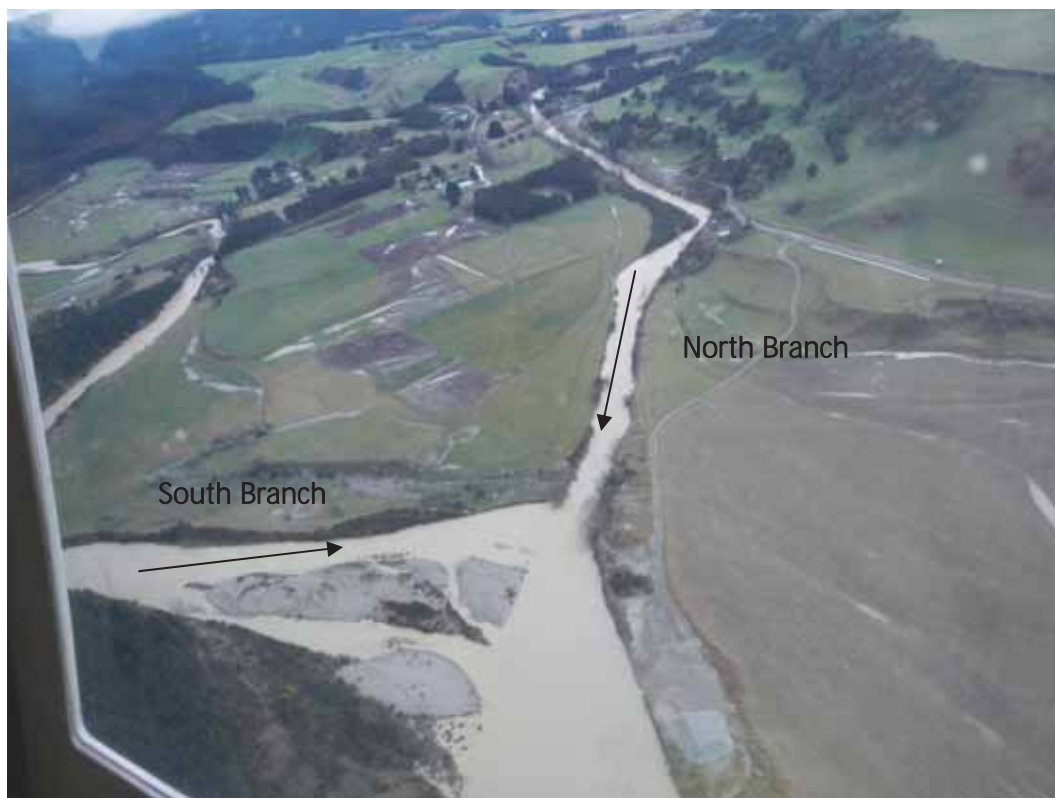
Figure 18. Aerial view of the Waianakarua River catchment in flood, looking upstream at the confluence of the North and South branches, August 2012

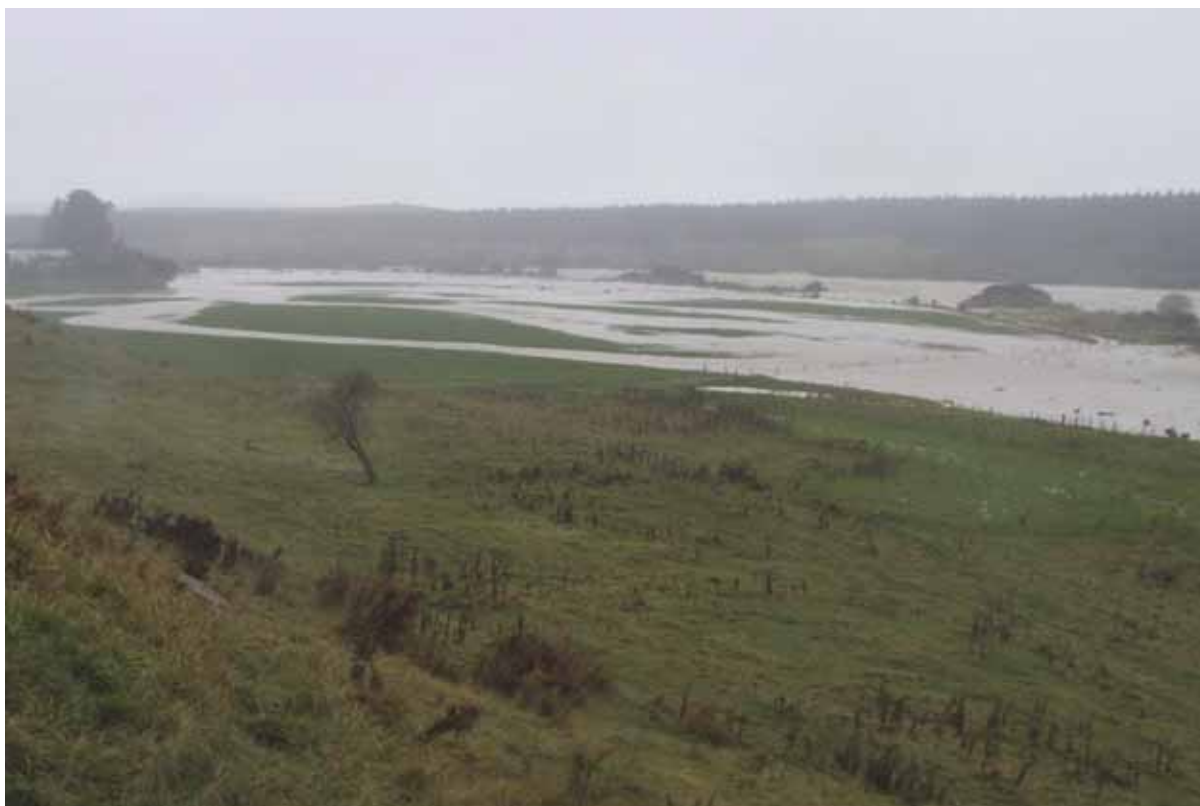
A large flood occurred in April 2014 (after the latest set of cross-section data were collected) which peaked at $427\text{m}^3/\text{s}$ at Brown's Hydrological site (Figure 19). Additional cross-section survey data would be required to describe any changes in channel morphology which may have resulted from this event.

Figure 19. Flooding of farmland on the true left bank of the Waianakarua River, below the confluence of the North and South Branches. (Photo taken in the morning of 19 April 2014 by Jill and Gray Campbell).
