**Hazard and risk assessment of the Roxburgh
debris flows of 26th November 2017**

**GNS Science Consultancy Report 2018/65
May 2018**

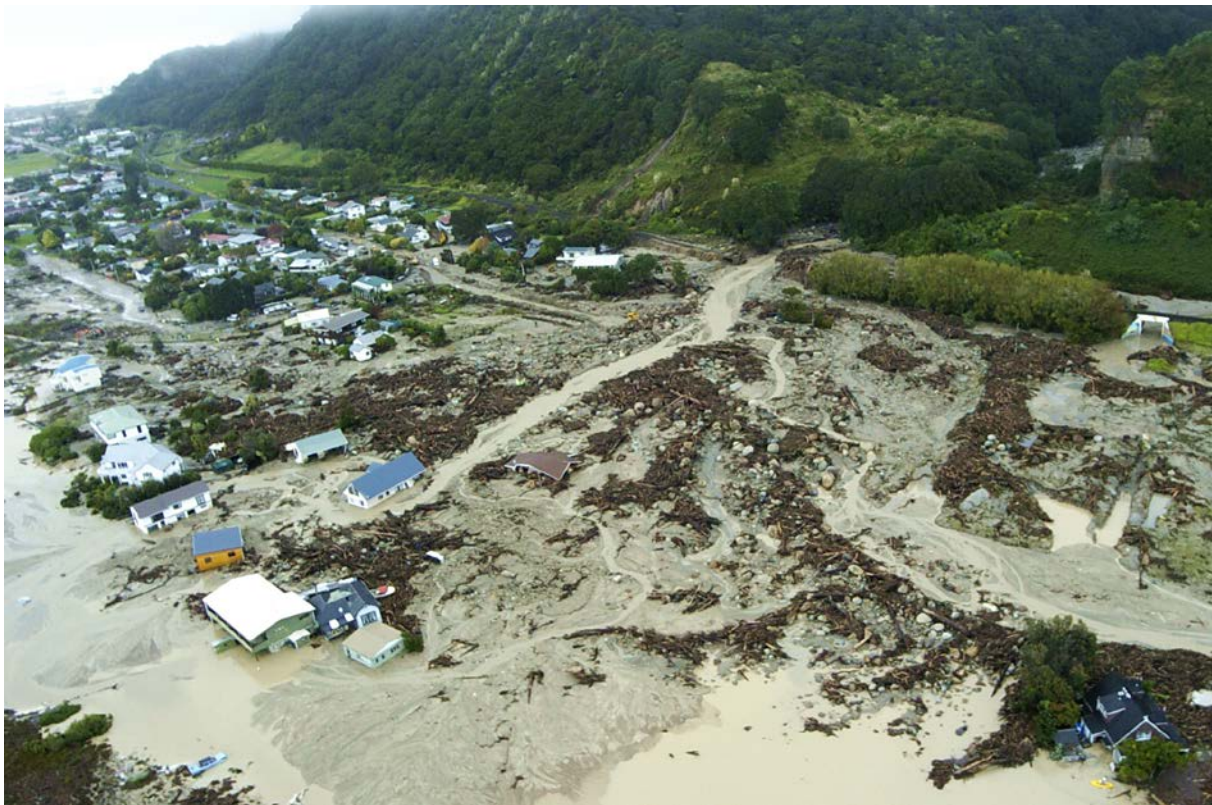
Debris flows occurred at Matata on 18th May 2005 (Figure 2.1) (McSaveney et al, 2005). Seventeen people were rescued from damaged buildings but it is worth noting, no buildings (homes) collapsed and no-one was caught in the open by a debris flow. Relevant extracts from the Executive Summary of the McSaveney et al (2005) report are presented here:

Figure 2.1 Debris flow deposit from the Awatarariki Stream behind Matata in the Bay of Plenty after heavy rainfall on the 18th May 2005. (Photo: G.T Hancox)

A concrete channel at Reservoir Creek allowed most of the large debris to remain within the channel. However, it appears that the bridge on SH8 over Reservoir Creek acted as a minor constriction and water and fine-grained sediment (sand and silt) left the channel and flooded some properties between SH8 and the Clutha River. If the debris flow channel had not been present the scene after the debris flows would have been more like Figure 2.1.

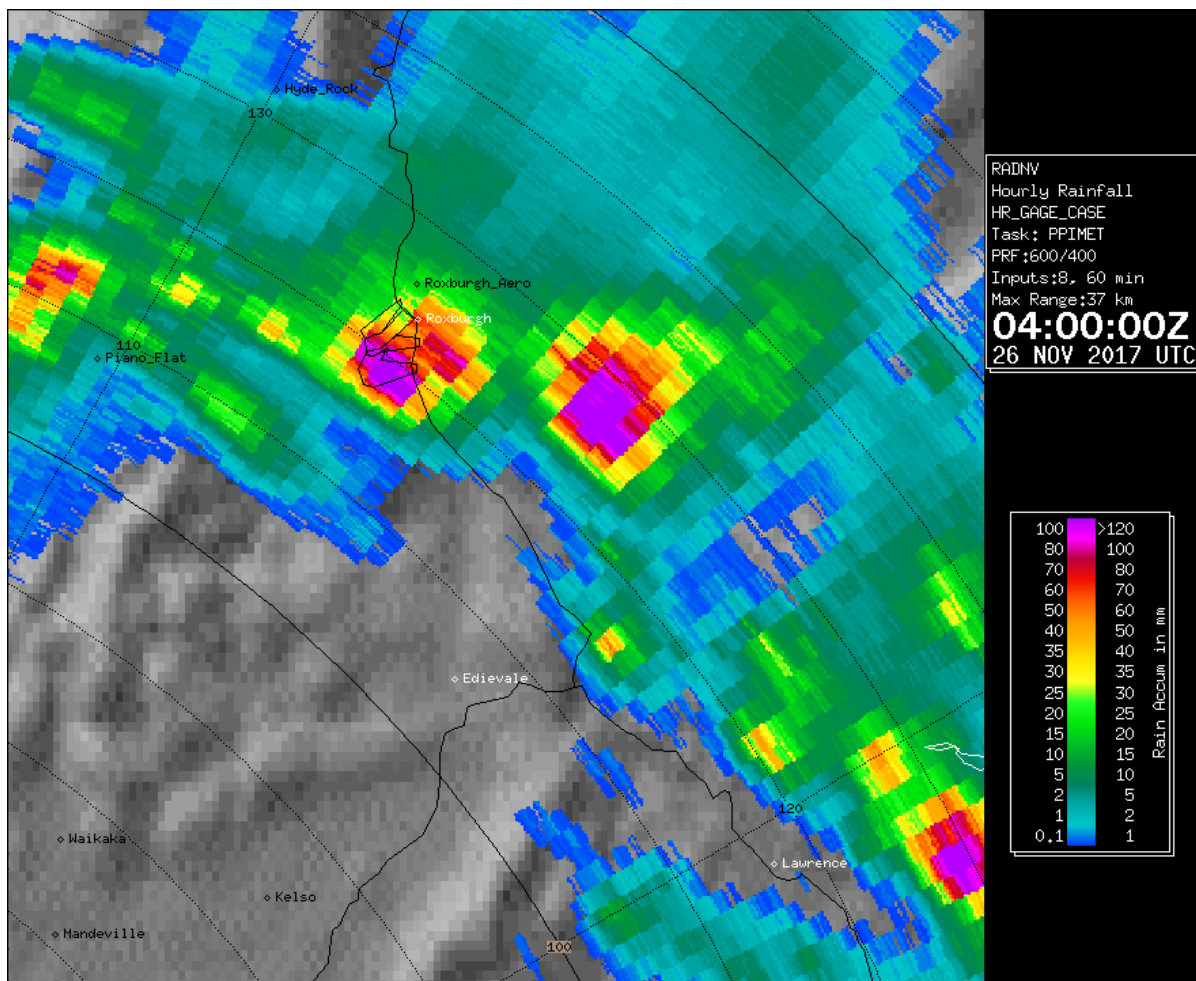
The NZ MetService provided rainfall estimates for the afternoon of 26th November 2017 near Roxburgh based on rain radar data from the Invercargill weather radar facility. The rain radar data showed the highest intensity rainfall occurred between 4.00 and 5.00 pm (Figure 3.1). Although the time interval for this data is one hour the distribution of rainfall within that hour is unlikely to have been uniform. There are likely to have been short periods when the rainfall may have been more intense.

Figure 3.1 MetService weather radar one-hour estimated rainfall between 4.00 pm and 5.00 pm (NZDT) on Sunday 26th November 2017. In this image four thunderstorm cells are visible. The thunderstorm cell below Roxburgh Aero produced debris flows in the outlined catchments. The cell to the right of Roxburgh is the one near Tima Burn.

The other noticeable feature of the rainfall shown on Figure 3.1 is the presence of at least three other short-duration, high-intensity rainfall cells to the west and south of Roxburgh. None of these other rainfall cells resulted in debris flow activity.

The MetService weather radar showed that a rainfall cell similar to the one over Roxburgh was present in the Tima Burn area (Figure 3.1). Field inspection found evidence for a flood event in Tima Burn on the 26th November 2017. The evidence included damage to the post and railings on the deck on a small bridge 2 to 3 m above the stream channel (Figure 3.18 and Figure 3.19). Farther down the valley evidence for a thin layer of silt deposition was observed.

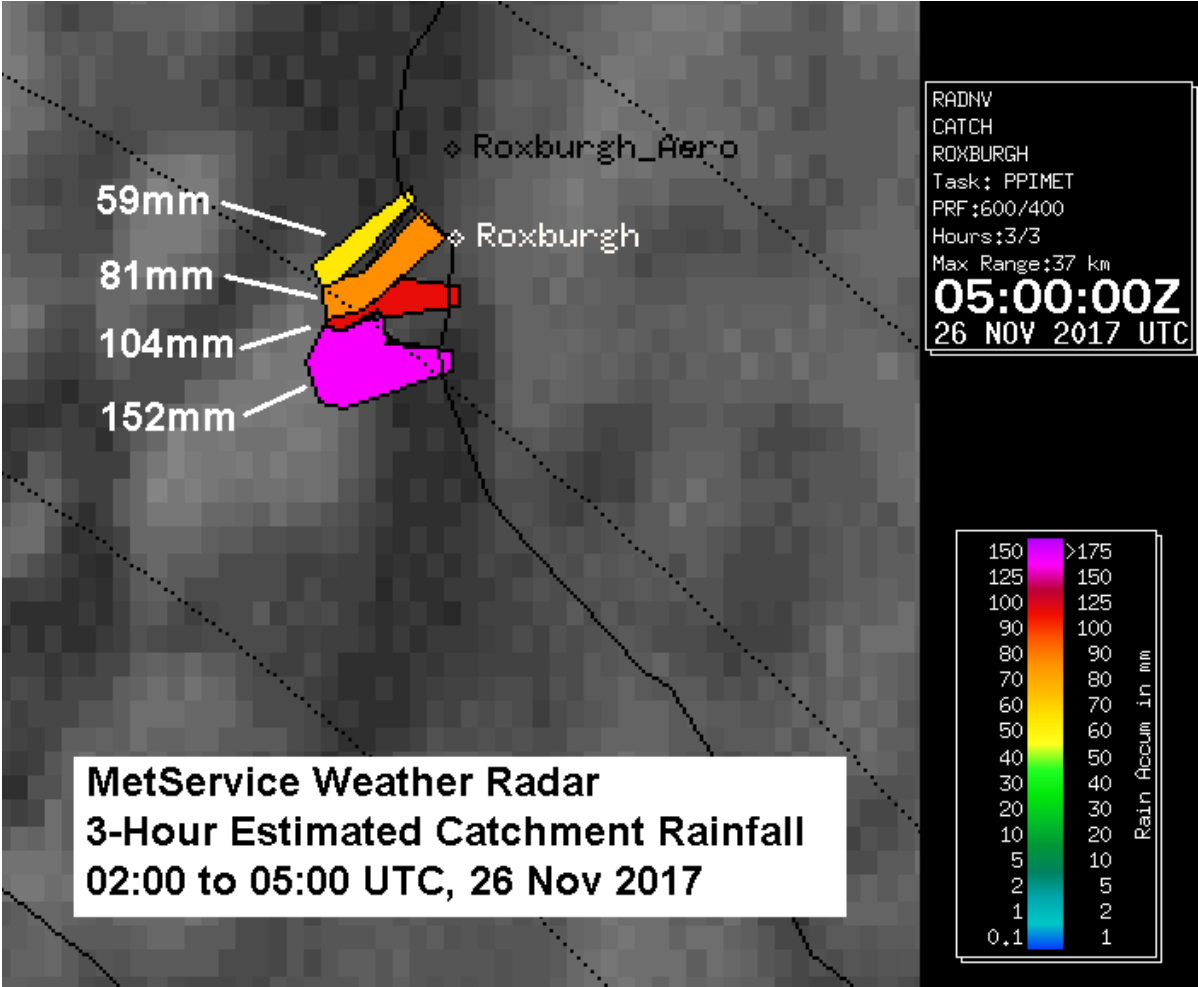
The cumulative rainfall, averaged over the catchment area for the three-hours from 3.00 to 6.00 pm for the four stream catchments to the west of Roxburgh that had debris flow activity are shown in Figure 3.2. The rainfall is noticeable for the increase in rainfall towards the south. This is consistent with the rainfall shown in Figure 3.1 where the individual catchments are shown in outline.

Figure 3.2 MetService weather radar three-hour (3.00 pm to 6.00 pm (NZDT)) estimated rainfall totals in the four stream catchments where debris flows occurred on Sunday 26th November 2017.

Statistical rainfall patterns for Roxburgh was obtained from the National Institute of Water and Atmosphere (NIWA) High Intensity Rainfall System V3 (HIRD). The NIWA HIRD's data (Table 3.2) shows the 60-minute rainfall at the 100-year return period as 42 mm/hour. The one-hour rainfall estimated from Figure 3.2 shows the rainfall in the catchment that received the least amount of rain (Pump Station Creek) was about 40 mm/hour (Table 3.3).
