Active landslides in the Dunedin area

October 2015

Report writer: Ben Mackey, Hazards Analyst (Geologic)
Reviewed by: Michael Goldsmith, Manager Natural Hazards

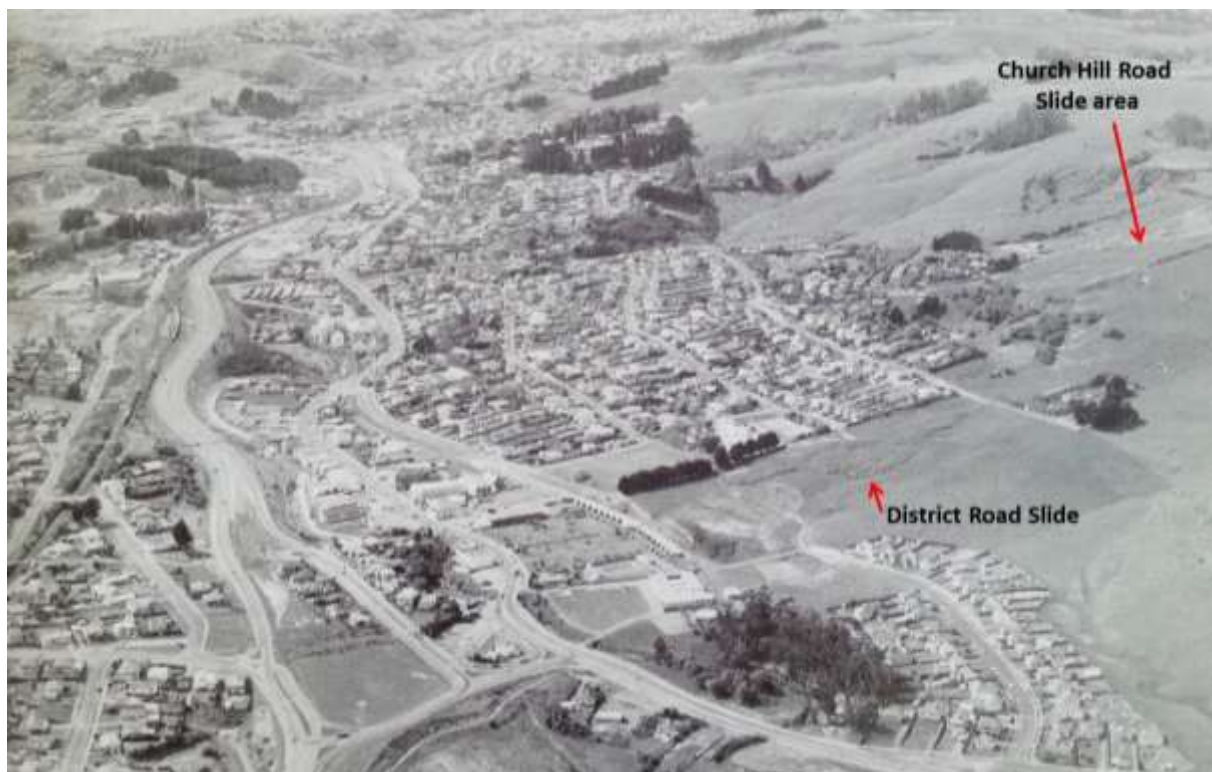
Figure 8 Oblique view east along Kaikorai Valley and Green Island, showing the District Road Slide and Church Hill Road Slide on the southern slopes. Background image from McKellar (1990), original date unknown

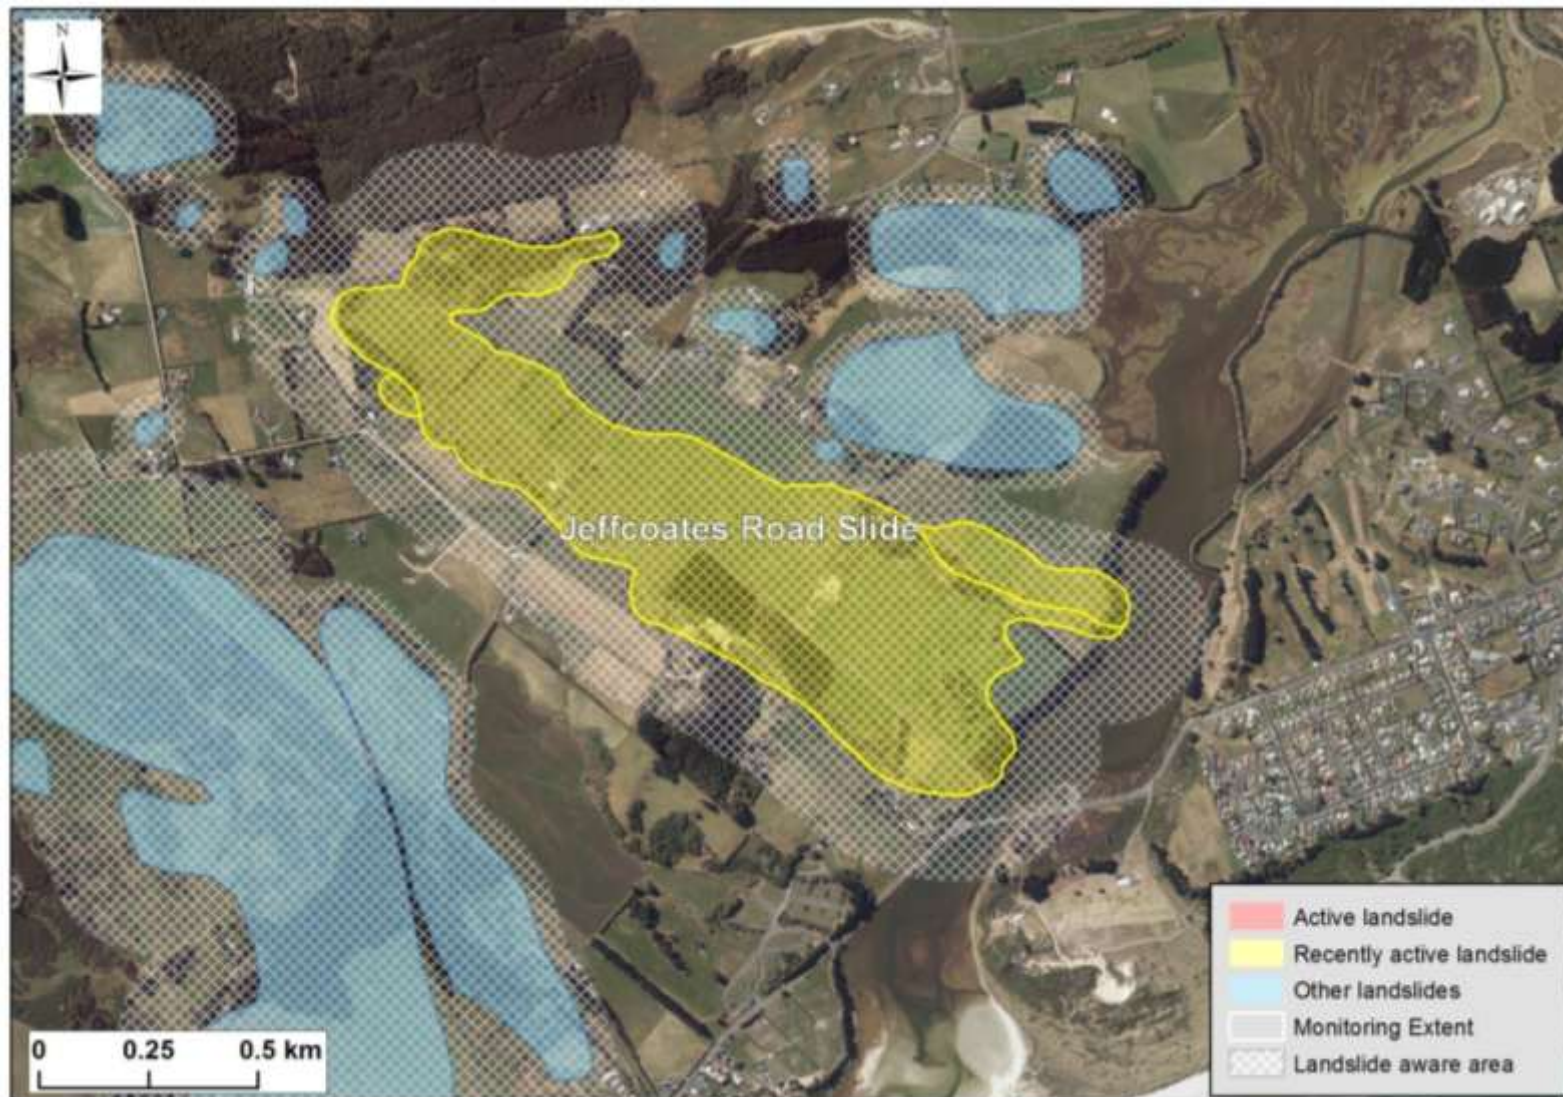
Figure 14 Jeffcoates Road Slide

No evidence of large-scale surficial movement of these two landslides was observed during an aerial inspection in June 2015. However, some new surficial landslides were observed further upslope, as shown in Figure 16.

The justification for including these slides in category 'a' ('active'), when there is no ongoing monitoring to confirm current movement, is the earthflow-style nature of these landslides. Earthflow features similar to the Jeffcoates Road Slide or the Rockview Road Slide can remain active for centuries, and commonly show periods of creeping activity interspersed with decades of dormancy. They are highly sensitive to changes in groundwater level.

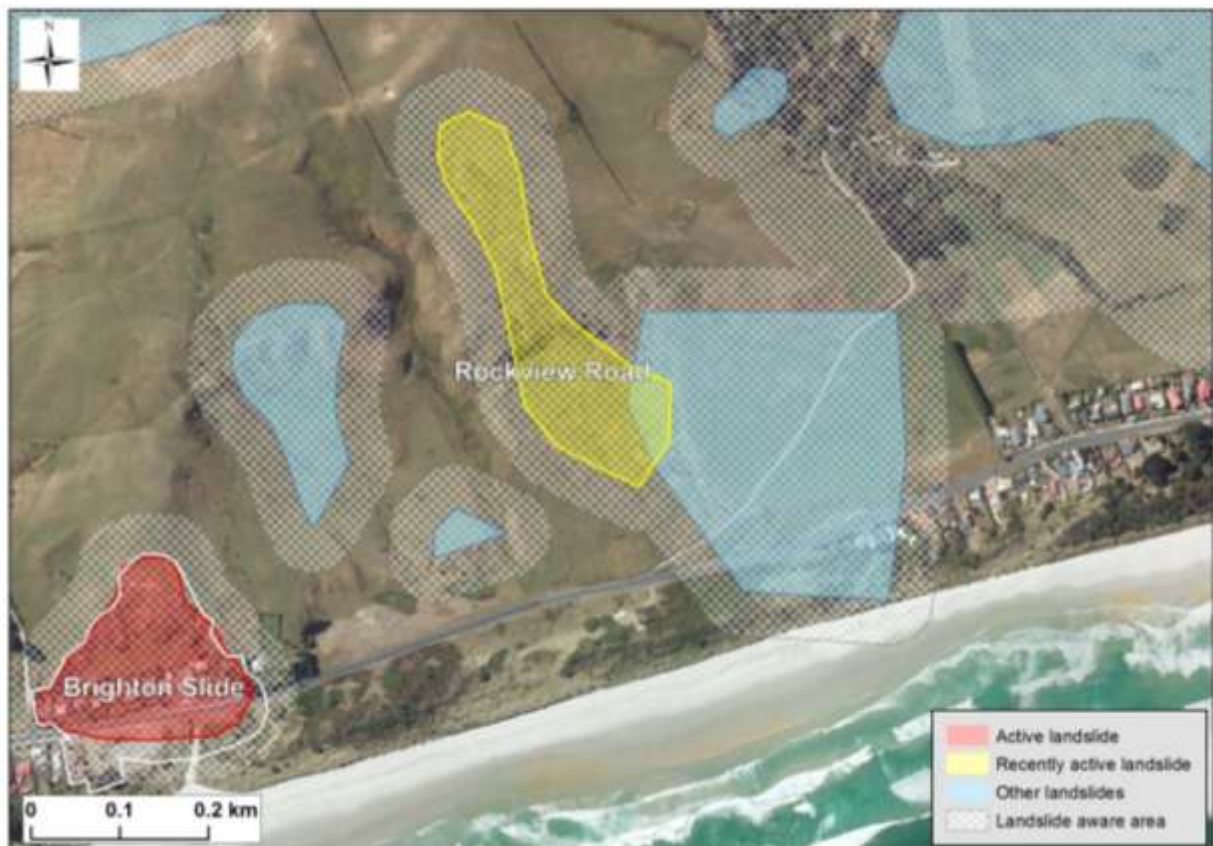
Figure 17 Rockview Road Slide. The Brighton Slide is approximately 500 m to the west.

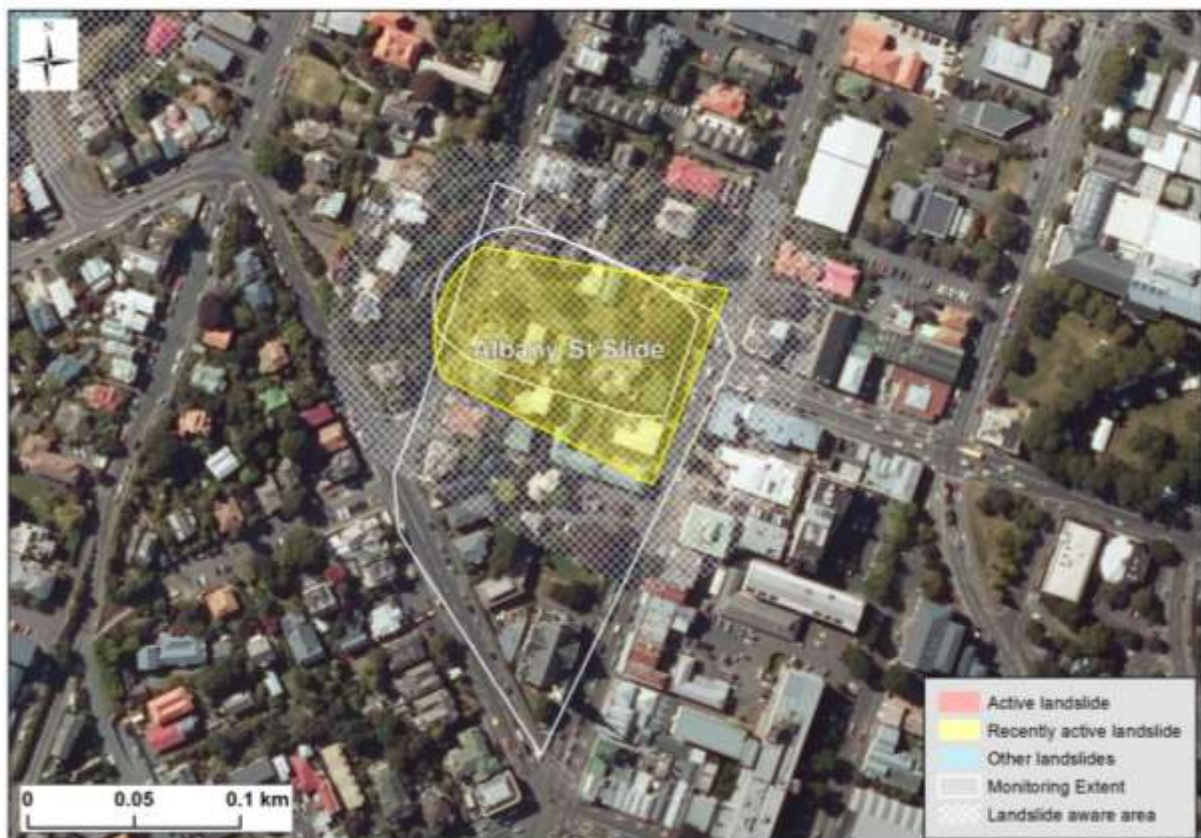
Figure 20 Albany Street Slide

MWH monitors the site for the DCC for signs of ongoing movement. Monitoring has been conducted since 1987, although the current survey network was established in 2010. There was minimal movement detected in the most recent survey (2014), with about 10–12 mm total horizontal movement and 10–14 mm vertical settlement in the four-year survey period since 2010. The greatest amount of surveyed vertical displacement (14 mm between 2010–2014) occurs near the intersection of Albany and Queen Streets.

The Albany St Slide has been the focus of multiple engineering reports (Johnson, 1987; Glassey, 1991).

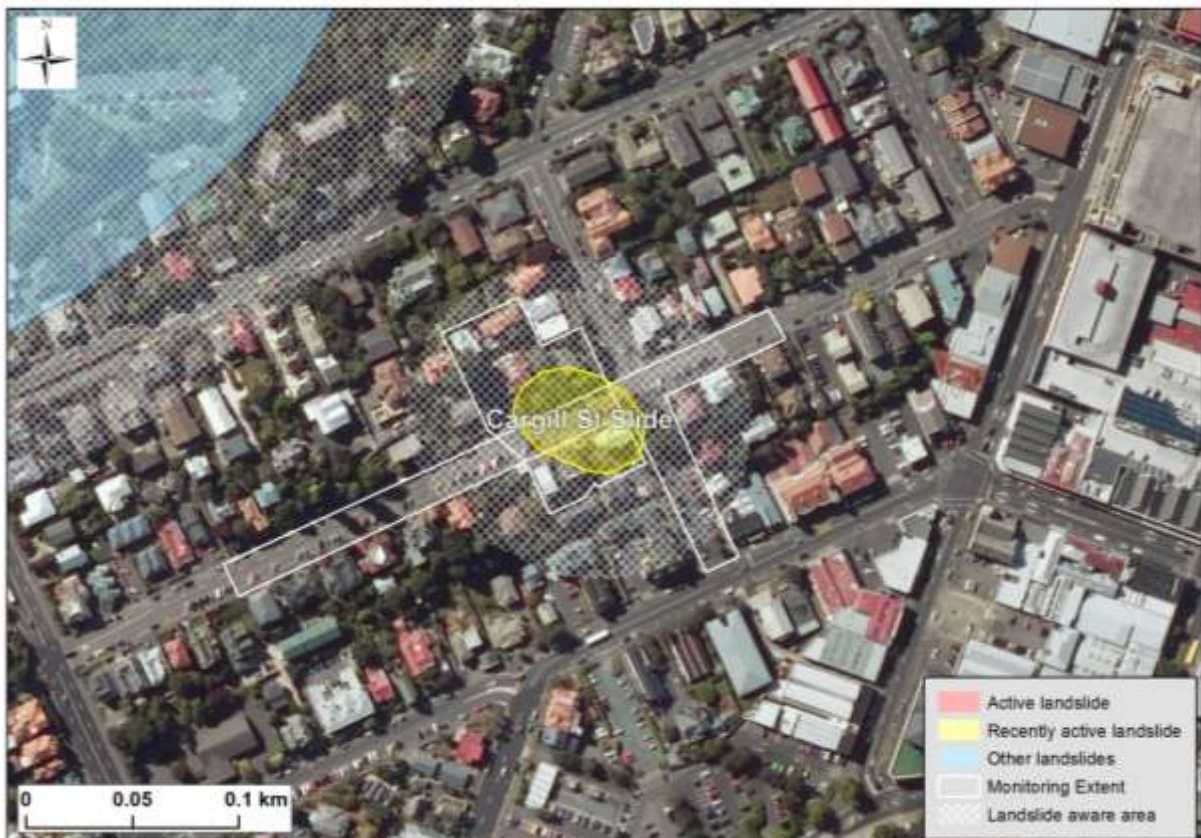
Figure 21 The Cargill St Slide

MWH has monitored the slide for the DCC since 2000. A series of pins along the southern margin of Cargill Street form a survey transect that is monitored for vertical and horizontal deformation. Most movement occurs between 74 and 84 Cargill Street, with up to 37 mm horizontal (downslope) and 42 mm of vertical lowering recorded over the 15-year monitoring period. There is little discernible movement during the recent survey intervals.

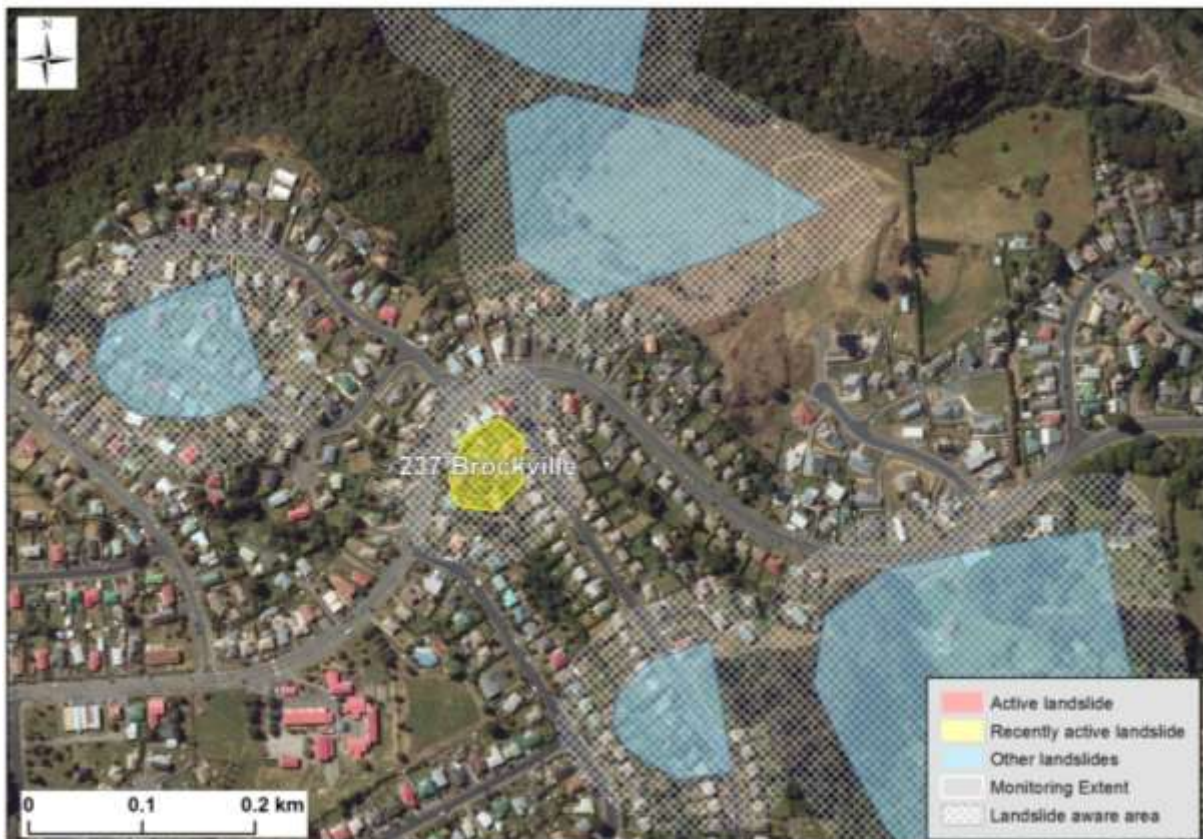
Figure 22 237 Brockville Road Landslide

The landslide at 237 Brockville Road was a pre-existing slump before residential development. The landslide experienced episodes of movement after heavy rains in 1968, 1977 and 1980 (MWH, 2015). The site has since been stabilised and drainage measures installed. According to the reports, periodic (currently decadal) visual monitoring by MWH for the DCC, most recently in 2015, has revealed no additional movement of the site.

The landslide database identifies this landslide as having a moderate sensitivity to environmental change. As such, it does not meet the criteria outlined in Section 1.1; however, it has been included in this report as it is still monitored for movement by MWH for the DCC.

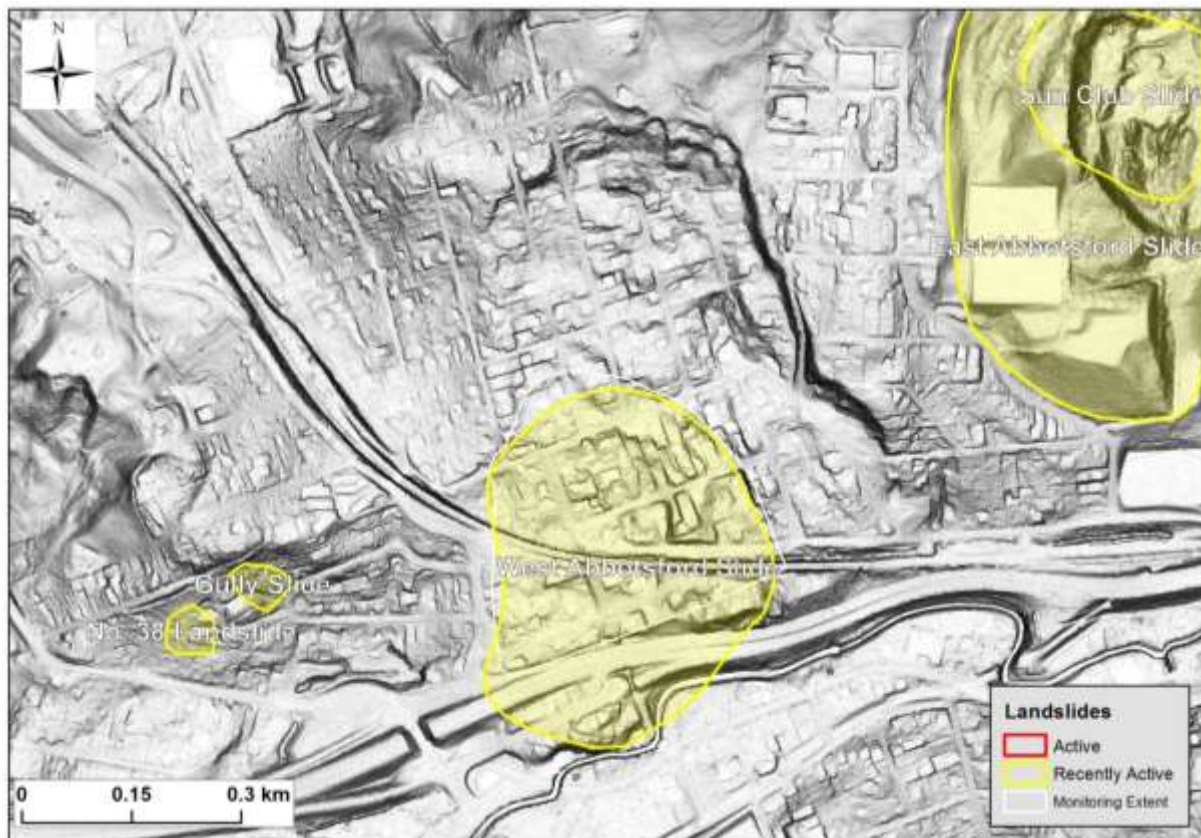
The West Abbotsford Slide is a large deep-seated failure that extends across a large area of residential Abbotsford (Barrell, 1999). The outline of the landslide is clearly visible in LiDAR-derived digital topography (Figure 24). The southwest lower toe area of the larger slide complex (sometimes referred to as the 'motorway slide') is identified as recently active, and is traversed by the main South Island main trunk line and the Southern Motorway.

This slide is reported to have been reactivated during removal of toe support during construction of the motorway, and the last documented movement was in 1968. Sand was placed to re-buttress the toe during road construction, which inadvertently partly contributed to the failure of the East Abbotsford Slide in 1979, as the sand was sourced from the base of the East Abbotsford Slide hillslope (Hancox, 2008).

MWH monitor the slide for the DCC, with most recent monitoring in January 2014, by way of a visual inspection of features (cracks, fissures). Field observations were compared with previous surveys. No new evidence of movement was documented during this 2014 inspection.

Figure 24 Lidar-derived slope map of the West Abbotsford Slide. The scarp of the larger inactive part of the landslide is clearly visible upslope. Mapped inactive slides omitted for clarity.

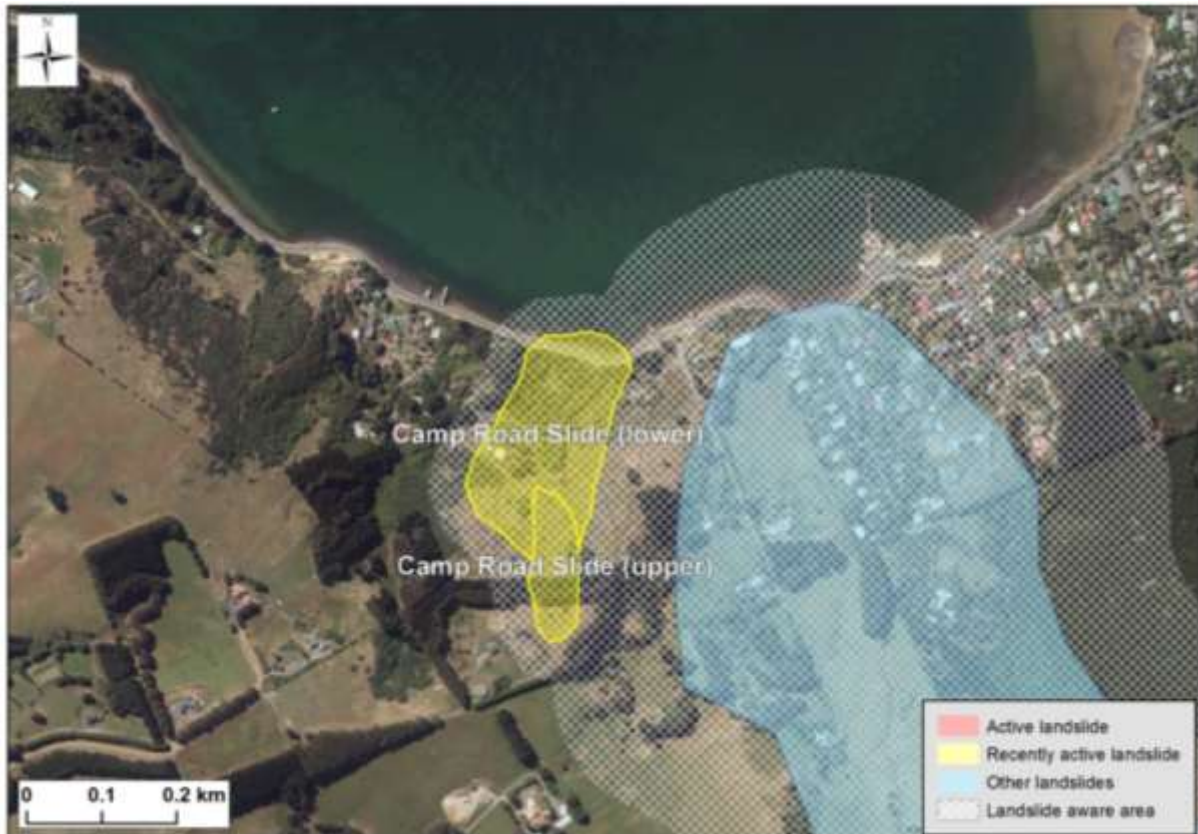
The Camp Road Slide is located on the southern side of Otago Harbour at Broad Bay. The toe of the slide extends across Portobello Road to the shoreline. Several structures are located on the left (western) margin of the lower body of the slide.

Movement was reportedly initiated in 1950, with the last known period of movement in 1986 (Johnson, 1986).

Figure 29 The Camp Road Slide (lower and upper), shaded yellow

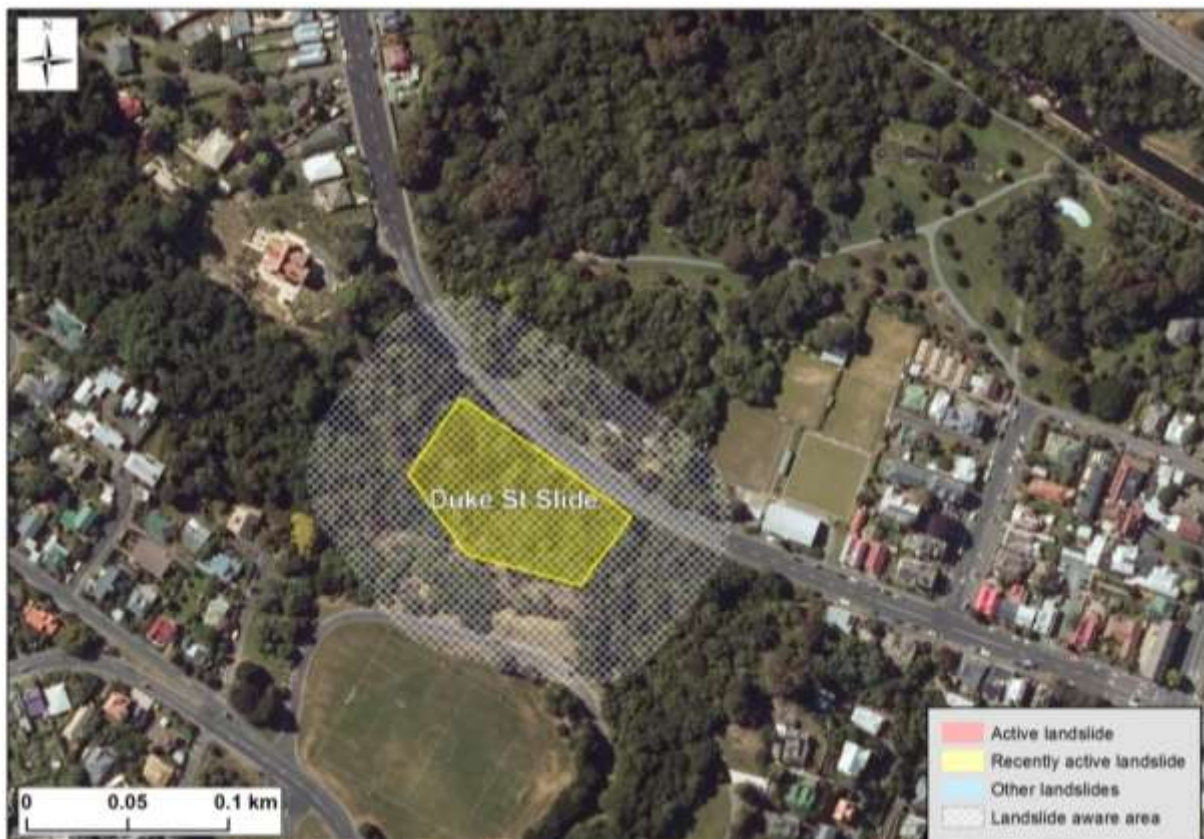
Figure 31 The Duke St Slide

The Duke St Slide is located to the south of Duke and Malvern Streets, at the base of a steep basalt cliff within the Dunedin Volcanic Group. The toe of the slide area abuts alluvial fan deposits of the Leith River. The slide is within the 'Green Belt' and is some distance from any residential dwellings. A foot trail known as the Bullock Track, leading from Stonelaw Terrace to Duke Street cuts across the top of the landslide.

The landslide database indicates that the slide was last active in 1991 (Glassey, 1991). Following a heavy rainfall event on 3 June 2013, landslide activity was observed to the southeast of this mapped feature (Figure 32), suggesting that the wider area is still prone to shallow failure.

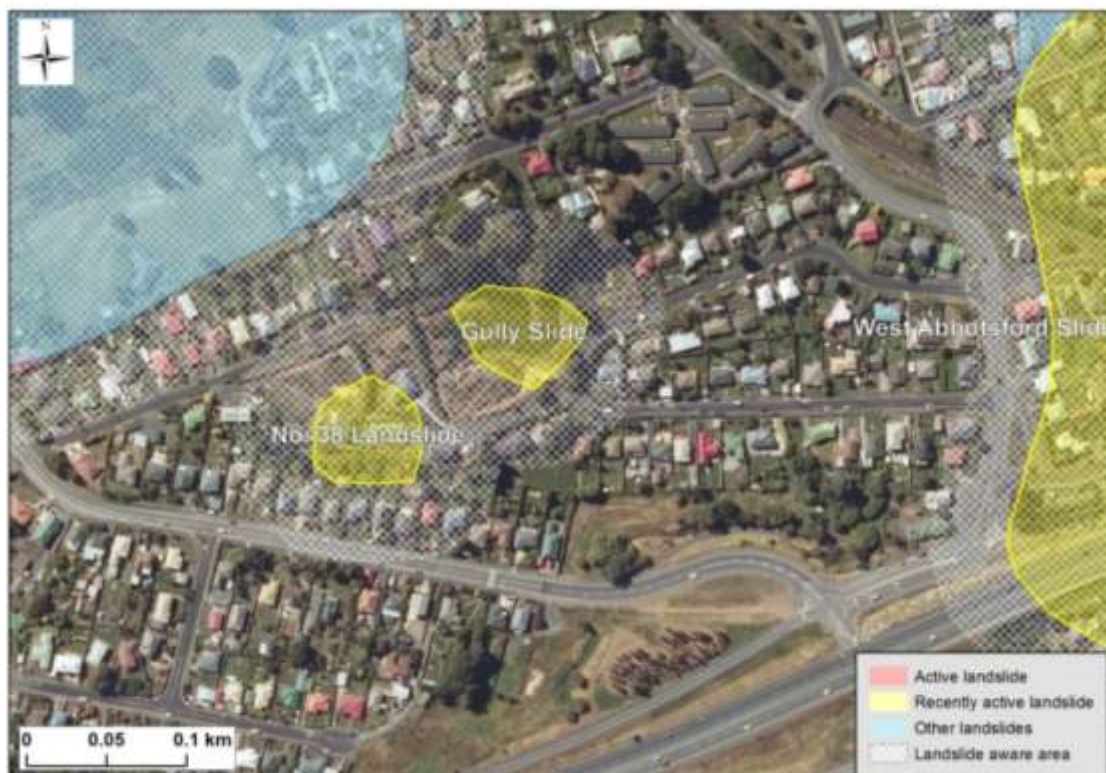
Figure 33 Gully Slide and No. 38 Landslide

The Gully Slide and No. 38 Landslide are located in Waldron Crescent in the Sunnyvale suburb, west of Green Island. Barrell and Glassey (1993) found that the No. 38 Landslide was initiated during excavation of a building platform in 1993. The nearby Gully Slide was identified during assessment of the No. 38 Landslide. Both slides occur in clayey colluvium overlying Abbotsford Formation.

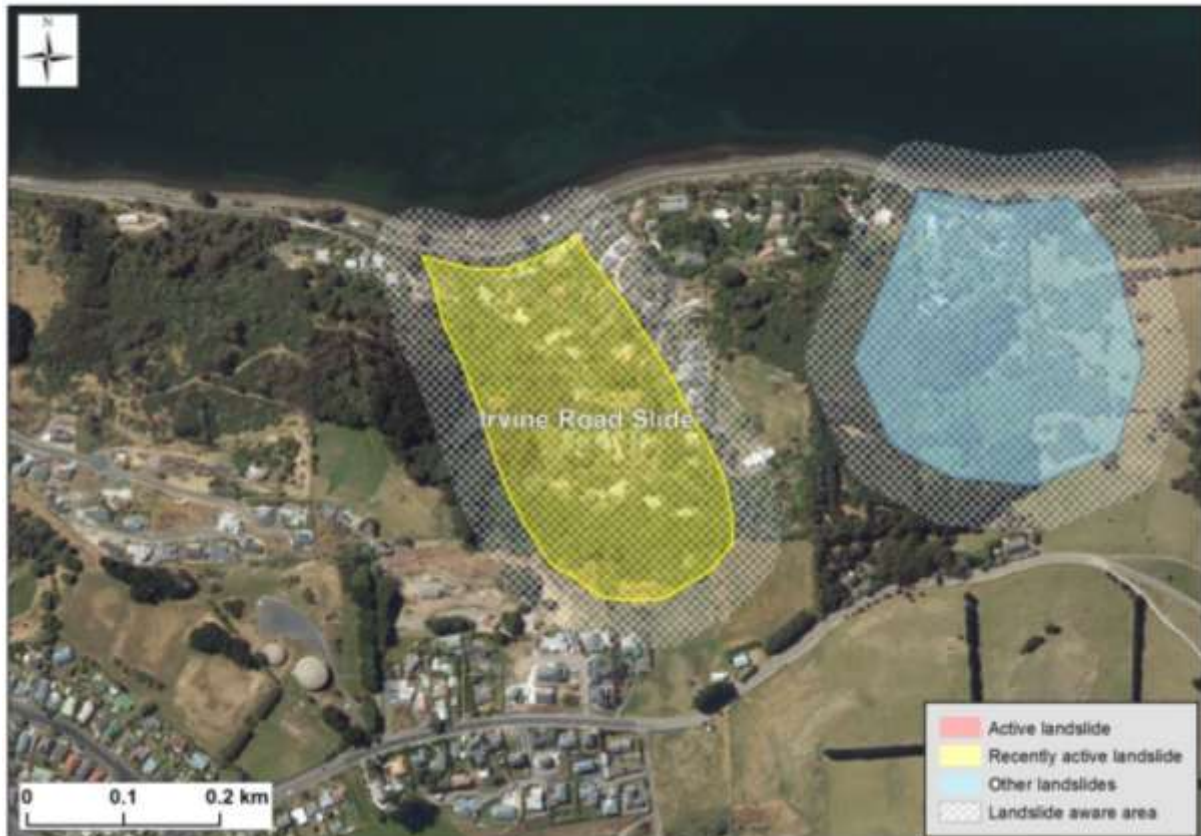
Figure 34 Irvine Road Slide

The Irvine Road landslide is in a topographic hollow on the south side of the Otago Peninsula. It extends from the shore up to the crest of the slope. The last known movement was in 1979 (Turnbull, 1979).

There is extensive urban development across much of the mapped landslide area.

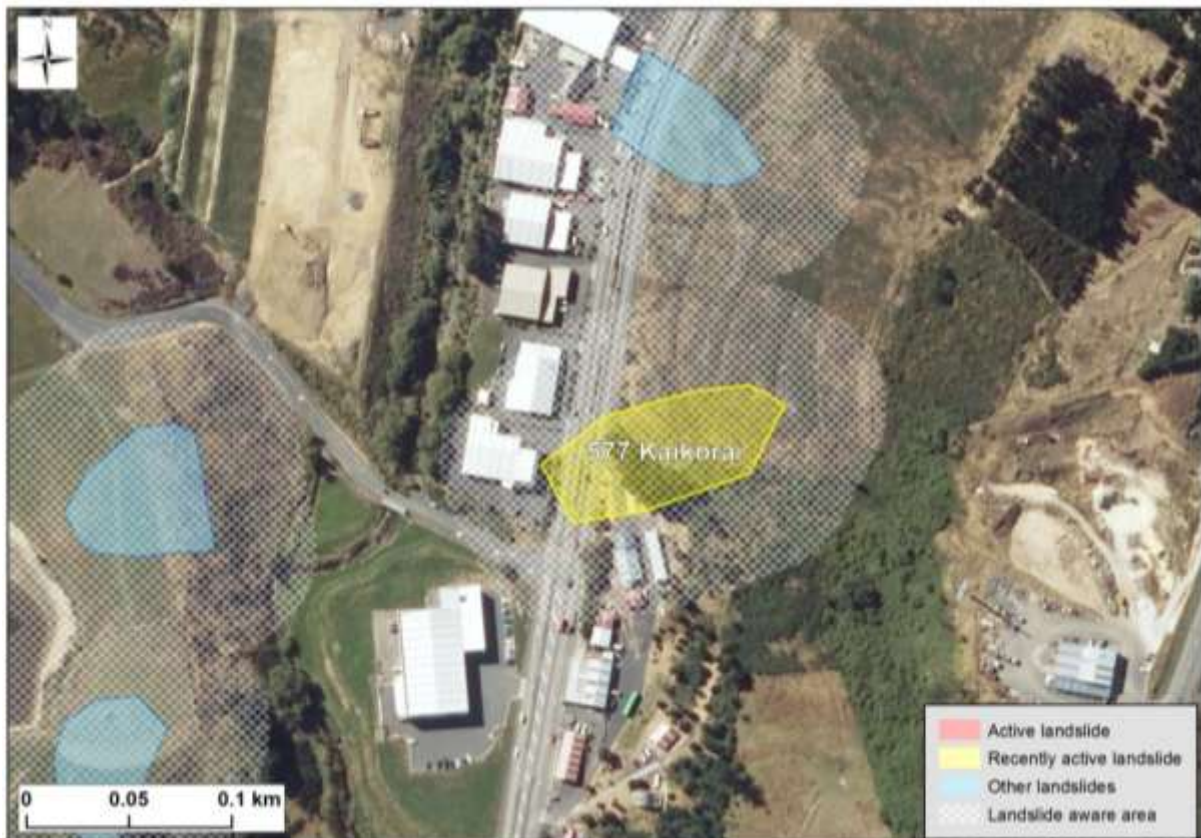
Figure 35 The 577 Kaikorai Valley Road landslide

This landslide is mapped on the west-facing slope of Kaikorai Valley, near the intersection of Kaikorai Valley Road and Townleys Road. The landslide was originally mapped by McKellar (1990), and the last known movement was 1980 (landslide database).

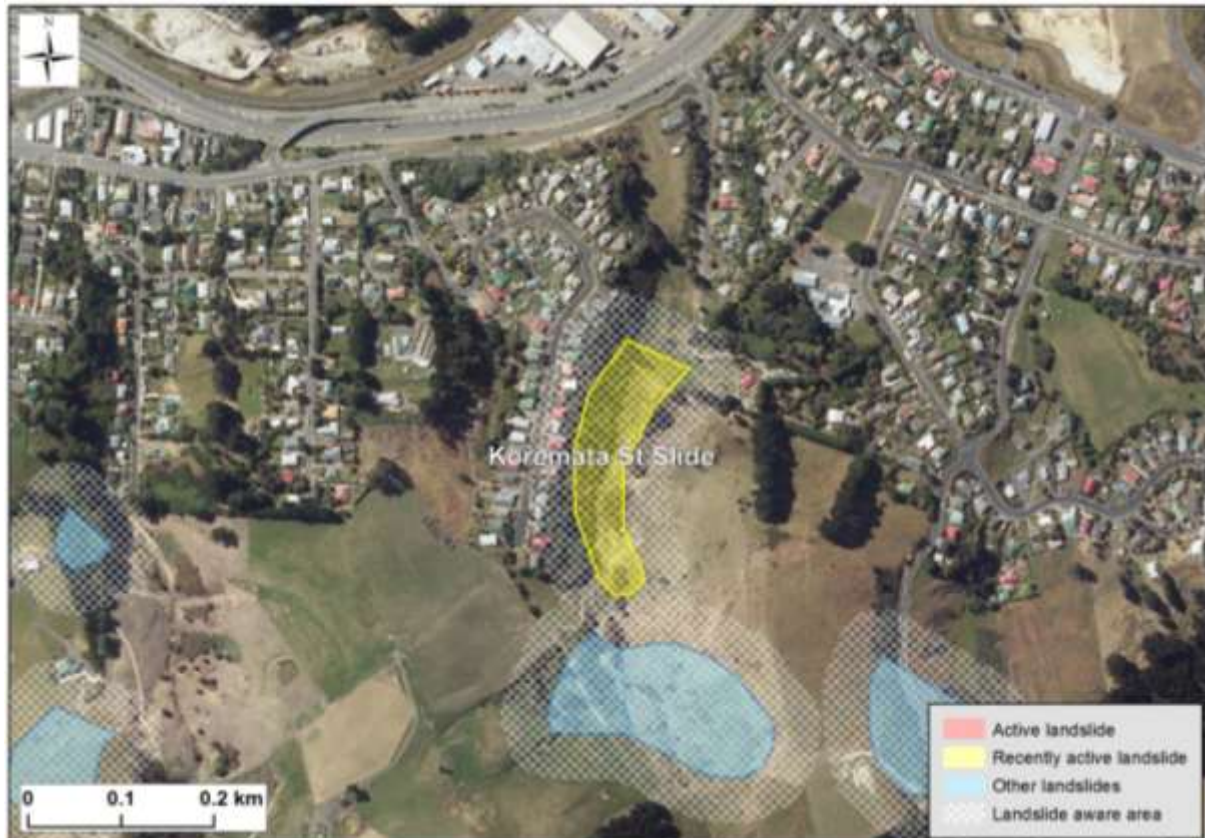
Figure 37 The Koremata St Slide

The Koremata Street landslide in Green Island (Brickell Moss & Partners, 1981) was last reported active in 1980 (landslide database). It is on the eastern side of a small gully backing onto Koremata St, and appears to involve a section of slope having collapsed into the gully. There is evidence for pre-historic, deep-seated landsliding to the east of the mapped area.

The DCC does not currently monitor the landslide for movement, and no residential dwellings appear to be directly affected by the extent of the mapped movement as the land is currently undeveloped.

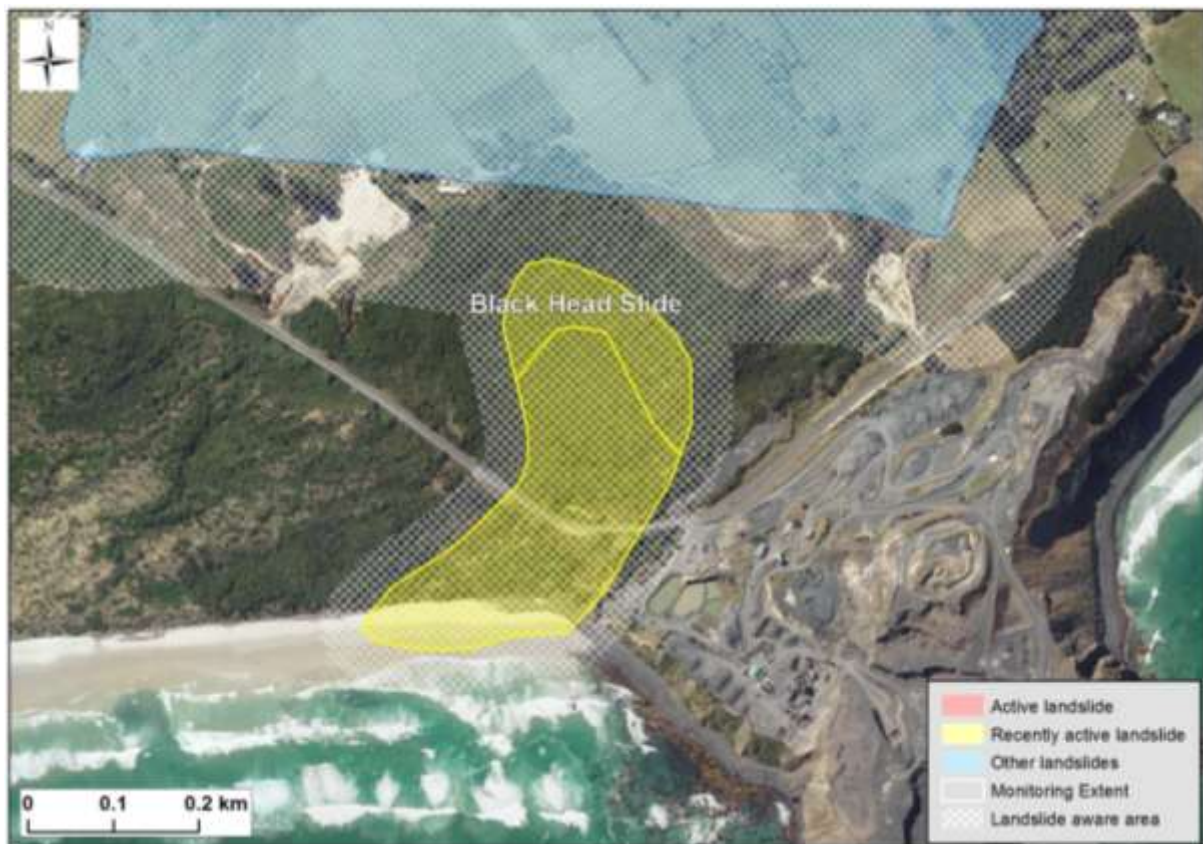
Figure 38 Black Head Slide

The Black Head Slide was depicted from aerial photo mapping in a 2001 compilation (Glassey, 2001). Although the terrain is largely obscured by sand dunes, the landslide became evident in the mid-1990s when slow earthflow movement displaced and deformed the Blackhead Road carriageway. A deep excavation was made, and the road was repaired, with little noticeable movement since. At the time, an exposure at the back of the active beach showed plastic greensand at the foot of the slide area, and it is likely that the movement was at least in part seated on Concord Greensand (D. Barrell, pers. comm., July 2015).

The mapped extent of the slide cuts across Blackhead Road, but is not in the vicinity of any dwellings.
