TOP TIPPERARY TAILINGS STORAGE FACILITY

Preliminary Geotechnical Assessment

Report Number. 1078301051.002-R200A

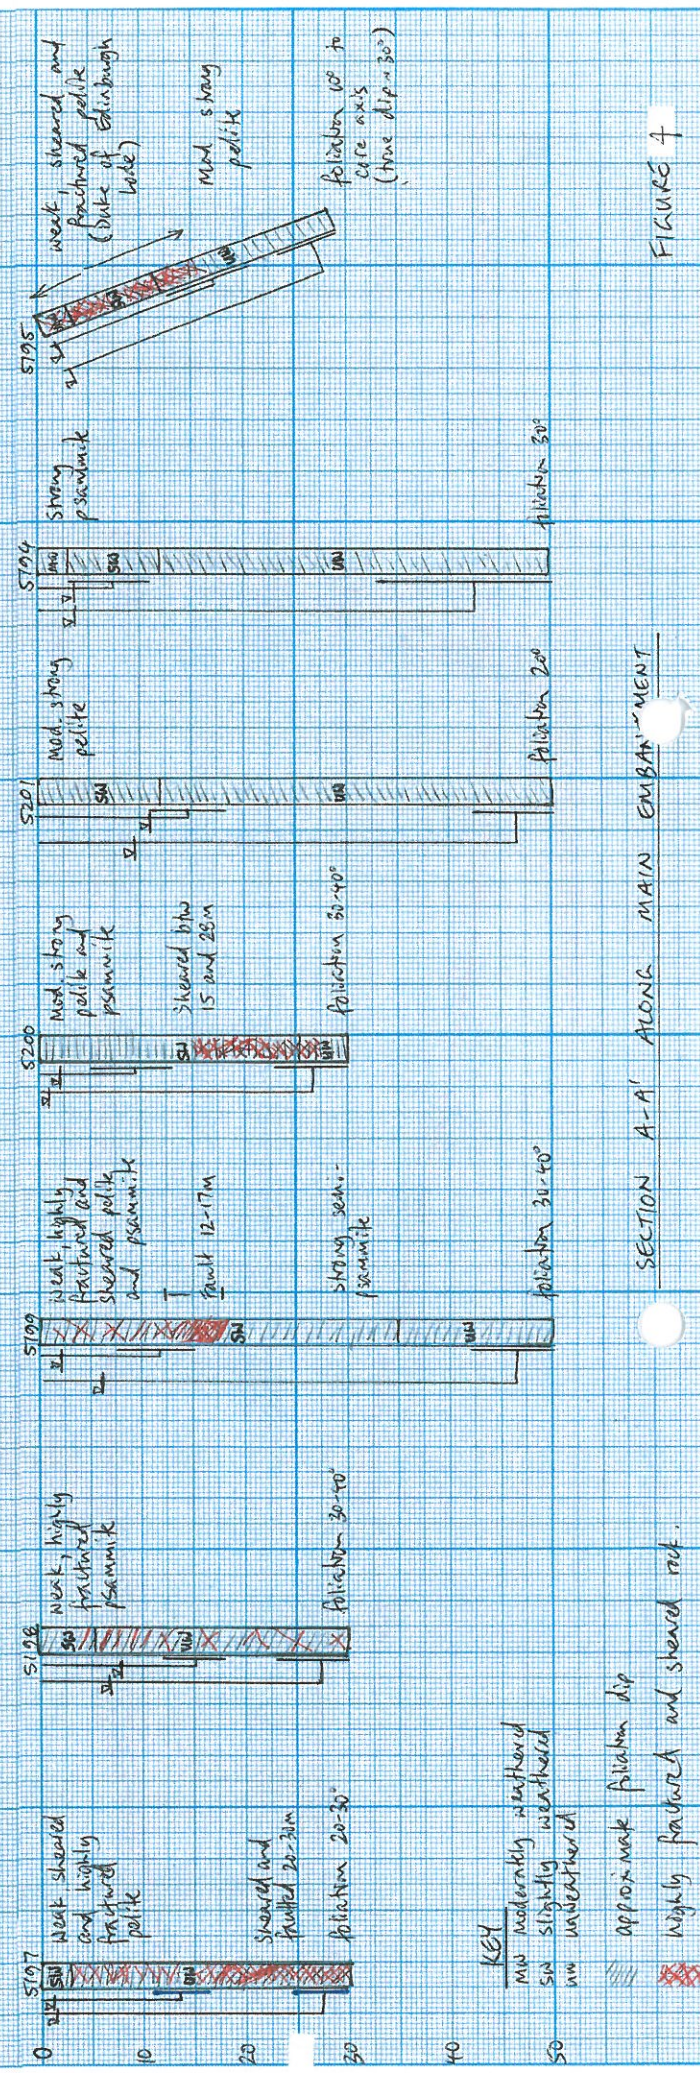
FIGURE 4

SECTION A-A' ALONG MAIN EMBANKMENT

The soils are directly underlain by schist comprising well foliated, fine grained pelite to coarser grained psammite. North and south of the impoundment, foliation typically dips at 20° - 40° towards the east, which is consistent with the regional foliation pattern (Figure 3). Foliation locally dips towards the southeast as a result of drag folding adjacent to the Macraes Fault. Figure 4 and Figure 5 summarise the geology of the main embankment in cross sections.

The weathering profile encountered by the drill holes is summarised in Table 1. The weathering intensity described in Table 1 and shown graphically in Figure 4, has been interpreted by Golder based on the descriptions on the logs, inspection of the core photographs and observations of the core. The weathering terms used in Table 1 follow the commonly used classification system in New Zealand (NZGS 2005).

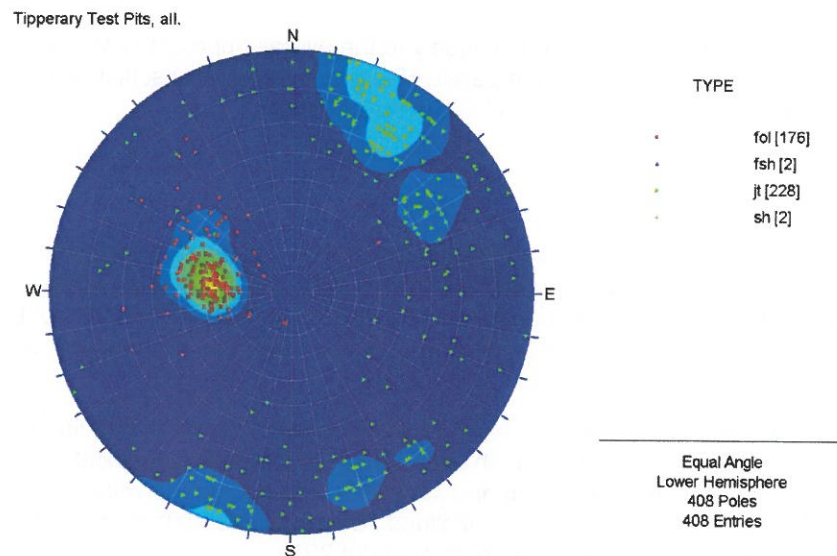
Figure 6: Stereographic projection of all discontinuity data collected from embankment footprint.

Joint orientations have been measured from outcrops and excavations. The most common joint orientations measured in the impoundment are steeply dipping ($>70^\circ$) with a dip direction to the south or southwest. Other joints typically dip steeply to the west or northwest. Figure 6 presents all discontinuity data (foliation and joints) collected from test pits and trenches from the embankment footprint. Discontinuity data from individual test pits and trenches is presented in Appendix C.

Foliation typically dips at about 40° to the east in the vicinity of the proposed impoundment, which is consistent with the regional trend. Figure 6 shows that the greatest concentration of foliation measurements (red symbols) dip towards about 100° , however, a significant number of measurements indicate foliation dipping to the southeast. This is consistent with the folding within the deformation zone of the Macraes Fault. Figure 3 shows the distribution of foliation attitudes around the reservoir in plan view.
