**OCEANA GOLD (NZ) LTD, MACRAES GOLD
PROJECT
CAMP CREEK DAM
DAM BREACH REPORT**

**OCEANA GOLD (NZ) LTD, MACRAES GOLD PROJECT
CAMP CREEK DAM
DAM BREACH REPORT**

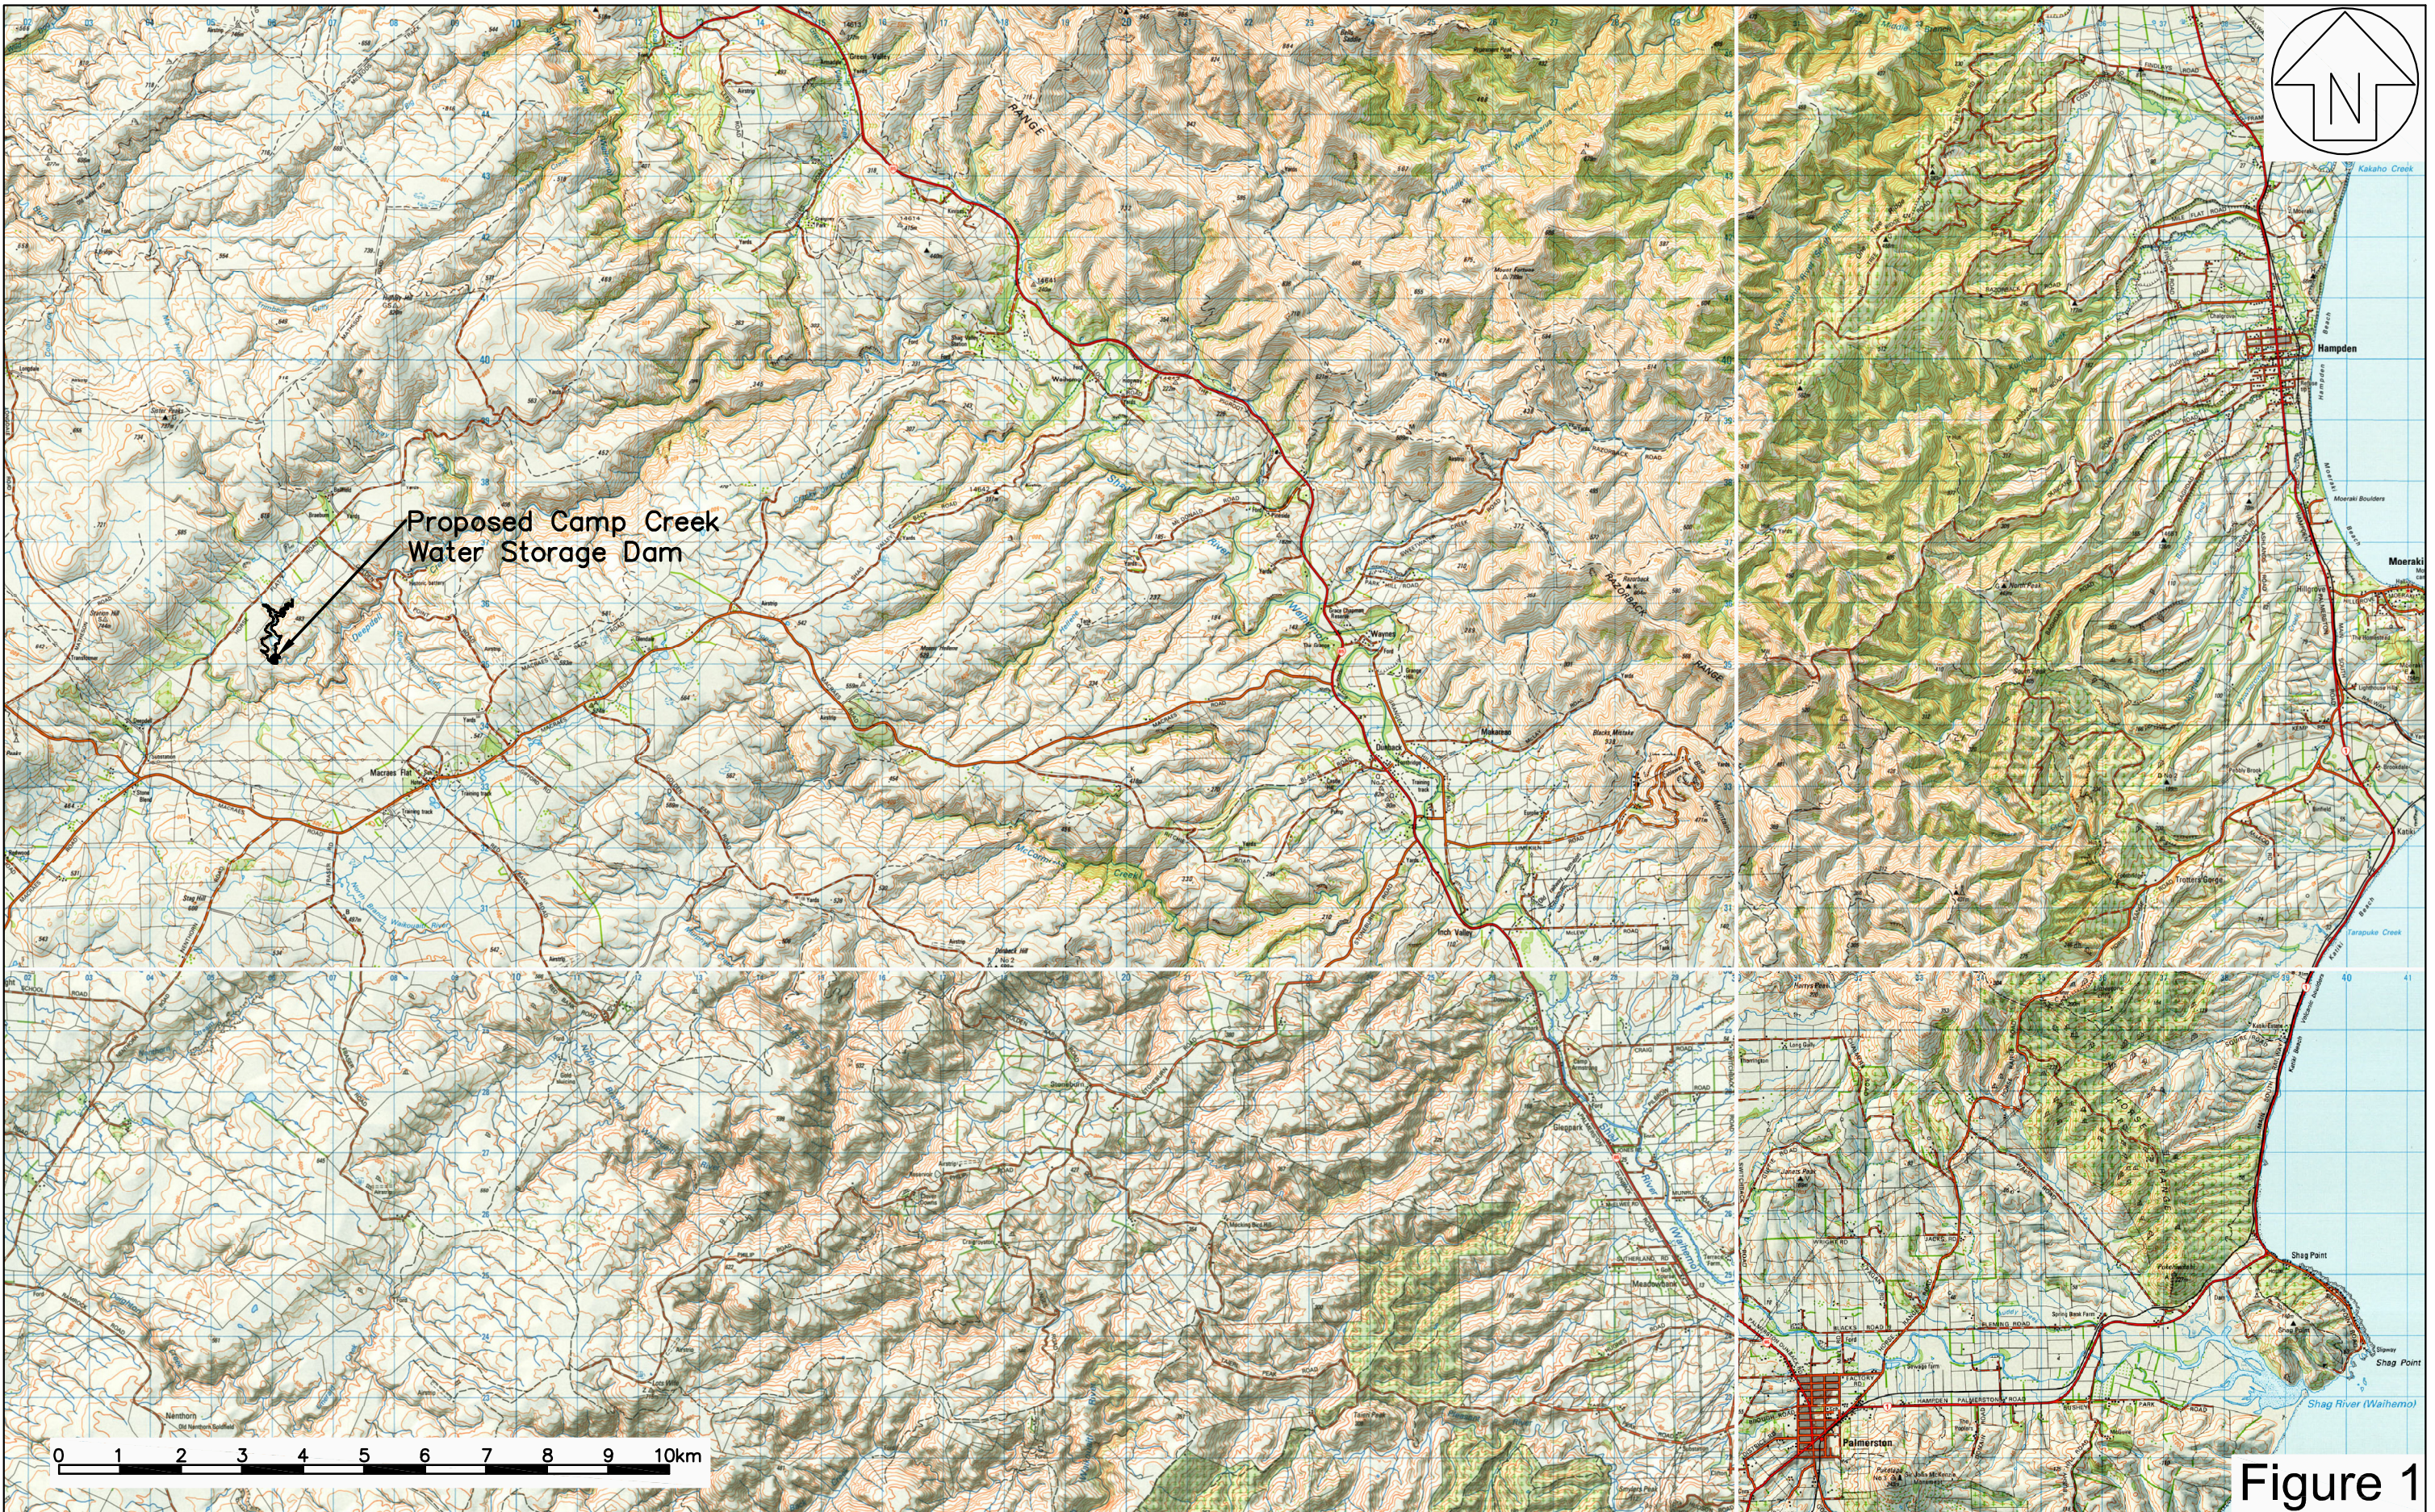
Drawing No. 6914-Figure 1
 Date: 22 Mar 2011
 Drawn: BL
 Scale: 1:100000 (@A3)
 Filename: 6914-Figure 1.dwg

OCEANA GOLD (NZ) LTD, MACRAES GOLD PROJECT
Camp Creek Water Storage Dam Breach Study
Locality Plan

The location of the proposed Camp Creek Dam is shown in Figure 1. A larger scale plan of the dam is shown in Figure 2. It is located on the lower part of Camp Creek. Camp Creek flows in a southern direction and joins Deepdell Creek about 1.7km from the proposed dam. Deepdell Creek flows in a north eastern direction and joins the Shag River about 14.7km (distance measured along the gully) from the Camp Creek – Deepdell Creek confluence. It is noted that the plan grid on Figure 1 is New Zealand Map and the grid on Figure 2 is based on mine north which is approximately 45 degrees anti-clockwise from true north.
