#### **REVIEW OF KAIKORAI ESTUARY INVESTIGATION**

You have asked us to independently review the compliance investigation conducted by the Otago Regional Council (ORC) into a fish kill incident at the Kaikorai Estuary (Estuary) on 20 February 2021, particularly as to whether ORC's conduct in opening the Estuary tidal inlet (Tidal Inlet) was permitted by the Regional Plan: Coast for Otago (Coastal Plan), or may have constituted an offence against the Resource Management Act 1991 (RMA).

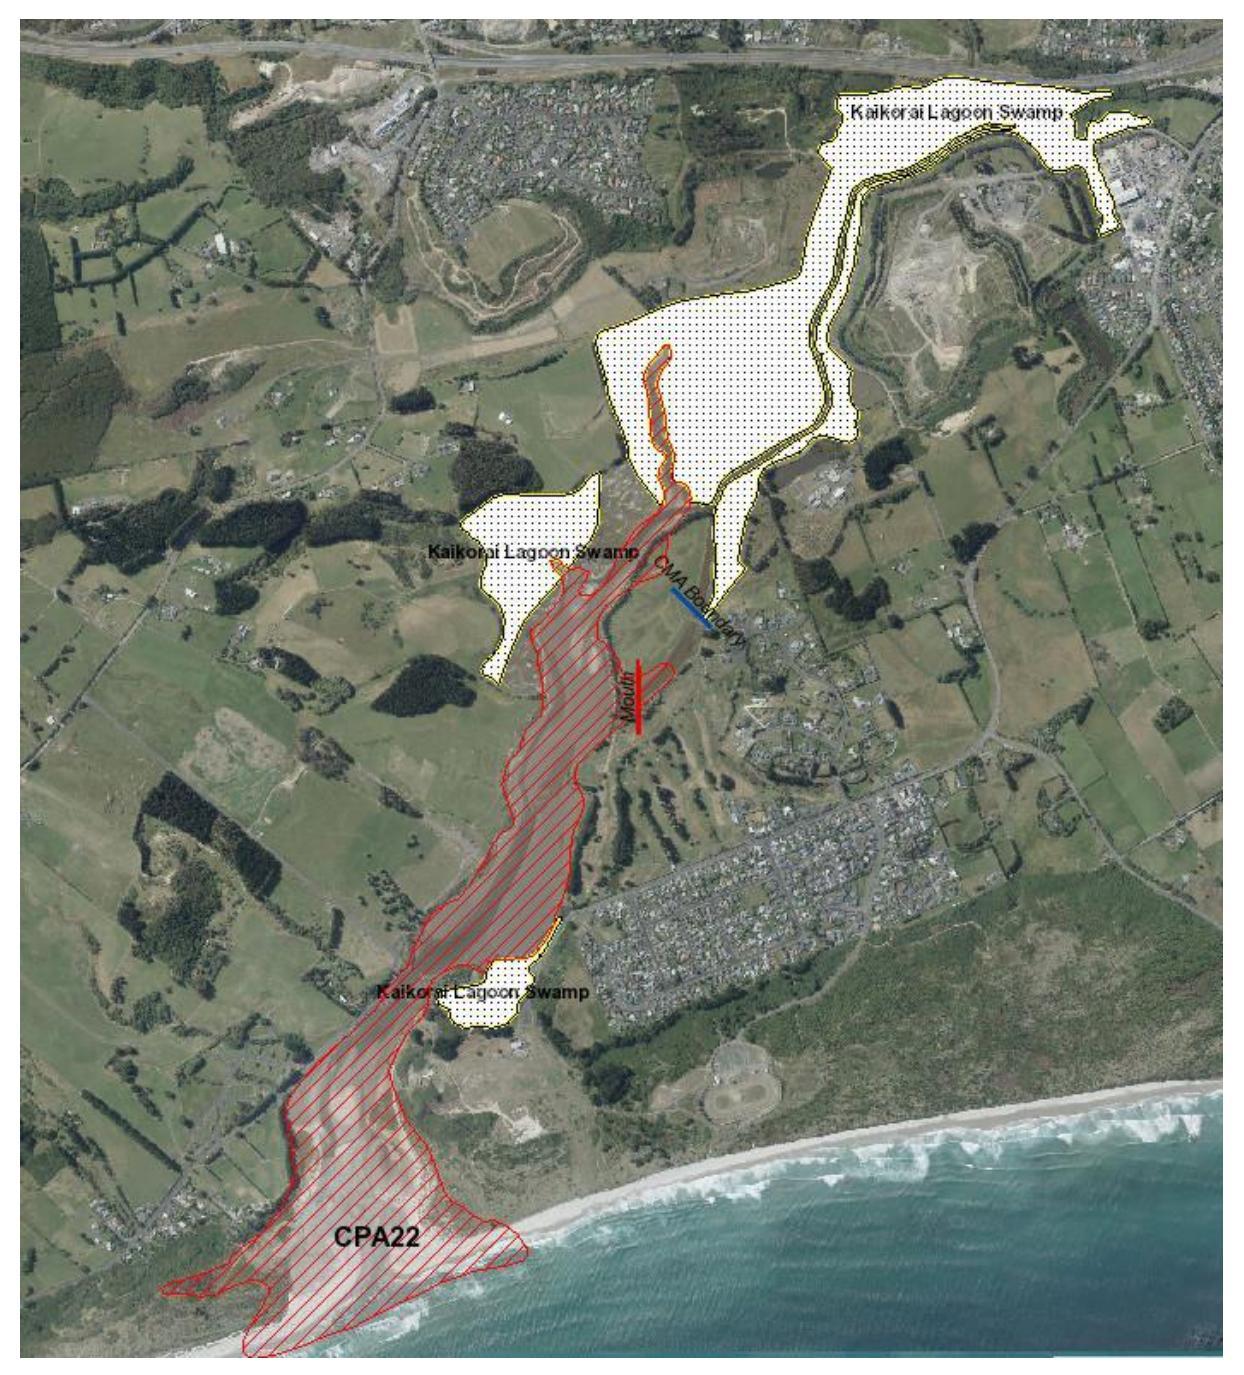
#### **ANNEXURE 1**

- 23. The mouth and the CMA boundary are identified in Schedule 1 of the Coastal Plan, which is consistent with a GIS diagram of the Estuary provided to us by ORC. The diagram identifies the Kaikorai Lagoon Swamp, the Kaikorai Creek Swamp, the river mouth and the CMA boundary. A copy of the GIS diagram is annexed as **Annexure 1**.

### GIS Diagram of Kaikorai Estuary, Lagoon and Stream

- 28. Having regard to the CMA illustrated in Annexure 1, the works carried out by ORC's engineering team and its contractor occurred within the CMA, which means that s 12 of the RMA applies. While the exact nature of the work carried out to open the Tidal Inlet is unclear,<sup>6</sup> we consider that excavating a channel in a sand bar within the CMA is likely to fall within at least one of the sub-sections of s 12 of the RMA outlined above at paragraph 30. Accordingly, for ORC's actions to have been lawful, they must have been expressly allowed by, relevantly, a rule in the Coastal Plan.
