DWG REF
 FLOOD-5665-7

DRAWING TITLE
**MACRAES
 GOLD
 PROJECT**

TOP TIPPERARY TAILINGS
 STORAGE FACILITY
 INUNDATION MAP
 FOR BREACH ASSOCIATED
 WITH 1 in 100 AEP FLOOD EVENT

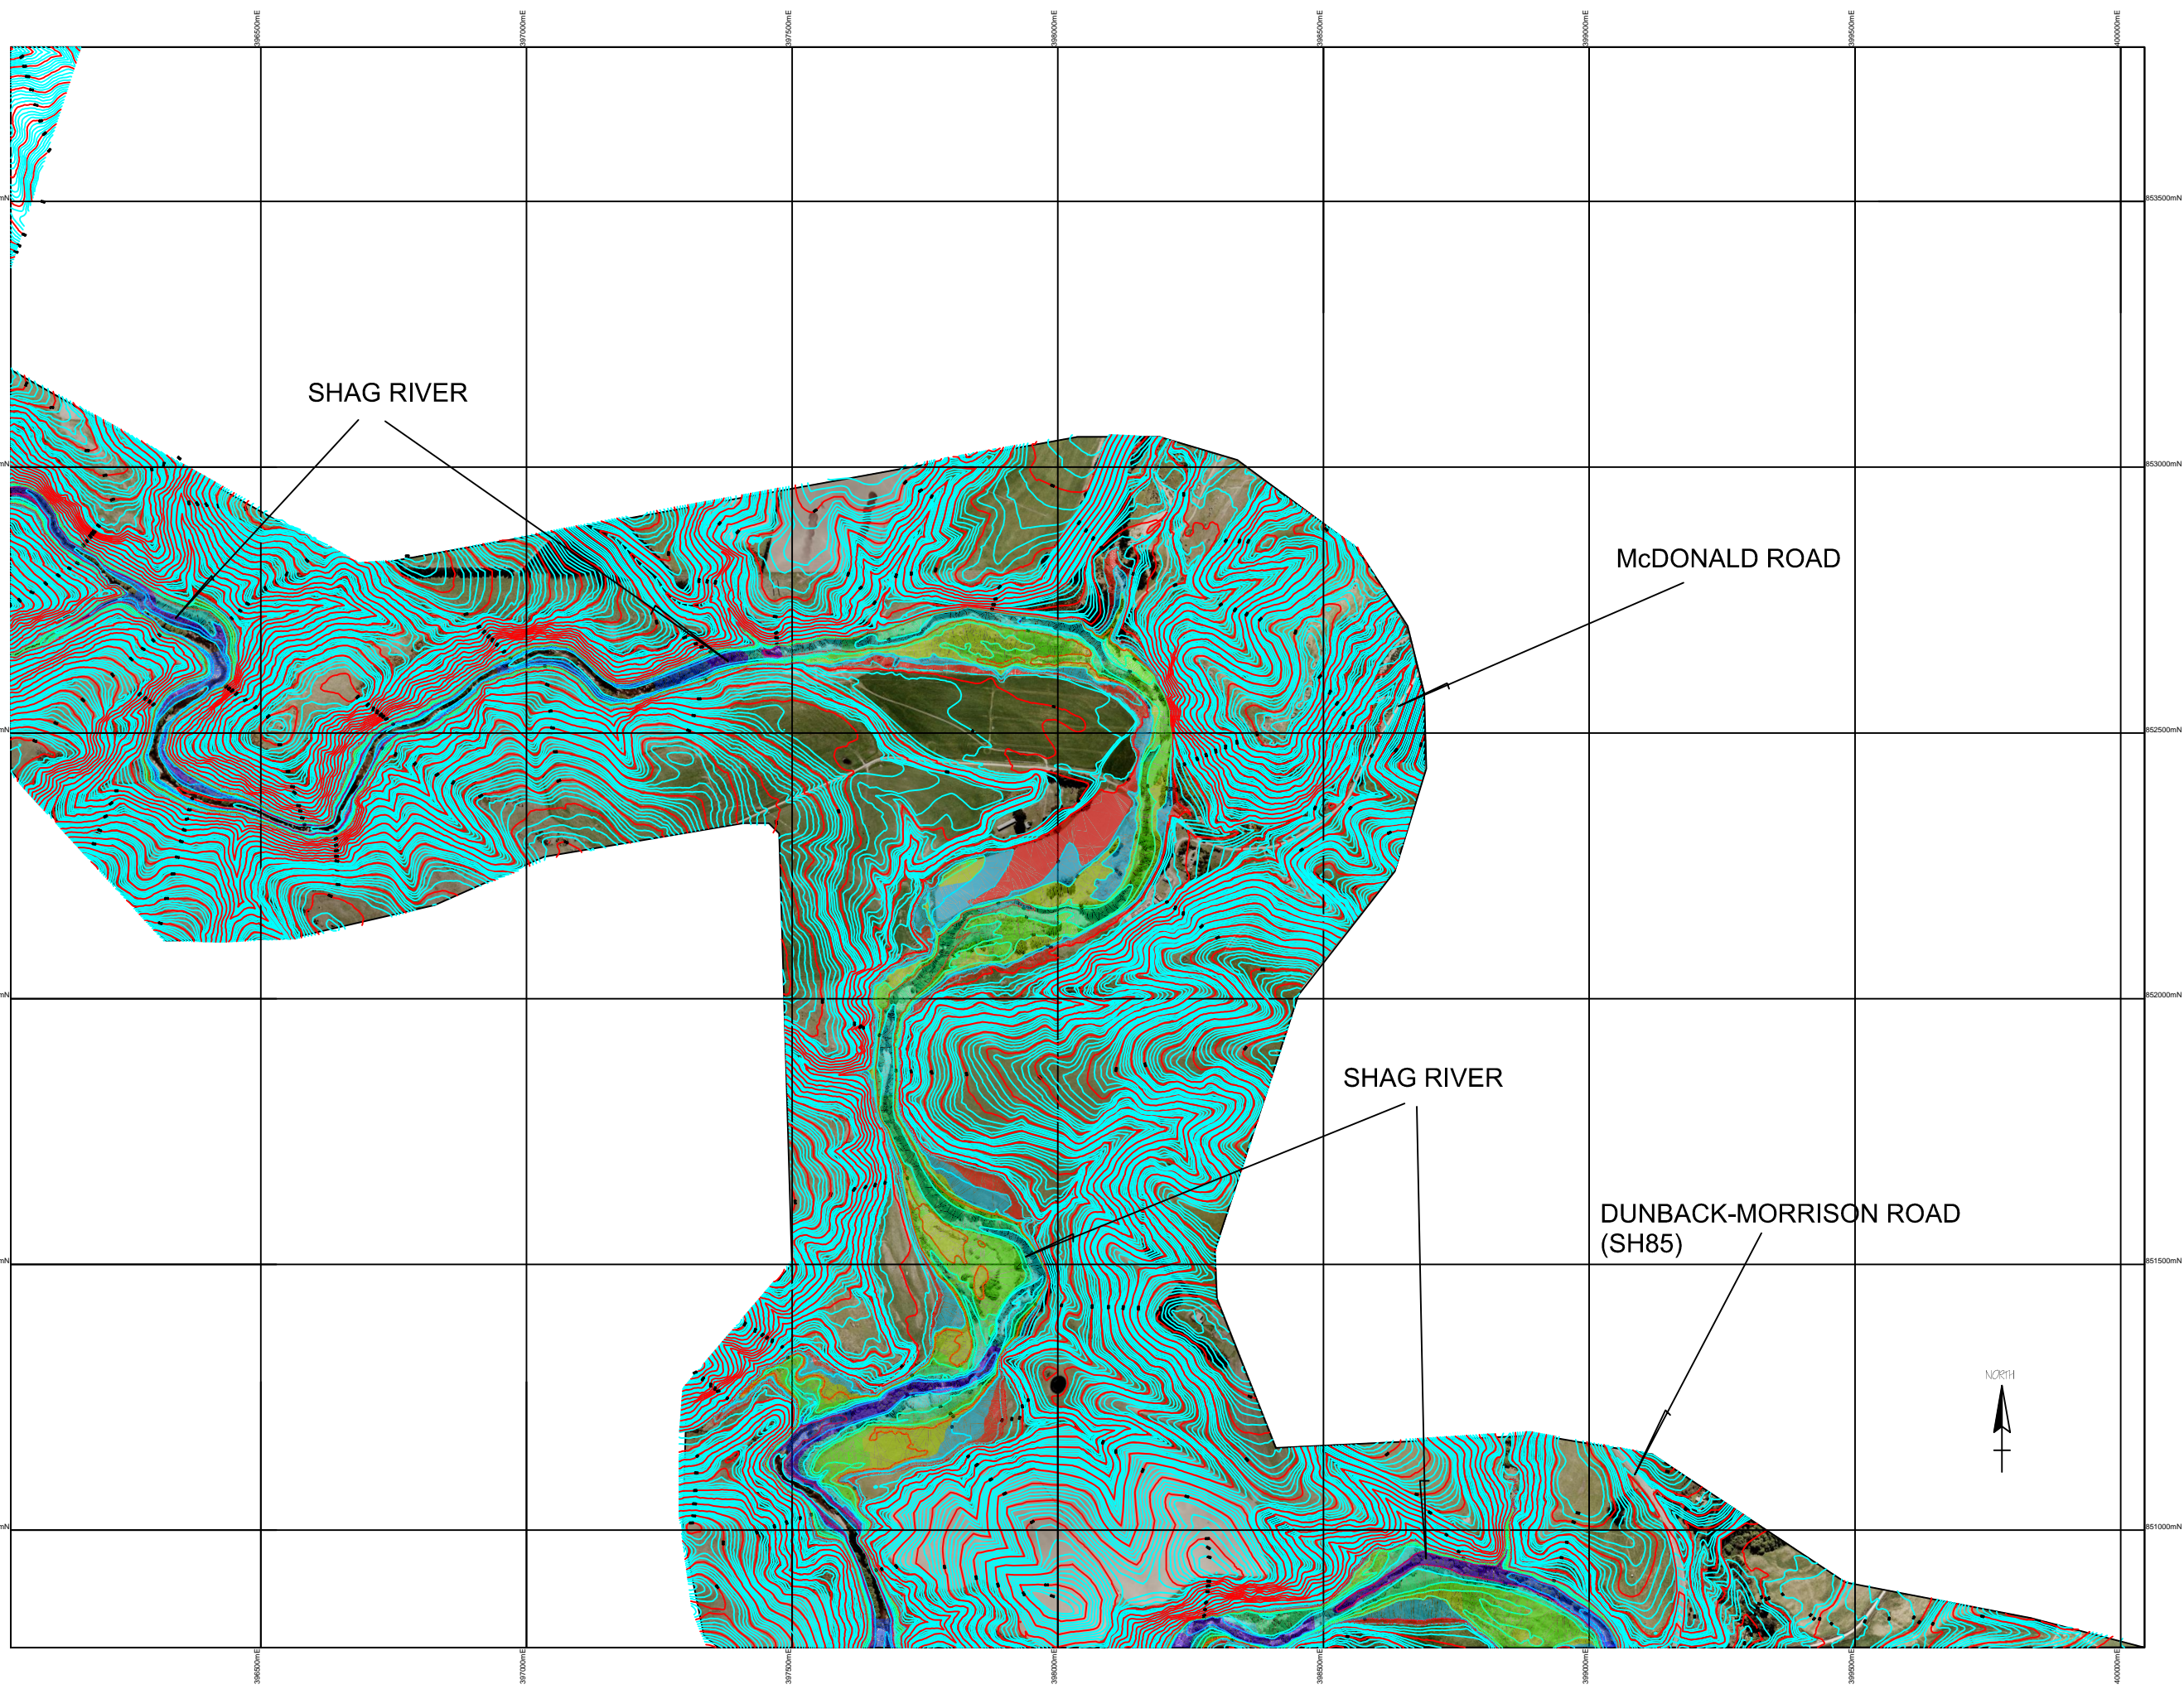
Photogrammetry by: PRECISION AERIAL SURVEYS
 Photography Date: 13th OCTOBER 2010
 Negatives Used: N13101936 - N13102167
 Photo control by: PRECISION AERIAL SURVEYS
 Co-Ordinate Circuit: OBSERVATION POINT 2000
 Datum: MACRAES MINE
 Contour Interval: 1M

DEPTH OF INUNDATION (m)			
Number	Minimum Depth	Maximum Depth	Color
1	0.00	1.00	Red
2	1.00	2.00	Orange
3	2.00	3.00	Yellow
4	3.00	4.00	Light Green
5	4.00	5.00	Green
6	5.00	6.00	Dark Green
7	6.00	7.00	Blue
8	7.00	8.00	Dark Blue
