DWG REF: FLOOD-5665-7-CAMP

DRAWING TITLE: **MACRAES GOLD PROJECT**

CAMP CREEK DAM INUNDATION MAP FOR BREACH ASSOCIATED WITH 1 in 100 AEP FLOOD EVENT

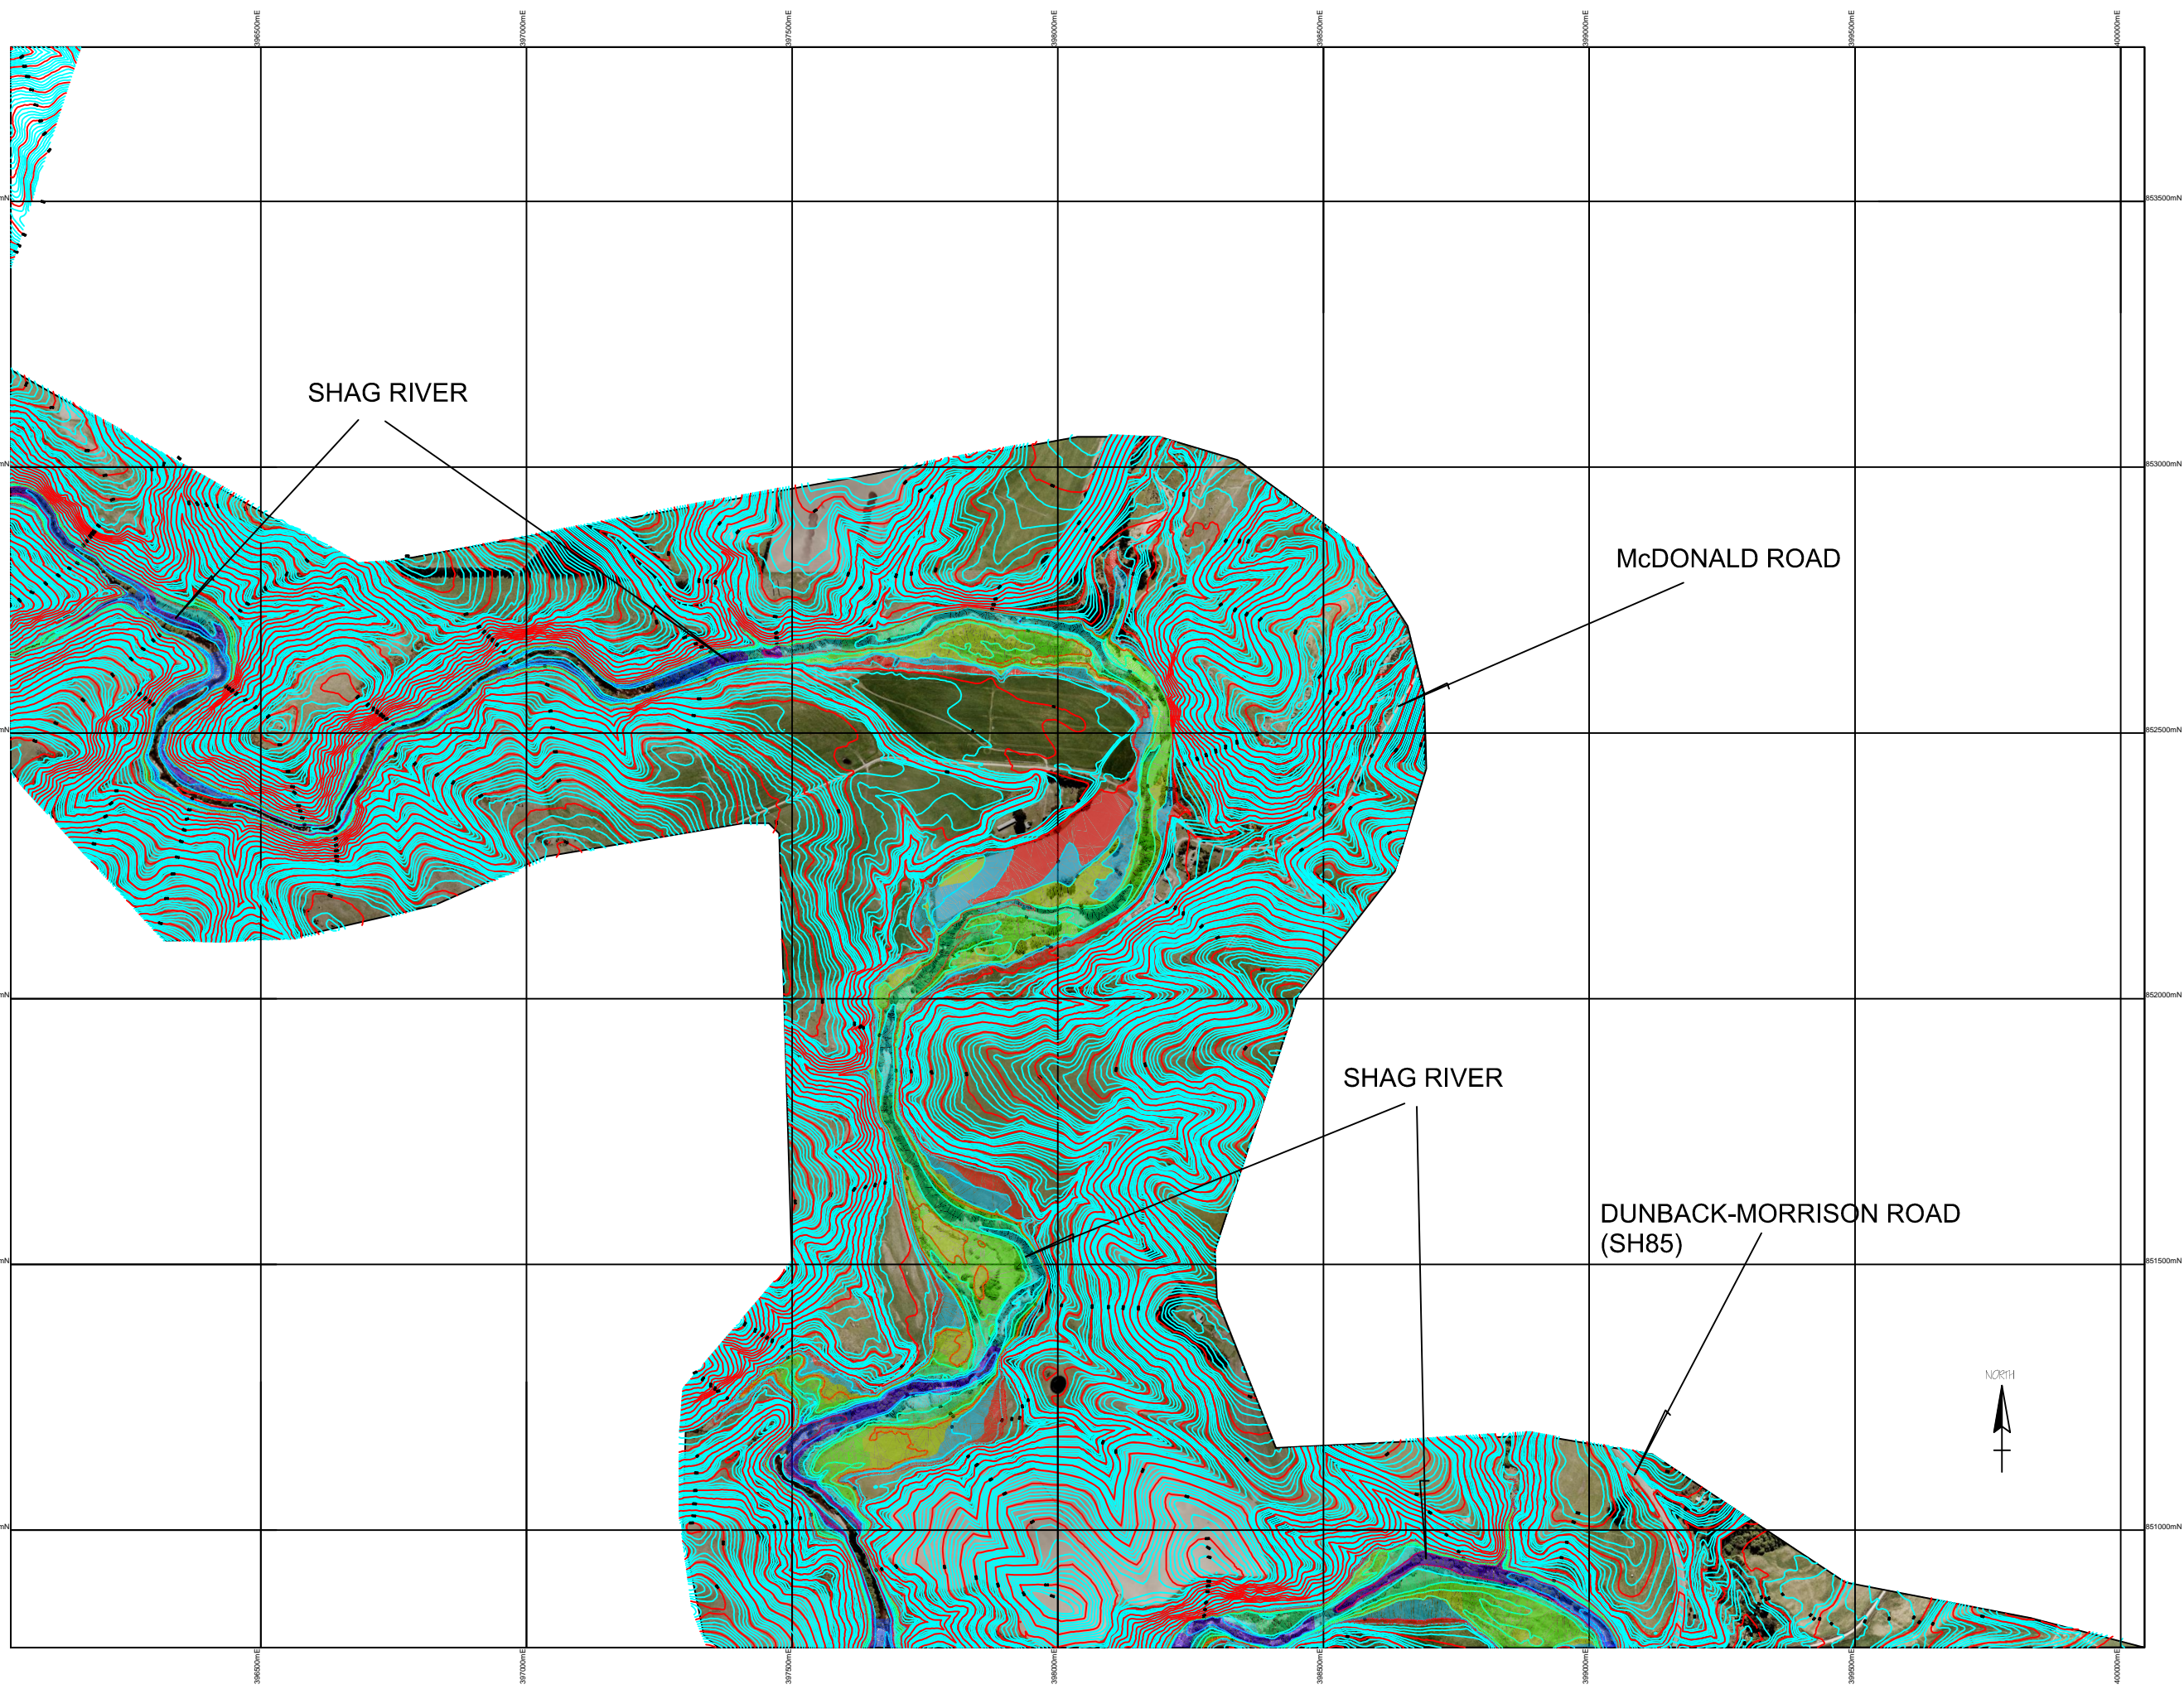
DEPTH OF INUNDATION (m)			
Number	Minimum Depth	Maximum Depth	Color
1	0.00	1.00	Red
2	1.00	2.00	Orange
3	2.00	3.00	Yellow
4	3.00	4.00	Light Green
5	4.00	5.00	Green
6	5.00	6.00	Dark Green
7	6.00	7.00	Blue
8	7.00	8.00	Dark Blue
