OCEANAMA GOLD PROJECT  
 MACRAES GOLD PROJECT

CAMP CREEK DAM  
 INUNDATION MAP  
 FOR BREACH ASSOCIATED  
 WITH 1 in 100 AEP FLOOD EVENT

PREPARED BY:  
 ENGINEERING GEOLOGY LTD  
 Unit 2C, 331 Rossdale Rd, PO Box 301094, Albany, NZ  
 Ph: +64-9-48825246, Fax: +64-9-48825256

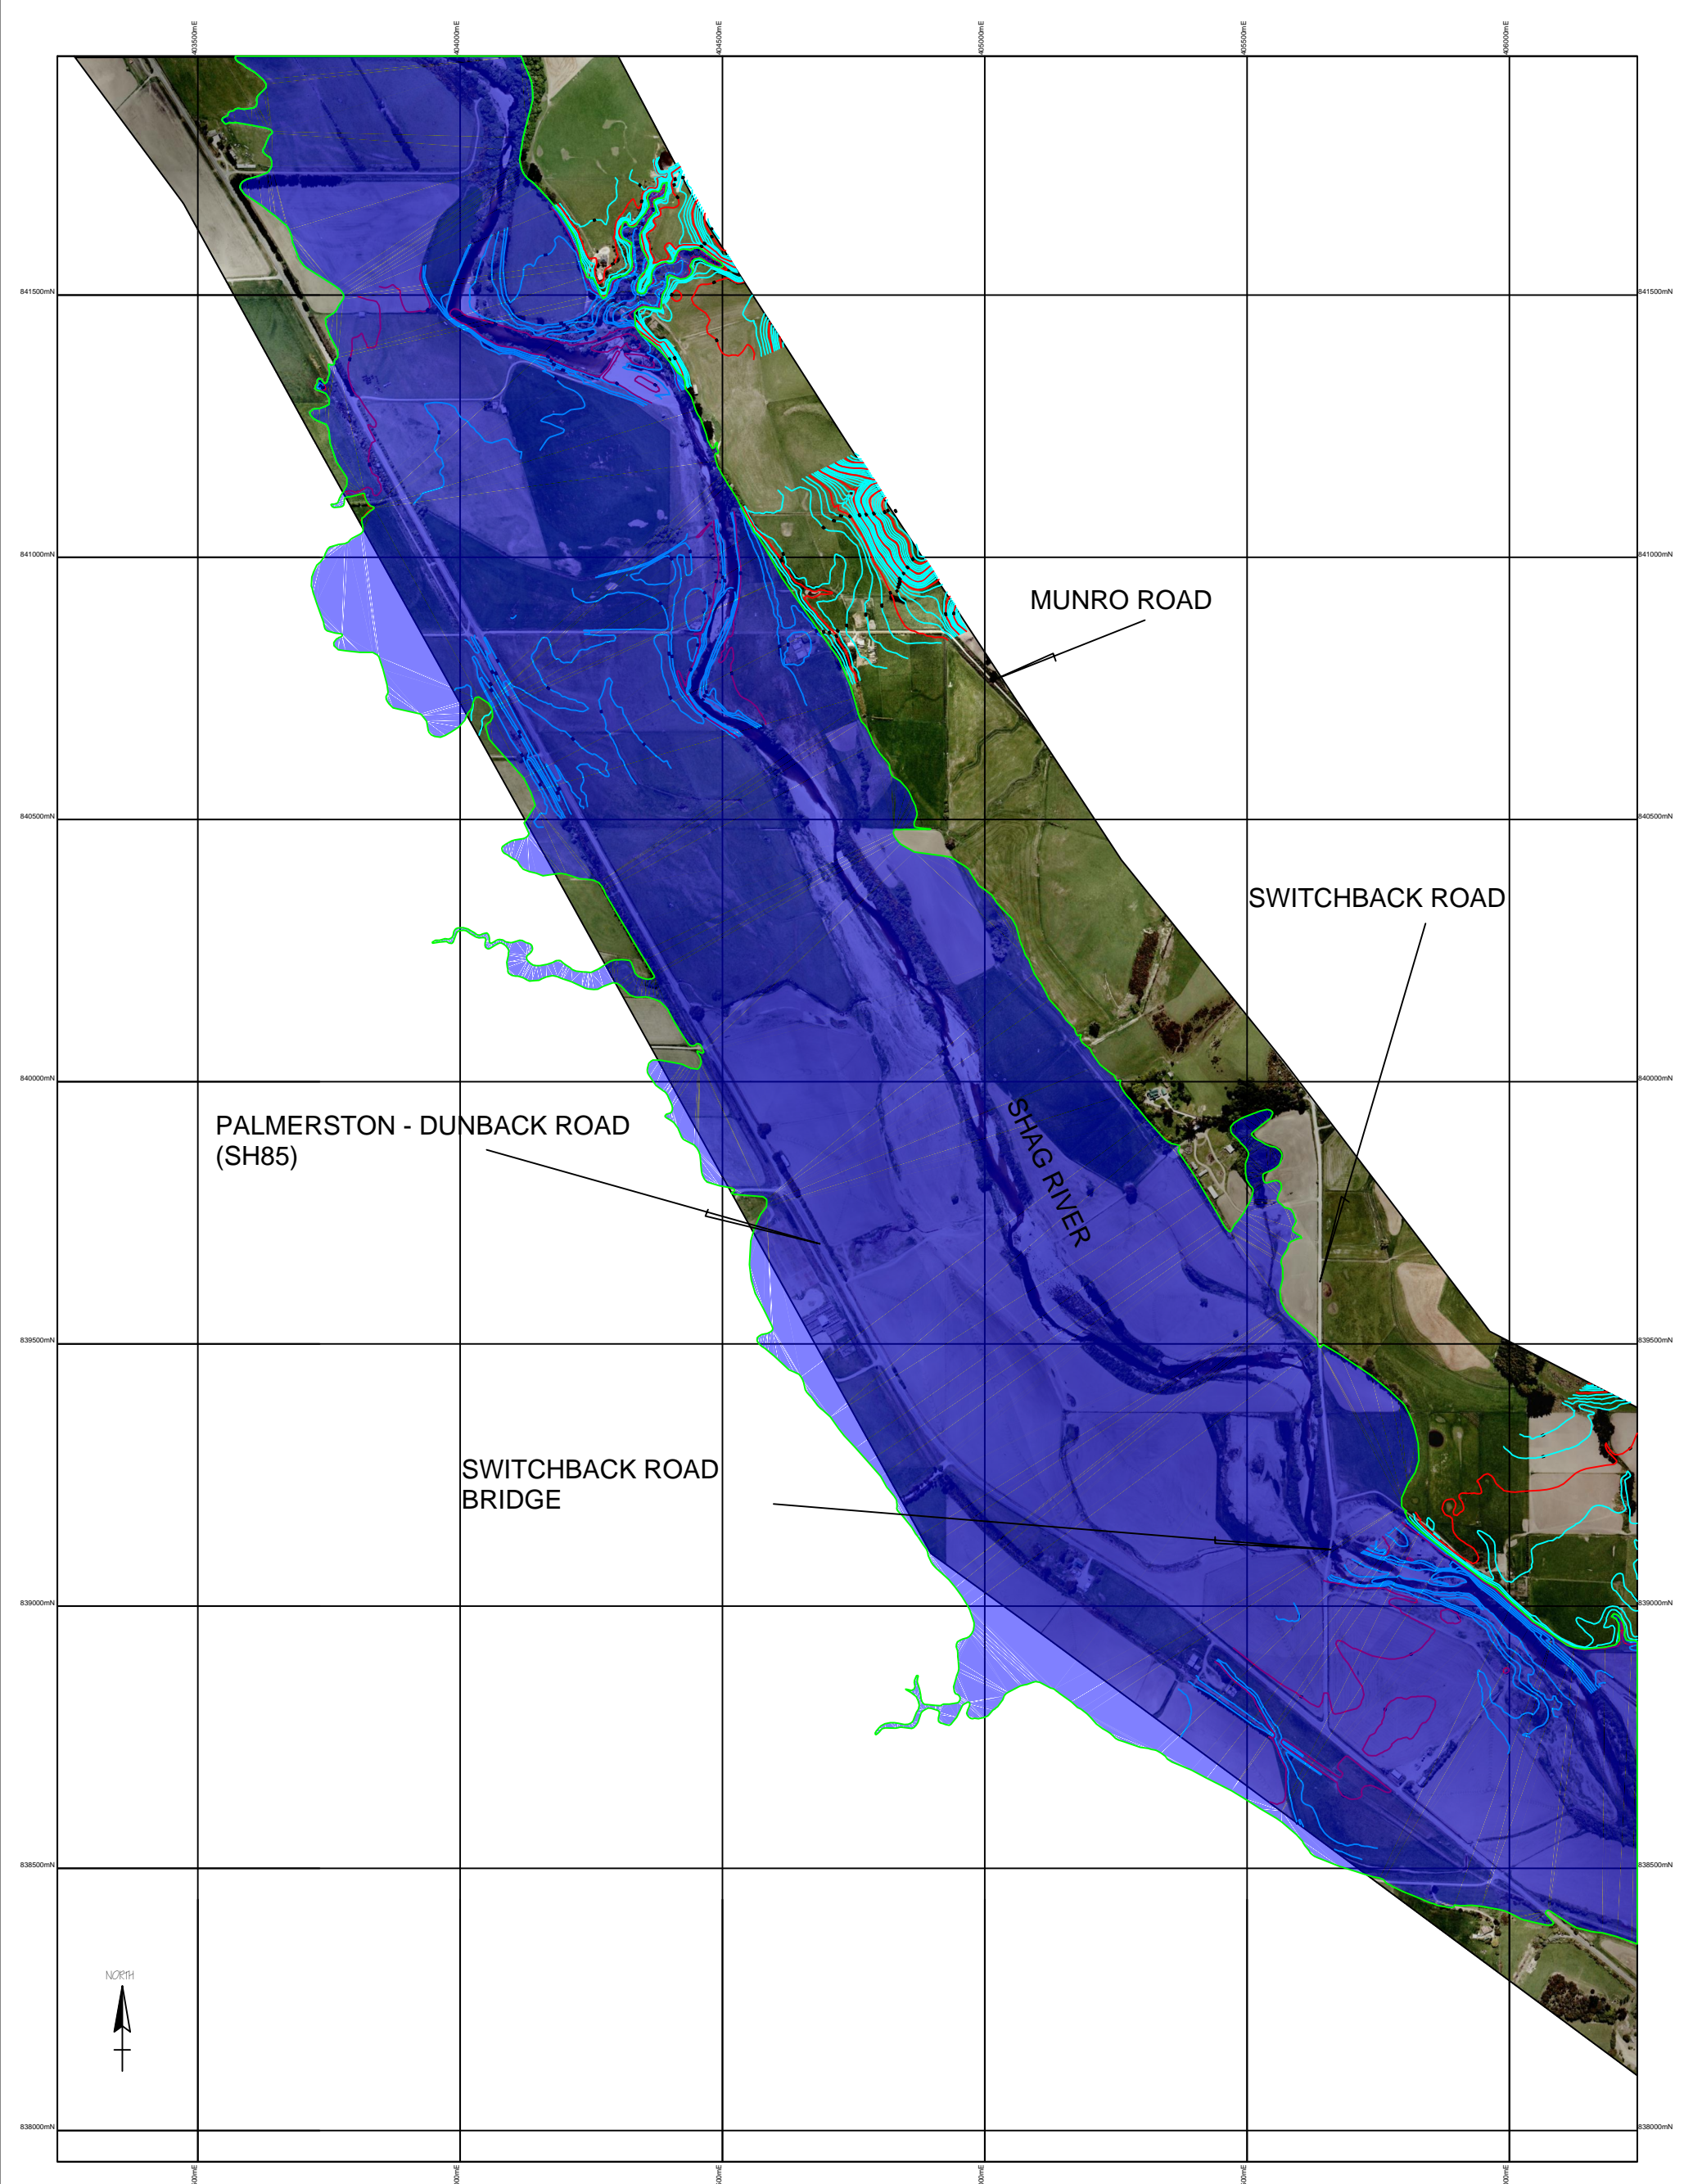
Photogrammetry by: PRECISION AERIAL SURVEYS  
 Photography Date: 13th OCTOBER 2010  
 Negatives Used: N13101936 - N13102167  
 Photo control by: PRECISION AERIAL SURVEYS  
 Co-Ordinate Circuit: OBSERVATION POINT 2000  
 Datum: MACRAES MINE  
 Contour Interval: 1M

APPROXIMATE EXTENT OF INUNDATION
